# WOOD DESTROYING PESTS AND ORGANISMS INSPECTION REPORT

#: 20223305

BUILDING NO. <b>1619</b>	STREET <b>ARMOUR LN.</b>	CITY <b>REDONDO BEACH</b>	ZIP <b>90278</b>	Date of Inspection <b>06/30/2022</b>	NUMBER OF PAGES <b>1 of 6</b>
-----------------------------	-----------------------------	------------------------------	---------------------	---	----------------------------------

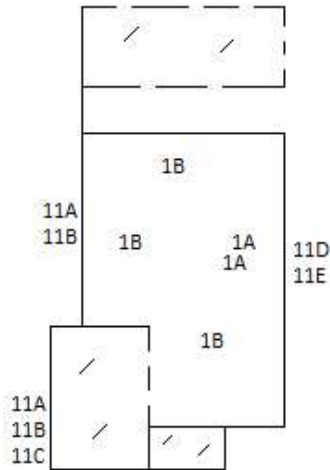
**FINDING:** FUNGUS DAMAGE indicated by 1A on diagram. The FUNGUS DAMAGE was noted in or near: SUBFLOOR.

**FINDING AND RECOMMENDATION: 1B** CELLULOSE DEBRIS noted as 1B on the diagram.

**FINDING:** Evidence of DRYWOOD TERMITES as indicated by 11A on the diagram. Evidence noted in or near: FASCIA, RAFTER.

- ITEM NO. 11B** (Section 1)  
**FINDING:** DRYWOOD TERMITE DAMAGE as indicated by 11B on diagram. The damage was noted in or near: FASCIA, RAFTER.  
**RECOMMENDATION: 11B** Remove and replace damaged wood as necessary with today's available widths and grades.

- ITEM NO. 11C** (Section 1)  
**FINDING:** FUNGUS DAMAGE indicated by 11C on diagram. The FUNGUS DAMAGE was noted in or near: FASCIA, RAFTER.  
**RECOMMENDATION: 11C** Remove and replace damaged wood as necessary with today's available widths and grades.

**NOTE:** Price included in item 11B.
- ITEM NO. 11D** (Section 1)  
**FINDING:** Evidence of DRYWOOD TERMITES as indicated by 11D on the diagram. Evidence noted in or near: DOOR JAMB.

**RECOMMENDATION: 11D** This item included in 11A.
- ITEM NO. 11E** (Section 1)  
**FINDING:** DRYWOOD TERMITE DAMAGE as indicated by 11E on diagram. The damage was noted in or near: DOOR JAMB.

**RECOMMENDATION: 1A** Remove and replace damaged wood as necessary with today's available widths and grades.

**RECOMMENDATION: 1A** We recommend scraping or brushing area and treating with a registered fungicide.

We recommend removing CELLULOSE DEBRIS of rake size or larger.

**RECOMMENDATION: 11A** Fumigate the structure with a fumigant lethal to DRYWOOD TERMITES (Sulfuryl Fluoride). See the occupants fumigation notice for further details. This company is not responsible for delays or schedule changes due to inclement weather or other agencies, nor is it responsible for damage to roof or plants as a result of the fumigation. Refer to the occupant's fumigation notice/preparation sheet (sent separately) for additional information.

**RECOMMENDATION: 11E** Remove and replace damaged wood as necessary with today's available widths and grades.
