Del Fine Home Inspections

Property Inspection Report

Property address: **1936 Homeworth Dr
Rancho Palos Verdes, CA 90275**

Inspection date: **Wednesday, November 19, 2025**

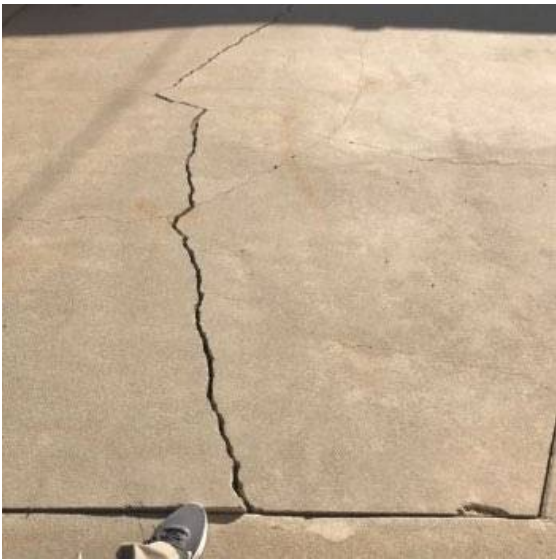
Photo 8-1

Cracks, holes, settlement, heaving and/or deterioration resulting in trip hazards were found in the driveway. For safety reasons, recommend that a qualified contractor repair as necessary.

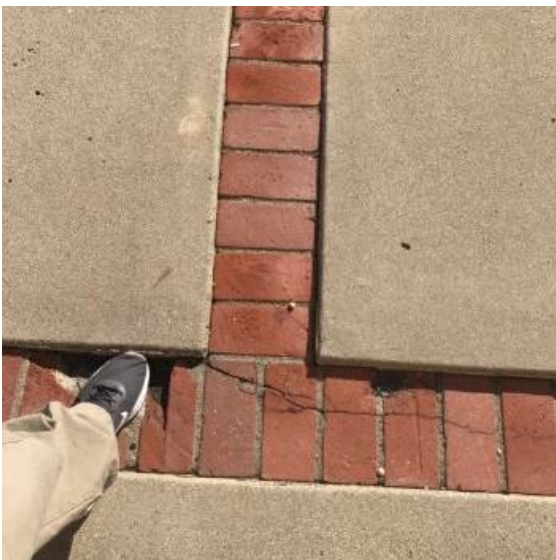
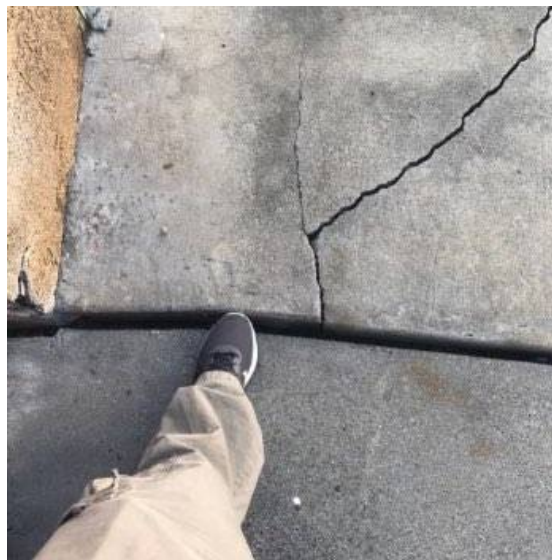
9) 🛠️🔍 Cracks, holes, settlement, heaving and/or deterioration resulting in trip hazards were found in the sidewalks or patios. For safety reasons, recommend that a qualified contractor repair as necessary to eliminate trip hazards.

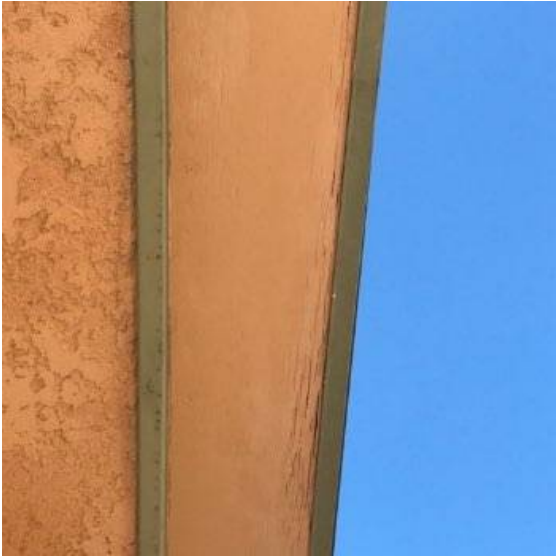
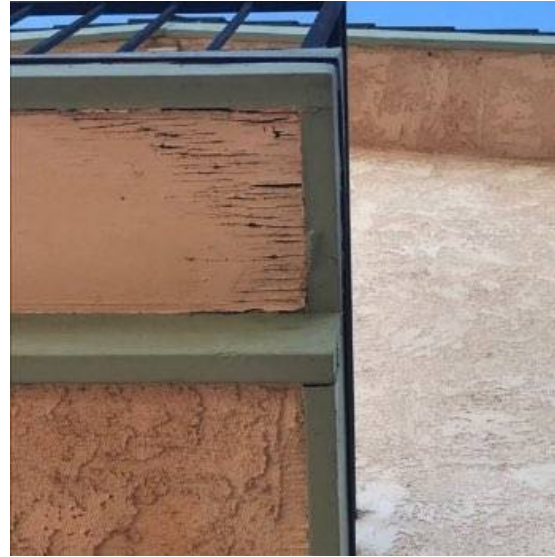
10) 🛠️🔍 Deterioration, damage or fungal rot was found at sheathing below balcony deck. Recommend that a qualified contractor evaluate and repair as necessary.

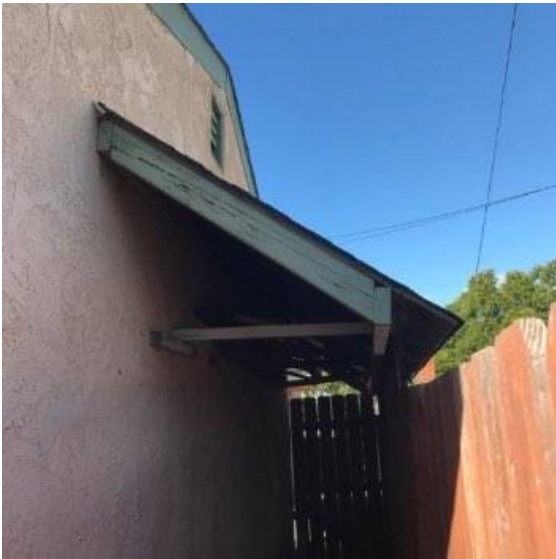
Photo 11-1

One or more covers were deteriorated, substandard and/or non-standard. Recommend that a qualified person repair or replace as necessary.

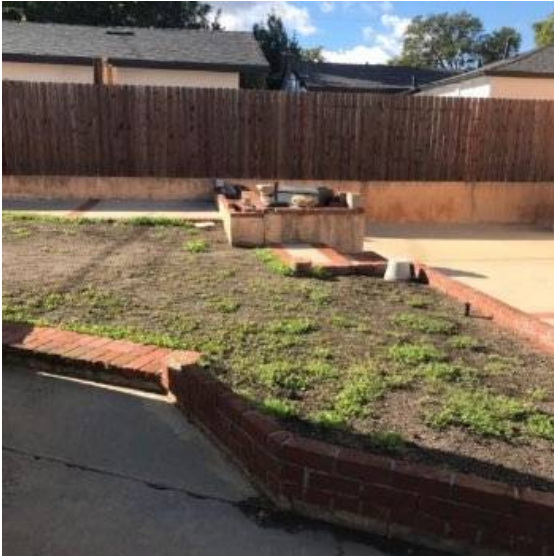
Photo 12-1

Significant amounts of standing water or evidence of past accumulated water were found at one or more locations in the yard or landscaped areas, and no drain was visible. If evidence of past water was found (e.g. silt accumulation or staining), monitor these areas in the future during periods of heavy rain. If standing water exists, recommend that a qualified person repair as necessary. For example, installing one or more drains, or grading soil.

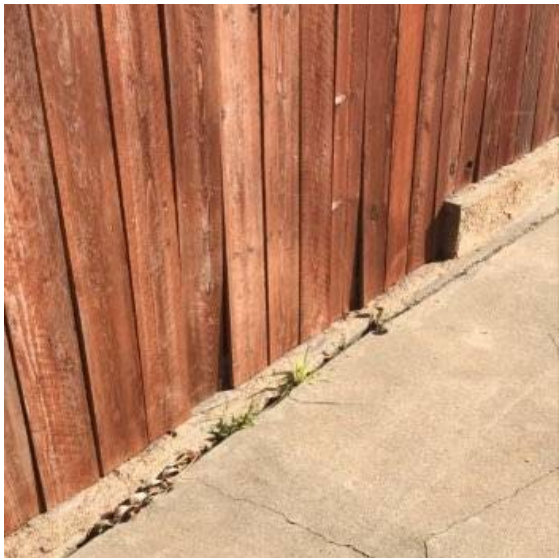
Photo 13-3

13) 🛠️ One or more fences and/or gates were damaged or deteriorated and need repair.

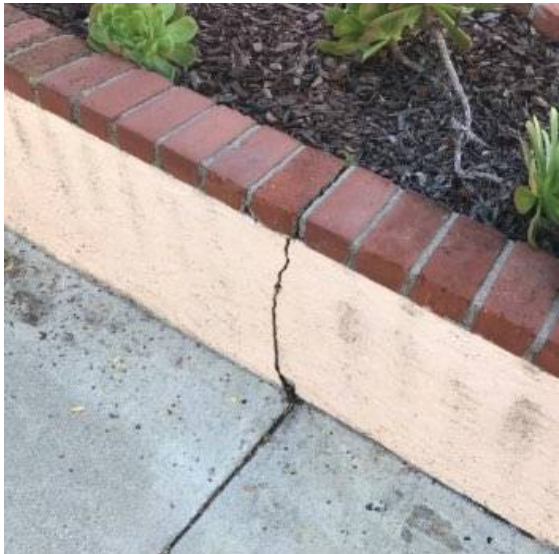
Photo 14-1

14) 🛠️ Cracks and/or deterioration were found in one or more walls. Recommend that a qualified person repair as necessary.

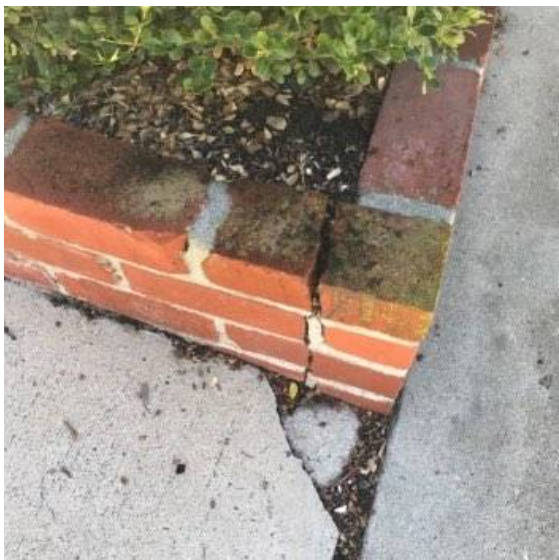
Photo 16-1

One or more planters were damaged or deteriorated. Recommend that a qualified person remove, repair or replace planters as necessary.

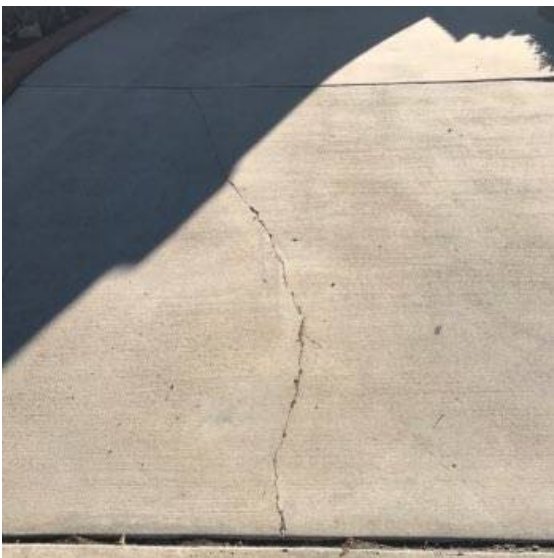
Photo 17-1

Cracks, holes, settlement, heaving and/or deterioration were found in the driveway. Recommend that qualified contractor repair as necessary.

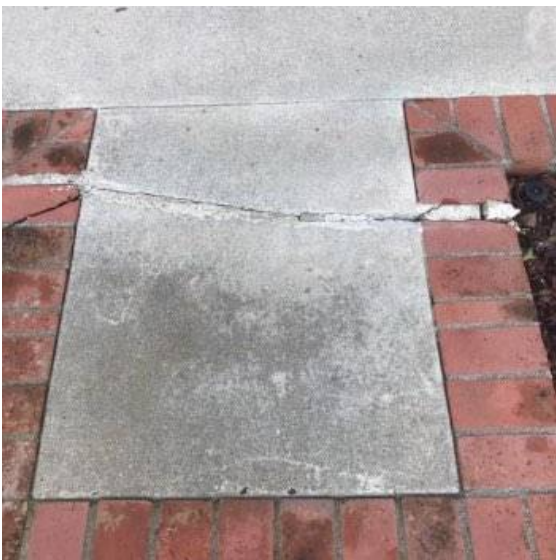
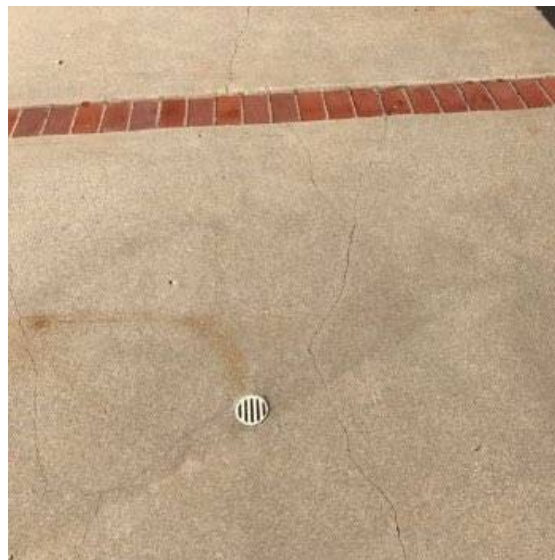
18) 🛠️ Cracks, holes, settlement, heaving and/or deterioration were found in sidewalks and/or patios. Recommend that qualified contractor repair as necessary.

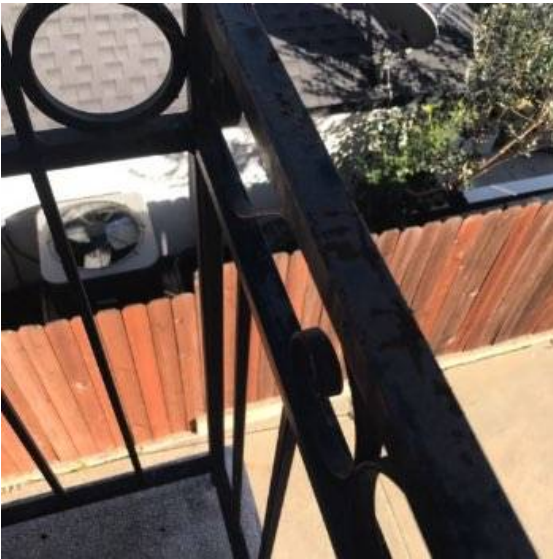
Photo 19-1

19) 🛠️ Guardrails at one or more locations were deteriorated or paint was failing. Recommend that a qualified person repair guardrails as necessary.

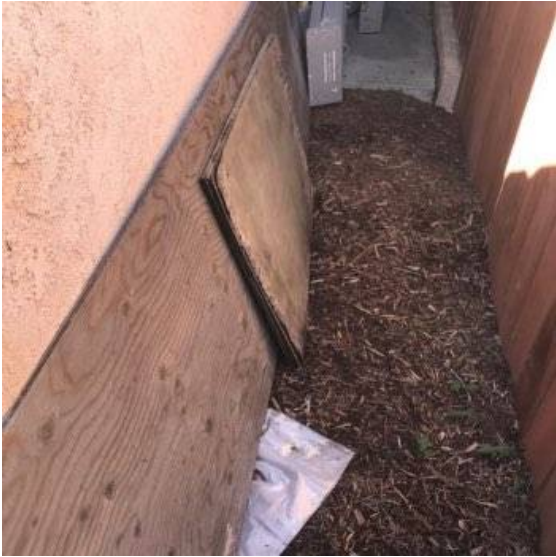
Photo 21-1

21) 🛠️ The soil or grading sloped down towards building perimeters in one or more areas. This can result in water accumulating around building foundations or underneath buildings. At a minimum, monitor these areas, and areas under the structure in the future for accumulated water. If water does accumulate, recommend grading soil so it slopes down and away from buildings with a slope of at least 1 inch per horizontal foot for at least 6 feet out from buildings.

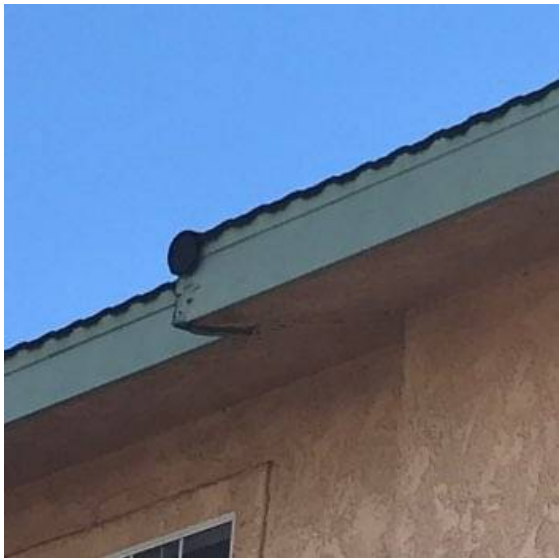
Photo 24-1

24) 🐛 Fungal rot and/or deterioration was found at one or more fascia and/or trim. Conducive conditions for rot should be corrected (e.g. wood-soil contact, reverse perimeter slope). Recommend that a qualified contractor repair as necessary. All rotten wood should be replaced.

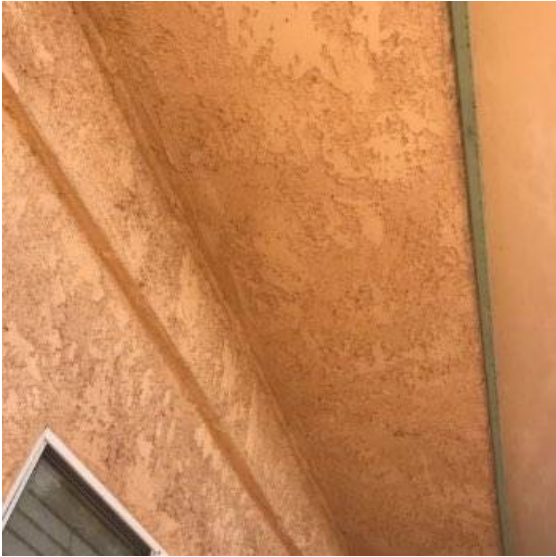
Photo 25-1

25) 🔧🔍 One or more soffits, pop-outs or cantilevered sections of the exterior were not vented. This may result in moisture accumulation. This is a conducive condition for wood-destroying organisms. Recommend that a qualified contractor evaluate and repair as necessary.

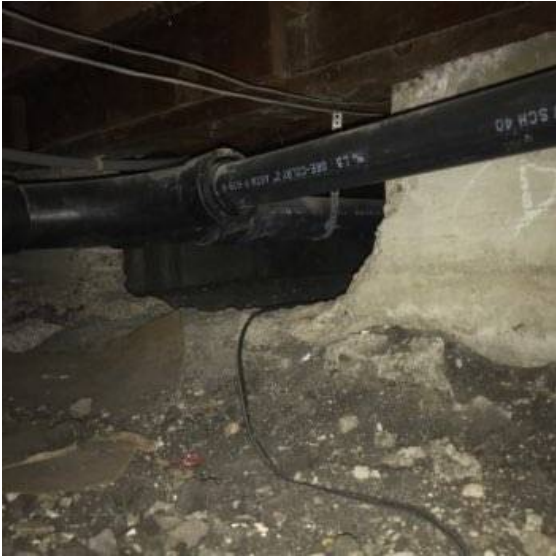
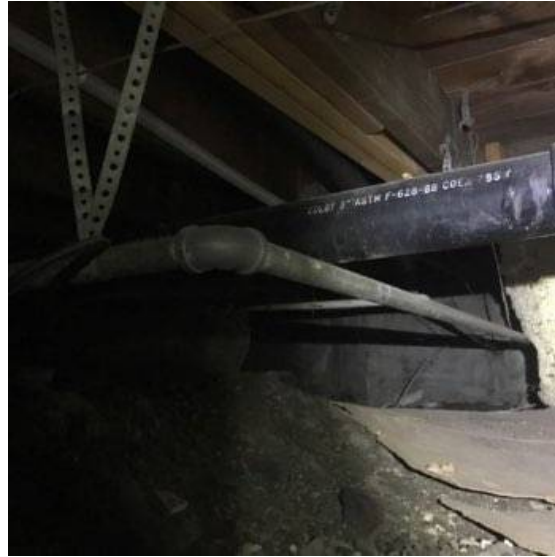
Some modifications, deterioration and/or damage was found at foundation walls. Recommend that a qualified contractor evaluate and repair as necessary.

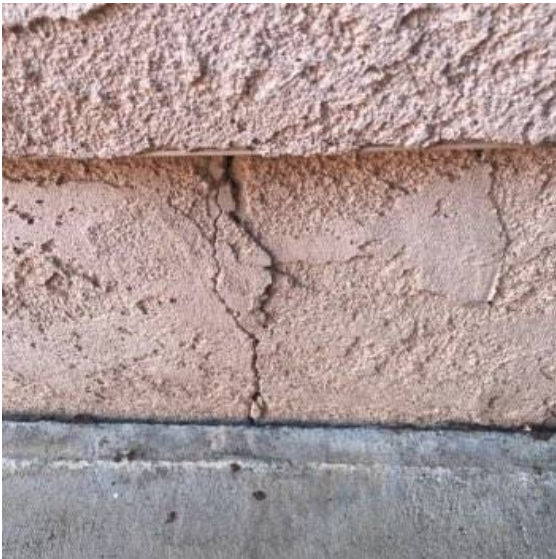
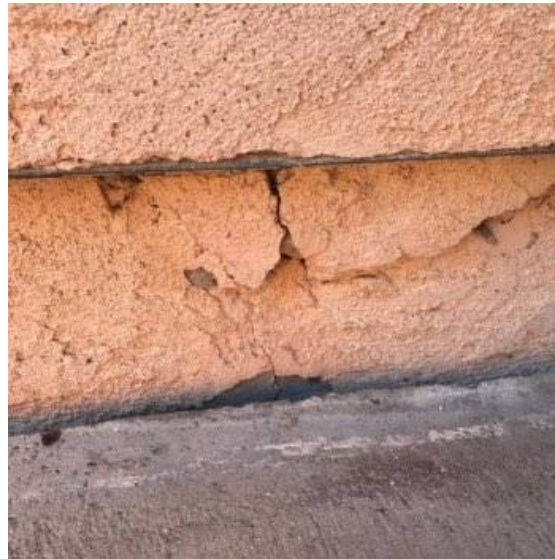
One or more cracks (1/8 inch - 1/4 inch) were found in the foundation. Recommend a qualified contractor evaluate and repair as necessary.

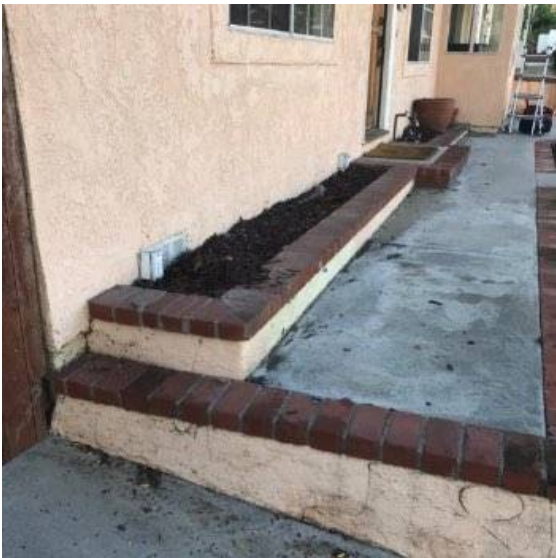
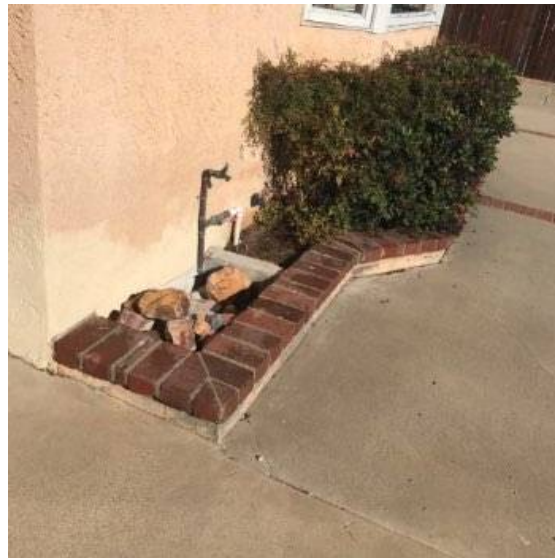
28) 🛠️ One or more planters were attached to the building exterior. This can result in high levels of moisture at the building exterior near planters. It is a conducive condition for wood-destroying organisms. Recommend removing planters, or repairing so there is a gap of at least 2 inches between planters and the building exterior for better airflow and to allow building exteriors to dry quickly.

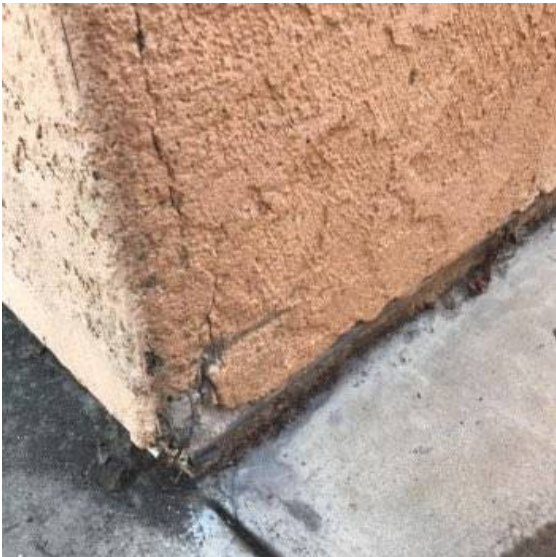
Photo 29-1

29) 🛠️ Cracks, deterioration and/or damage were found in one or more areas of the exterior stucco finish. In damp climates, moisture may enter cracks or damaged areas and further deteriorate the stucco. Also the wall behind the stucco may become damaged from moisture. Note that areas behind the stucco are inaccessible and excluded from this inspection. Recommend that a qualified contractor repair or replace stucco as necessary.

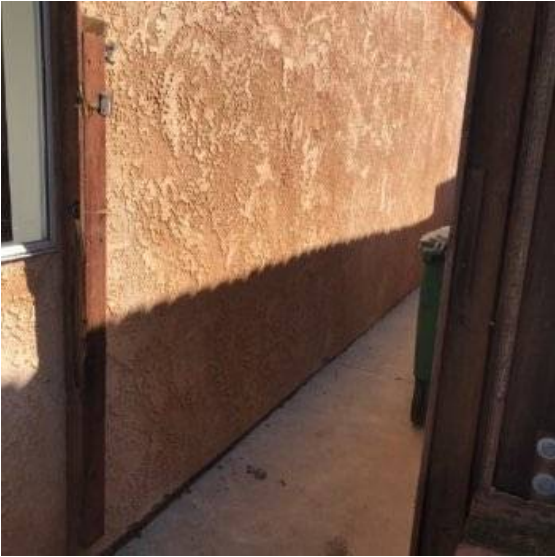
Photo 31-1

31) 🛠️ Fence(s) or gate(s) were attached to or in contact with the building exterior. Such attachments can serve as a pathway for wood-destroying insects and can retain moisture against the exterior after it rains. This is a conducive condition for wood-destroying organisms. Recommend that a qualified person repair as necessary.

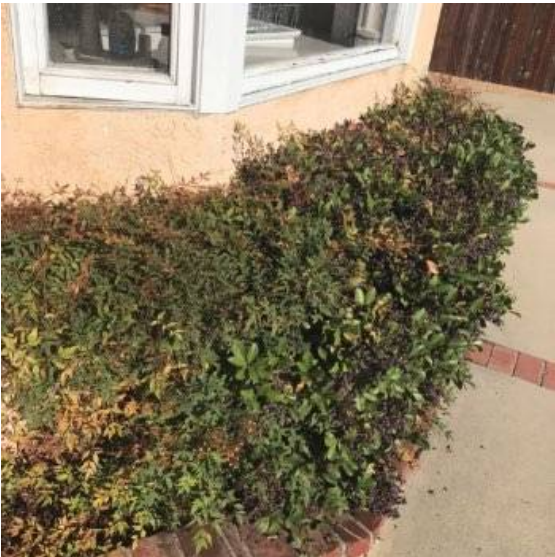
Photo 32-1

32) 🗑️ Vegetation such as trees, shrubs and/or vines was in contact with or close to the building exterior. Vegetation can serve as a pathway for wood-destroying insects and can retain moisture against the exterior after it rains. This is a conducive condition for wood-destroying organisms. Recommend pruning, moving or removing vegetation as necessary to maintain at least 6 inches of space between it and the building exterior. A 1-foot clearance is better.

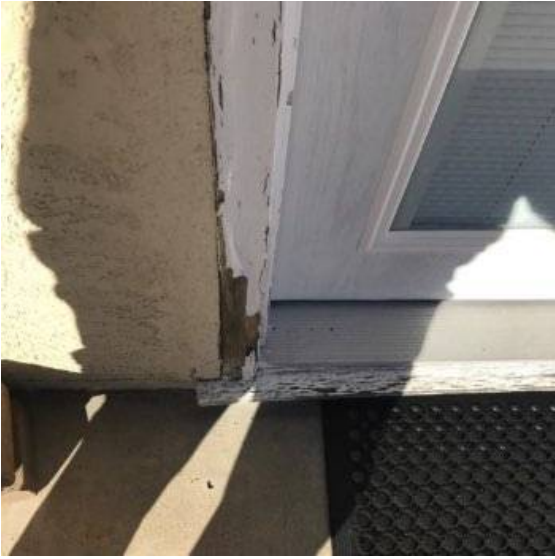
Photo 33-1

33) 🗑️ Some areas of the exterior paint or stain finish were incomplete and/or substandard (e.g. primed only, too few coats). Recommend that a qualified contractor prep (e.g. clean, scrape, sand, prime, caulk) and repaint or restain the exterior where necessary and per standard building practices. Any repairs needed to the siding or trim should be made prior to this.

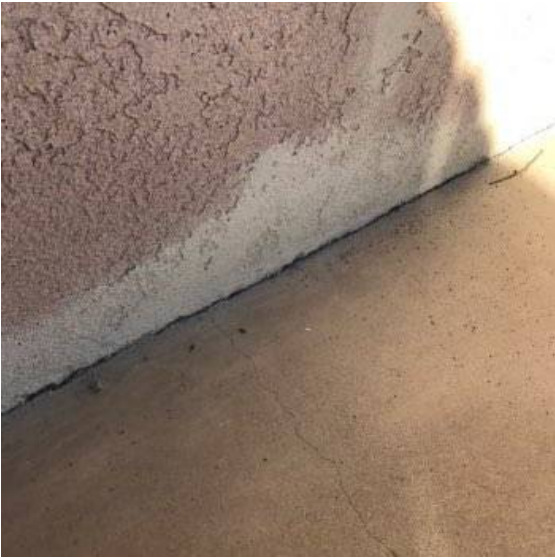
Photo 34-1

Caulk was missing in some areas. For example, where sidewalk meets structure. Recommend that a qualified person renew or install caulk as necessary. Where gaps are wider than 1/4 inch, an appropriate material other than caulk should be used. For more information, visit: <https://www.reporhost.com/?CAULK>

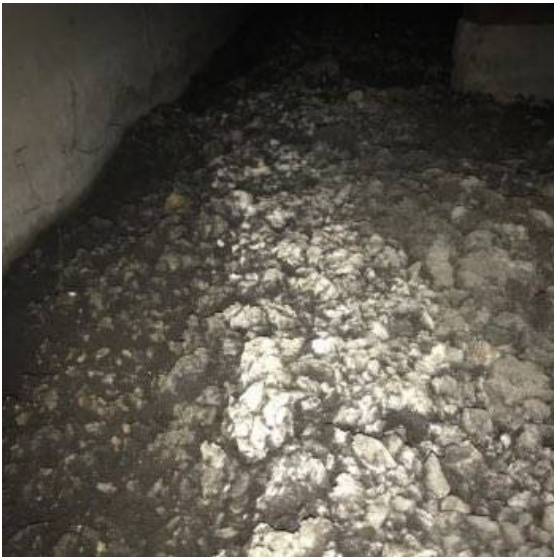
Photo 37-1

Evidence of prior water intrusion or accumulation was found in one or more sections of the crawl space. For example, sediment stains on the vapor barrier or foundation, and/or efflorescence on the foundation. Accumulated water is a conducive condition for wood-destroying organisms and should not be present in the crawl space. Recommend that the client review any disclosure statements available and ask the property owner about past accumulation of water in the crawl space. The crawl space should be monitored in the future for accumulated water, especially after heavy and/or prolonged periods of rain. If water is found to accumulate, then recommend that a qualified contractor who specializes in drainage issues evaluate and repair as necessary. Typical repairs for preventing water from accumulating in crawl spaces include:

- Repairing, installing or improving rain run-off systems (gutters, downspouts and extensions or drain lines)
- Improving perimeter grading
- Repairing, installing or improving underground footing and/or curtain drains

Ideally, water should not enter crawl spaces, but if water must be controlled after it enters the crawl space, then typical repairs include installing trenches, gravity drains and/or sump pump(s) in the crawl space.

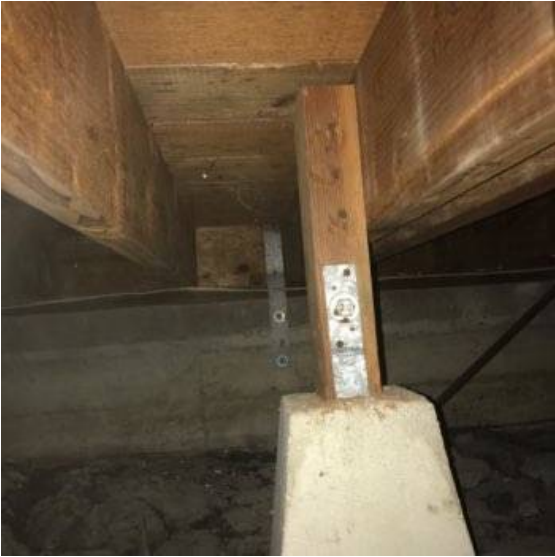
Photo 46-1

One or more beams, joist, post and/or pier were damaged, non-standard or substandard. Floors and/or the structure can deflect, resulting in non-level floors or damage to the structure. Recommend that a qualified contractor evaluate and repair per standard building practices.

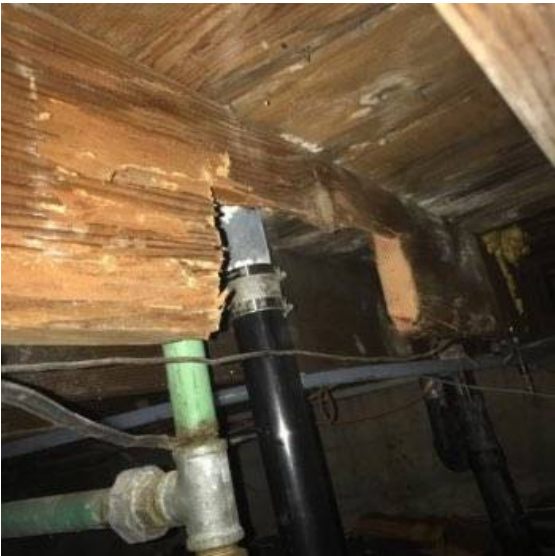
Photo 46-3 One or more joists were notched or had holes cut in them in such a way as to significantly weaken the joist(s)

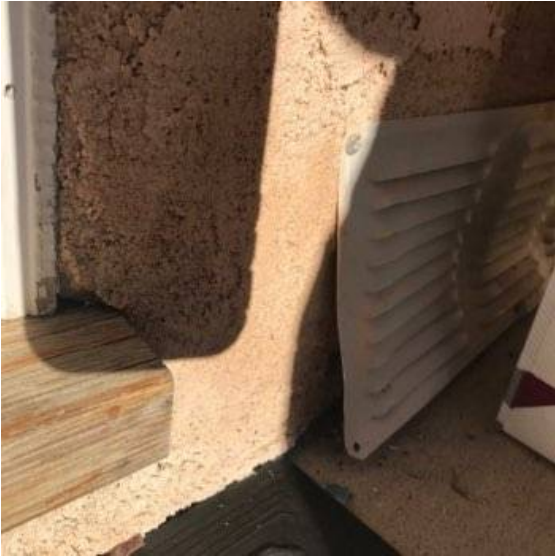
Photo 47-1

47) 🛠️ The crawl space vent covers were loose at one or more locations. Recommend that a qualified person repair as necessary.

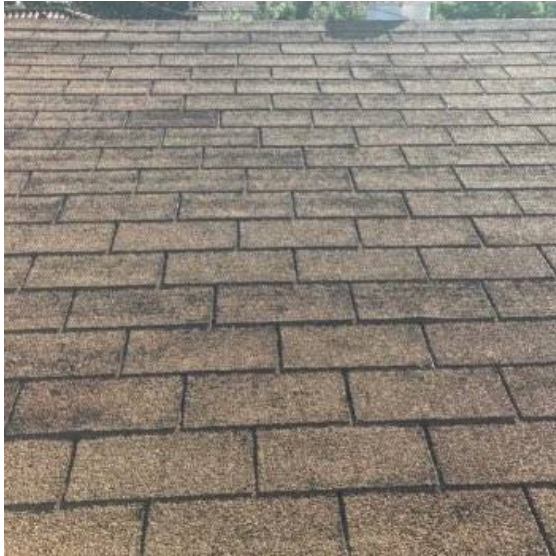
Photo 51-1

(Garage) The roof surface was significantly deteriorated and appeared to be at or beyond its service life. It needs replacing now. This is a conducive condition for wood-destroying organisms. Consult with a qualified contractor to determine replacement options. Note that some structural repairs are often needed after old roof surfaces are removed and the structure becomes fully visible. Related roofing components such as flashings and vents should be replaced or installed as needed and per standard building practices. No prediction of future performance or warranties can be offered.

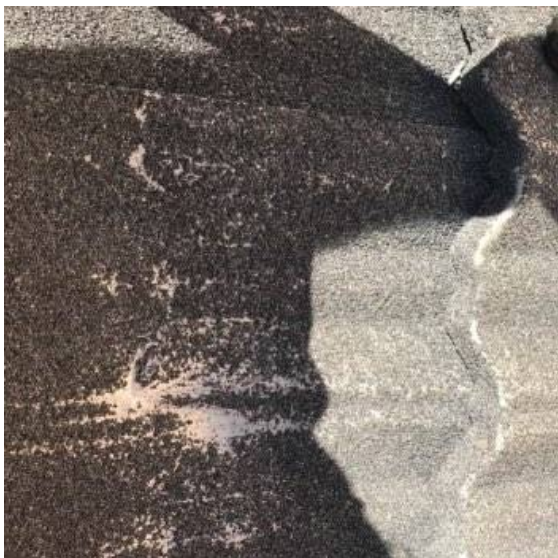
Photo 53-1

Many metal roof tiles were dented and/or damaged. Leaks may occur as a result. Recommend that a qualified contractor repair as necessary.

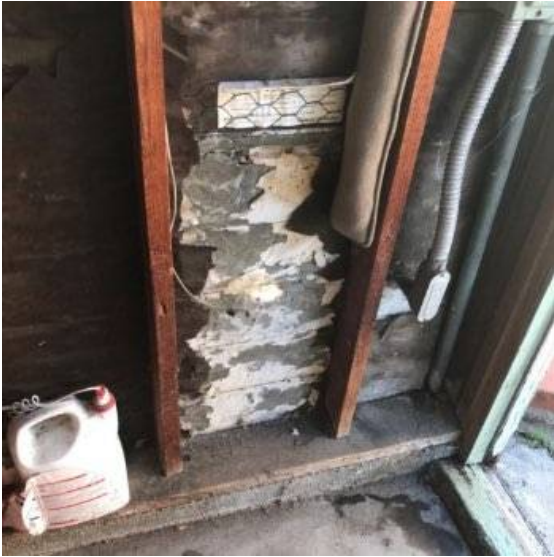
Photo 61-1

Water resistant membrane was damaged at one or more locations. This may result in water intrusion. Recommend that a qualified contractor evaluate and repair as necessary.

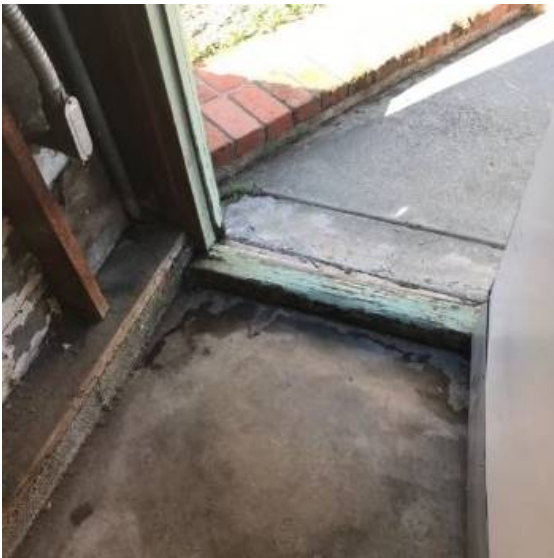
Photo 62-1

Evidence of prior water intrusion or accumulation was found in one or more sections of the garage/storage area. For example, sediment stains on the vapor barrier or foundation, and/or efflorescence on the foundation. Recommend that a qualified contractor evaluate and repair as necessary.

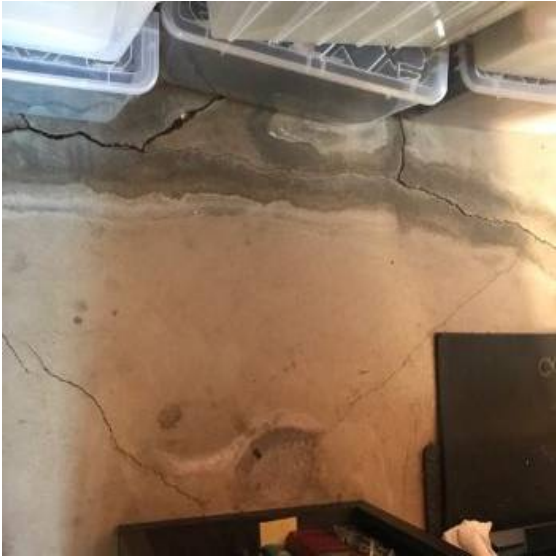
Photo 63-1

Cracks, heaving and/or settlement were found in one or more sections of concrete slab floors. Recommend that a qualified contractor repair as necessary.

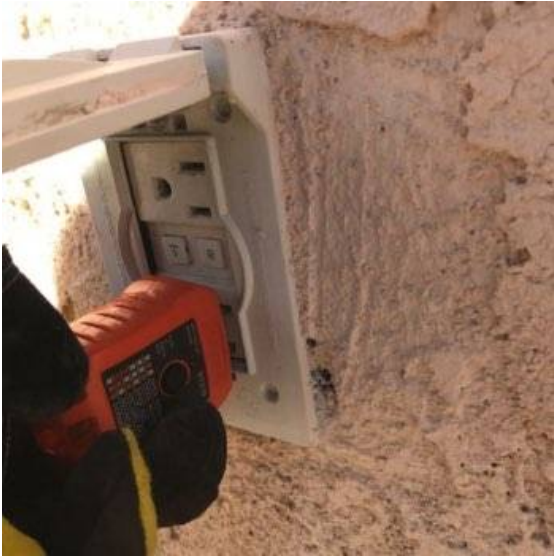
Photo 68-1

One or more ground fault circuit interrupter (GFCI) devices protecting receptacles at the building exterior or bathroom would not reset or trip when tested. This is a potential shock hazard. Recommend that a qualified electrician evaluate and repair as necessary.

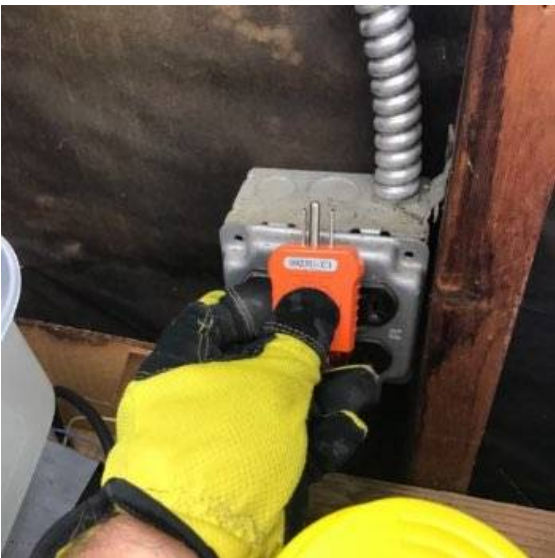
Photo 78-1

78) 🔍 (Garage) One or more electric receptacles appeared to have no power. Recommend asking the property owner about this. Switches may need to be operated or GFCI/AFCI protection may need to be reset to make some receptacles energized. If necessary, recommend that a qualified electrician evaluate and repair.

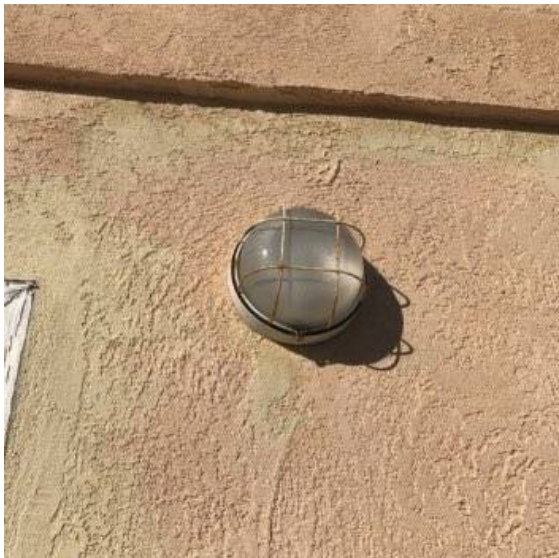
Photo 82-1

One or more light fixtures were inoperable (didn't turn on when nearby switches were operated). Recommend further evaluation by replacing bulbs and/or consulting with the property owner. If replacing bulbs doesn't work and/or no other switch(es) can be found, then recommend that a qualified electrician evaluate and repair or replace light fixtures as necessary.

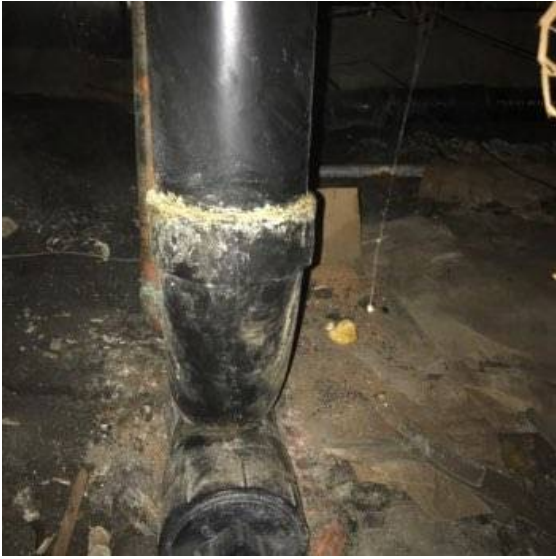
Photo 84-1

Stains were found in one or more sections of drain and/or waste lines, but no active leaks were found near the stains. This may indicate that past leaks have occurred. Consult with the property owner about this, and either monitor these areas in the future for leaks or have a qualified plumber evaluate and repair as necessary.

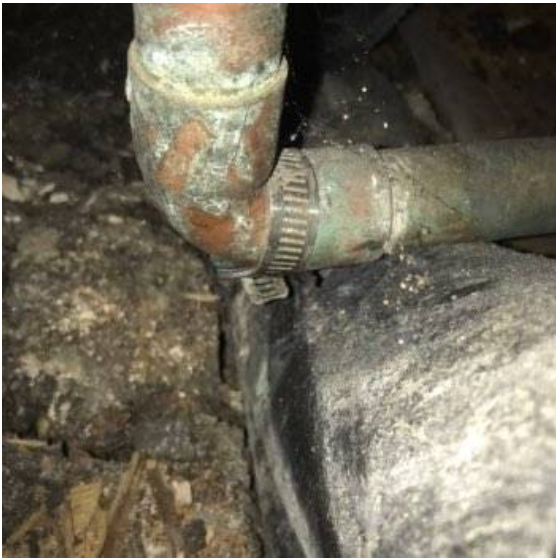
Photo 85-1 Crawl space

Water supply lines had substandard repairs in one or more areas. Recommend that a qualified plumber evaluate and repair per standard building practices.

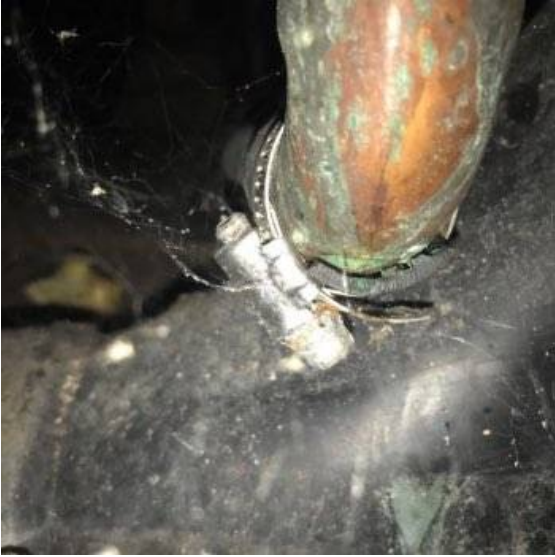
Photo 88-1 Crawl space

One or more clamps were installed on copper water supply pipes and the clamps were made with a metal other than copper (e.g. steel, brass). Contact between such dissimilar metals causes corrosion and can damage the water supply pipes. Recommend that a qualified person repair as necessary.

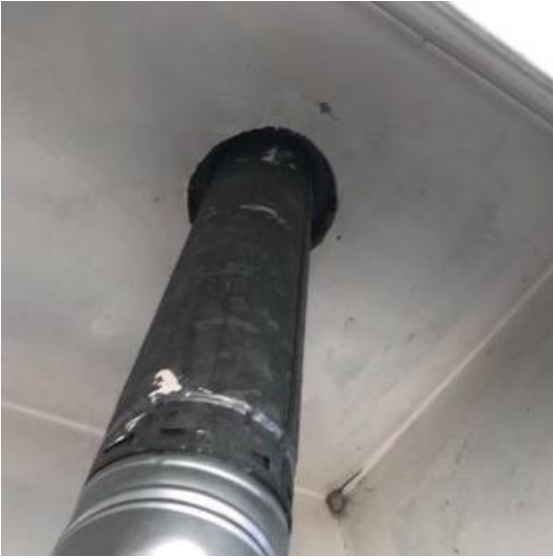
Photo 92-1

Combustible materials was in contact with water heater flue pipe/venting. This is a fire hazard. Recommend having a qualified contractor evaluate and repair as necessary.

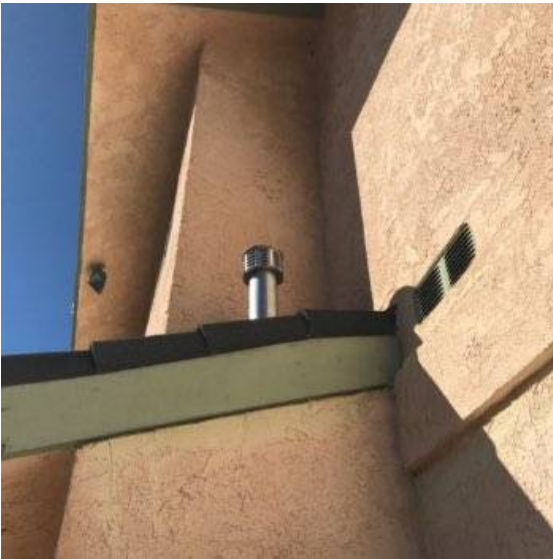
Photo 93-1

93) 🛠️ The water heater flue pipe did not terminate above the highest roof surface. This is a potential hazard. A qualified person should repair per standard building practices.

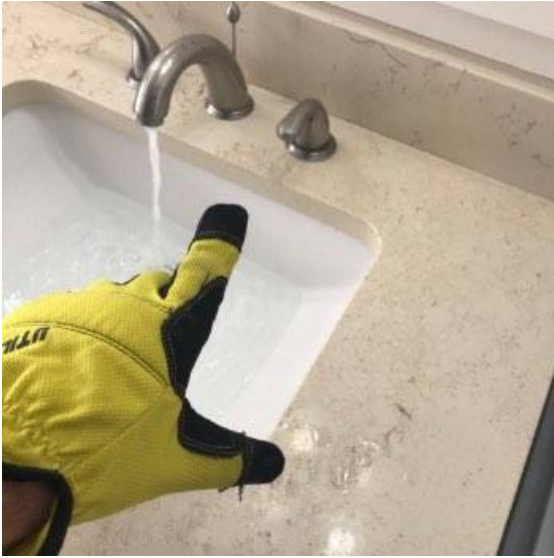
Photo 102-1

The hot and/or cold water supply flow for the sink at location(s) #A was low or inoperable. Recommend that a qualified plumber evaluate and repair as necessary.

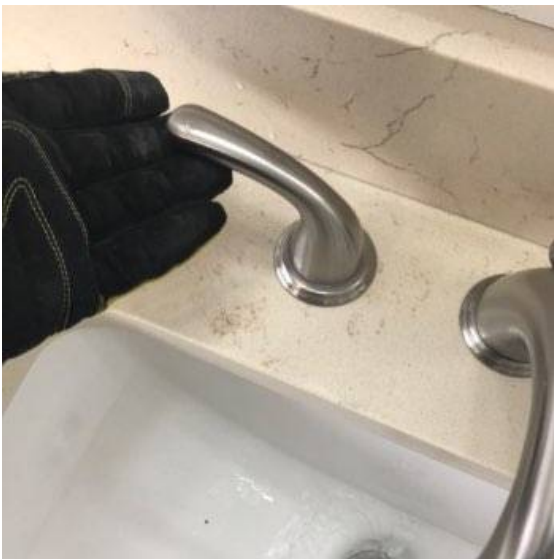
**Photo 105-1**

One or more sink faucet handles at location(s) #A were loose. Recommend that a qualified person repair or replace as necessary.

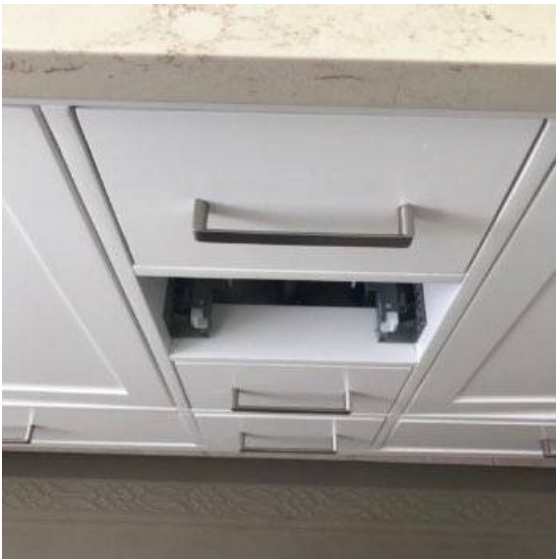
Photo 108-1

One or more cabinets, drawers and/or cabinet doors at location(s) #A were damaged or deteriorated. Recommend that a qualified person repair or replace as necessary.

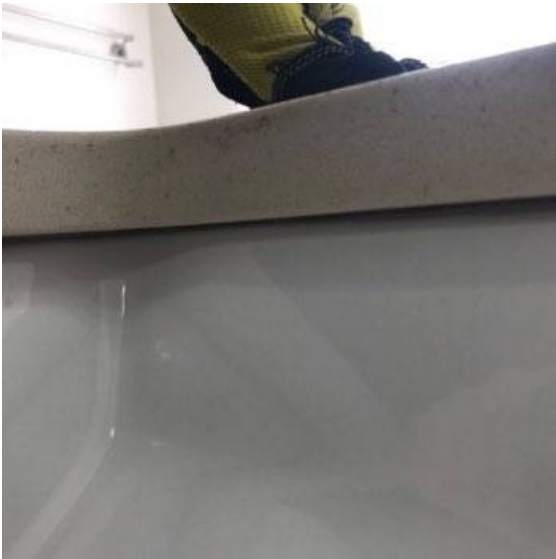
Photo 109-1

Gaps, no caulk, or substandard caulking were found around the sink at location(s) #A. Water can penetrate these areas and cause damage. Recommend that a qualified person repair as necessary. For example, by installing or replacing caulk.

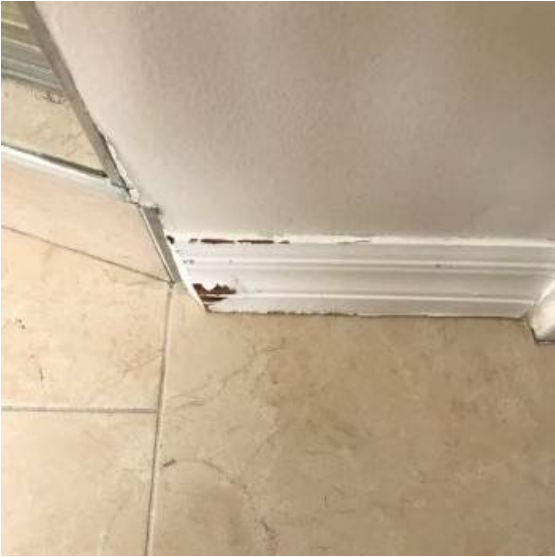
Photo 110-1

Trim at location(s) #A and B was deteriorated or missing. Recommend that a qualified contractor repair as necessary.

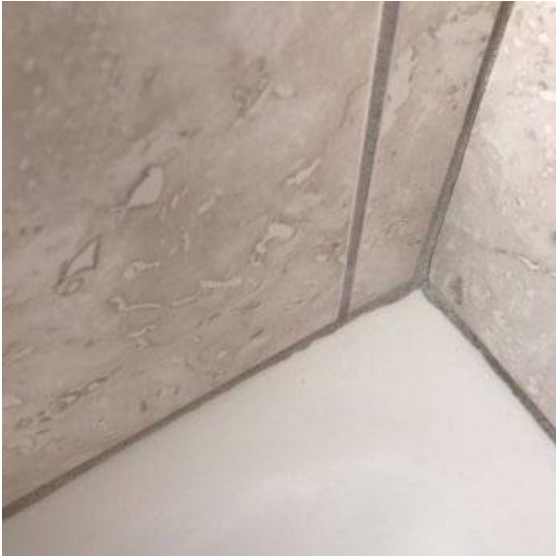
Photo 113-1

Tile and/or grout in the bathtub surround at location(s) #B and C was deteriorated (e.g. loose or cracked tiles, missing grout) or substandard. Water can damage the wall structure as a result. Recommend that a qualified contractor repair as necessary.

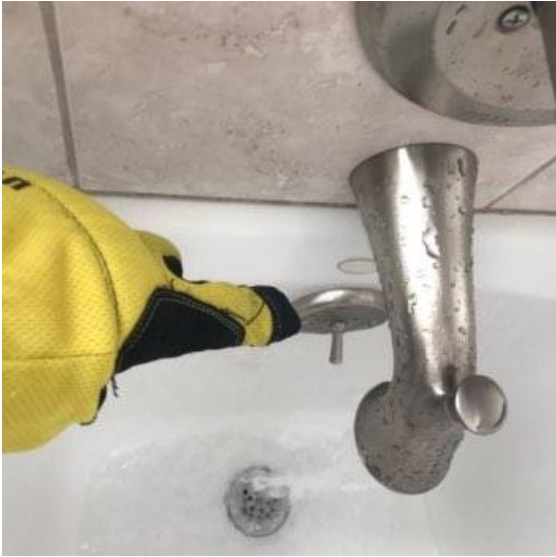
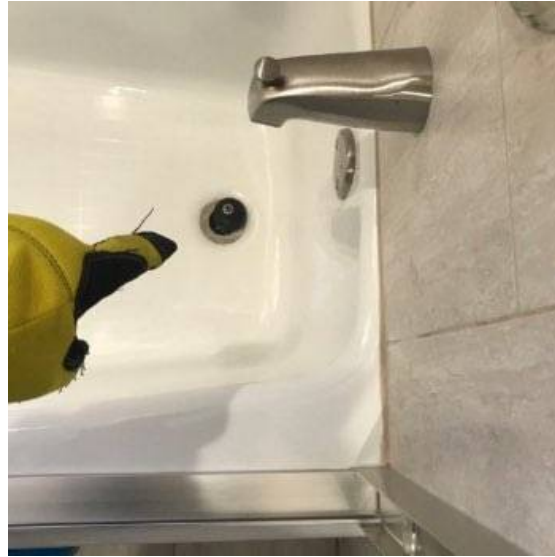
The bathtub drain stopper mechanism at location(s) #B and C was inoperable, loose and/or difficult to operate. Recommend that a qualified person repair or replace as necessary.

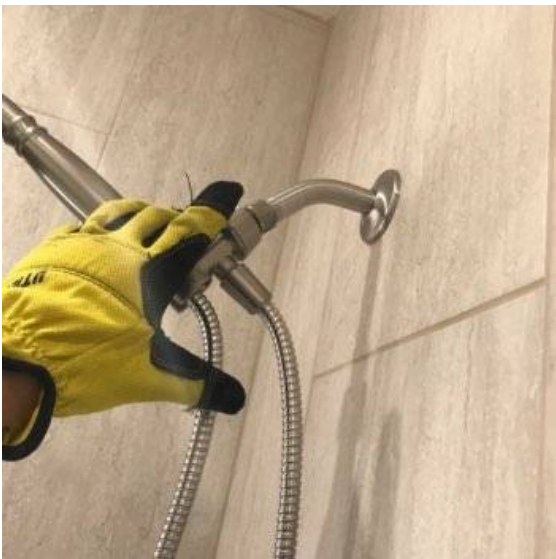
Photo 115-1

115) 🛠️ The shower arm at location(s) #C was loose. Recommend that a qualified person repair as necessary.

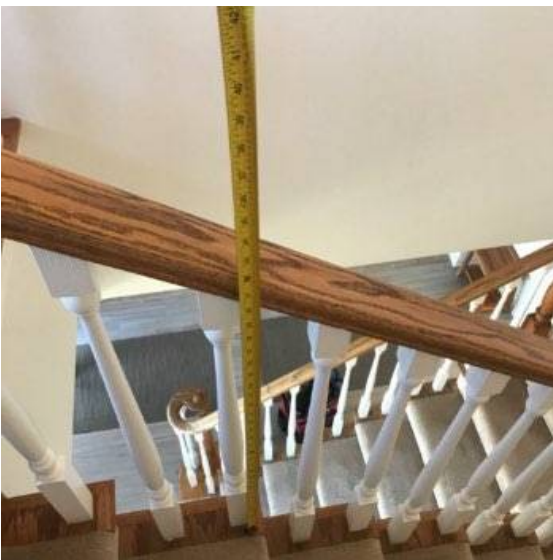
Photo 121-1

Guardrails at one or more locations with drop-offs higher than 30 inches were too low. This poses a fall hazard. Guardrails should be at least 36 inches in height. Recommend that a qualified contractor replace or repair guardrails per standard building practices.

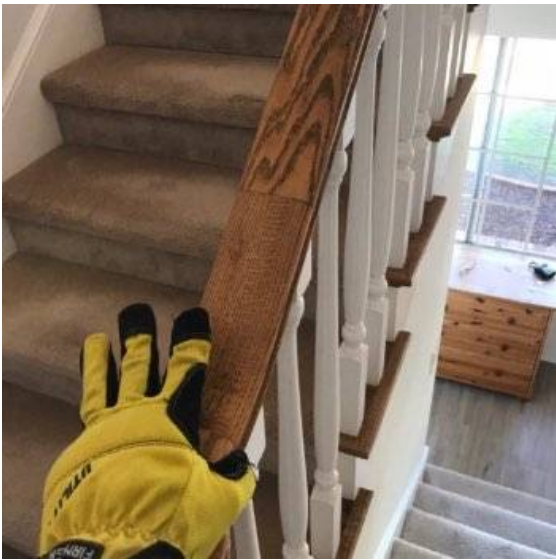
Photo 122-1

Guardrails at one or more locations with drop-offs higher than 30 inches were loose and/or wobbly, and pose a fall hazard. Recommend that a qualified person repair guardrails as necessary.

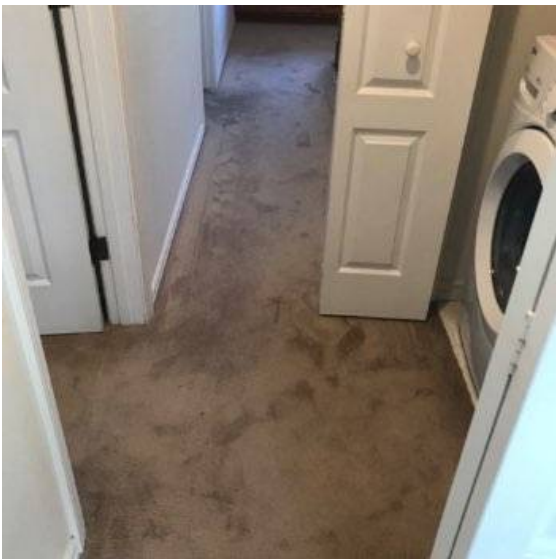
Photo 123-1

Floors in one or more areas were not level. Recommend that a qualified contractor evaluate and repair as necessary.

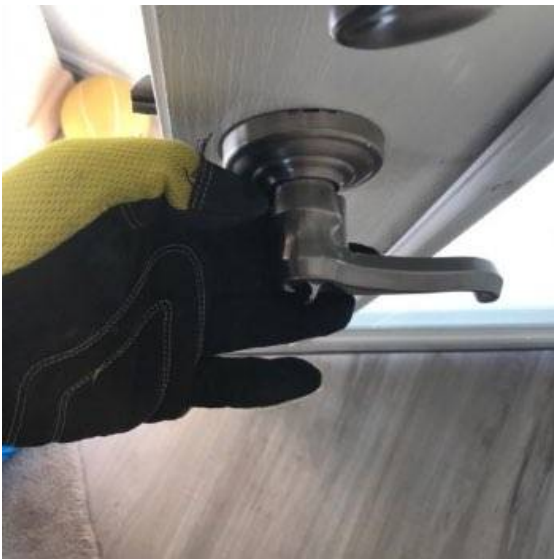
Photo 125-1

Some exterior door hardware, including locksets were loose. Recommend that a qualified person repair or replace as necessary.

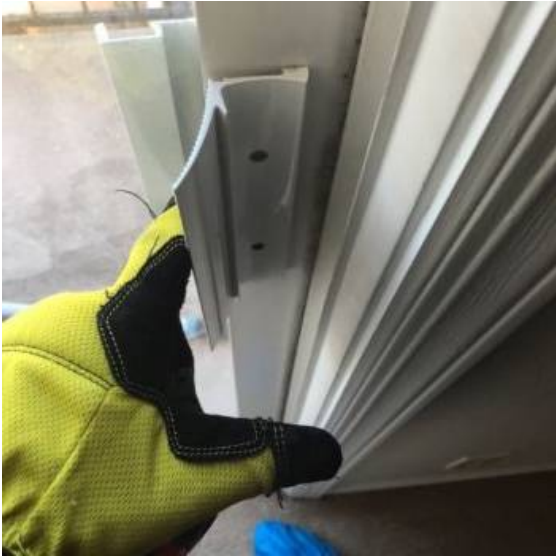
Photo 126-1

The lock mechanisms on one or more sliding glass doors were difficult to operate. Recommend that a qualified person repair as necessary.

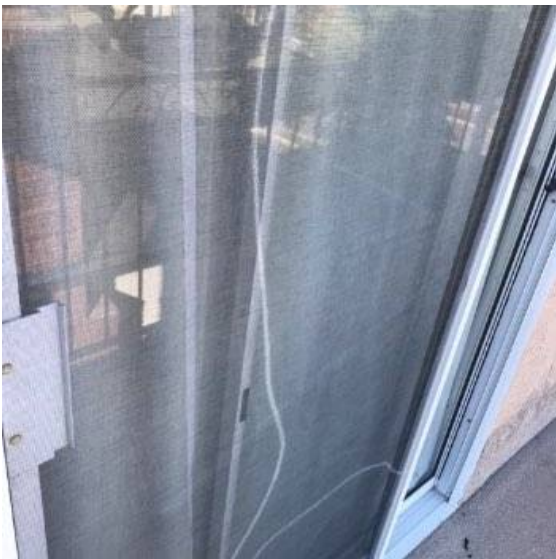
Photo 127-1

127) 🛠️ One or more screen doors were deteriorated. Recommend that a qualified person repair as necessary.

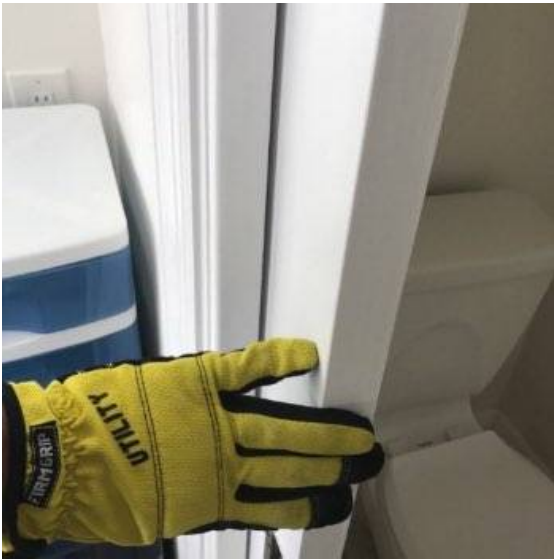
Photo 129-1

One or more "pocket" doors were stuck or difficult to operate or did not fully open. Recommend that a qualified person repair as necessary.
