**Inspection Report**

Property Address: 37523 Teal St Palmdale CA 93552

**C.L.M HOME INSPECTIONS**

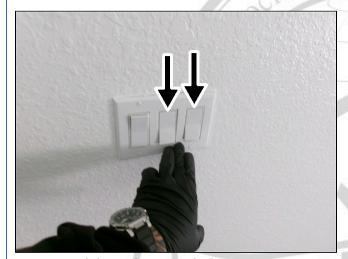
6.4~(4) Both switches at master bathroom control the light and fan at time of inspection. Switch usually controls either light or switch. Recommend further evaluation and repair by a qualified or licensed electrician.

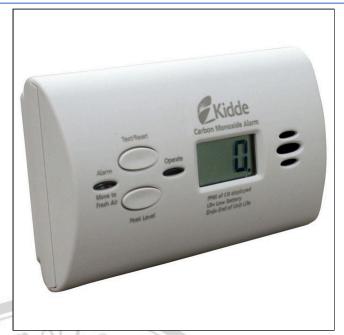
6.7 Item 1(Picture) General View

6.7 There is no carbon monoxide detector found in interior home. It is recommended that one be installed according to the manufacturer's instructions by a qualified person.

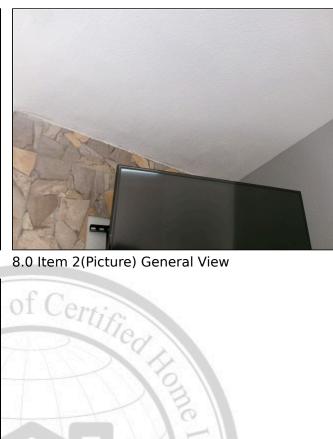
8.0 Item 2(Picture) General View

8.0 Possible moisture damage followed with repair was observed on interior ceiling at time of inspection. Paint covering was used in areas, in result difficult to determine underneath damage, staining. Recommend accordingly a qualified or licensed contractor evaluate and make repairs, repairs may include removing all painted repair at drywall ceiling, further evaluating possible moisture presence and replacing affected drywall back to it's original

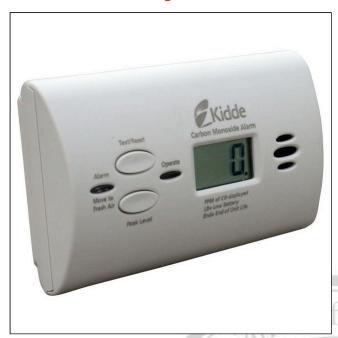
6.7 Item 1(Picture) General View

be installed according to the manufacturer's instructions by a qualified person.
