Inspection Report

Property Address:
618 Prospect Ave
Hermosa Beach CA 90254

Ferguson Home Inspections

Date: 10/13/2022	Time: 02:00 PM	Report ID: 10132022Prospect
Property: 618 Prospect Ave Hermosa Beach CA 90254	Customer: Wendy & Scott Fletcher	Real Estate Professional: Amy Teitelbaum

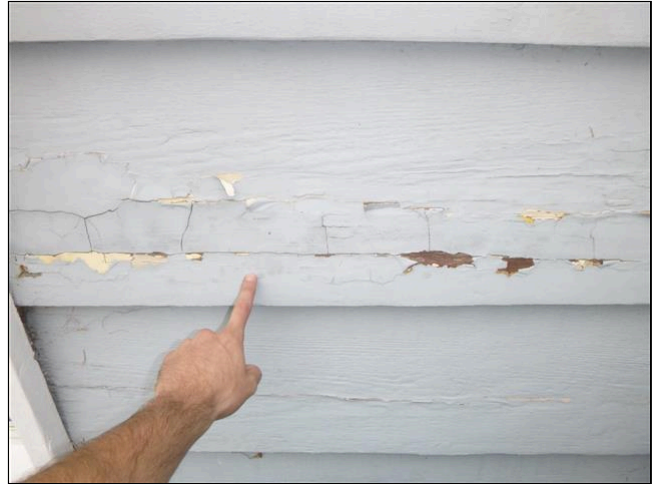
1.4 Item 1 (Picture)

1.4 (1) Paint blistering, peeling and wood deterioration noted at various wood siding areas. Suggest review with a licensed termite company and/or a licensed contractor for repair/replacement costs as needed.

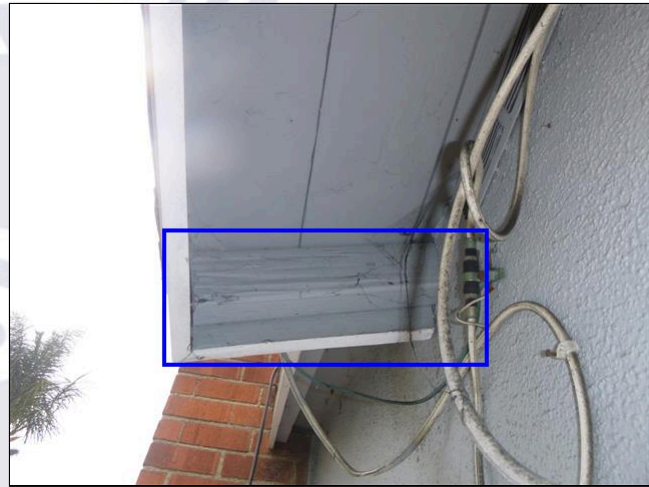
1.5 Item 1 (Picture)

1.5 Wood deterioration noted at various trim areas. Suggest review with termite company and/or a licensed contractor and repair/replace as needed.

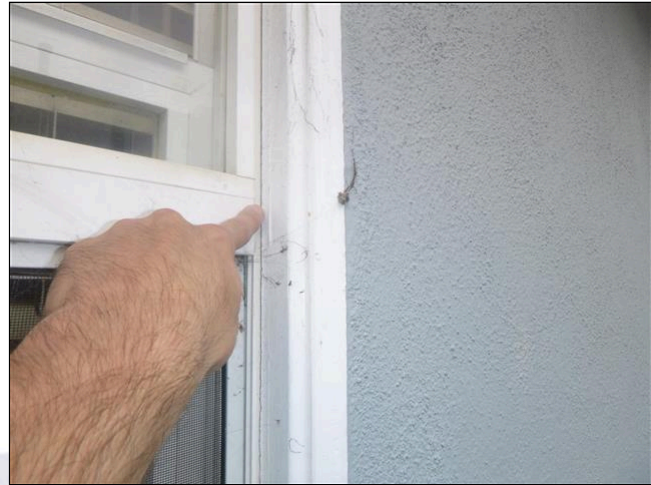
1.6 Item 4 (Picture)

1.6 (2) Various windows have not been fully sealed/flushed to the sills/siding as required and/or the sealant has deteriorated leaving extensive voids. Suggest review with a licensed contractor for costs to seal/flash the windows as required to prevent future water leakage and/or insect intrusion at these areas.

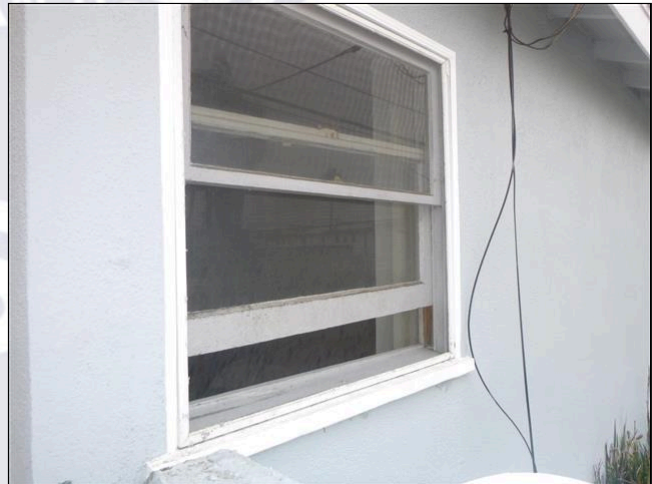
1.6 Item 9 (Picture)

1.6 (4) Wood deterioration noted at various wood windows. Suggest review with termite company and/or a licensed contractor and repair/replace as needed.

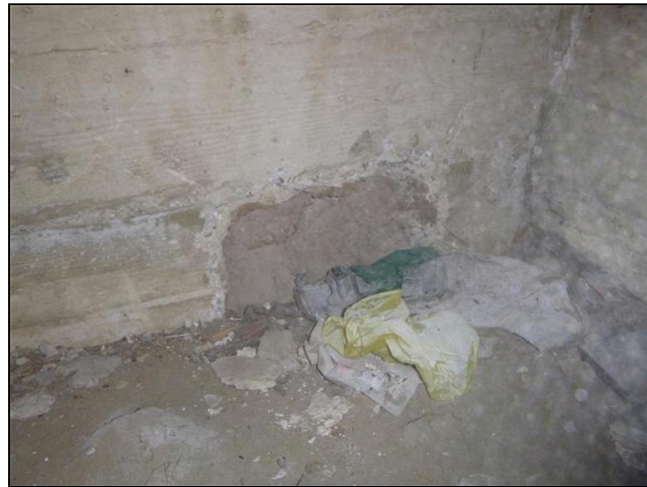
3.0 Item 10 (Picture)

3.0 (3) A notched/repaired section of the foundation was noted at the front, suggest review with the seller on this item as needed.

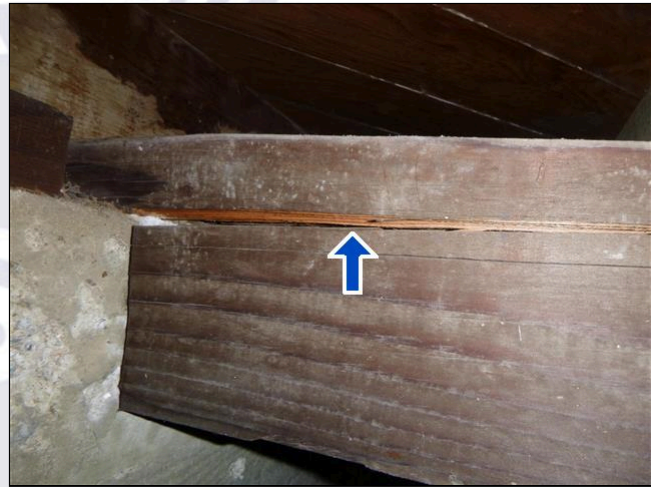
3.1 Item 1 (Picture)

3.1 (1) Various interior floor girders have settled, cracked and are missing the lower shims, suggest review with a licensed contractor for repairs as needed to prevent ongoing settling of the foundation.

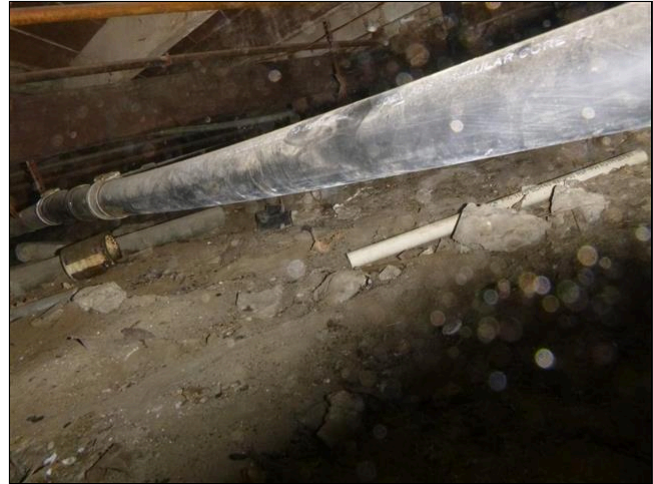
4.3 Item 9 (Picture)

4.3 (4) Inadequate slope noted at various drains in the crawl area, suggest review with a licensed plumber for costs to re-slope the drains as required/needed.

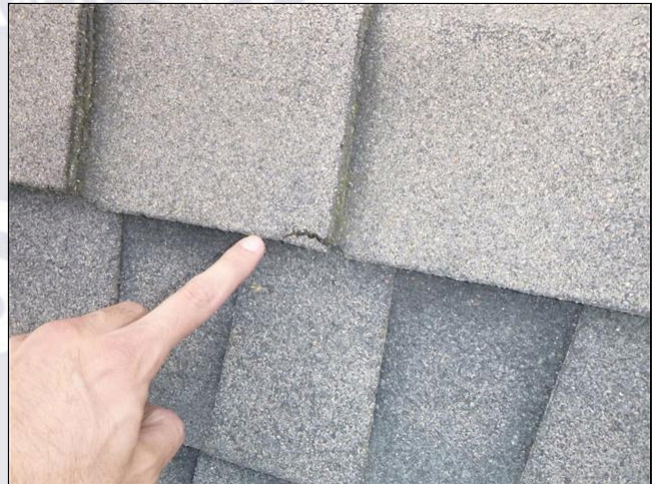
5.0 Item 5 (Picture)

5.0 (2) Deteriorated ridge caps noted at the pitched roof, suggest review by licensed roofer for replacement costs and replace as needed.

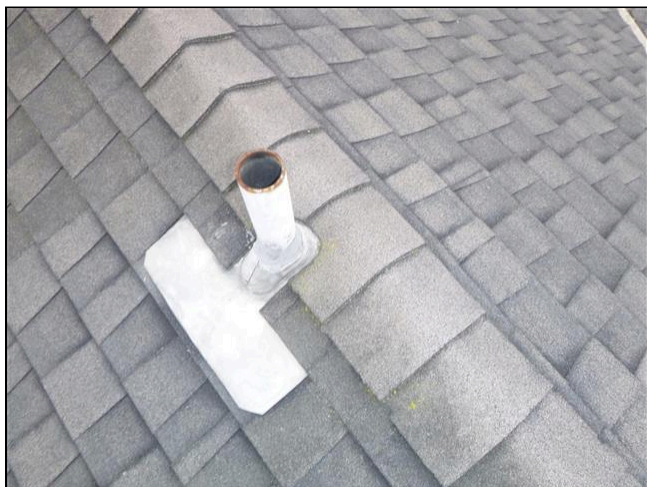
5.1 Item 1 (Picture)

5.1 (2) Two flashings are incorrectly installed on the ridge (penetrations should not be installed on a ridge). Suggest review with a licensed roofer for repair/relocation costs as needed to prevent future leakage.

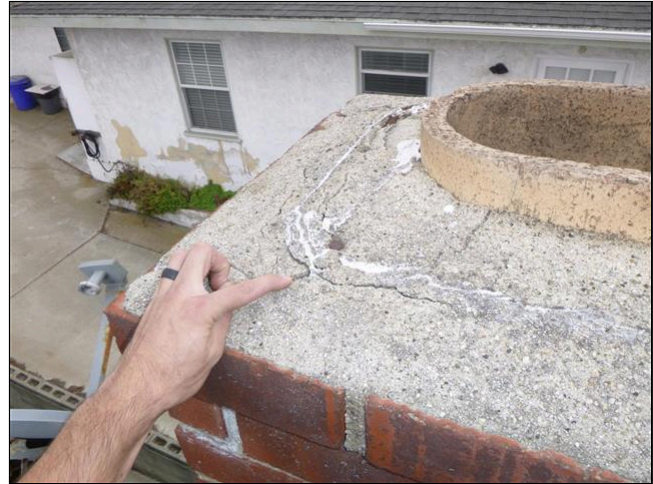
5.2 Item 1 (Picture)

5.2 (1) Excessive cracks and exposed rebar was noted at the chimney crown, suggest repairs/sealing as needed to prevent future water intrusion and deterioration.

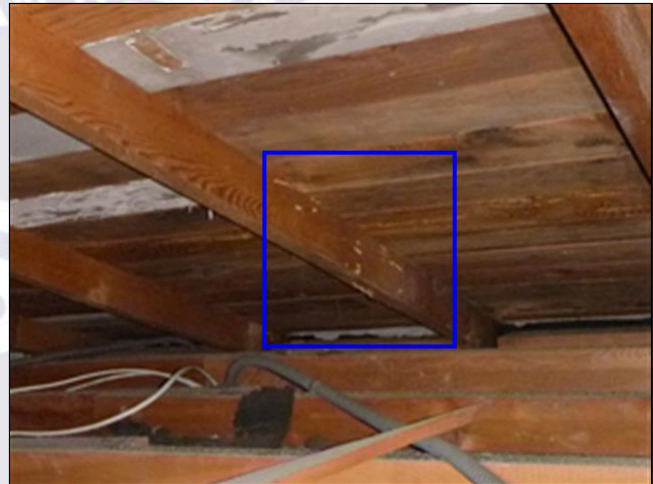
6.0 Item 4 (Picture)

6.0 (2) Wood deterioration noted at various areas of the roof framing, suggest review with a termite company and/or a licensed contractor for repairs as needed.

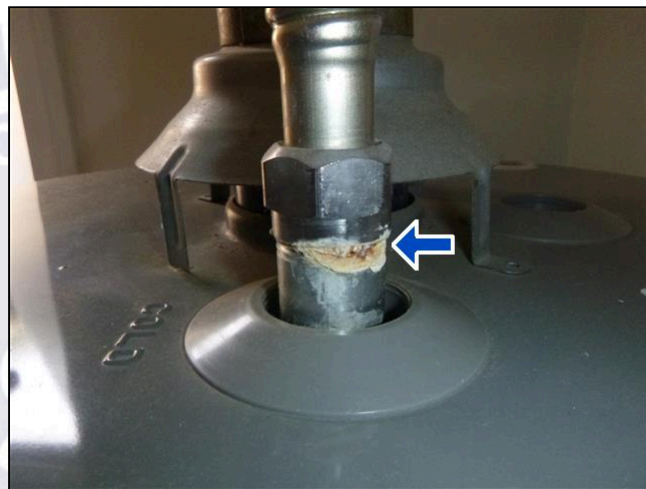
15.0 Item 4 (Picture)

15.0 (3) Rusted and corroded riser connection(s) noted, no leaking was visible at the time of the inspection. Suggest review by a licensed plumber for repair/replacement costs as needed.

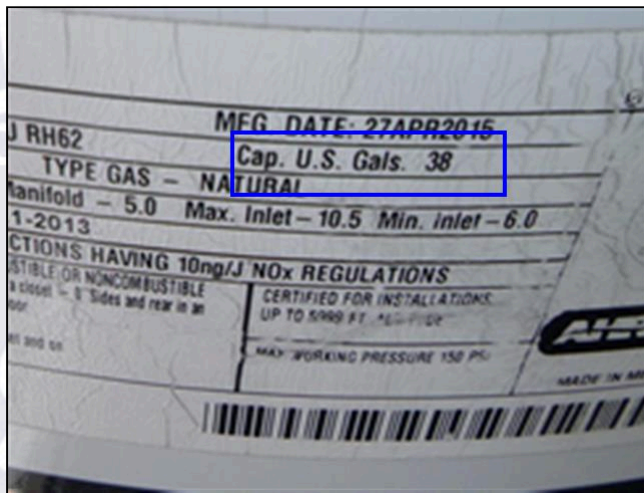
15.0 Item 7 (Picture)

15.0 (6) The capacity of the existing water heater is below plumbing standards for adequate hot water heating for this size dwelling (based on the number of beds/bathrooms). Suggest review by a licensed plumbing contractor for evaluation of this dwellings water heating system for replacement costs as needed.

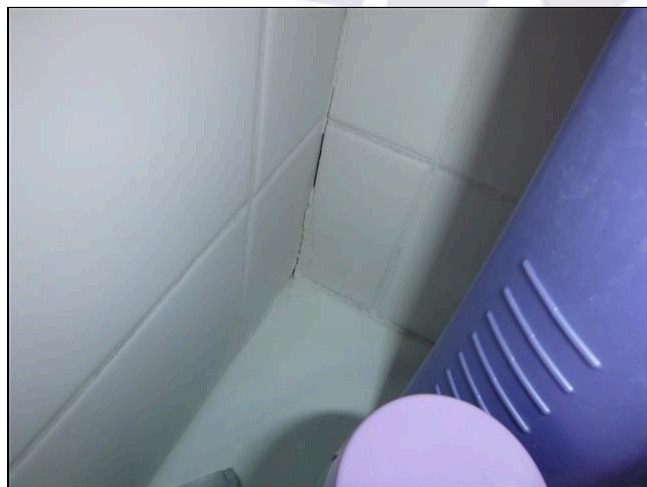
18.9 Item 1 (Picture)

18.9 Suggest caulking or re-grout as needed. The edges of the tub walls should be caulked to prevent moisture penetration. Failure to keep walls sealed can cause deterioration and extensive moisture damage to the interior walls, which is not always visible. However, water damage/deterioration was noted in the master bedroom's closet which is directly behind the shower/tub area which indicates that there is likely leakage from this shower/tub enclosure. Suggest review with a licensed contractor to verify/confirm and for removal/repair/replacement costs as needed.

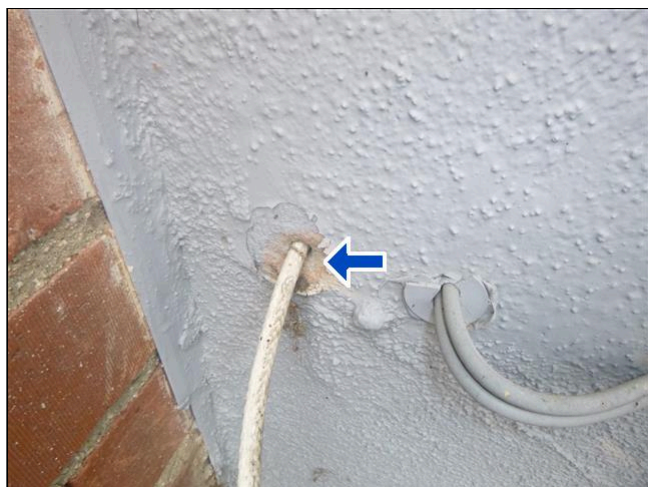
1.4 Item 5 (Picture)

(3) Suggest sealing around the siding penetration's to prevent future water/insect/rodent intrusion at these areas.

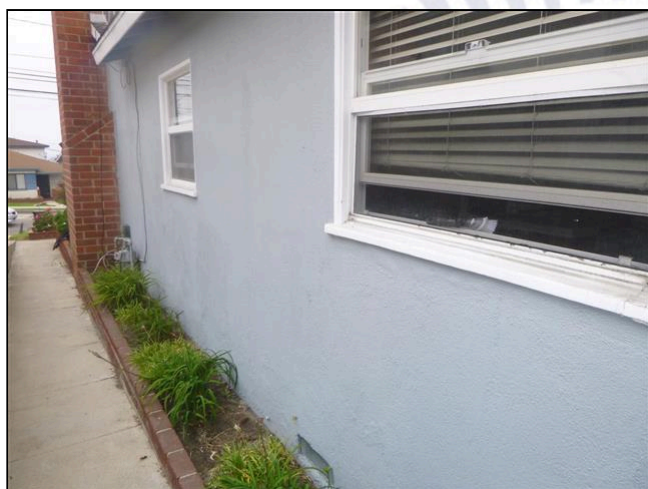
1.4 Item 6 (Picture)

(4) Various areas of the siding have been patched, suggest review with the seller on the cause and any repairs needed.

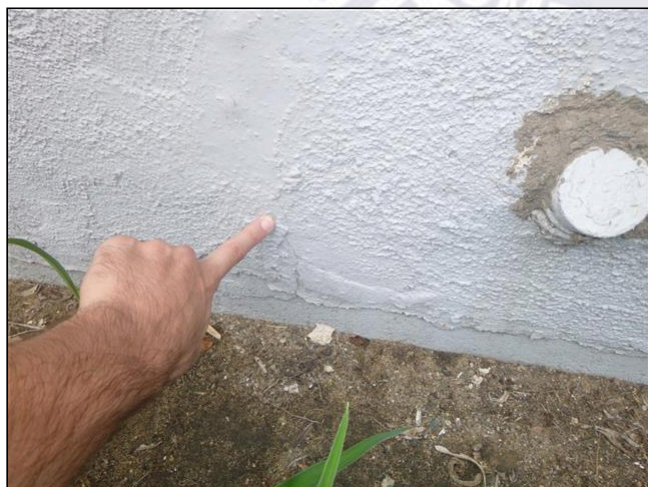
1.4 Item 7 (Picture)

(5) Common settling cracks noted at various areas of the stucco siding, suggest maintenance as needed.

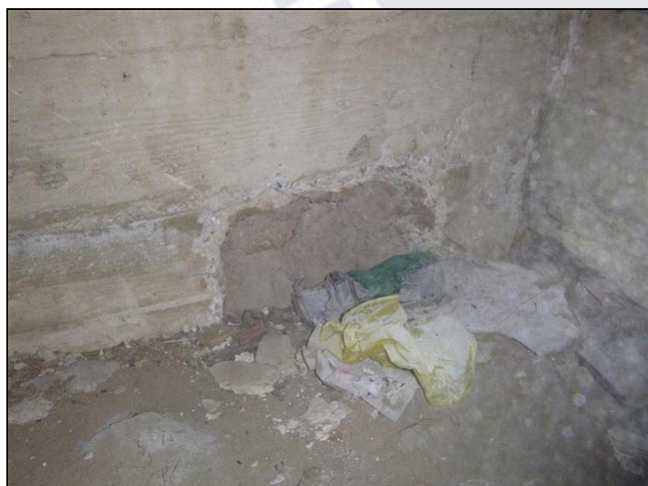
3.0 Item 10 (Picture)

(3) A notched/repaired section of the foundation was noted at the front, suggest review with the seller on this item as needed.

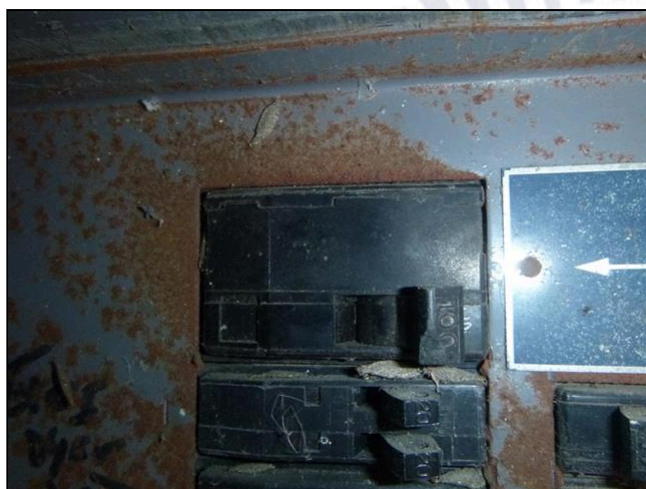
12.1 Item 3 (Picture)

(3) Due to the age and size/overall amperage of this system relative to the square footage of the dwelling, suggest review with a licensed electrician for replacement cost to upgrade the electrical panel, increase the overall amperage and install additional circuits to the interior of the dwelling as needed/desired.

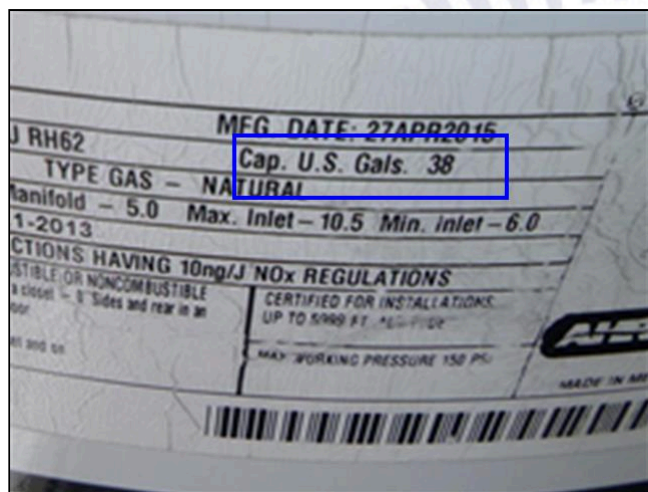
15.0 Item 7 (Picture)

(6) The capacity of the existing water heater is below plumbing standards for adequate hot water heating for this size dwelling (based on the number of beds/bathrooms). Suggest review by a licensed plumbing contractor for evaluation of this dwellings water heating system for replacement costs as needed.

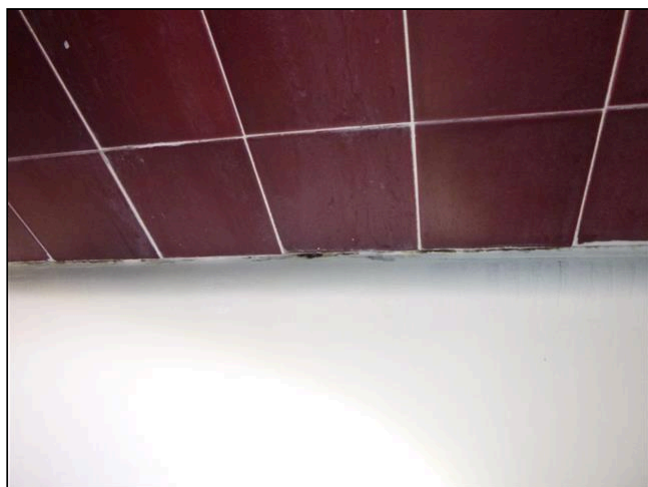
17.9 Item 1 (Picture)

(1) Suggest caulking or re-grout as needed. The edges of the tub walls should be caulked to prevent moisture penetration. Failure to keep walls sealed can cause deterioration and extensive moisture damage to the interior walls, which is not always visible.

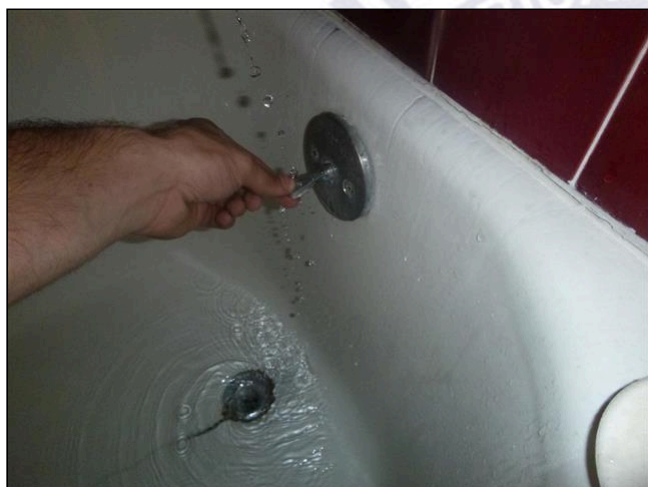
17.9 Item 2 (Picture)

(2) The tub stopper was inoperable at the time of the inspection, suggest repair/replace as needed.

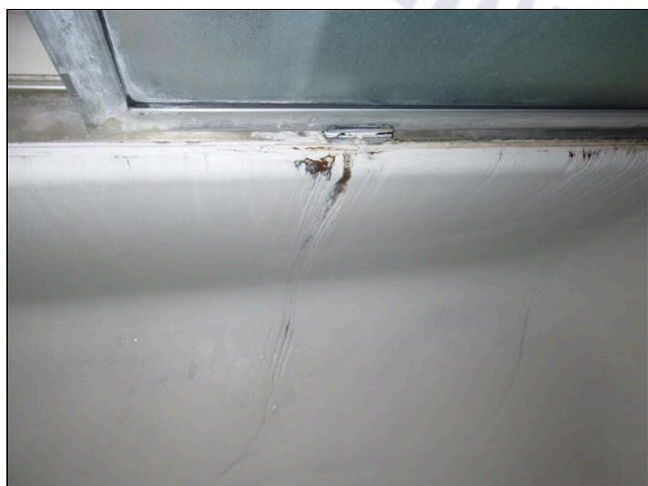
17.9 Item 3 (Picture)

(3) Excessive wear/rusting/deterioration was noted at the tub and surround. Suggest repair/replace as needed.

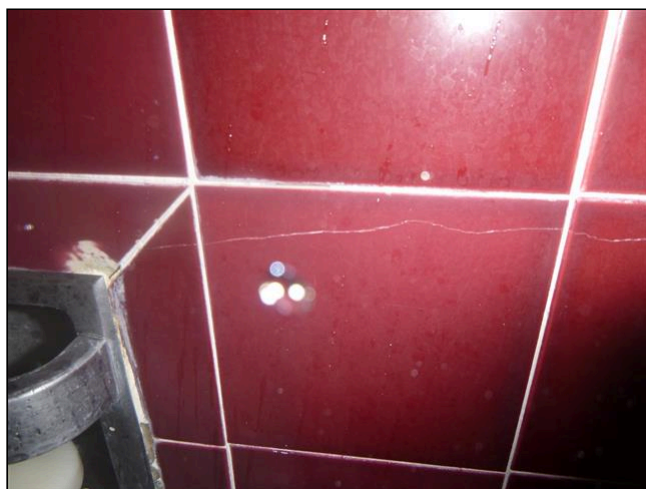
17.11 Item 1 (Picture)

(2) Cracked tiles noted at the shower area, suggest review with a licensed contractor for repair/replacement costs as needed.

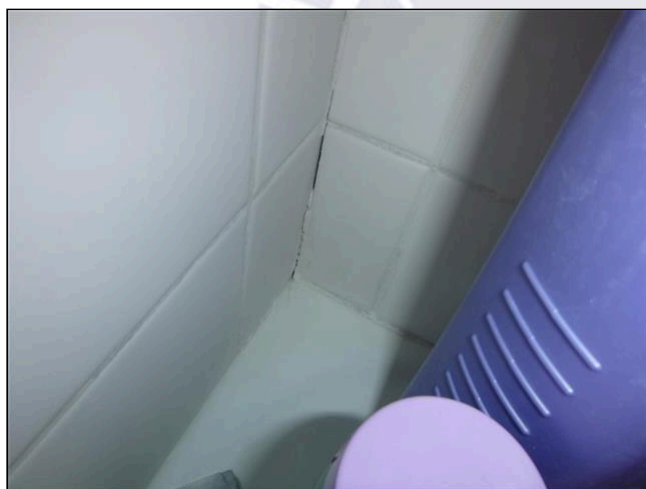
18.9 Item 1 (Picture)

Suggest caulking or re-grout as needed. The edges of the tub walls should be caulked to prevent moisture penetration. Failure to keep walls sealed can cause deterioration and extensive moisture damage to the interior walls, which is not always visible. However, water damage/deterioration was noted in the master bedroom's closet which is directly behind the shower/tub area which indicates that there is likely leakage from this shower/tub enclosure. Suggest review with a licensed contractor to verify/confirm and for removal/repair/replacement costs as needed.

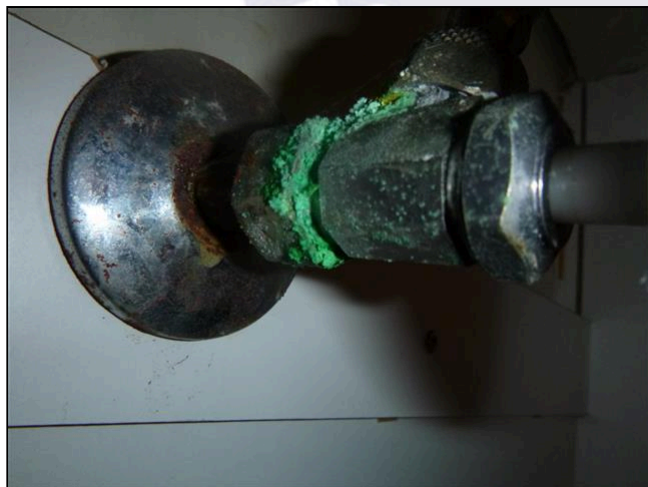
18.16 Item 1 (Picture)

Corrosion noted at the sink drain and angle valve(s), no leaking noted at the time of the inspection. Suggest review by a licensed plumber and repair/replace as needed.

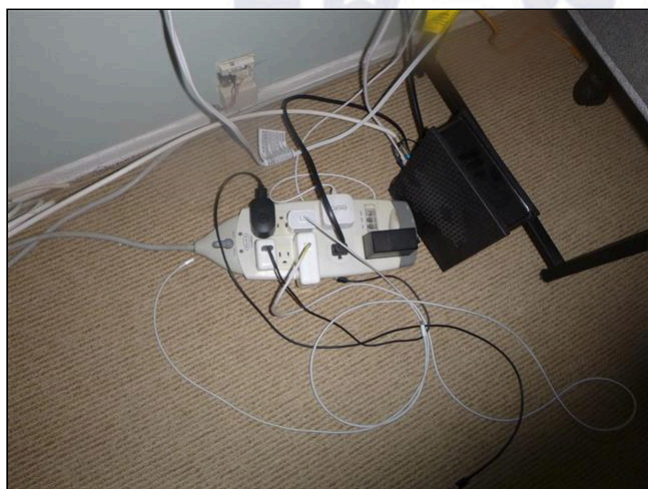
22.6 Item 1 (Picture)

(2) Excessive use of electrical plugs/strips/extension cords used at this area, this is a potential fire safety hazard. Suggest review with a licensed electrician for additional electrical circuits/outlets costs as needed for safety.

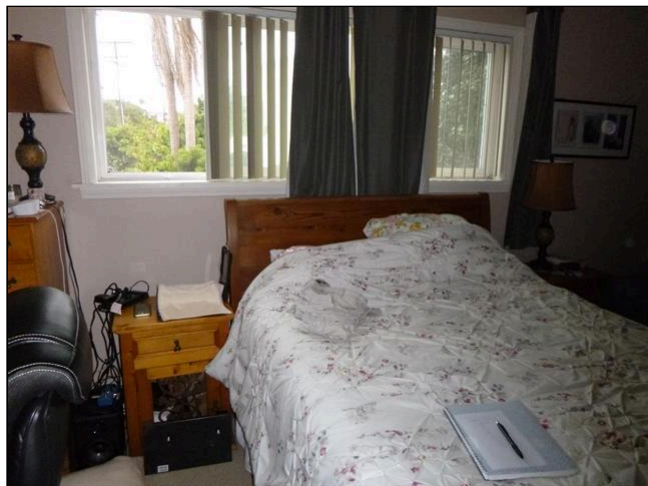
24.4 Item 1 (Picture)

- (1) The windows are difficult to operate, suggest repair/replacement as needed/required to allow for emergency exit/egress and ventilation.
- (2) The window(s) will not close and latch correctly, suggest repair as needed.
- (3) The glass is loose in the window frame(s), this is a potential safety hazard, suggest repair/replace as needed.
- (4) The replacement windows sill height is above 44" as required for a bedroom for Egress/Emergency exit. This is not uncommon for the age of the dwelling as the windows may have been replaced without getting a city permit. Suggest review with the city and/or a licensed contractor for replacement costs if desired or concerned.

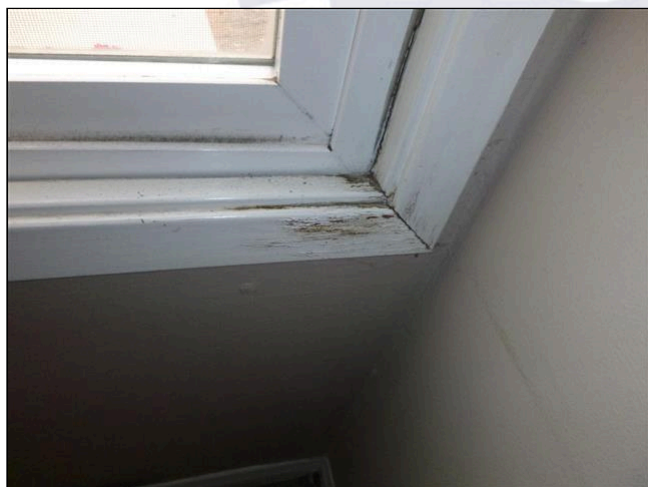
24.4 Item 2 (Picture)

- (5) Multiple stains and evidence of on-going leakage at various windows, suggest review with a licensed contractor for repair/replacement costs as needed.

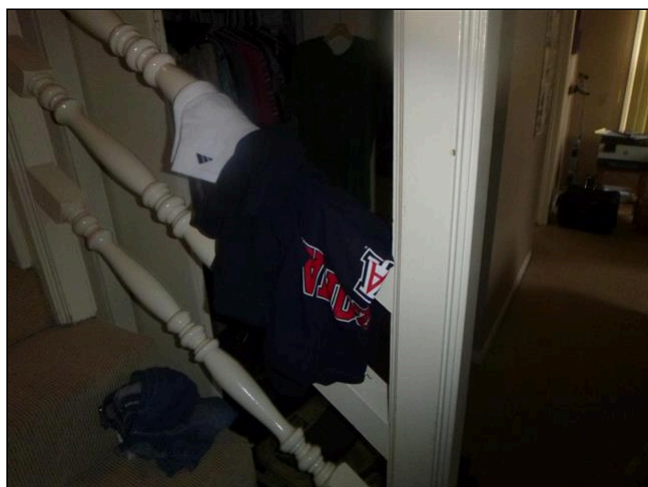
24.8 Item 1 (Picture)

(2) A non graspable handrail was noted at this area, this is a potential safety hazard. Suggest review with a licensed contractor for costs to upgrade to current standards for safety and/or as needed.
