Date: March 3, 2026

SEWER LINE INSPECTION REPORT

Property Address: 165 Cumberland Rd,
Glendale, CA 91202

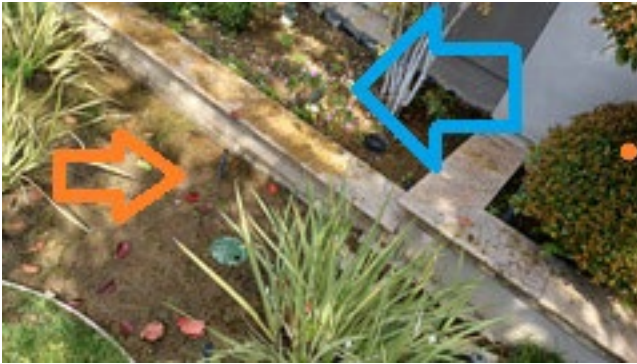
The two access points in the front planter

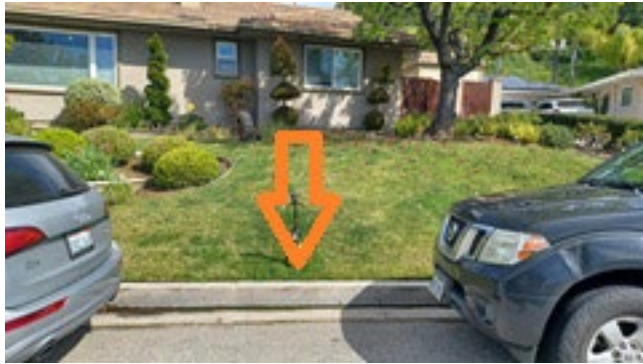
the sewer line leaving the property about 7 feet deep

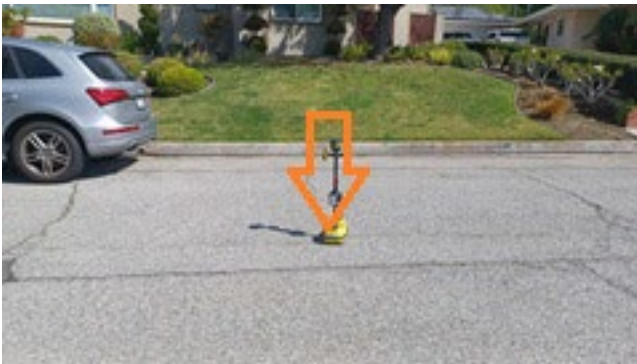
The sewer line connecting to the city sewer about 10 feet deep

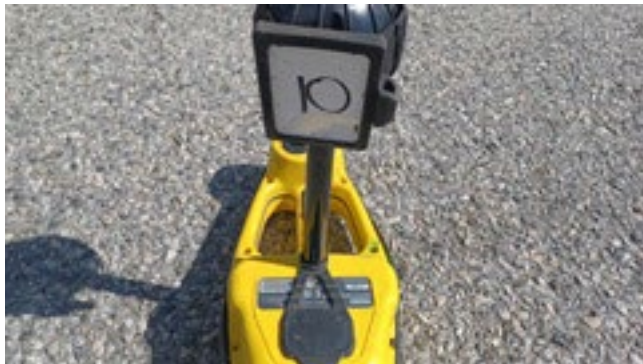
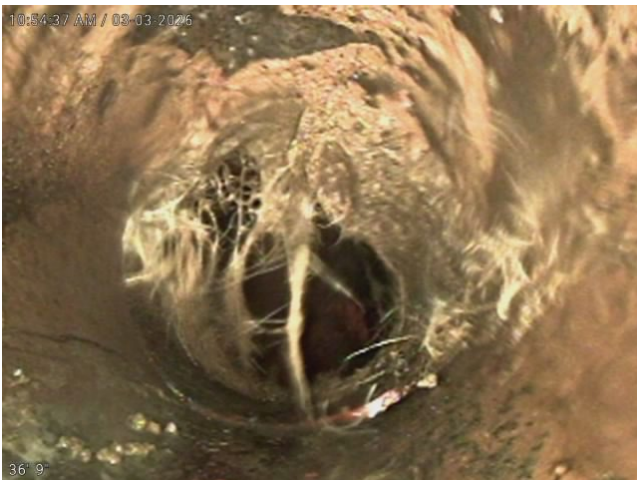
Roots in the sewer line

x	Some cracking. Average for clay		Moderate cracking; slightly below average condition		Heavy cracking allows for sewage to leak from system
x	Some misalignment in joints. Average condition for clay.		Moderate misalignment in joints; slightly below average		Heavy shifts in pipe obstruct maintenance/allow leaking
	Few or no roots in clay pipe	x	Moderate roots should be cleared in the next 6 months		Heavy roots should be cleared now.

The sewer line appeared to be in acceptable condition structurally, however, there are several root intrusions that should be cleared at this time. Hydro jetting is a highly effective type of sewer cleaning that uses water at very high pressures to cut roots cleanly out of a system. Standard hydrojetting will always use a camera to verify that the roots were cleared satisfactorily from the system.

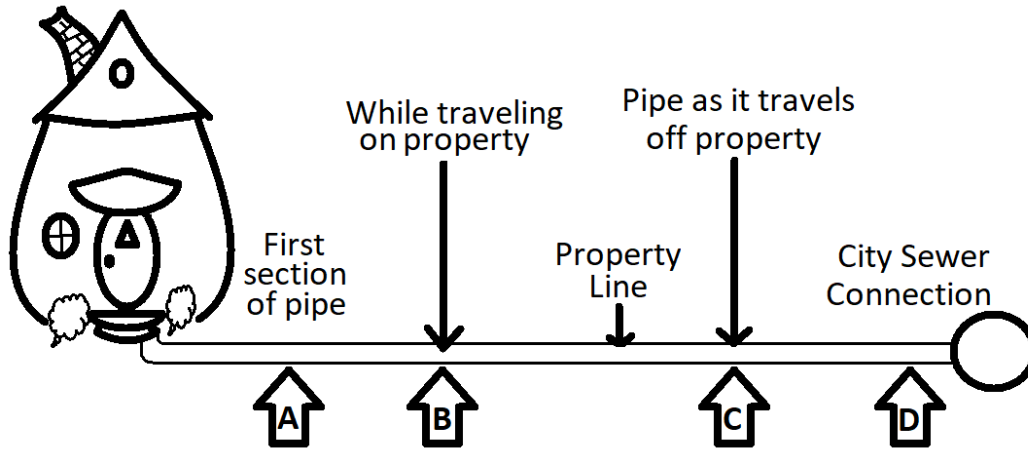
A: cast iron under the house

B: clay

C: clay

D: clay
