**Address:** 2112 Vía Pacheco, Palos Verdes Estates

**Date of Inspection:** 3-18-24

## Main Sewer Line Inspection Report

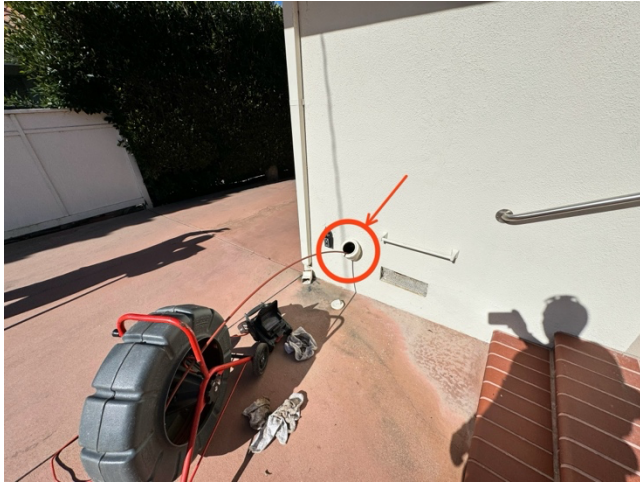
**Main Sewer Line Access Points:** In order to view the main sewer line for this property we used a 4" cleanout located behind the house. There's an additional cleanout in the front planter area that can also be used for routine maintenance and inspections on the main sewer line.

Location of 4" cleanout used for inspection.

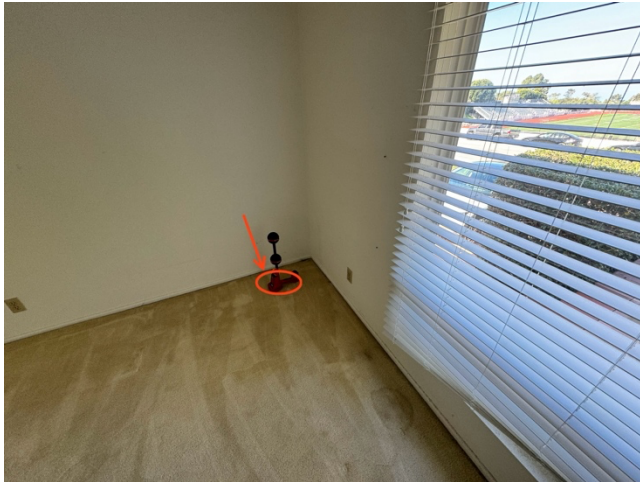
Some of the pipe under the structure was visible to this inspection. While this is not the primary focus of this inspection it was noted that portions of this pipe are a cast iron material. Cast iron is the strongest of the pipe materials available for sewer. It is susceptible however to oxidation. The thick iron walls of the pipe typically wear away through gradual rusting over the course of 60-80 years. For this reason, cast iron has a finite life potential and will need replacement eventually. Due to the nature of the material, it can be difficult to determine if the pipe is able to leak from only an interior view.

The cast iron pipe viewed during the inspection appears to be original to the structure and is rusted heavily in areas. There are also roots intruding into the cast iron pipe. Roots are not able to penetrate the walls of a cast iron pipe until the pipe has rusted to a degree where the pipe wall reduces in thickness in areas sufficiently for roots to push their way into the line. This represents a breach of the system. The roots can be de-scaled out of the pipe but would be recommended to replace this section of cast iron pipe. Repairing this now it would appear that a fiberglass lining system might be usable. This is a method of repairing sections of pipe which travel under difficult to access locations. The most effective and cost-efficient method of repairing the line can best be determined with the assistance of your sewer contractor of choice who will be performing the work.

Transition from a plastic pipe to a cast iron pipe underneath the home.

To repair the cast iron pipe section with roots it might cost \$3,000 - \$3,200.

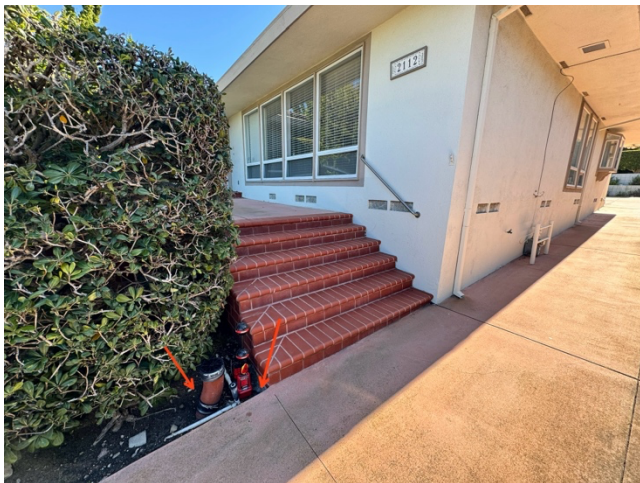
**Types of Materials used in sewer line:** Clay is a good material for sewer lines as it does not rust or corrode over time. There is no limit to how long clay can potentially last but can be damaged by earthquakes or roots or even bad installation. There are areas of root intrusion within this clay main sewer line that will need to be cleared by hydrojet. Roots intruding into a clay system are common and can normally be maintained with regular sewer line cleanings. If neglected, roots can cause blockages in the pipe as well as potential damage. The clay pipe that was visible of this sewer line is functioning but has some defects in the condition of the pipe typical to clay sewer lines. These include some cracking as well as some misalignment of the joints in the pipe. When these represent a breach of the system there

are certain definite indicators which are not being demonstrated here. While this line is not perfect it does appear to be functional at this time.

Transition from a cast iron pipe to a clay pipe 2.5' deep under tool.  
Location of additional sewer cleanout.

**Areas Needing Attention:** The root intrusion in the clay pipe should be removed by hydrojet at this time. Hydro-jetting is high powered pressured water that will cut the roots and push them out towards the city sewer.

**Estimated Costs for Repairs:** We can hydrojet and descale the line for \$600.

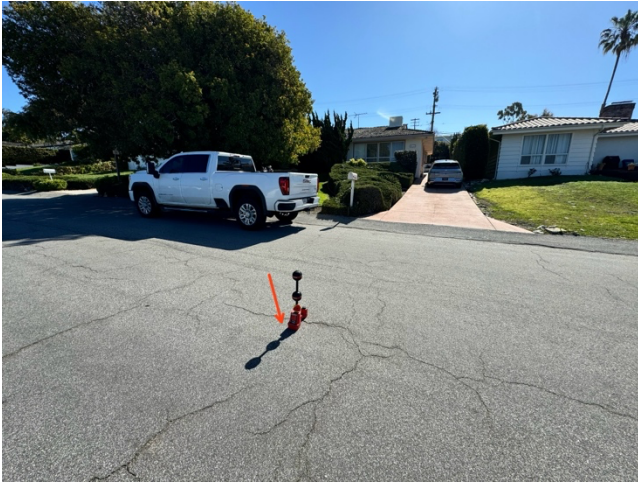
**Path of Main Sewer Line on Property:** The main sewer line is made of a cast iron material pipe as it exits the house near the front porch steps. The pipe then transitions into a clay material pipe as it travels alongside the driveway and out towards the center of the street. The connection to the city sewer is taking place underneath the street in front of the house.

**Connection to city sewer under tool 8.5' deep.**
