Imperial Home Inspection Services

February 18th 2022, 11:56 am

BUILDING ADDRESS: 1461 Lazy Trail Dr.
CITY: Chico
STATE: Ca
ZIP CODE: 95926
INSPECTION DESCRIPTION: Whole Home Inspection
SQUARE FOOTAGE: 2249

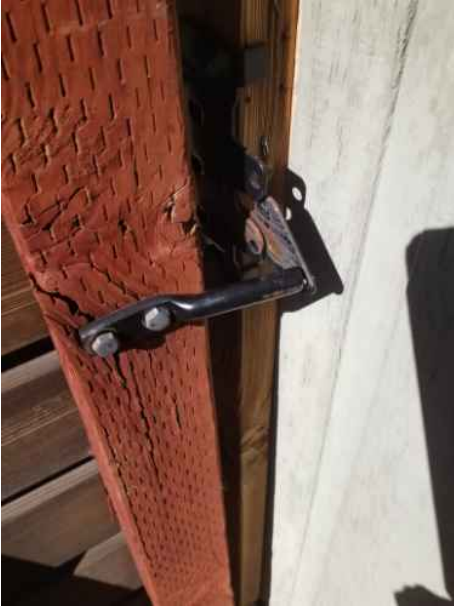
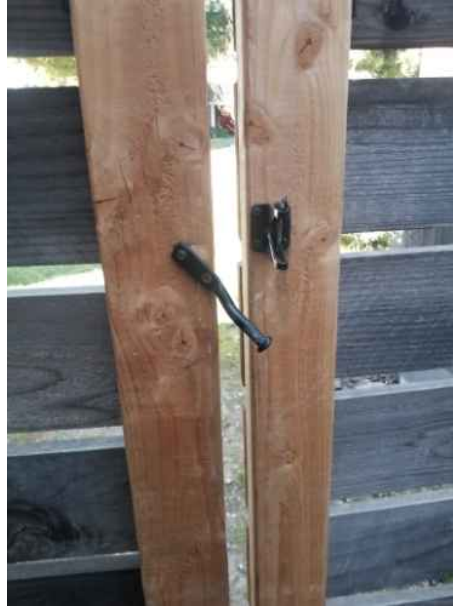
GATE Fair

The latch for the gate on the left side of the home is loose.
The gate on the right side of the home does not latch closed.
Recommend further evaluation by handyman.

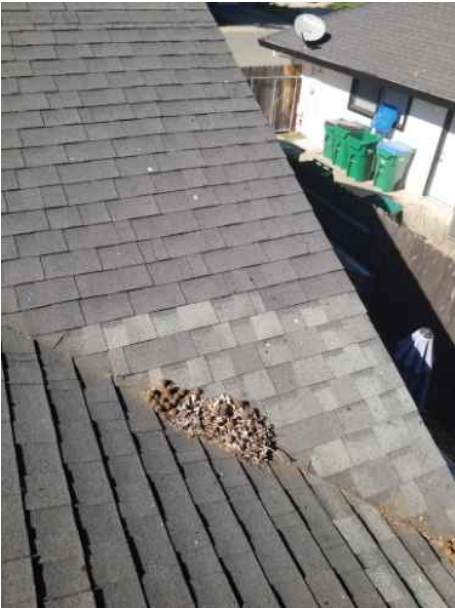
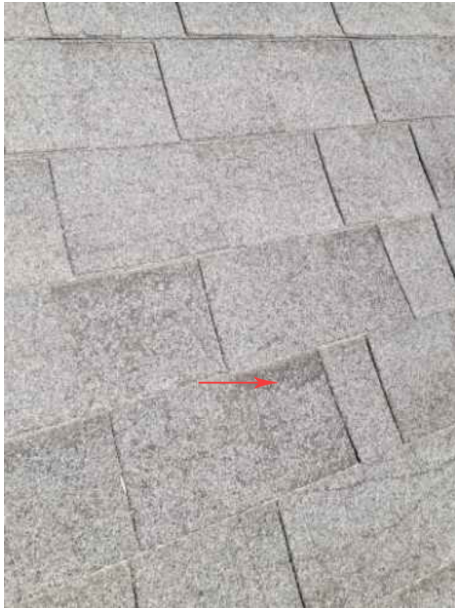
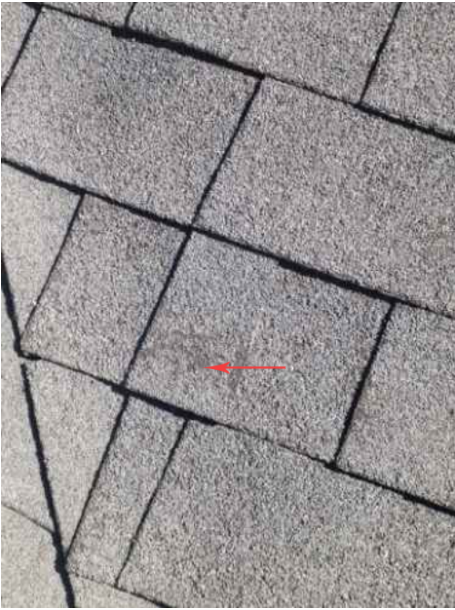
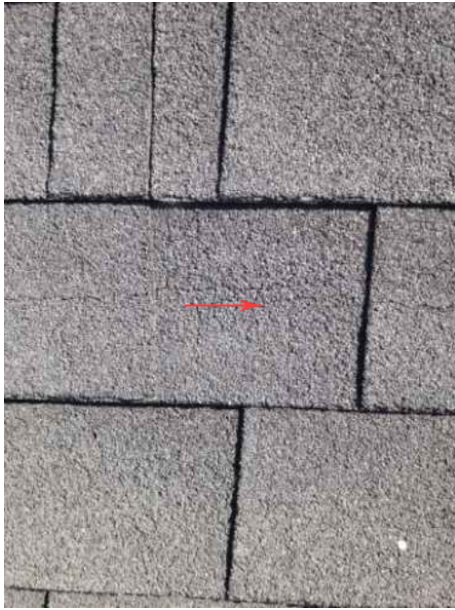
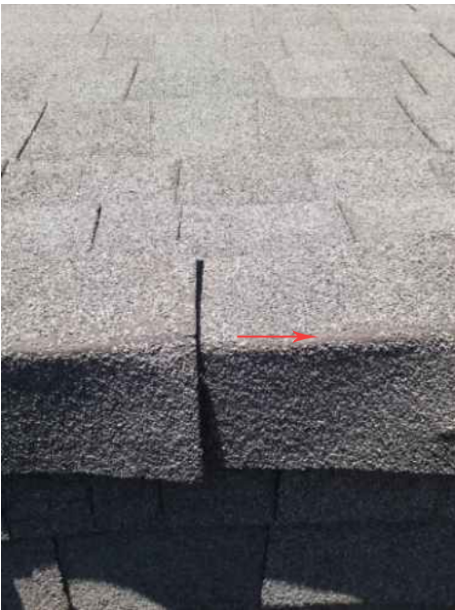
SHINGLES MISSING / DAMAGED? Fair

Granular deterioration was observed as well as shingles that are cracking. This roof is in the second half of its expected life span. Shingles have been replaced at an area on the left side of the roof, possibly from tree damage.

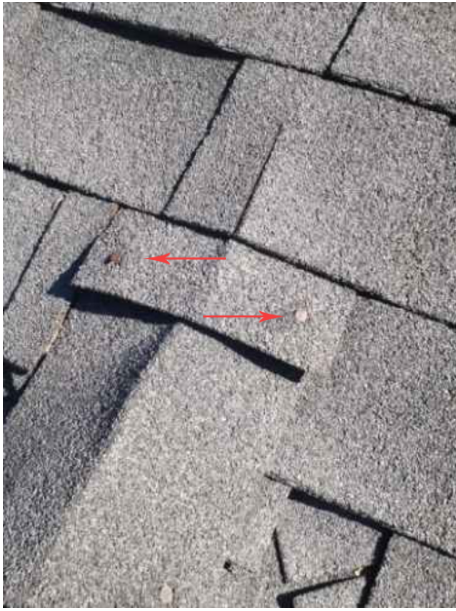
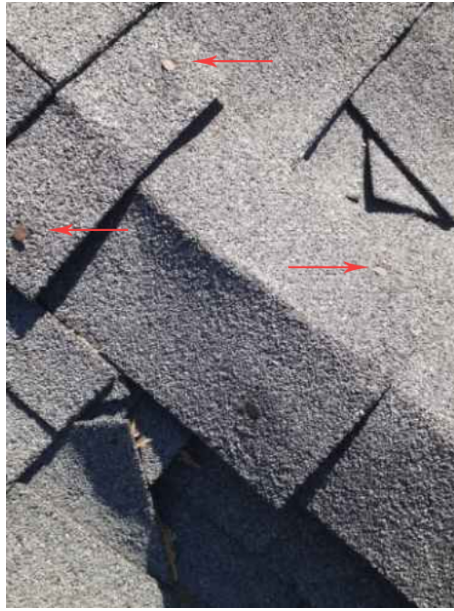
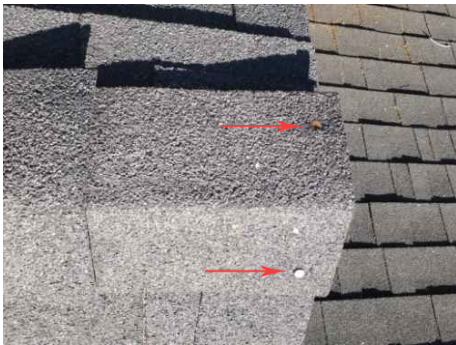
ROOF INSTALLATION Satisfactory

Exposed nail heads that have not been sealed were observed on the ridge line, recommend sealing to prevent them from backing out.

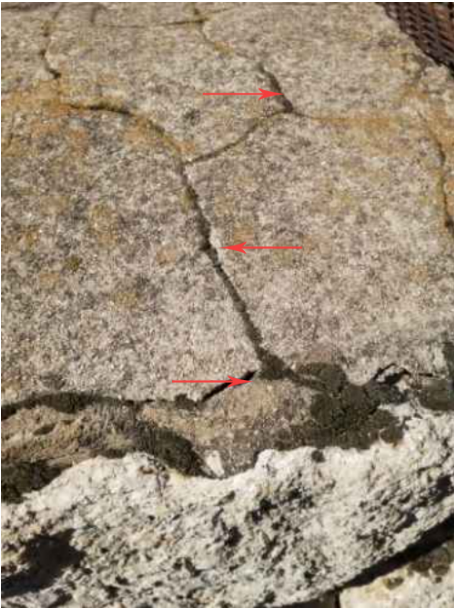
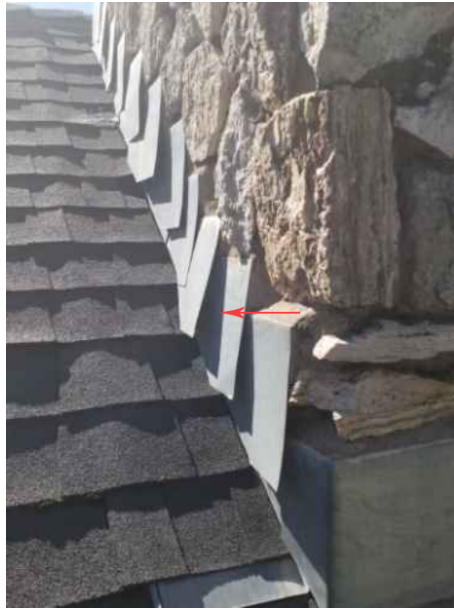
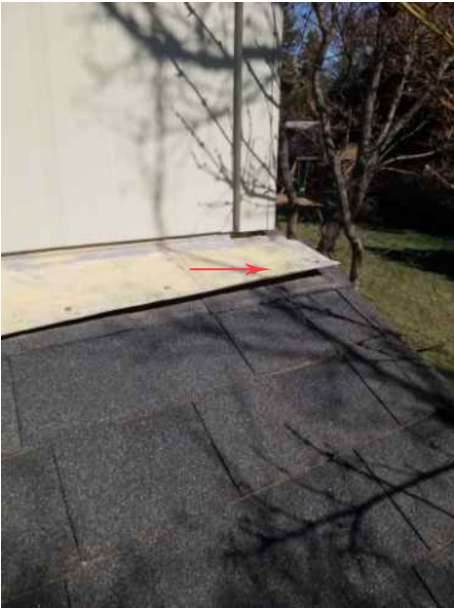
CHIMNEY Fair

Cracks were observed in the cement crown of the chimney on the front of the home, recommend sealing to prevent water intrusion.

Lifting flashing was observed at both chimneys, recommend securing flashing.

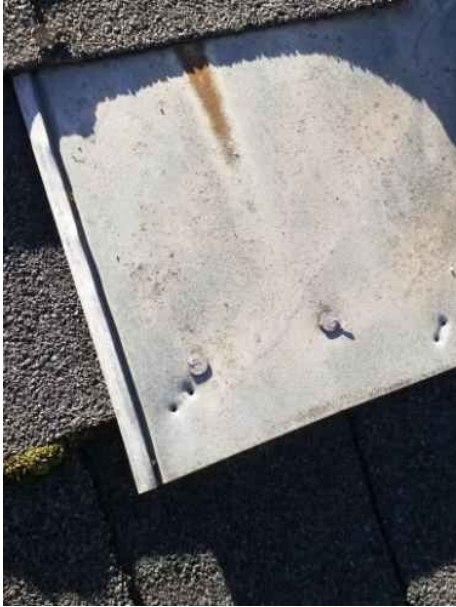
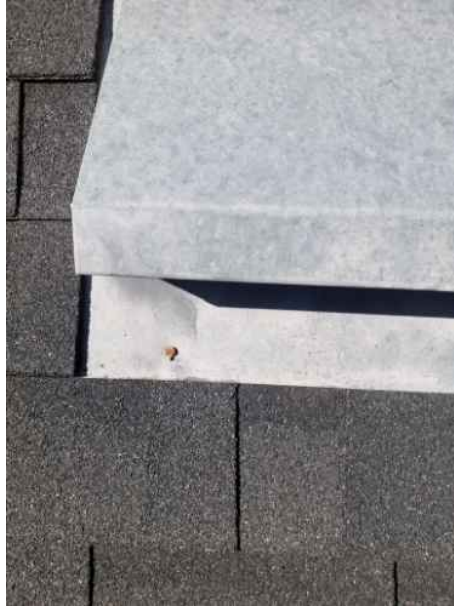
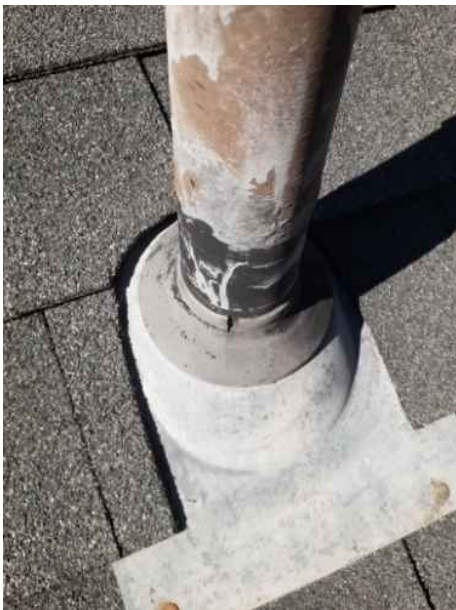
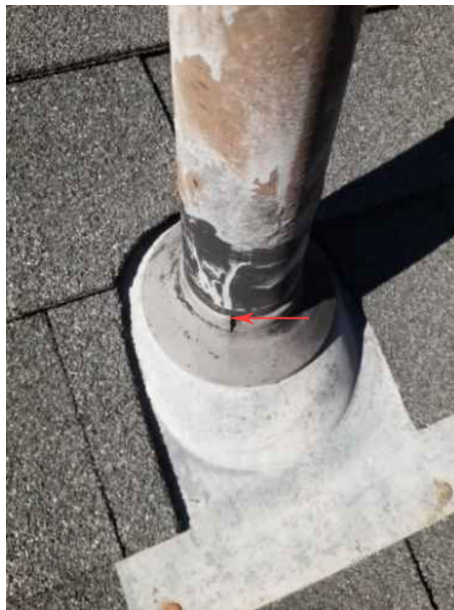
SKYLIGHTS / ROOF PENETRATIONS Fair

Exposed nail heads that have not been sealed were observed as well as bottoms that have not been secured. Recommend securing bottoms and sealing nail heads to prevent them from backing out.

A gap was observed at the boot for one of the plumbing vents, recommend replacing boot.

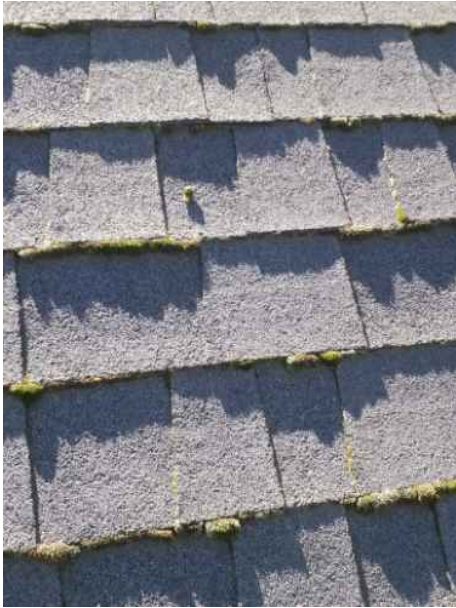
MILDEW PRESENT ON ROOF? Yes

Moss was observed on the roof. Moss absorbs moisture and causes the shingles to expand and contract, this excellerates the deterioration process of the roof. Recommend keeping roof free of moss.

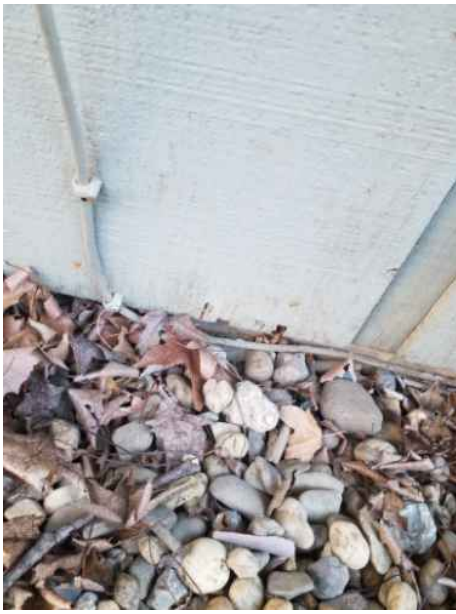
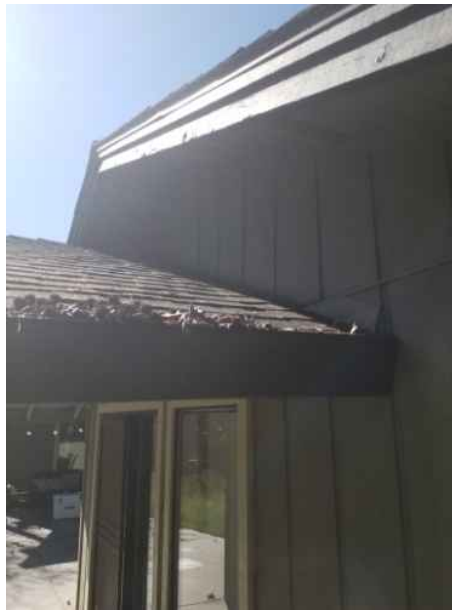
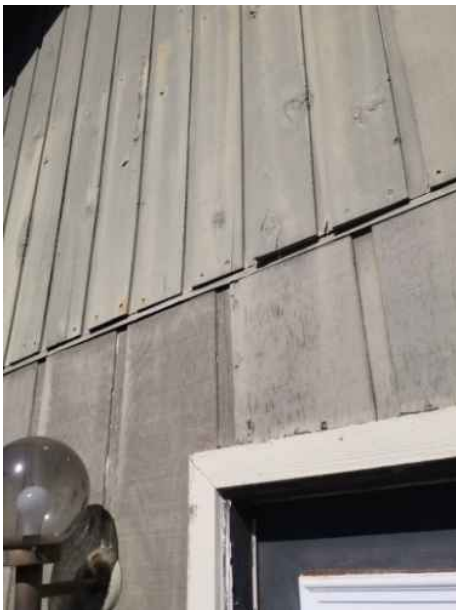
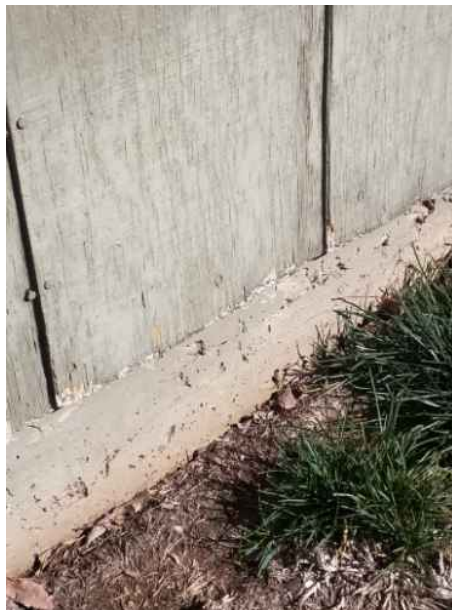
SIDING CONDITION Fair

Water damage and deterioration of wood was observed on the right side of the home.

Siding has been installed without a gap between the siding and roof, this will allow water to contact for prolonged periods of time when it is raining.

Early stages of water damage were observed to siding on the right side of the home as well as sun damage.

Recommend further evaluation by licensed siding contractor.

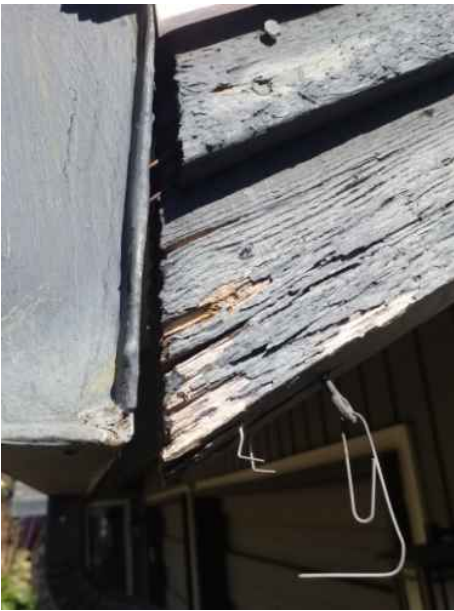
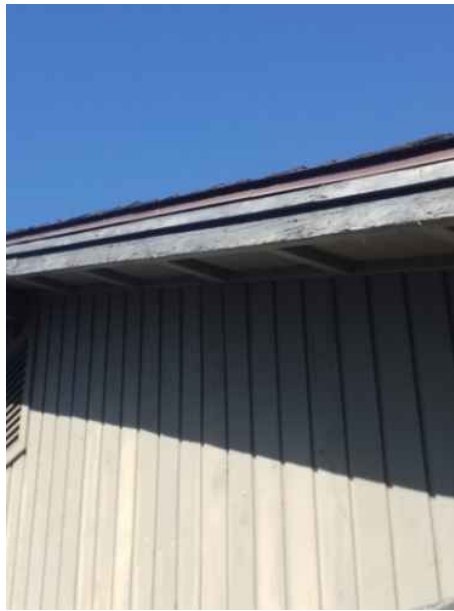
FASCIA Fair

Water damage and deterioration of wood was observed to fascia on the right side of the home.

Recommend further evaluation by licensed contractor.

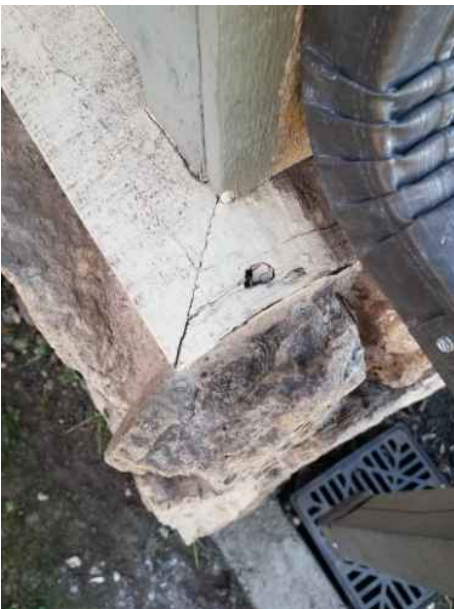
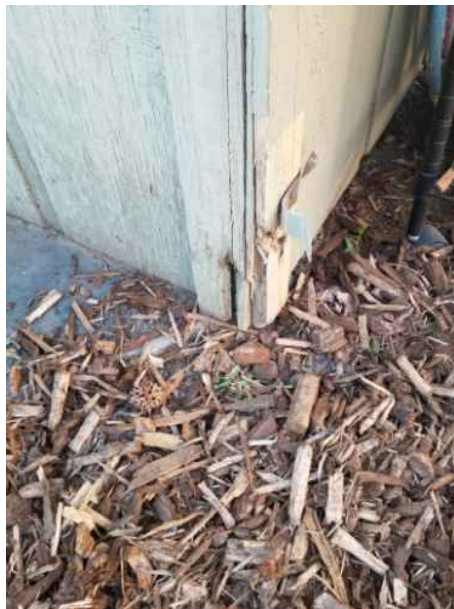
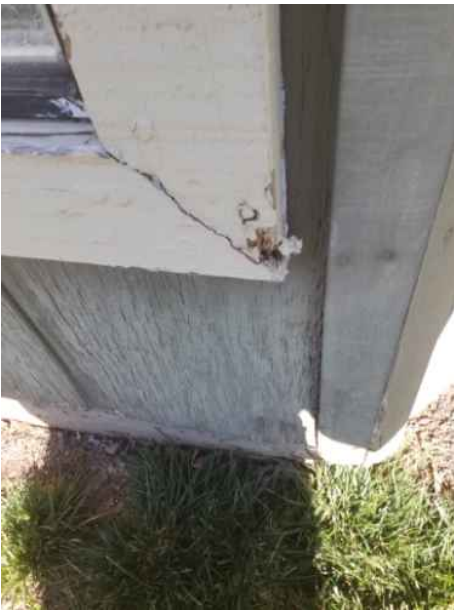
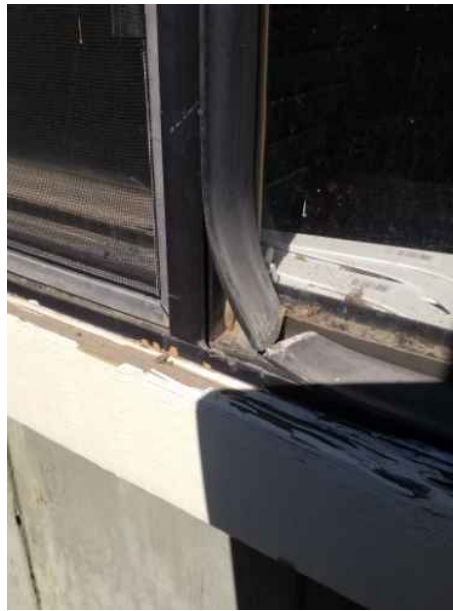
TRIM Fair

Damaged trim was observed at the left front corner of the home, the left rear corner, and at a window on the right side of the home.

Portions of window trim would benefit from paint maintenance.

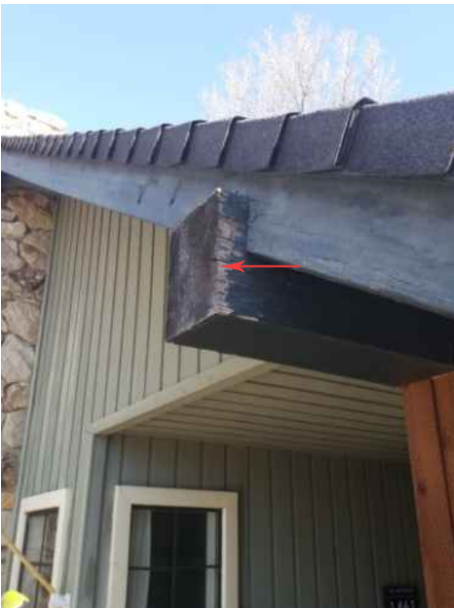
STOOP / PORCH Fair

Early stages of water damage and deterioration of wood was observed to the beam to the right of the front door.

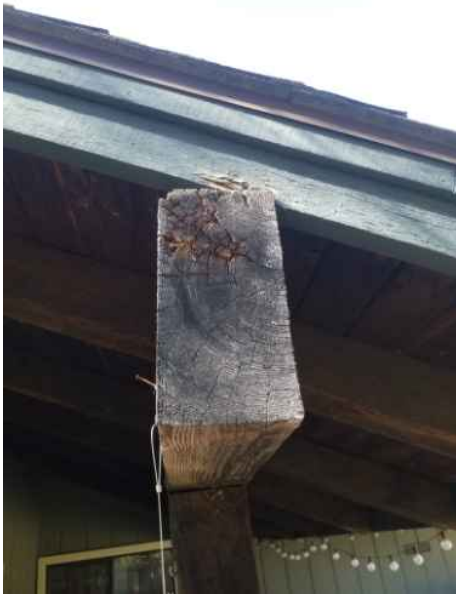
PATIO Fair

Early stages of water damage and deterioration of wood was observed to the beam near the patio area.

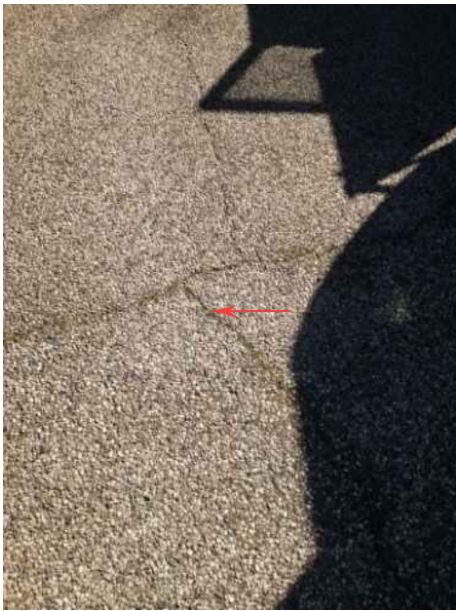
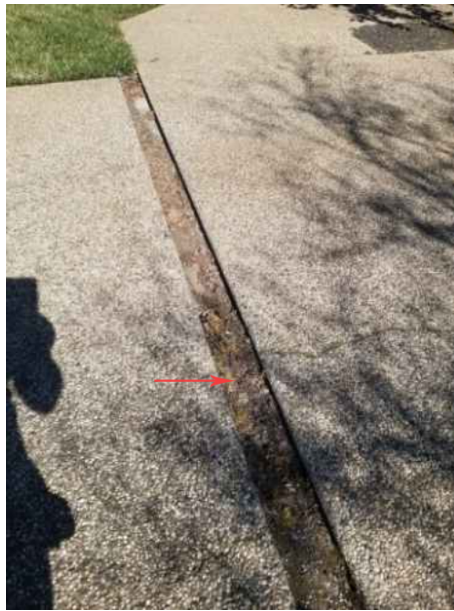
DRIVEWAY Fair

Cracking of concrete was observed as well as a spacer that is no longer intact. Recommend sealing cracks and installation of spacer.

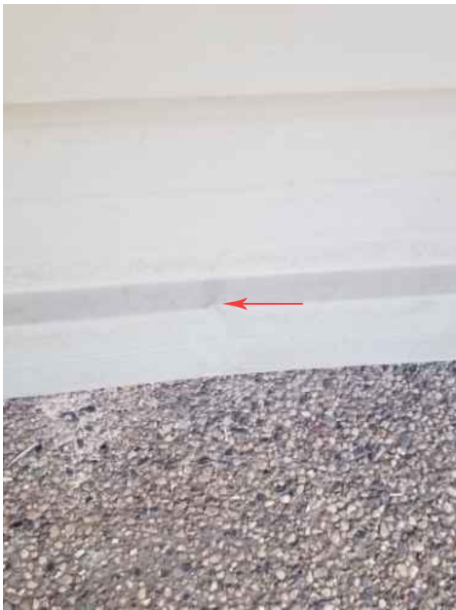
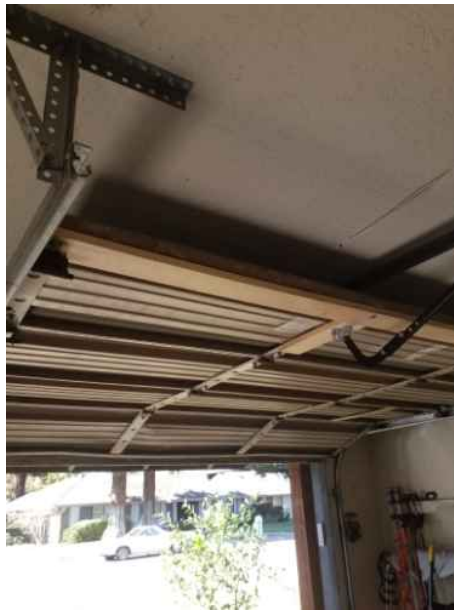
GARAGE DOOR Fair

Minor damage was observed to one of the garage doors. Repairs have been made to the same door.

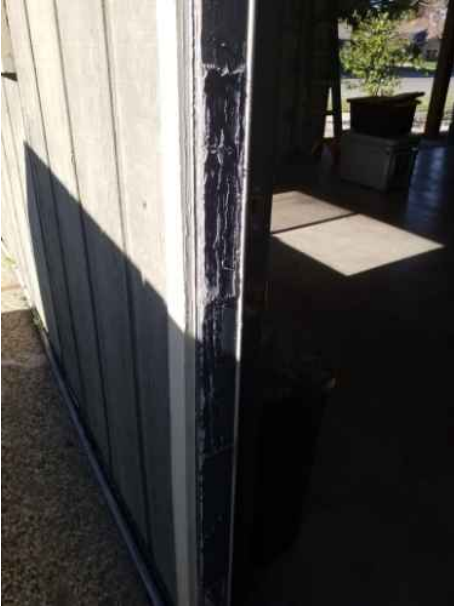
EXTERIOR DOORS Fair

The trim for this door would benefit from paint maintenance.

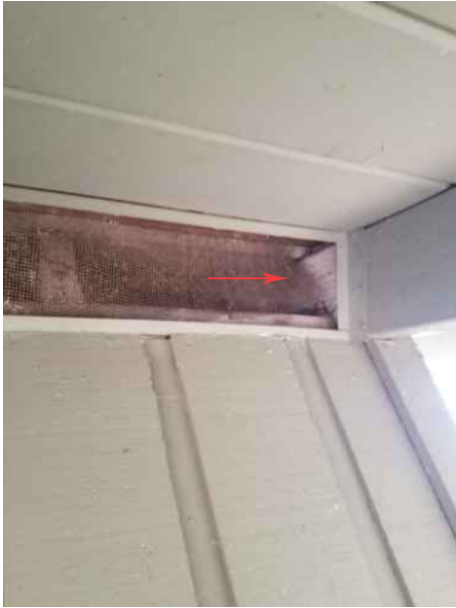
VENTILATION Satisfactory

A vent screen is not secured and is an access point for pests, recommend sealing.

This is on the right front corner of the garage.

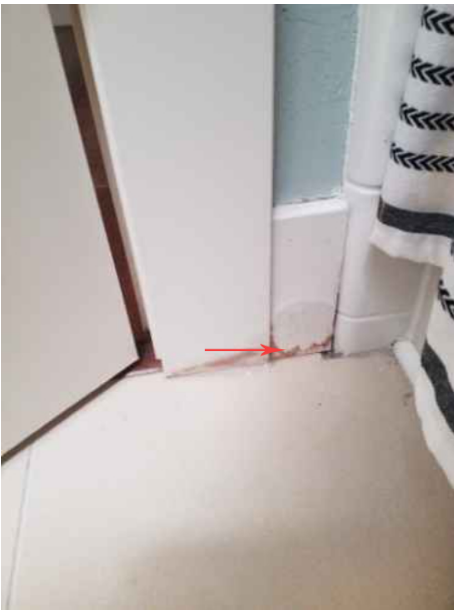
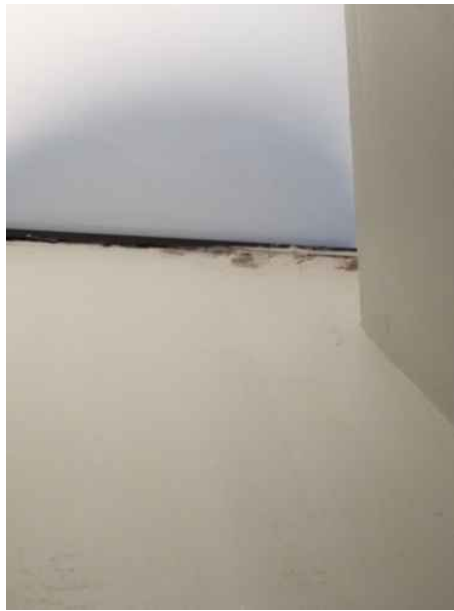
WALLS Fair

Signs of possible past water intrusion were observed at the tub and at the skylight.

Recommend further evaluation by licensed roofing contractor for the skylight.

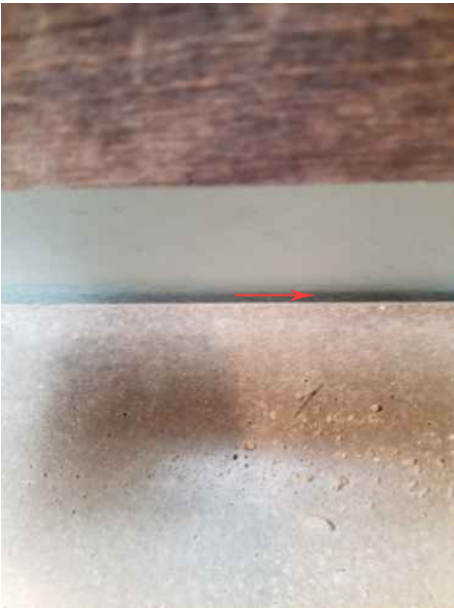
COUNTERS Fair

A gap was observed between the countertop and the wall, recommend application of sealant to prevent water intrusion.

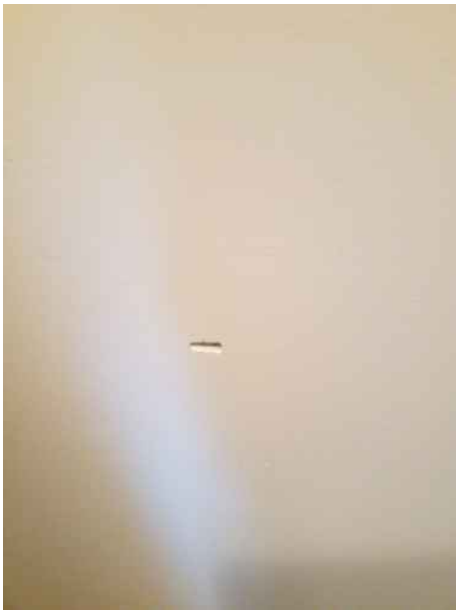
WALLS Satisfactory

Minor damage was observed behind the door that leads to the toilet.

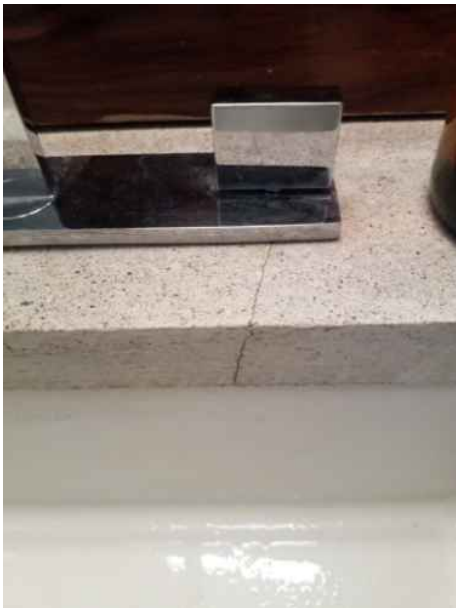
COUNTERS Fair

A crack was observed in the concrete countertop.

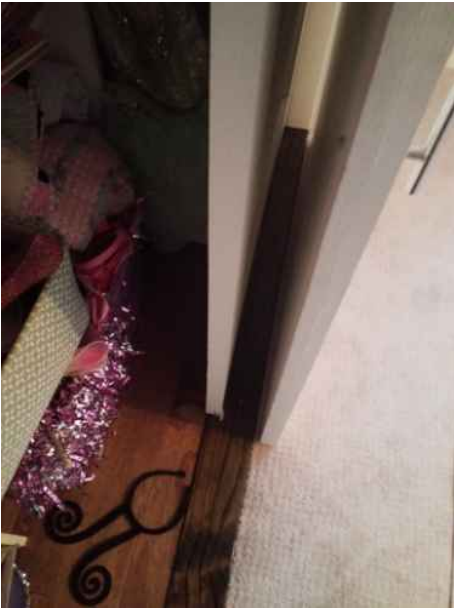
CLOSETS Fair

Door guides have not been installed

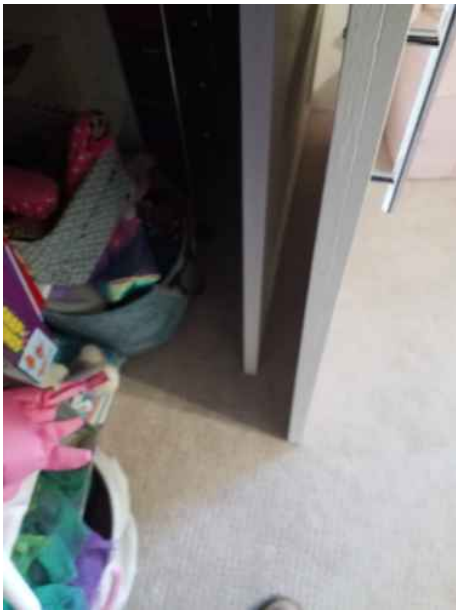
CLOSETS Fair

Door guides have not been installed

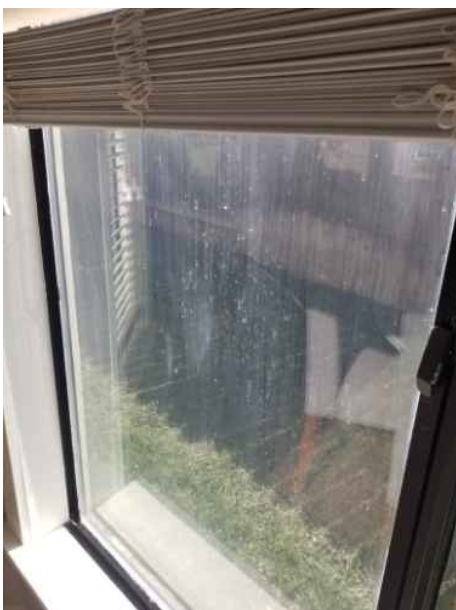
WINDOWS Fair

Condensation stains were observed in between the panes of glass of the center window at the breakfastnook. This indicates failed glazing. Recommend further evaluation by licensed window contractor.

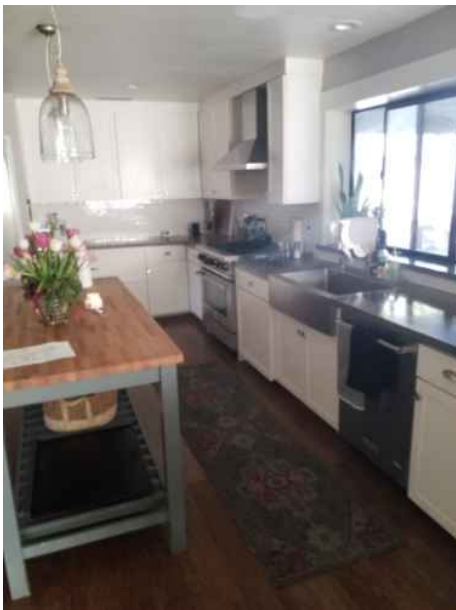
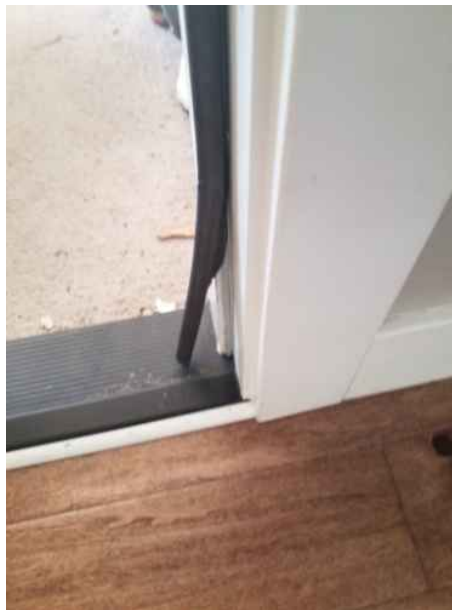
DOORS Fair

The door leading to the garage does not have self closing hinges as is required. This is a fire safety feature, recommend installation of self closing hinges.

Damaged weatherstripping was also observed at this door.

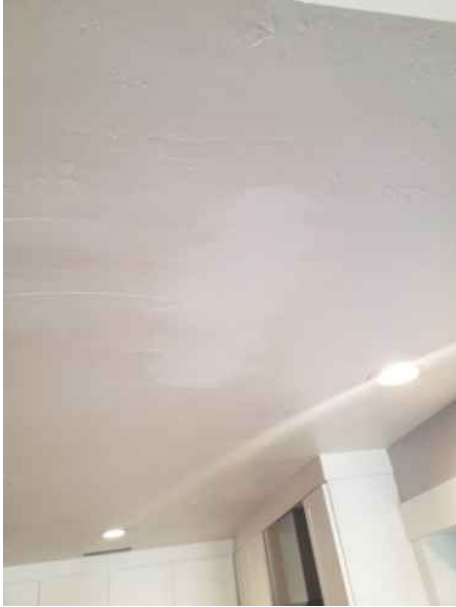
CEILING Fair

A patched area of ceiling was observed, possibly due to a past water leak.

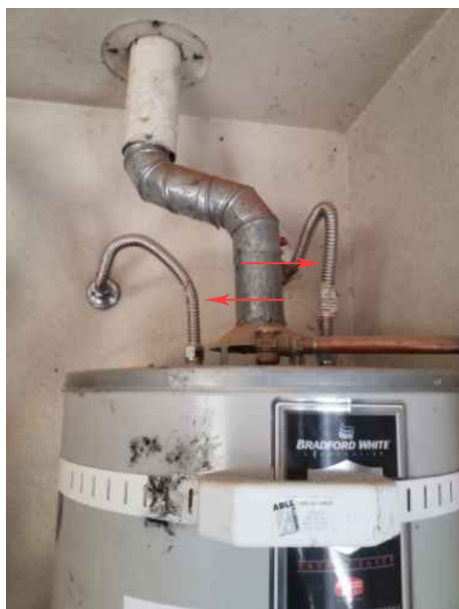
WATER HEATER Fair

The gas water heater is a 50 gallon unit and was manufactured in 2004. The expected life span of a water heater is 10-15 years. This unit is beyond its expected life span but still functioning.

Recommend wrapping hot and cold water lines to conserve energy.

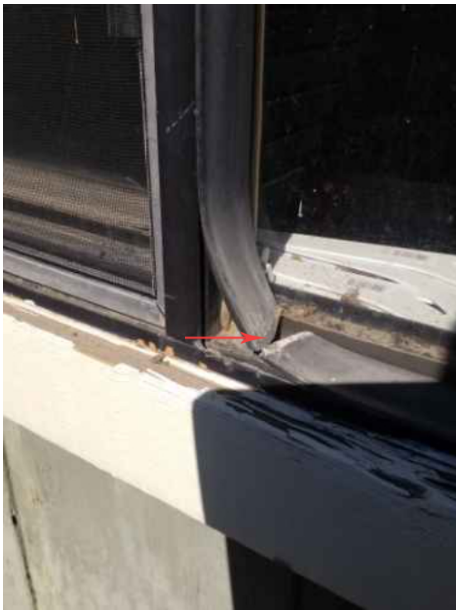
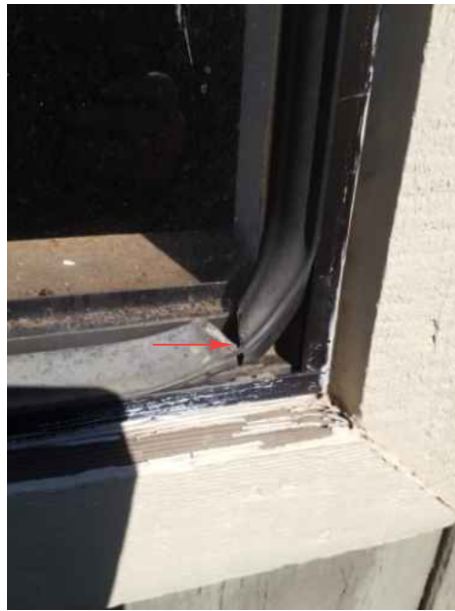
WINDOW SEALS N/A

Partially damaged window seals were observed at the garage window.

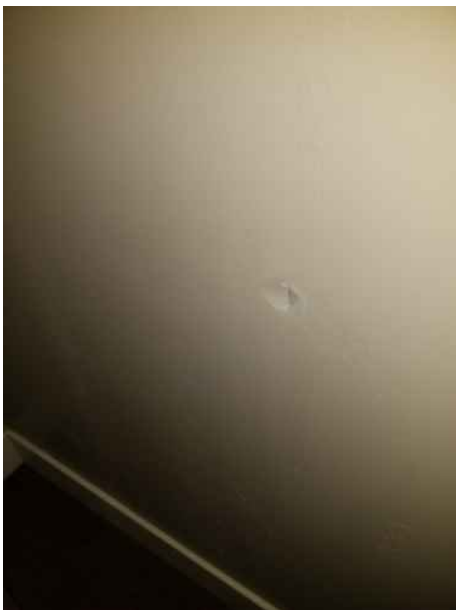
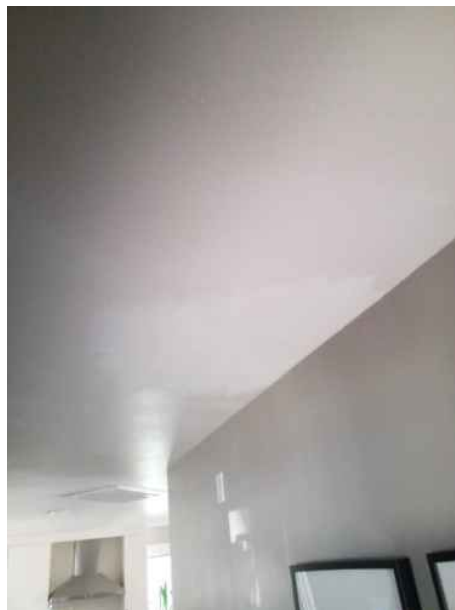
HALLWAYS Fair

Minor damage was observed to the wall behind the door leading to the bedrooms.

A patched area of ceiling was observed near the front door. This is possibly due to a past water leak.
