Duration Plumbing

Sewer Inspection Report

**26604 Shadow Wood
Rancho Palos Verdes, California 90275**

Tuesday, September 28, 2021 at 3:00 PM

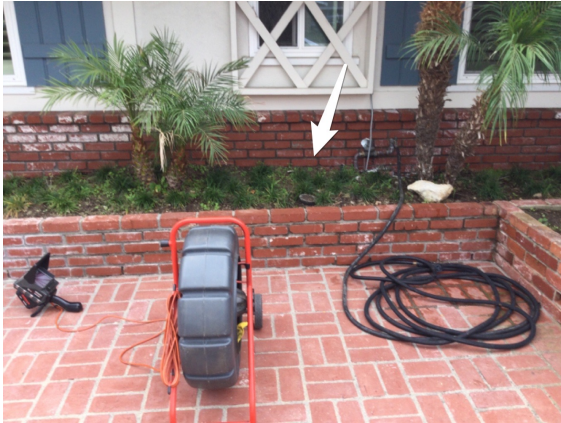
Four inch abs plastic clean out.
