Inspection Report

Property Address:
1931 Ruhland Ave
Redondo Beach CA 90278

Professional Inspection Network

Property Address 1931 Ruhland Ave Redondo Beach CA 90278	Date of Inspection 2/15/2023	Report ID 20230215-1931-Ruhland-Ave
Customer(s) Sanjeev Bhatia	Time of Inspection 09:00 AM	Real Estate Agent Linda Hernandez Shorewood Realtors

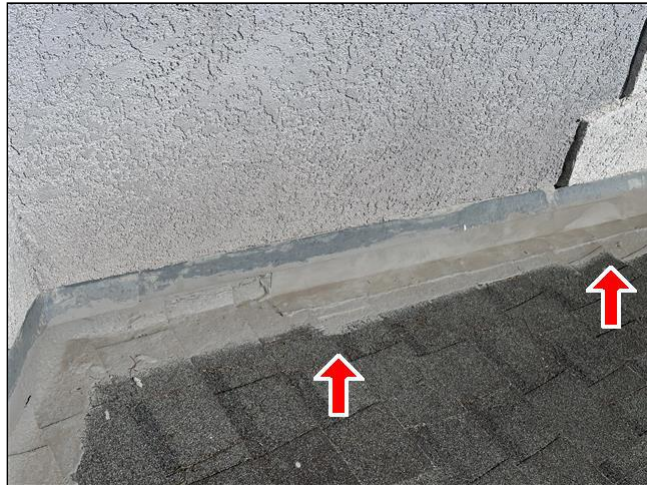
Item 1 - Item 3(Picture) Roofing

1. (1) **Major Concern:** The patching or repairs performed on this roof appear to have been done by a non-professional. They are not in accordance with industry standards are likely to leak or require ongoing maintenance. We suggest that the entire roof should be evaluated by a qualified roofer and repaired or replaced as necessary.

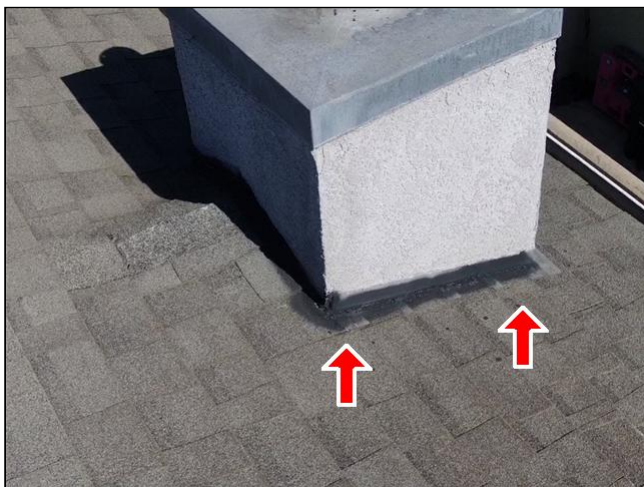
Item 3 - Item 1(Picture) Roofing
Flashings/Vents

3. (4) **Monitor:** The roof is covered with mastic in one or more locations. This is an indication of a past problem and note that these areas could not be properly viewed and will require ongoing maintenance. Inquire with the seller for more information Leaks can be difficult to repair, as the source of the leakage can be far removed from the water stain that shows up on the interior.

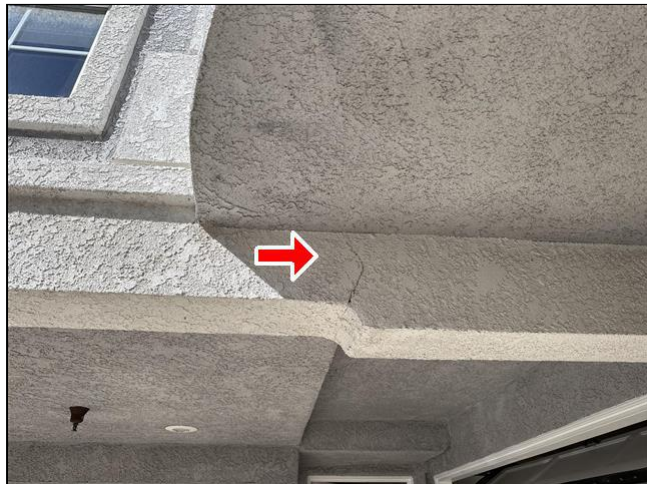
Item 7 - Item 1(Picture) Exterior

7. (1) **Repair/Replace/Monitor:** Visible cracking in the stucco cladding was observed at the exterior walls in one or more locations. Cracking in stucco walls happens when there is more stress placed on the wall than the material can withstand. The underlying cause of the hairline wall cracking may be due to problems with the wall's framing, contraction or expansion of wood sheathing, settling, thermal expansion or contraction, rapid changes in temperature, weak areas in the wall or abnormal vibrations in the ground. Suggest further evaluation by a qualified trades person for determination and/or corrective repairs within the inspection contingency period.

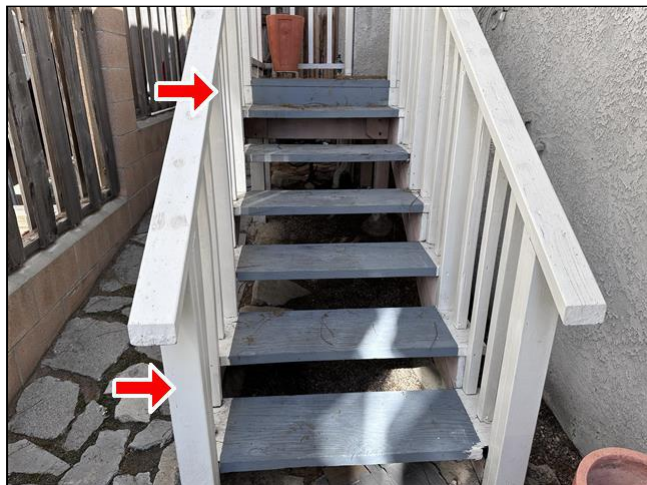
Item 8 - Item 1(Picture) Exterior

8. (2) **Repair or Replace:** Wood deterioration was observed at the West exterior wall **front unit** stairway/steps. If the home inspection reveals signs of damage you should have a pest control company inspect further for activity and possible hidden damage. Suggest repair/replacement of all deteriorated wood by a licensed contractor.

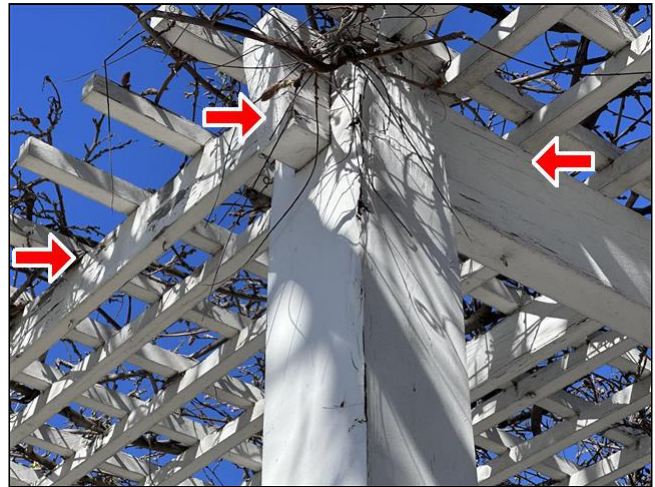
Item 9 - Item 2(Picture) Exterior

9. (3) **Repair or Replace:** Wood deterioration was observed at the front exterior wall **front unit** deck covering. If the home inspection reveals signs of damage you should have a pest control company inspect further for activity and possible hidden damage. Suggest repair/replacement of all deteriorated wood by a licensed contractor.

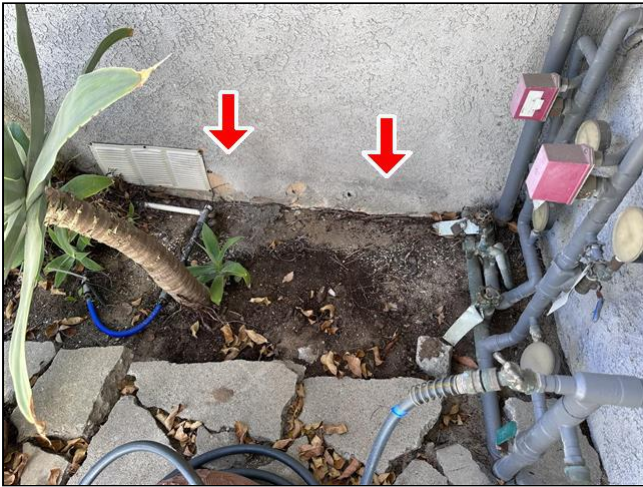
Item 11 - Item 1(Picture) Exterior

11. (5) **Repair or Replace:** The stucco cladding at the base of the exterior walls of the building is deteriorated in one or more locations. This type of deterioration is common in many older homes. The home was built in an era before weep screeds were installed at the bottom edge of the stucco siding, the stucco was extended into the soil. The stucco wicks water up out of the soil which causes the stucco to deteriorate from being moist for prolonged periods. We recommend minimizing moisture around the building to help protect the stucco and the foundation from moisture damage. Suggest further evaluation by a qualified trades person for determination and/or corrective repairs within the inspection contingency period.

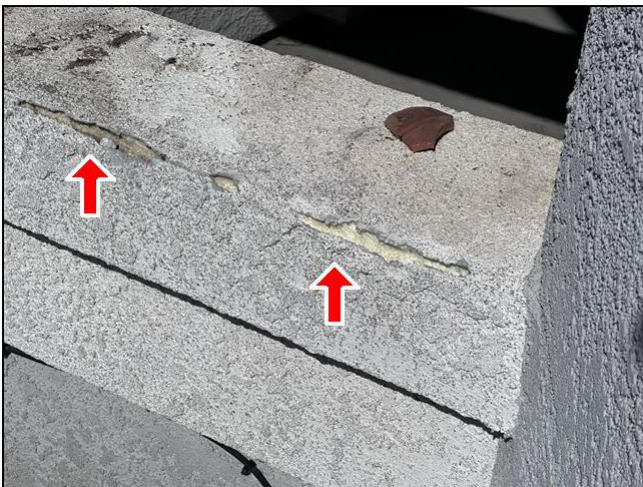
Item 12 - Item 1(Picture) Exterior

12. (6) **Repair or Replace:** The stucco cladding at the **rear unit** West exterior wall balcony is damaged in one or more locations. Suggest the stucco cladding be repaired by a qualified contractor to prevent water intrusion and water damage.

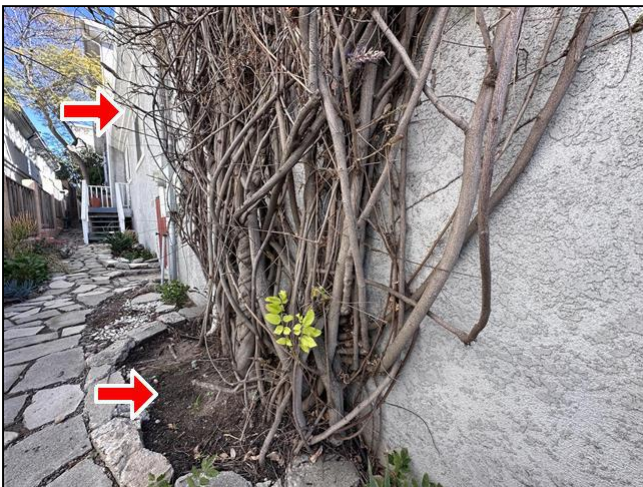
Item 13 - Item 1(Picture) Exterior

13. (7) **Improve:** It is suggested that all trees, tree limbs and vegetation in contact with the home be removed and/or trimmed away from the home to prevent damage and rodent activity.

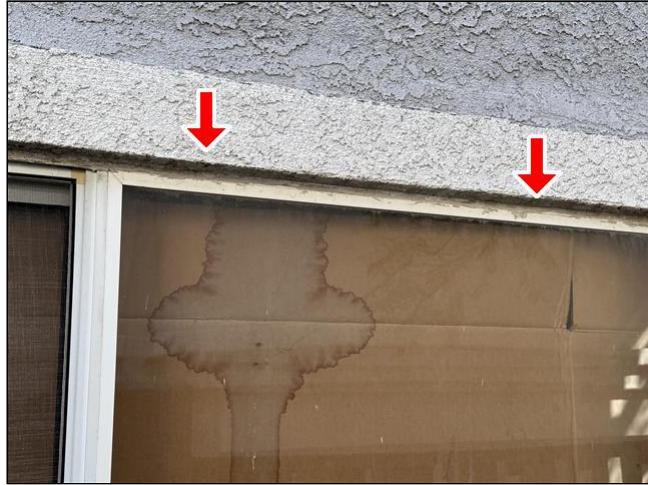
Item 16 - Item 2(Picture) Exterior

- 16. Repair/Replace/Monitor:** The rear West exterior wall window frame is covered with silicone in one or more locations. This is an indication of a past problem and note that these areas could not be properly viewed and will require ongoing maintenance. Inquire with the seller for more information Leaks can be difficult to repair, as the source of the leakage can be far removed from the water stain that shows up on the interior.

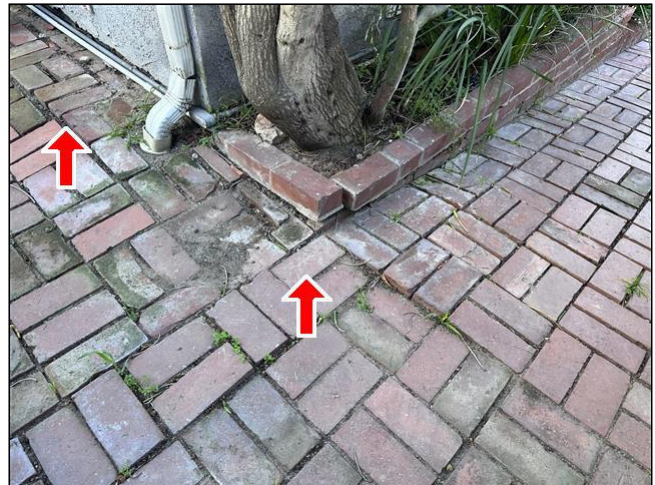
Item 19 - Item 2(Picture) Exterior

19. (3) **Repair or Replace:** There is a negative slope towards the building at the rear wall which will cause water to pond during rain or extended irrigation. This configuration can cause or contribute to water intrusion or deterioration of the foundation. Standing water can be detrimental to the integrity of the foundation of the house. It is important to prevent or minimize standing water around the house. Recommend further evaluation by a qualified grading contractor to determine corrections needed.

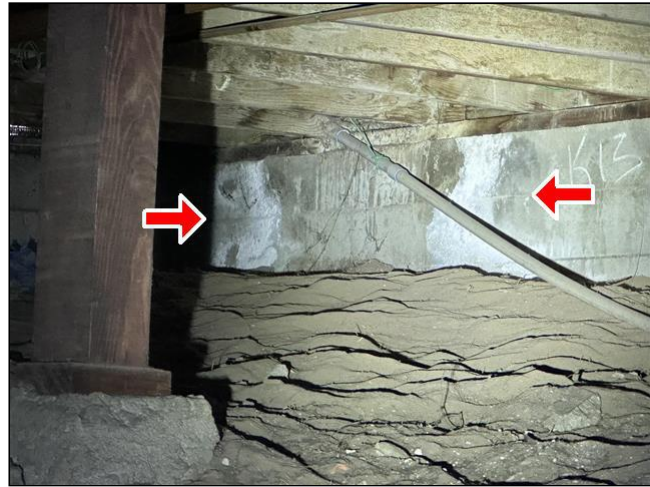
Item 25 - Item 2(Picture) Structural Components

25. (2) **Improve/Monitor:** A condition known as efflorescence is evident on portions of the concrete foundation walls or slab. This whitish, fuzzy material is a mineral deposit left when moisture in the concrete evaporates. The presence of efflorescence often indicates an occasional surplus of moisture on the outside of the foundation. We suggest to keep the exterior moisture to a minimum, exterior surface drainage, including downspout water, should be directed as far away from the building as possible. Landscape watering should always be directed away from the building and limited to short durations.

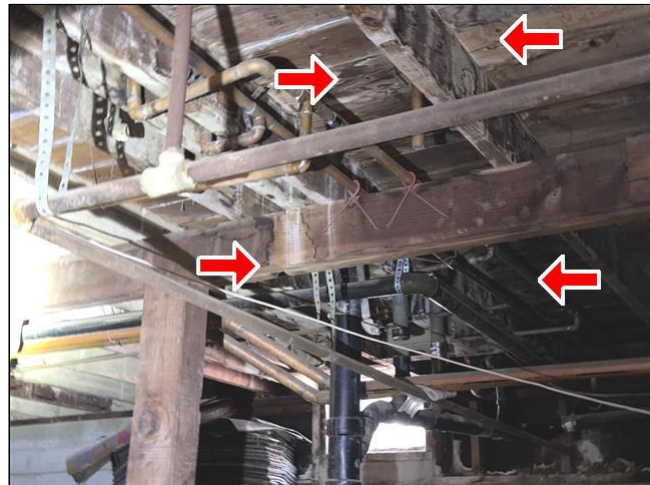
Item 26 - Item 2(Picture) Structural Components

26. (1) **Improve:** Water staining, possible wood deterioration and possible fungus was observed at the **front unit** subfloor and framing in one or more locations. It is suggested that the subfloor below bathrooms be further evaluated by a qualified contractor to determine if wood subfloors or in need of repair and or replacement.

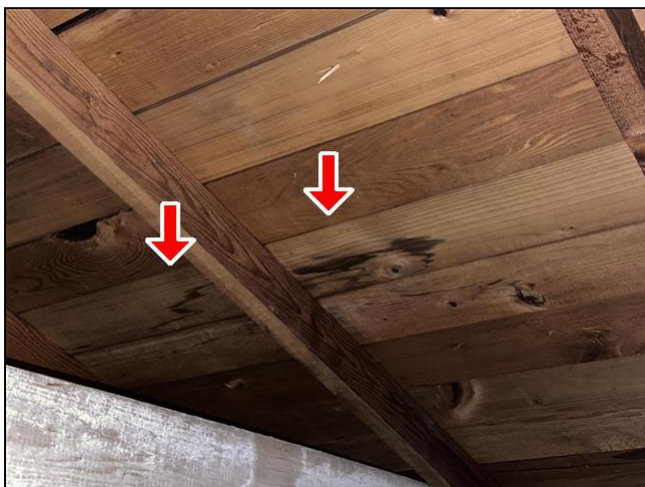
Item 29 - Item 1(Picture) Structural Components

29. (2) **Monitor:** Water staining was observed on the underside of the **front unit** roof sheathing and structure in various locations. We suggest asking the owner to provide you with information about the leak(s), and what corrective action (if any) was taken to repair the leak(s). Then if additional damage develops, the source of the leak(s) should be identified and repairs performed as necessary.

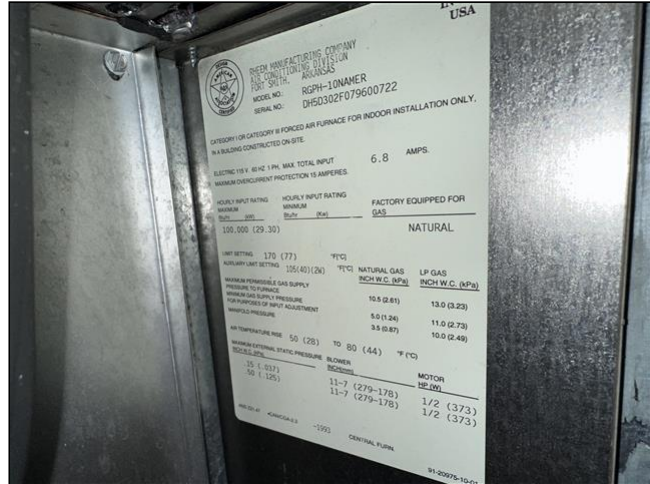
Item 33 - Item 1(Picture) Heating/Central Air
Flues and Vents (for gas heating systems)

33. (2) **Repair/Replace/Monitor:** The **rear unit** forced air heater is at or approaching the end of its service life. The wall heater is 20+ years old. The wall heater can fail at any time. Eventual replacement of this system should be anticipated.
 - A qualified HVAC contractor can inspect the system and provide you with replacement options and costs.

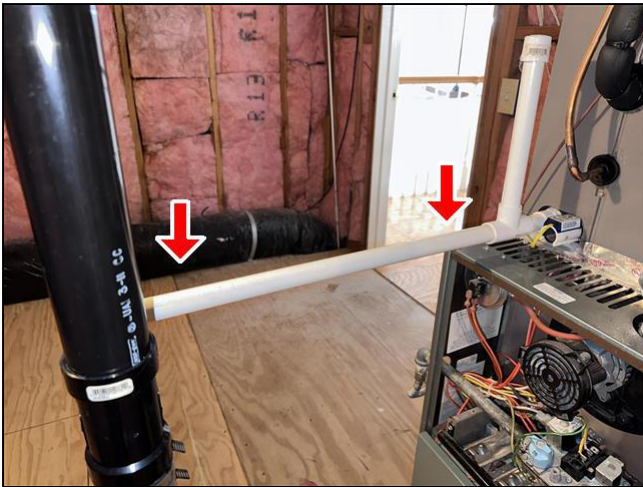
Item 38 - Item 1(Picture) Heating/Central Air

38. (3) **Repair or Replace:** The condensate drain line(s) for the indoor air component of the air conditioning system should be improved. The drain attaches to a plumbing vent without the use of a "P" trap. Suggest repair by a licensed HVAC contactor.

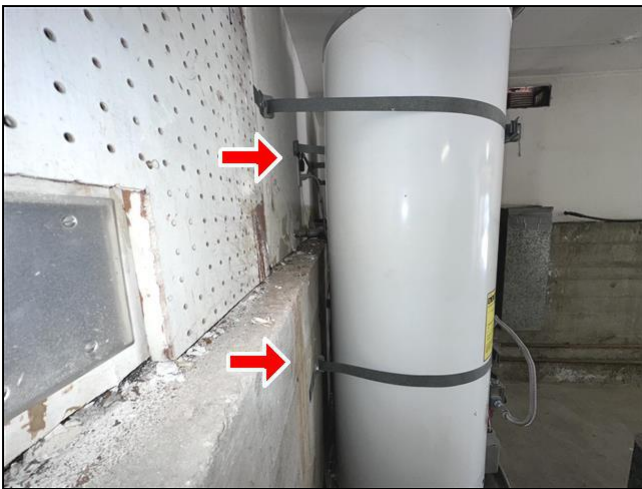
Item 48 - Item 1(Picture) Plumbing System

48. (4) **Safety Issue:** The water heaters at the **rear unit** garage are not "rigidly" reinforced (there is a gap between the unit and the walls) - "blocking" or equivalent is needed to prevent earthquake movement. Suggest further review and repairs by a licensed plumber.

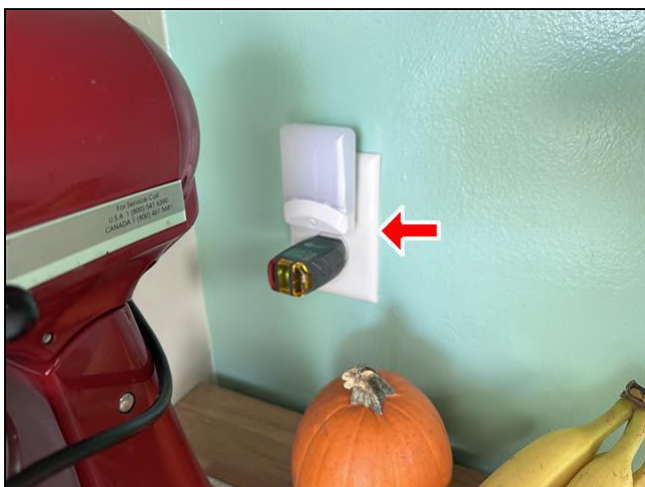
Item 57 - Item 1(Picture) Electrical System

57. (1) **Safety Issue:** The **front unit** kitchen countertop electrical outlet lacks GFCI (Ground Fault Circuit Interrupter) protection. Suggest the installation of a GFCI outlet by a qualified electrician.

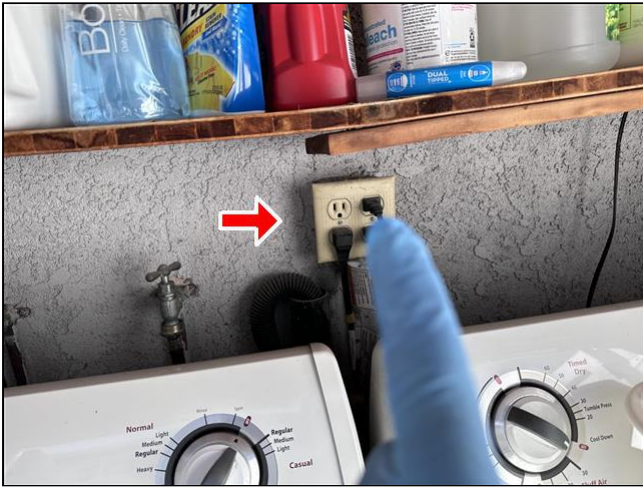
Item 61 - Item 1(Picture) Electrical System

61. (5) **Safety Issue:** The installation of ground fault circuit interrupter (GFCI) devices is advisable at all exterior and garage outlets. GFCI's are strongly recommended. A ground fault circuit interrupter (GFCI) offers protection from shock or electrocution; suggest repairs by a licensed electrical contractor.

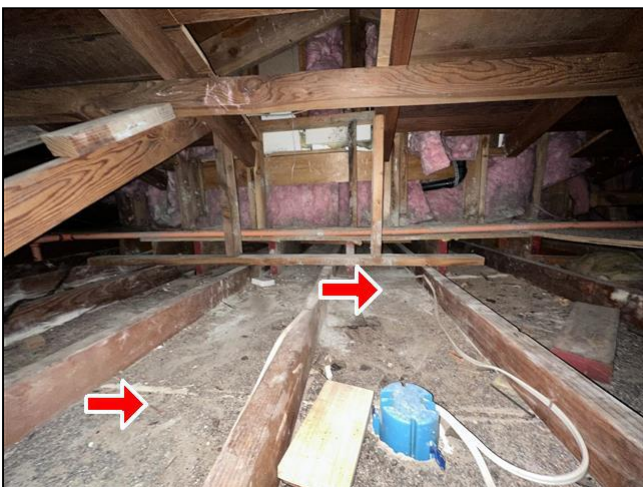
Item 63 - Item 1(Picture) Insulation & Ventilation

63. **Repair or Replace:** The front unit insulation is inconsistent. Insulation should be evenly distributed throughout the attic space. Suggest repair/replacement of the insulation by a qualified professional.

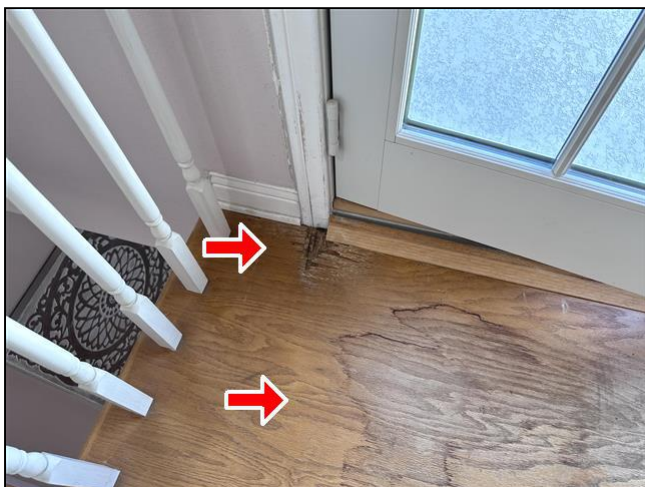
Item 72 - Item 1(Picture) Interiors

72. (1) **Repair or Replace:** Evidence of water damage/water leak was observed at the **rear unit** third floor area adjacent to the french doors. The floor is damaged. Areas of past and present moisture are favorable for growing many fungal like organisms. There is an extra risk of hidden damage/fungus/mold to be present in this location. The identification of molds, fungus and other microbial organisms is outside the scope of this inspection. We suggest a qualified environmental specialist should be retained to evaluate the surfaces and make further recommendations. Testing and remediation of mold growth can only be accomplished by a qualified environmental specialist. If strict protocol is not followed, spores can be released into the interior of the building and may create a health hazard for those with low tolerances to such organisms. Suggest repair/replacement of the floor by a qualified professional.

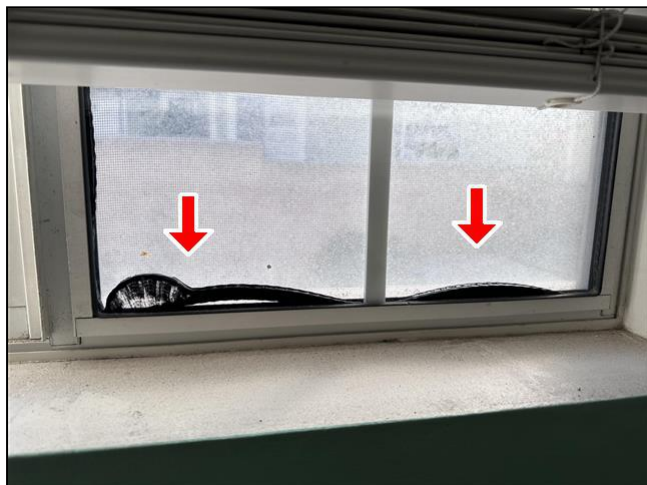
Item 73 - Item 1(Picture) Interiors

73. **Repair or Replace:** The **front unit** kitchen East wall dual pane widow interior gasket is bulging. This is common with many older dual pane window. This indicates that the gasket/seal is defective. Replacement of the window is suggested by a qualified professional.

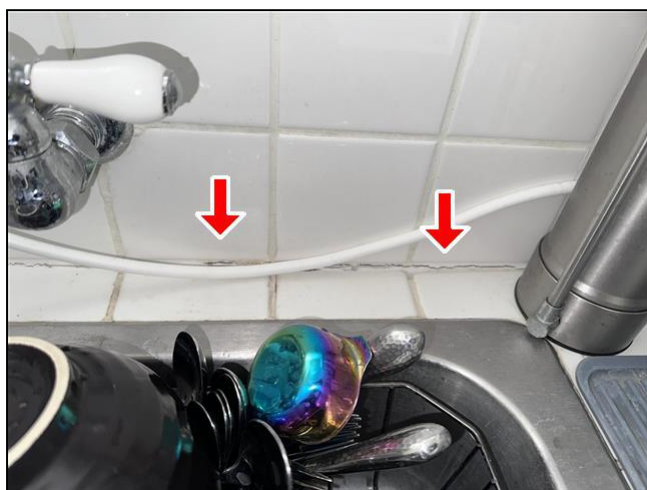
Item 74 - Item 1(Picture) Interiors

74. **Repair or Replace:** The **front unit** kitchen sink backsplash/countertop is in need of caulking with silicone at various areas to prevent moisture damage. Recommend repair or replace as necessary.

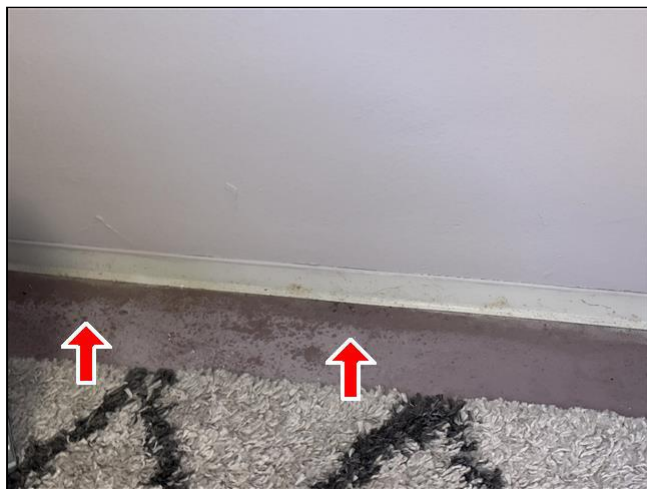
Item 77 - Item 1(Picture) Garage

77. (3) **Major Concern:** Evidence of water intrusion was observed at the **rear unit** West bonus room along the West and rear wall. The presence of water often indicates an occasional surplus of moisture on the outside of the foundation. We suggest to keep the exterior moisture to a minimum, exterior surface drainage, including downspout water, should be directed as far away from the building as possible. Landscape watering should always be directed away from the building and limited to short durations. Also, there is surface growth on the interior surfaces/finishes. This may indicate the presence of mold, fungus or other microbial organisms. The identification of molds, fungus and other microbial organisms is outside the scope of this inspection. We suggest a qualified environmental specialist should be retained to evaluate the surfaces and make further recommendations. Testing and remediation of mold growth can only be accomplished by a qualified environmental specialist. If strict protocol is not followed, spores can be released into the interior of the building and may create a health hazard for those with low tolerances to such organisms.

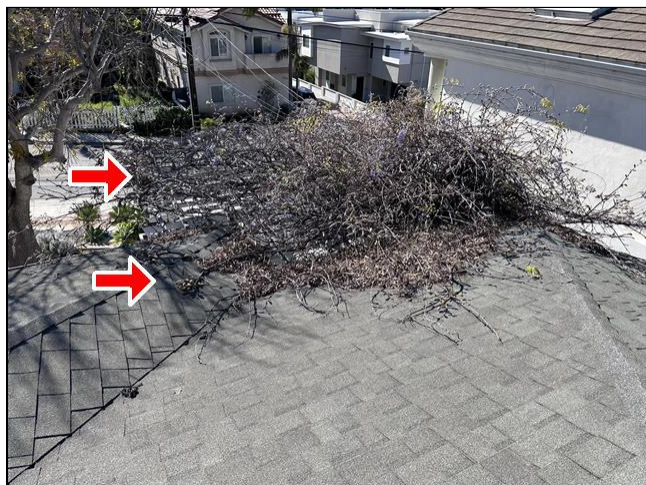
1.0 Item 10(Picture) Roofing

(3) **Improve:** It is suggested that all trees, tree limbs and vegetation in contact with the home be removed and/or trimmed away from the home to prevent damage and rodent activity.

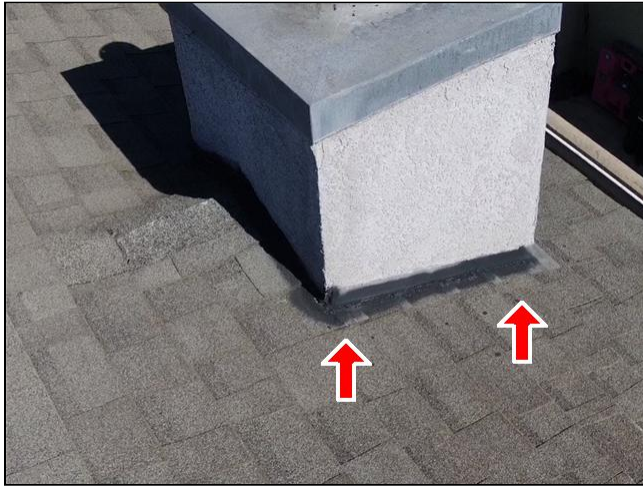
1.0 Item 11(Picture) Roofing

and note that these areas could not be properly viewed and will require ongoing maintenance. Inquire with the seller for more information. Leaks can be difficult to repair, as the source of the leakage can be far removed from the water stain that shows up on the interior.

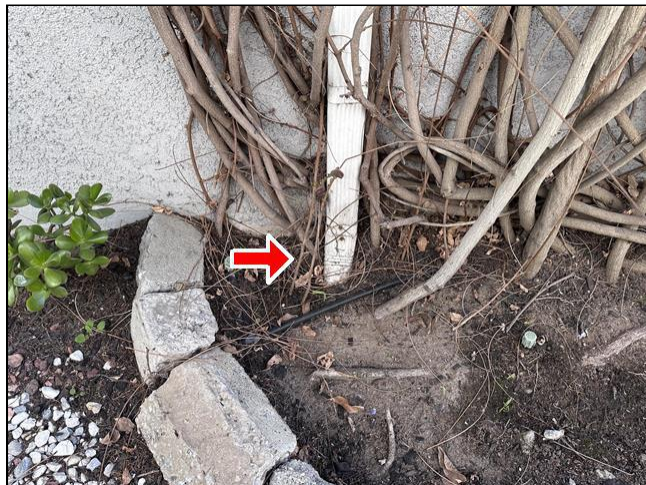
1.3 Item 1(Picture) Roofing

Monitor: Various downspouts are discharging into an underground drainage system. The drainage system was not water-tested during the inspection. We make no representations as to its nature or effectiveness. The operation of the drainage system should be observed during adverse weather. Inquires should be made to the seller(s) as to their knowledge of its past and present condition.

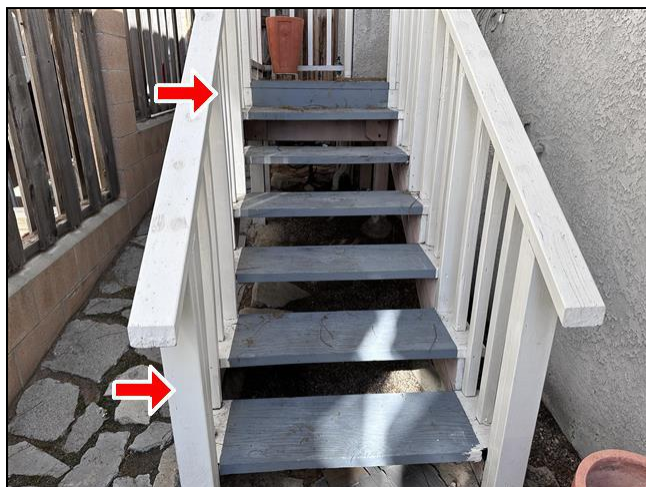
2.0 Item 3(Picture) Exterior

(2) **Repair or Replace:** Wood deterioration was observed at the West exterior wall **front unit** stairway/steps. If the home inspection reveals signs of damage you should have a pest control company inspect further for activity and possible hidden damage. Suggest repair/replacement of all deteriorated wood by a licensed contractor.

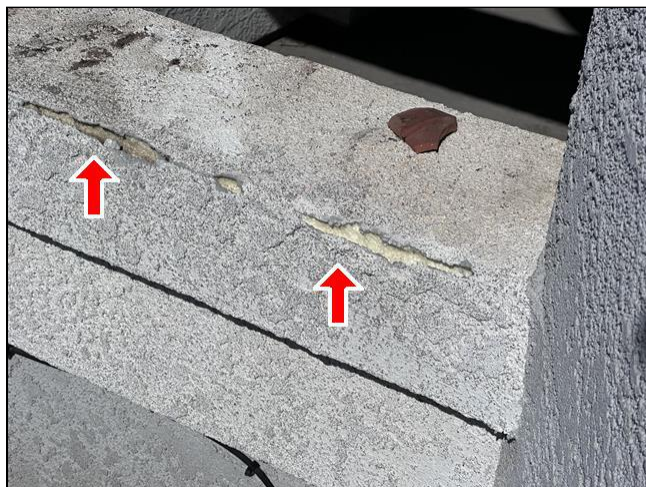
2.0 Item 9(Picture) Exterior

(6) **Repair or Replace:** The stucco cladding at the **rear unit** West exterior wall balcony is damaged in one or more locations. Suggest the stucco cladding be repaired by a qualified contractor to prevent water intrusion and water damage.

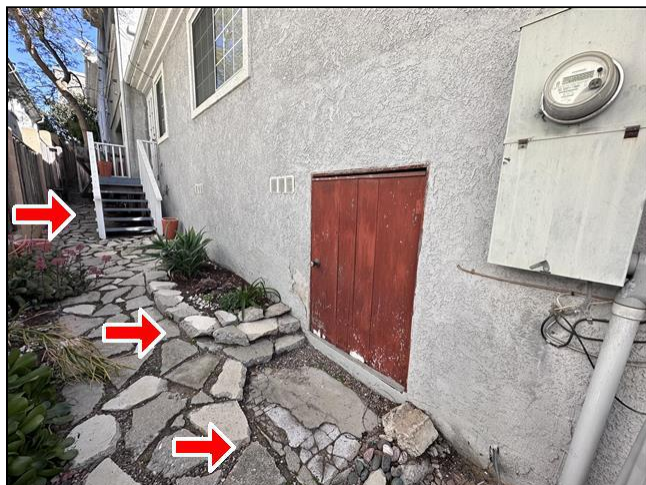
2.4 Item 5(Picture) Exterior

(4) **Repair or Replace:** There is a negative slope towards the building at the West exterior wall which will cause water to pond during rain or extended irrigation. This configuration can cause or contribute to water intrusion or deterioration of the foundation. Standing water can be detrimental to the integrity of the foundation of the house. It is important to prevent or minimize standing water around the house. Recommend further evaluation by a qualified grading contractor to determine corrections needed.

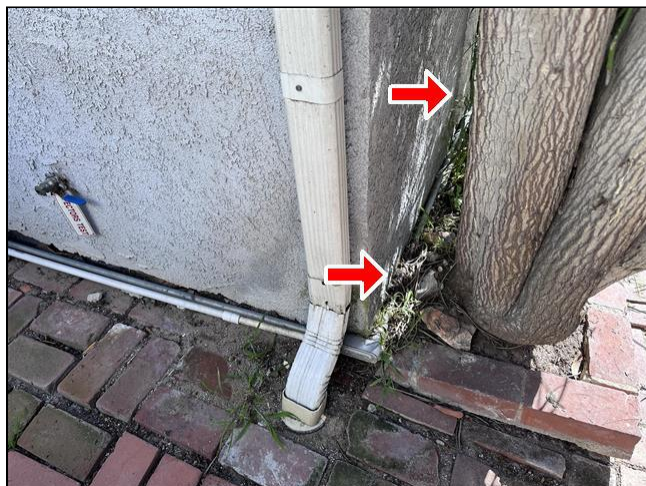
2.4 Item 6(Picture) Exterior

(5) **Improve/Monitor:** Unable to determine if a moisture barrier has been employed between the soil and exterior wall/foundation at the rear North-West corner of the home. The lack of a moisture barrier can allow to seep into the structure and cause damage. It is strongly advised that these exterior areas be further investigated and corrected by a qualified contractor.

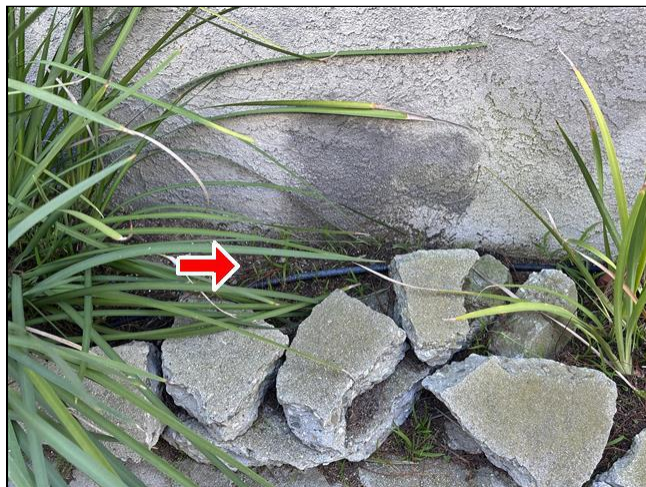
2.10 Item 1(Picture) Exterior

Improve: Various irrigation sprinklers at the are in close proximity to the exterior walls of the home. It is suggested that the sprinklers be relocated away from the home and foundation walls to prevent damage to the home.

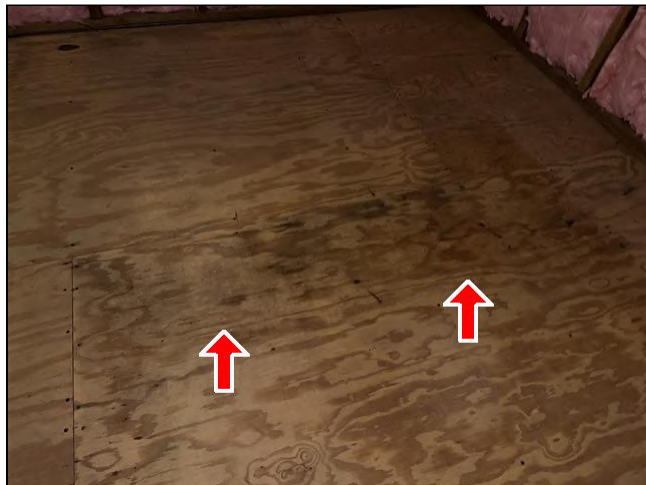
3.5 Item 5(Picture) Structural Components

(4) **Monitor:** Water staining was observed at the **rear unit** attic space platform and roof structure. We suggest asking the owner to provide you with information about the leak(s), and what corrective action (if any) was taken to repair the leak(s). Then if additional damage develops, the source of the leak(s) should be identified and repairs performed as necessary.

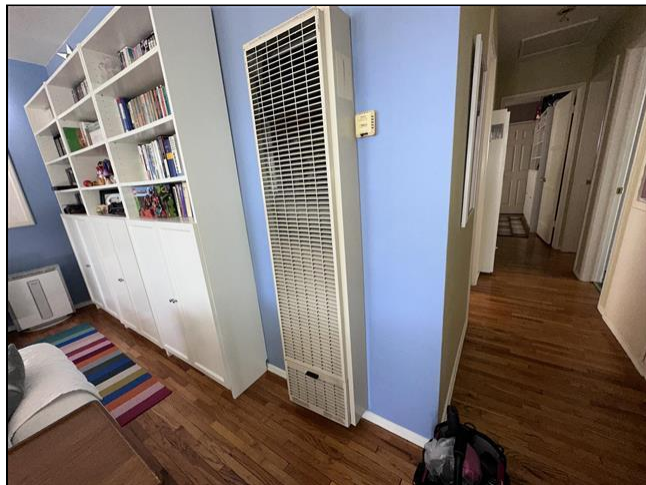
4.0 Item 4(Picture) Heating/Central Air

(3) **Monitor:** The **front unit** wall heater was operational and produced heat at time of inspection. However, due to the many components that are not visible (such as the heat exchanger and the entire length of the flue pipe), our inspection of the system is limited. Because of this, we recommend further evaluation/safety check be performed by the local gas company before the end of your contingency period.

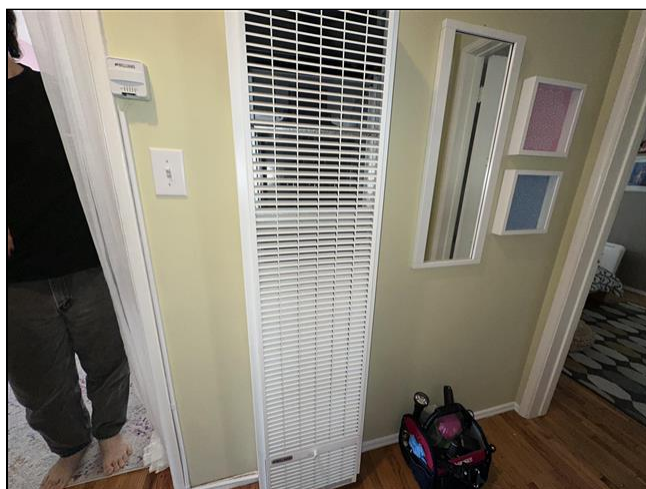
4.0 Item 5(Picture) Heating/Central Air

(4) **Monitor:** The **front unit** hallway wall installed is not original. The furnace appeared functional at the time of inspection. However, we recommend asking the sellers for documentation showing that this unit was installed by a licensed HVAC contractor per the manufactures installation requirements. If documentation cannot be produced, I recommend this unit be further explored by a licensed HVAC contractor for safety.

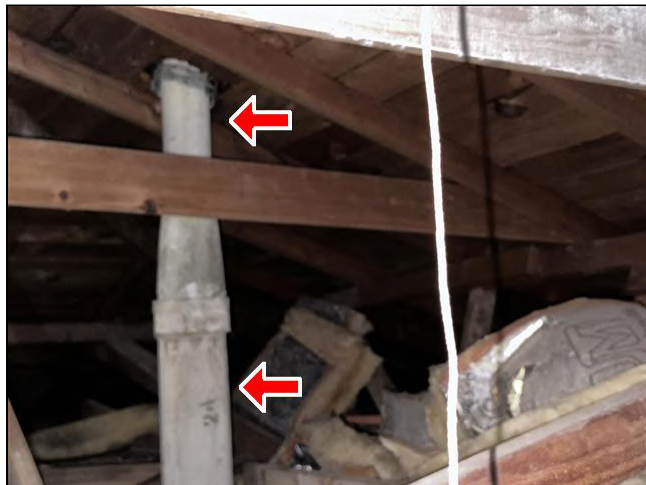
4.3 Item 3(Picture) Heating/Central Air

(2) **Monitor:** The older ceramic exhaust flue at the **front unit** living room wall heater may contain Asbestos. This can only be verified by laboratory analysis. The Environmental Protection Agency (E.P.A.) reports that asbestos represents a health hazard if "friable" (damaged, crumbling, or in any state that allows the release of fibers). Suggest further review, testing and removal by a qualified professional.

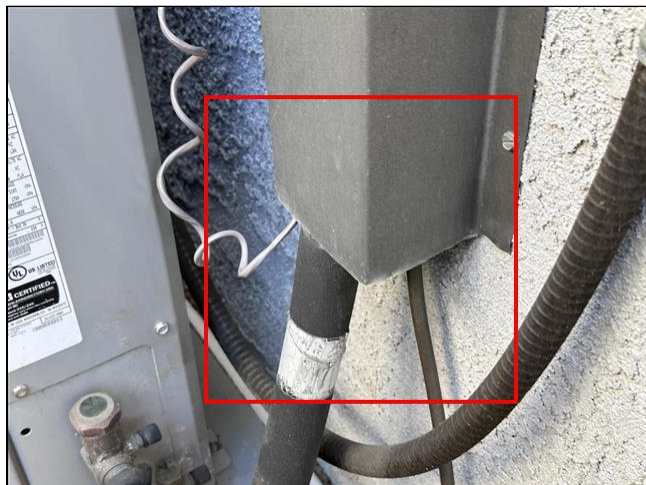
4.7 Item 5(Picture) Heating/Central Air

(2) **Improve:** The penetration(s) where the coolant refrigerant lines enter the building are not sealed. These areas are large enough to allow pest entry into the building. We suggest the holes in the penetrations should be properly sealed.

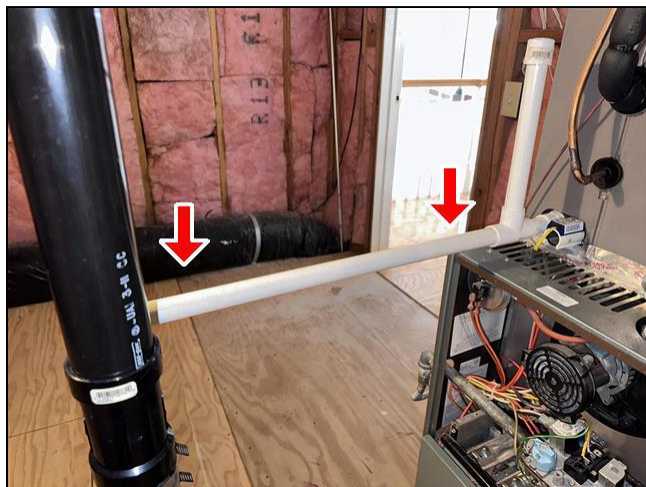
4.7 Item 6(Picture) Heating/Central Air

(3) **Repair or Replace:** The condensate drain line(s) for the indoor air component of the air conditioning system should be improved. The drain attaches to a plumbing vent without the use of a "P" trap. Suggest repair by a licensed HVAC contractor.

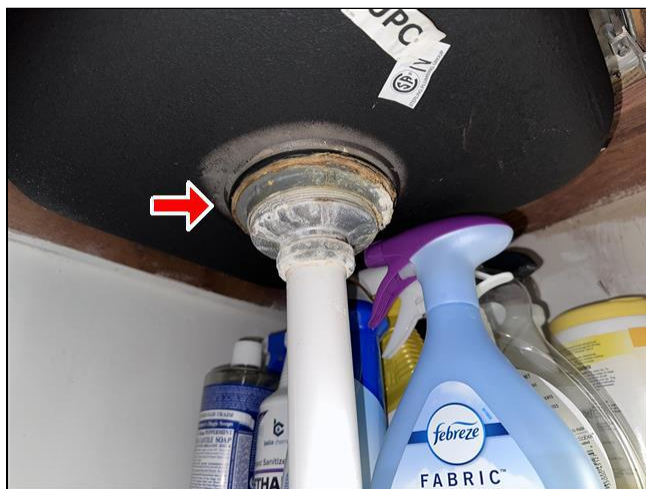
5.0 Item 1(Picture) Plumbing System

(1) **Repair or Replace:** The **front unit** kitchen sink drain pipe connection on the underside of the sink is corroded and appears to be leaking. Suggest replacement of the corroded drain by a qualified professional to prevent water damage.

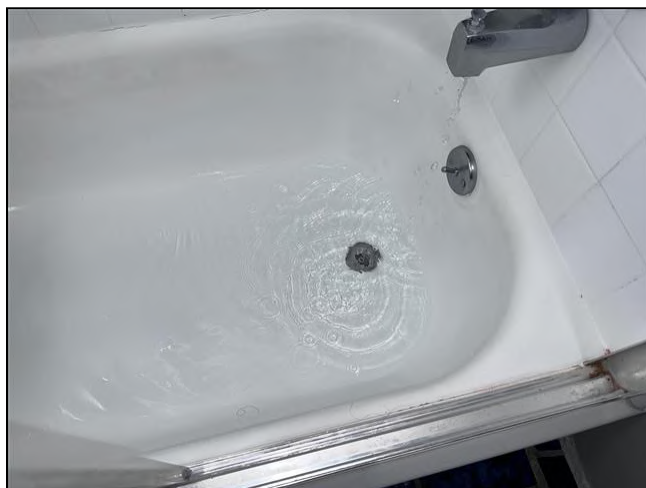
5.0 Item 2(Picture) Plumbing System

(2) **Repair or Replace:** The **front unit** hallway bathroom tub was slow to drain during the inspection. This would suggest that the drain is obstructed. Suggest repair by a qualified professional.
