WOOD DESTROYING PESTS AND ORGANISMS INSPECTION REPORT

Building No. 37855	Street Via Majorca	City Murrieta	Zip 92562-7102	Date of Inspection 09/01/2022	Number of Pages 1 of 6
-----------------------	-----------------------	------------------	-------------------	----------------------------------	---------------------------

Report #: 18119

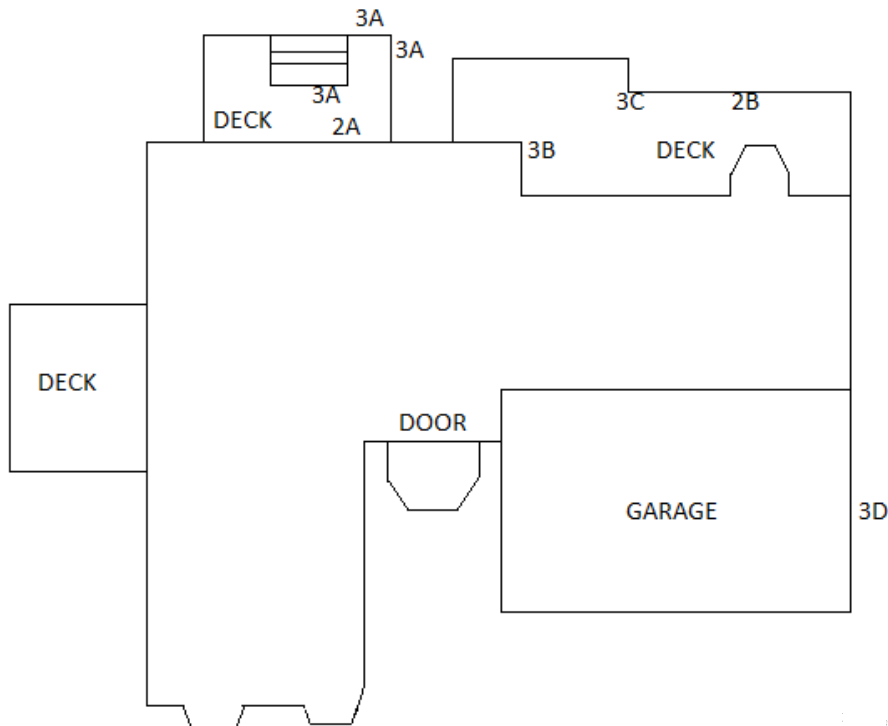
Finding: 2A FINDING - Drywood termite evidence noted at the bedroom door jamb to deck as marked 2A on the diagram. (SECTION 1 ITEM)

Finding: 2B FINDING - Drywood termite evidence noted at the 6x6 deck support post as marked 2B on the diagram. (SECTION 1 ITEM)

Finding: 3A FINDING - Fungus damage was noted at the 2x6 deck rim joist and steps as marked 3A on the diagram.(SECTION 1 ITEM)

Finding: 3B FINDING - Fungus damage was noted at the fascia board and barge rafter as marked 3B on the diagram.(SECTION 1 ITEM)

Finding: 3C FINDING - Fungus damage was noted at the 6x6 deck support post as marked 3C on the diagram.(SECTION 1 ITEM)

Finding: 3D FINDING - Fungus damage was noted at the fascia board and shadow board on the second story as marked 3D on the diagram.(SECTION 1 ITEM)
Recommendation: RECOMMENDATION - Repair the infested damaged materials. Should the damage extend into an area that was inaccessible at the time of the original inspection, work will cease and a supplemental report will be issued. Repaired or replaced wood will be primer only.
Price: Inc in 3A

Recommendation: RECOMMENDATION - Treat the infested area with an approved termiticide - Invader: propoxur or Termidor Foam: fipronil - to eliminate drywood termites. Guaranteed for a period of one (1) year in treated area only. Patch to repair. ALL TREATMENTS MUST BE DONE BY BLACK KNIGHT TERMITE FOR A CLEAR TERMITE REPORT.

Recommendation: RECOMMENDATION - Remove, replace and/or repair the infested damaged materials. Should the damage extend into an area that was inaccessible at the time of the original inspection, work will cease and a supplemental report will be issued. Repaired or replaced wood will be painted to match with the brand of paint that is standard to us. Color and sheen are not guaranteed to match If the homeowner wishes, they may supply exact paint to match.

Recommendation: RECOMMENDATION - Repair the infested damaged materials. Should the damage extend into an area that was inaccessible at the time of the original inspection, work will cease and a supplemental report will be issued. Repaired or replaced wood will be primer only.
