# WOOD DESTROYING PESTS AND ORGANISMS INSPECTION REPORT

Building No. 43060	Street Corte Salamanca	City Temecula	Zip 92592-3722	Date of Inspection 11/23/2021	Number of Pages 1 of 7
-----------------------	---------------------------	------------------	-------------------	----------------------------------	---------------------------

**Black Knight Termite & Pest Control**  
**39433 Colleen Way**  
**Temecula, CA 92592**  
 Tel 951-694-8100 Fax 951-693-0988  
 Registration #: PR4946

General Description: SINGLE FAMILY TWO STORY, TILE ROOF, STUCCO SIDING, DOUBLE GARAGE, SLAB FOUNDATION, OCCUPIED	Inspection Tag Posted: GARAGE
Other Tags Posted:

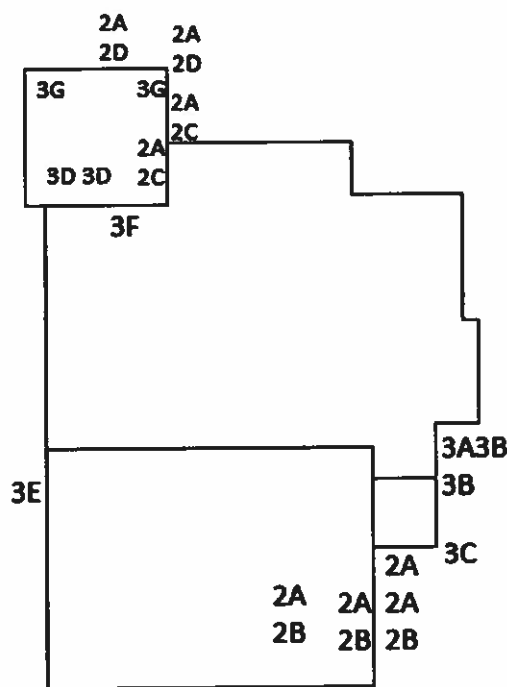
- Finding: 2A      FINDING - Drywood termite evidence noted at the second story roof eaves, patio cover framing as marked 2A on the diagram. (SECTION 1 ITEM)

- Price: \$2,250.00
- 
- Finding: 2B      FINDING - Drywood termite damage was noted at the second story roof eave framing as marked 2B on the diagram. (SECTION 1 ITEM)

- Price: \$4,950.00
- 
- Finding: 2C      FINDING - Drywood termite damage was noted at the balcony decking as marked 2C on the diagram. (SECTION 1 ITEM)

- Price: Inc in 2B
- 
- Finding: 2D      FINDING - Drywood termite damage was noted at the balcony header beam as marked 2D on the diagram. (SECTION 1 ITEM)

- Finding: 3A      FINDING - Fungus damage was noted at the fascia and trim as marked 3A on the diagram.(SECTION 1 ITEM)

**Finding:** 3B FINDING - Fungus damage was noted at the window trim as marked 3B on the diagram.(SECTION 1 ITEM)

**Finding:** 3C FINDING - Fungus damage was noted at the small fence at front porch as marked 3C on the diagram.(SECTION 1 ITEM)

**Finding:** 3D FINDING - Fungus damage was noted at the balcony decking as marked 3D on the diagram.(SECTION 1 ITEM)

**Finding:** 3E FINDING - Fungus damage was noted at the side garage door jamb as marked 3E on the diagram.(SECTION 1 ITEM)

**Finding:** 3F FINDING - Fungus damage was noted at the exterior door jamb at balcony/master bedroom as marked 3F on the diagram.(SECTION 1 ITEM)

**Finding:** 3G FINDING - Fungus damage was noted at the balcony handrail framing as marked 3G on the diagram.(SECTION 1 ITEM)

- Recommendation:      RECOMMENDATION - Fumigate structure with an approved lethal gas, Vikane (Sulfuryl Floride) to control drywood termites. Where accessible termite evidence will be covered or removed upon completion of fumigation. Owner or agent to prepare the structure for fumigation as per list of instructions to be furnished by this company. BLACK KNIGHT TERMITE AND PEST CONTROL AND FUMIGATOR are not responsible for damage to plants or roof tiles. Guaranteed for a period of one (1) year.

- Recommendation:      RECOMMENDATION - Remove, replace and/or repair the infested damaged materials. Should the damage extend into an area that was inaccessible at the time of the original inspection, work will cease and a supplemental report will be issued. Repaired or replaced wood will be painted to match with the brand of paint that is standard to us. Color and sheen are not guaranteed to match If the homeowner wishes, they may supply exact paint to match.

**Recommendation:** RECOMMENDATION - Remove, replace and/or repair the infested damaged materials. Should the damage extend into an area that was inaccessible at the time of the original inspection, work will cease and a supplemental report will be issued. Repaired or replaced wood will be painted to match with the brand of paint that is standard to us. Color and sheen are not guaranteed to match. If the homeowner wishes, they may supply exact paint to match.

**Recommendation:** RECOMMENDATION - Repair the infested damaged materials. Should the damage extend into an area that was inaccessible at the time of the original inspection, work will cease and a supplemental report will be issued. Repaired or replaced wood will be primer only.

RECOMMENDATION - Remove, replace and/or repair the infested damaged materials. Should the damage extend into an area that was inaccessible at the time of the original inspection, work will cease and a supplemental report will be issued. Repaired or replaced wood will be painted to match with the brand of paint that is standard to us. Color and sheen are not guaranteed to match. If the homeowner wishes, they may supply exact paint to match.
