# WOOD DESTROYING PESTS AND ORGANISMS INSPECTION REPORT

Building No. 190	Street Sienna Street	City Morro Bay	Zip 93442	Date of Inspection 03/14/2019	Number of Pages 1 of 6
---------------------	-------------------------	-------------------	--------------	----------------------------------	---------------------------

**Report #: 91286**

General Description: Single Story, single family residence; Stucco exterior; Composition shingle roof; Furnished and occupied.	Inspection Tag Posted: GARAGE
Other Tags Posted:

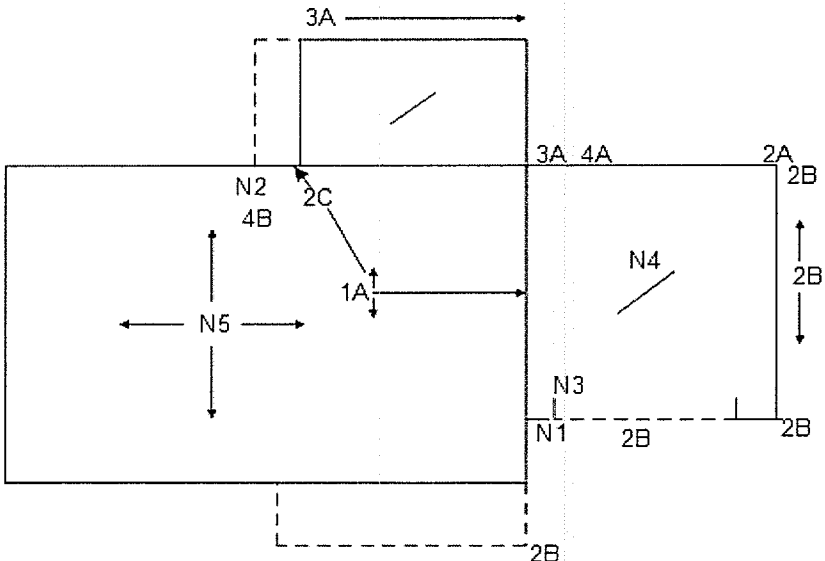
**\*\*\*Complete Inspection Report\*\*\***  
 Diagram not to scale  
 Finding locations approximate

Finding: 1A Evidence of Subterranean Termites infestation was found in the substructure area.  
Recommendation: Chemically treat the substructure soil in areas of termite activity using Termidor (fipronil). In addition, an application will be made to the soil adjacent to the exterior wall around the complete perimeter of the structure. Holes may be drilled through concrete, paving or masonry adjacent to the foundation in areas such as, but not limited to; patios, sidewalks, porches and driveways, to allow for chemical treatment of the soil below. We will exercise reasonable caution when drilling but assume no liability for damage to hidden plumbing, electrical, or other utility below these areas. The location of such utilities should be identified prior to our arrival. Regardless of locations of Subterranean Termite infestation found, control of the entire structure is guaranteed. Control is guaranteed by Key Termite and Pest Control for a period of 5 years from the date of treatment.

Finding: 2A Evidence of Drywood Termite infestation was found at the exterior and appears to extend into inaccessible areas of the structure.  
Recommendation: Seal the structure and fumigate with a gas lethal to Drywood Termites (Sulfuryl Fluoride). All occupants and pets must vacate the structure until the fumigation is complete. This company will exercise reasonable caution, but cannot be held responsible for damage to plants, TV antennas or roofing due to the fumigation. Further terms and instructions will be supplied upon request or upon scheduling of the fumigation. Information may also be obtained from the fumigation page on our website at [www.keytermite.com](http://www.keytermite.com)  
**\*\*\*Fumigations are guaranteed for 5 years from the date completed\*\*\***  
Price: \$1,696.00

Finding: 2B Drywood Termite damage was found at the fascia.  
Recommendation: Remove and replace the damaged portion of the fascia as needed.  
Price: \$890.00

Finding: 2C Evidence of Drywood Termite infestation was found at the attic.  
Recommendation: Refer to item 2A for recommendation. Cost included in item 2A.  
Price: Included as noted in recommendation.

Finding: 3A Fungus damage was found at the base of wall panel inserts of the patio enclosure. Removal and replacement of the panels appears to be impractical.  
Recommendation: Chemically treat the base of the panel inserts with disodium octaborate tetrahydrate or copper naphthenate. Install cement board from bottom of window frame to base of wall panel to protect the base of wall panels from further exposure. Install metal counter flashing at top of new siding sealed to metal frame.  
Price: \$1,157.00

Finding: 3B Fungus damage was found at the fascia of the eave area.  
Recommendation: Replace the fungus damaged portions of fascia as needed.  
Note: Cost included in item 2B.  
Price: Included as noted in recommendation.

Finding: 4A Moisture damage was noted at the exterior door and appears to have been caused by normal exposure to the weather.

Finding: 4B The toilet was found to be loosely bolted to the floor. This creates a potential source of leakage.

Recommendation: Replace the weather damaged door with the same or similar type. Existing door hardware (lock; hinges; sweep, etc) will be reused. Additional costs will apply if the hardware is not functional. Exterior doors are limited to the manufacturers warranty of one year.

Recommendation: Reset the toilet using a new wax seal and bolts. Additional costs may apply if the toilet flange is found to be damaged or if existing supply line/valve cannot be reused.
