**Address:** 6919 Grovespring Dr, Rancho Palos Verdes

**Date of Inspection:** 5-23-25

## Main Sewer Line Inspection Report

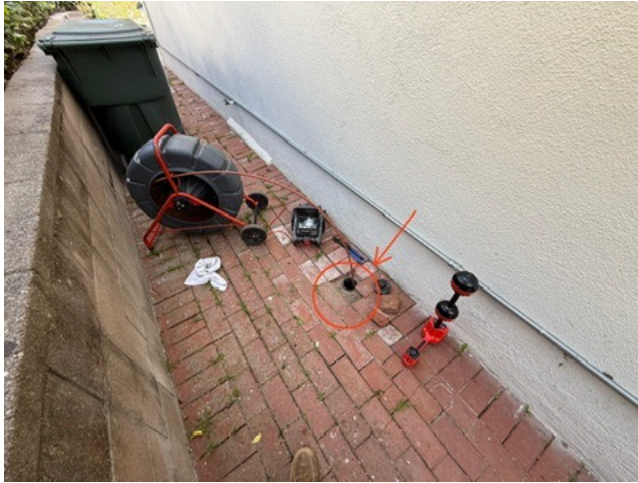
Location of 3" cleanout used for inspection.

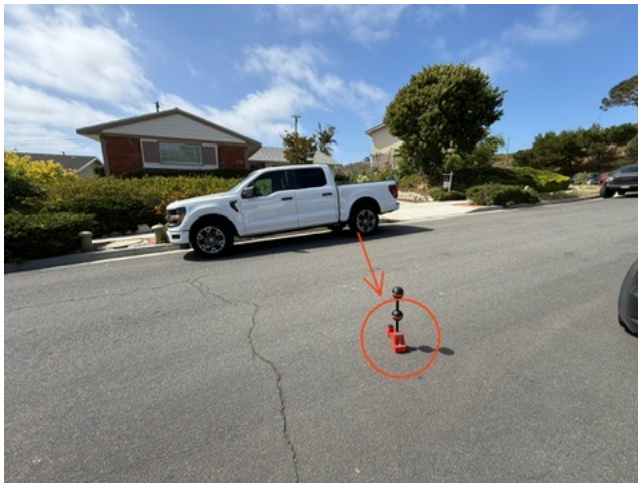
Connection to city sewer under tool.
