Address: 3850 E 15th St, Long Beach

Date of Inspection: 2-29-24

Name of Inspector: Nemesio "Nemo" Padilla

Main Sewer Line Inspection Report

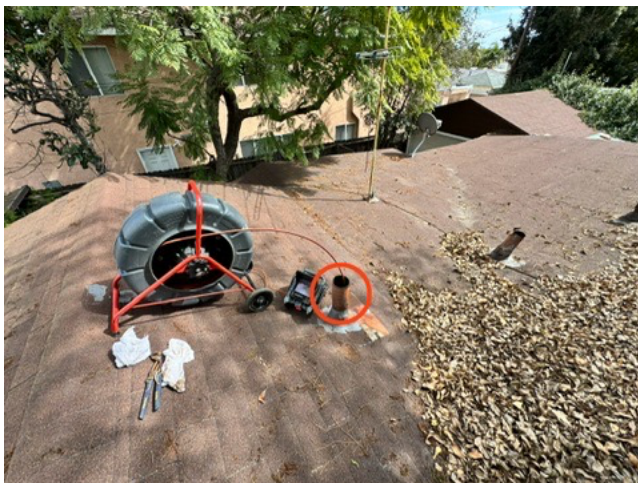
Main Sewer Line Access Points: In order to view the main sewer line for this property we used a 4" roof vent. This roof vent is insufficient access to perform routine maintenance and inspections on the main sewer line.

4" roof vent used for inspection.

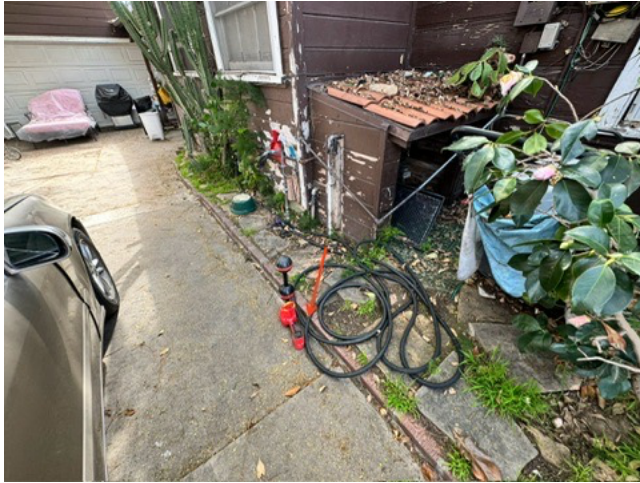
The cast iron pipe in this system is aged at this time and has characteristics which indicate it is possibly able to leak sewer out of the pipe into the surrounding soil. There is deformation of the interior of the pipe from the rusting which has been wearing away the steel of the pipe. This pipe may require replacement in the not-too-distant future.

Location where the cast iron pipe exits the house and then transitions into a clay material pipe. Good location for a clean out to be installed under tool.

Areas Needing Attention: A cleanout should be installed (see pictures for location) for routine maintenance and inspections. A cleanout is a pipe that comes out of the ground and allows cleaning tools and inspection cameras to be pushed towards the house and towards the city sewer.

Estimated Costs for Repairs: To install a cleanout it might cost \$1,800 - \$2,000.

Replacing the cast iron pipe under the property is a significant repair and it is advised to contact contractor/plumber for a more precise estimate.

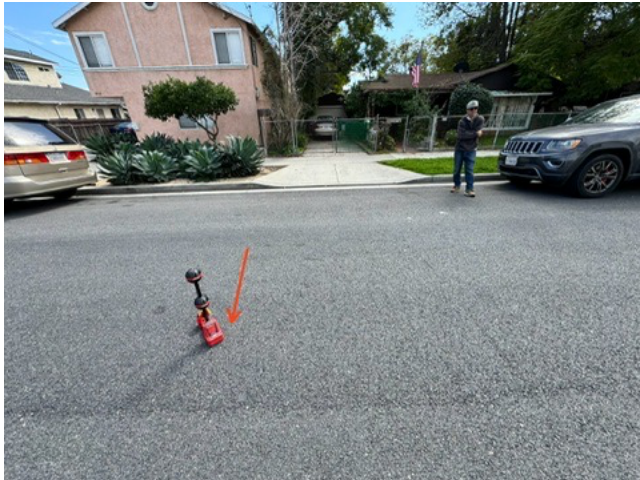
Connection to city sewer under tool.
