# WOOD DESTROYING PESTS AND ORGANISMS INSPECTION REPORT

| 28701 | Highridge Road, Rolling Hills Estate CA 90274 | 6/30/2026 | 7 |
| General Description:<br>1-STORY HOUSE, ATTACHED GARAGE, TILE ROOF, CONCRETE SLAB, STUCCO EXTERIOR, FURNISHED AND OCCUPIED | | Inspection Tag Posted:<br>ATTIC | |

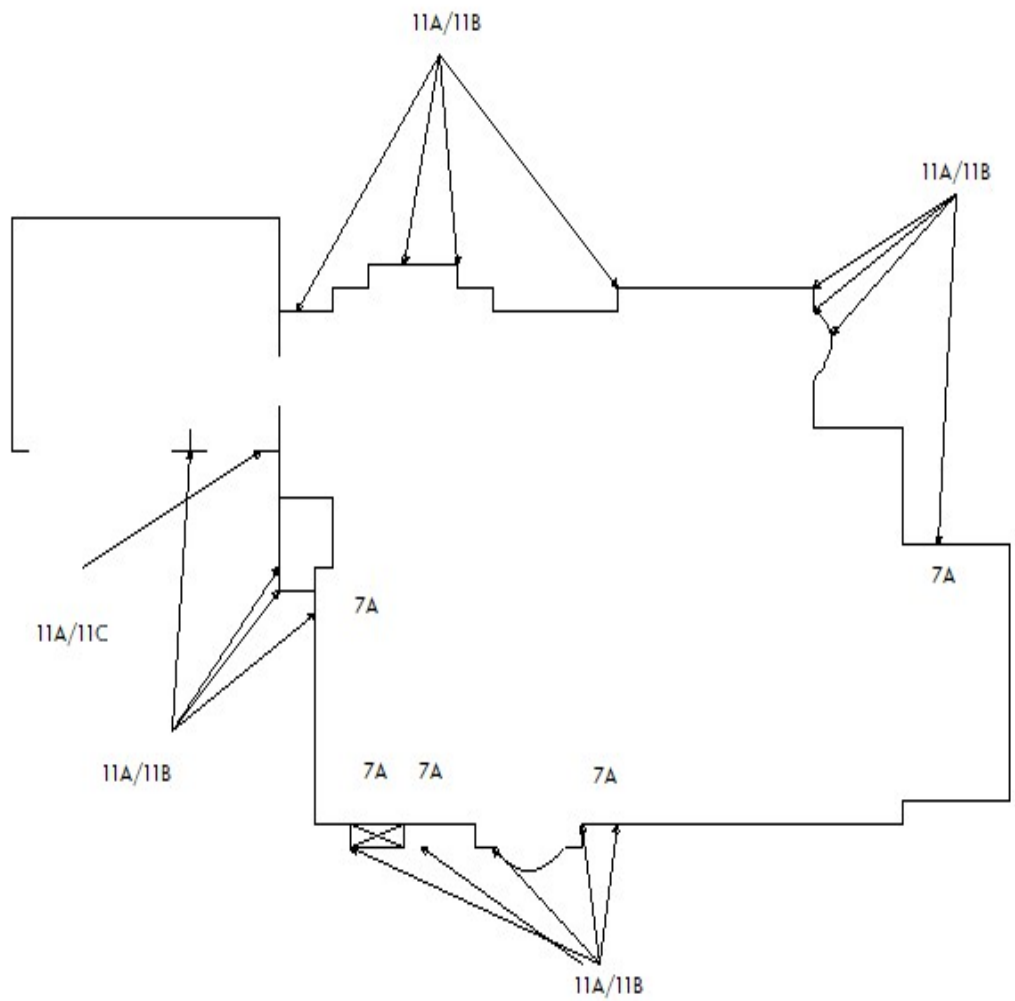
DIAGRAM NOT TO SCALE

ITEM 7A Evidence of drywood termites was noted in attic areas as marked 7A on the diagram.

ITEM 11A Evidence of drywood termites was noted in exterior areas as marked 11A on the diagram.

ITEM 11B Drywood termites & dryrot have damaged roof fascia, rafter, and eave sheeting areas as marked 11B on the diagram.

ITEM 11C Drywood termites have damaged door jamb/stucco molding area as marked 11C on the diagram.

RECOMMENDATION: Fumigation of structure with a registered fumigant. Mask/cover or remove the termite pellets. While all due care will be taken: we cannot be responsible for any damage to roof, plants, and/or antennas.

RECOMMENDATION: Fumigation of the structure with a registered fumigant. Mask/Cover or remove the termite pellets. While all due care will be taken: we cannot be responsible for any damage to roof, plants, and/or antennas.

RECOMMENDATION: Replace/reinforce and/or wood fill damaged wood with new material as needed. Painting is not included.
