## **Property Inspection Report**

**2650 Main St, Unit 7, Cambria, CA 93428**  
**Inspection prepared for: Patrick Forrest**  
**Real Estate Agent: -**

**Date of Inspection: 2/8/2024 Time: 10:00 AM**  
**Age of Home: 1971 Size: 800**  
**Weather: Overcast**  
**Order ID: 10402**

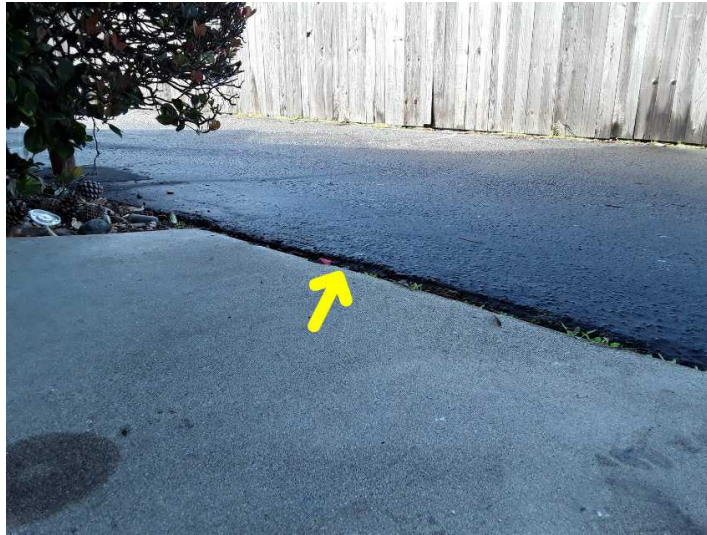
There are one or more offsets in the driveway that could prove to be trip-hazards.

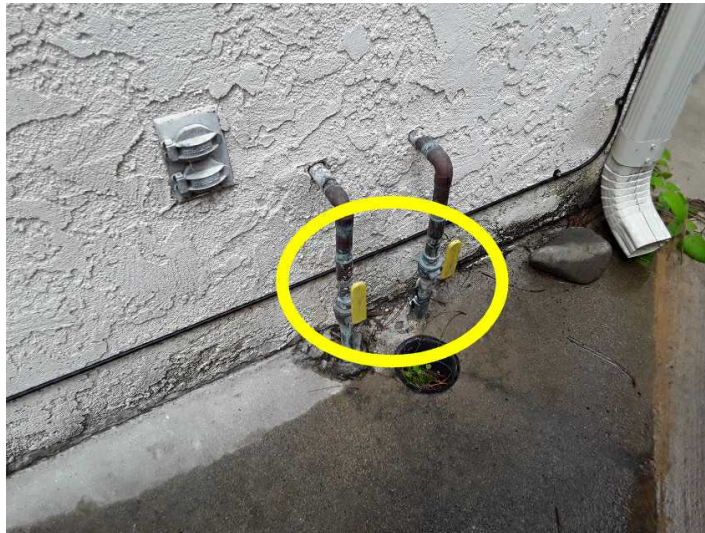
The main water shut-off valve is located at the rear of the home, unit, or building.

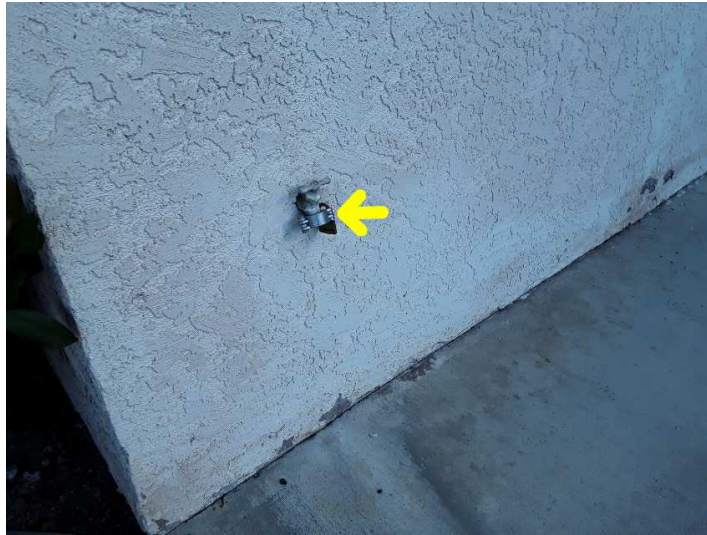
A hose bib has been capped which implies it might have been dripping, which you may want to have evaluated.

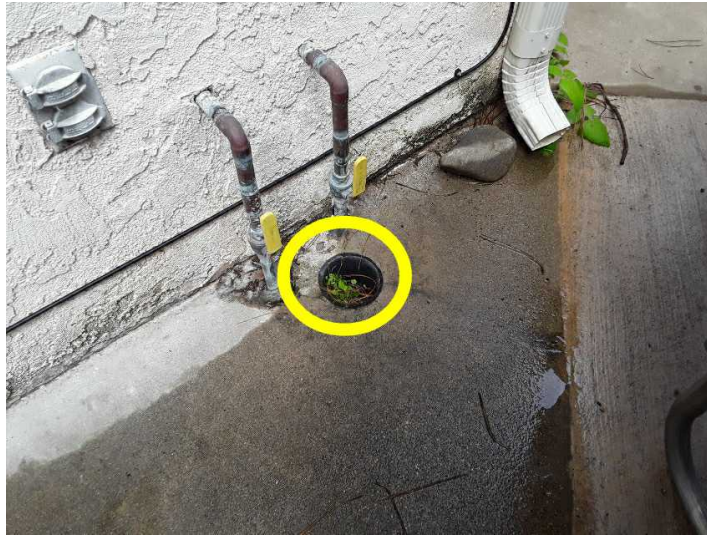
A clean-out is located at the rear.

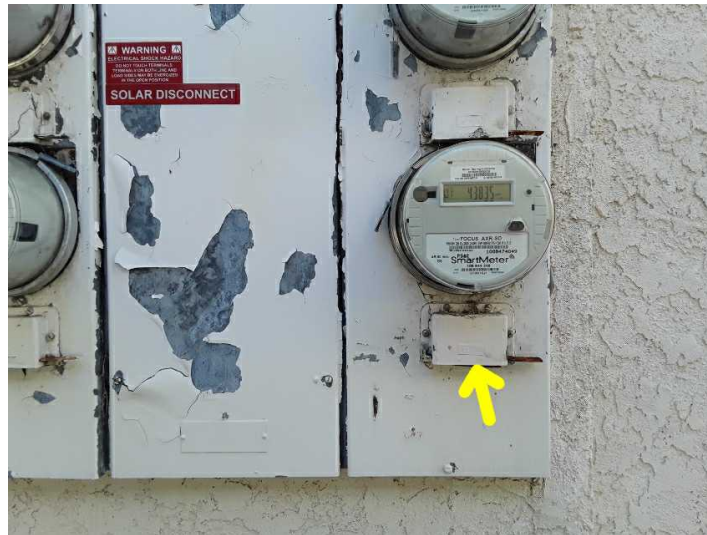
The residence is served by an unknown amp main electrical panel, located at the left side of the home or unit.

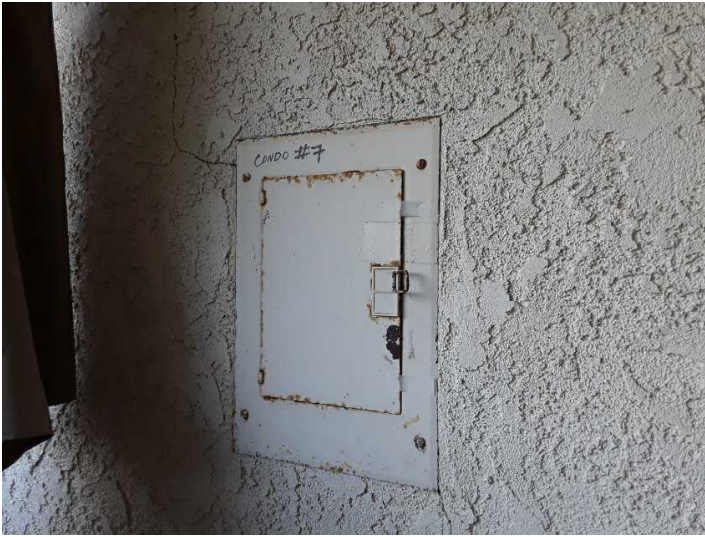
The sub panel is located at the right exterior side of the home.

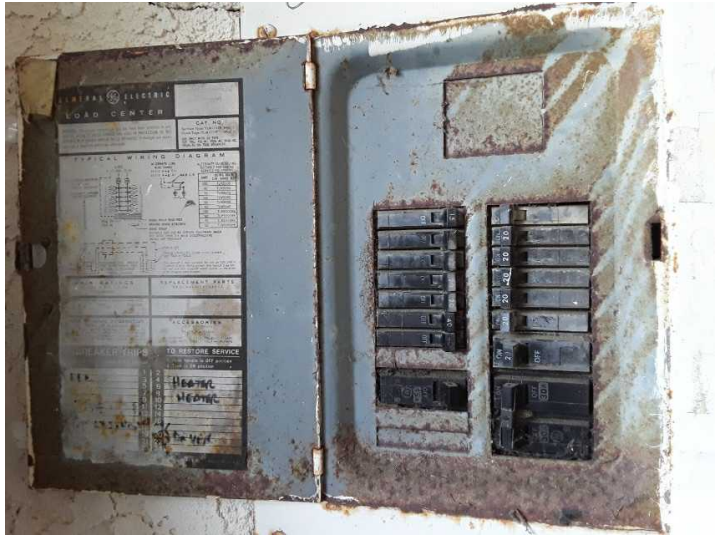
Various circuits within the sub-panel are not labeled, and should be serviced by an electrician so that the appropriate load calculations and breaker sizes could be determined.

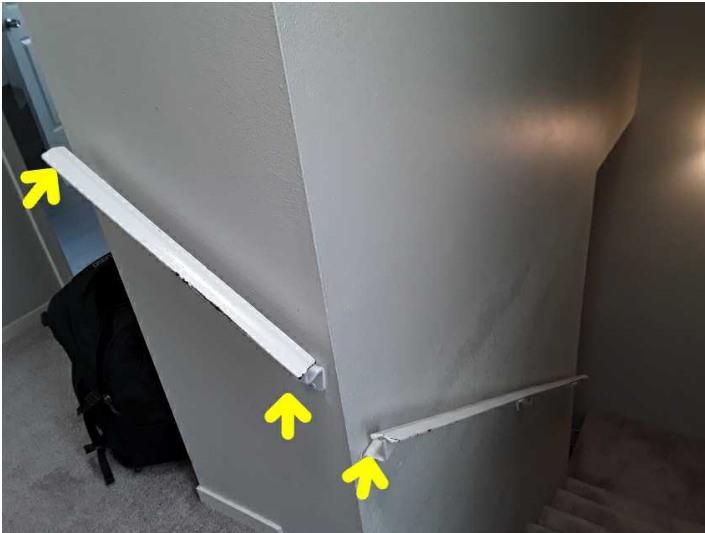
4.1. The handrail does not return which is required at the top and bottom of the stairs which is required by current building standards. This condition could allow a purse or clothing to initiate a fall.

The handrail does not return which is required at the top and bottom of the stairs which is required by current building standards. This condition could allow a purse or clothing to initiate a fall.

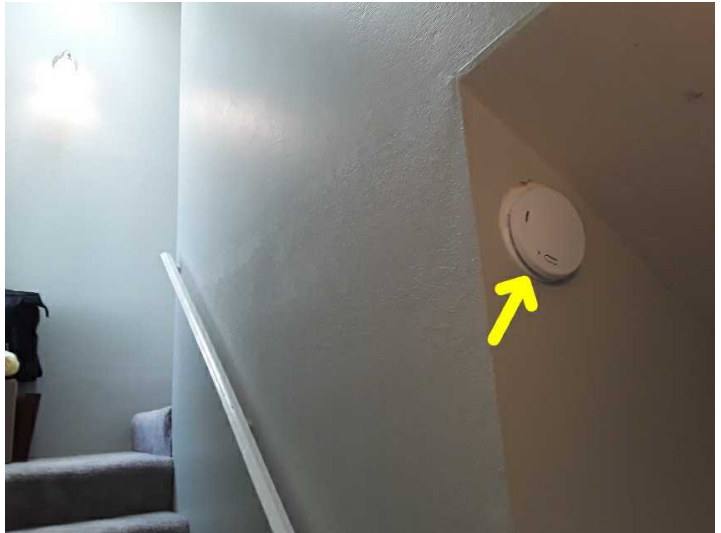
4.2. The smoke detector may not be in the location recommended by the manufacturer. We can elaborate but you may wish to verify this.

The smoke detector may not be in the location recommended by the manufacturer. We can elaborate but you may wish to verify this.

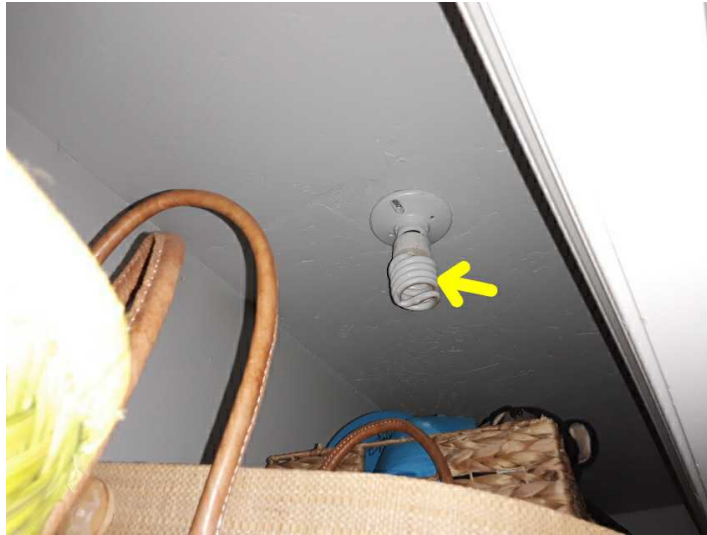
1.5. The closet light is missing its globe or cover, which should be installed to improve safety.

The closet light is missing its globe or cover, which should be installed to improve safety.

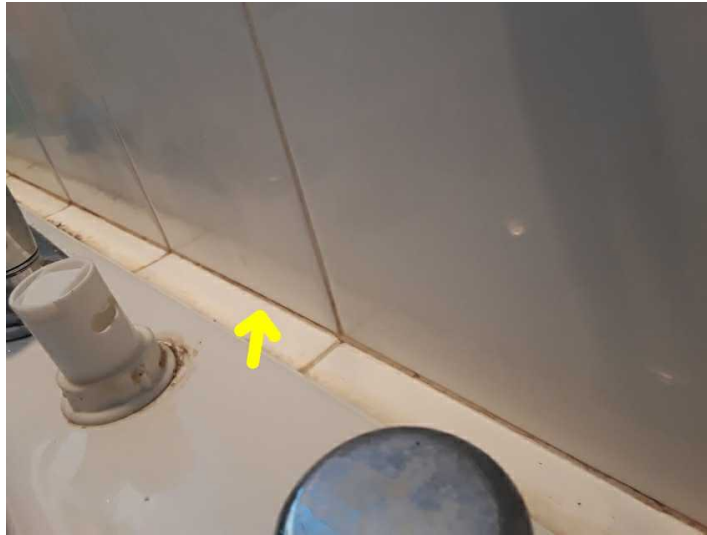
3.1. A typical separation between the kitchen counter top and the backsplash should be grouted or caulked to forestall moisture intrusion.

A typical separation between the kitchen counter top and the backsplash should be grouted or caulked to forestall moisture intrusion.

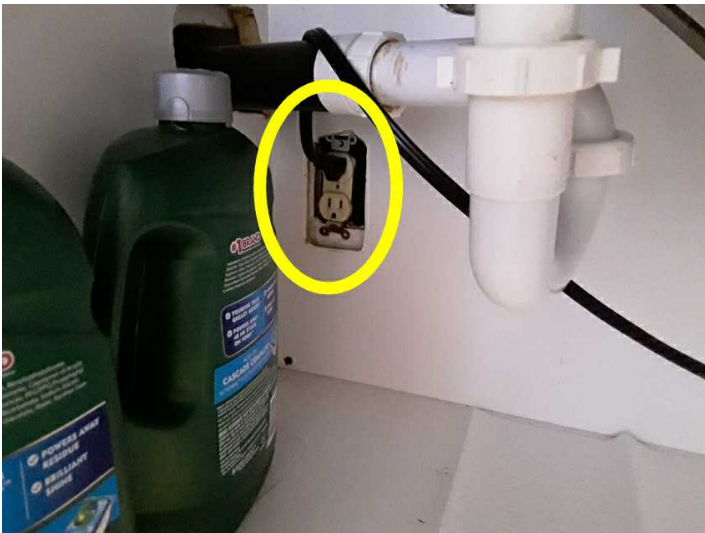
4.4. One or more outlet covers are missing or broken and should be serviced.

One or more outlet covers are missing or broken and should be serviced.

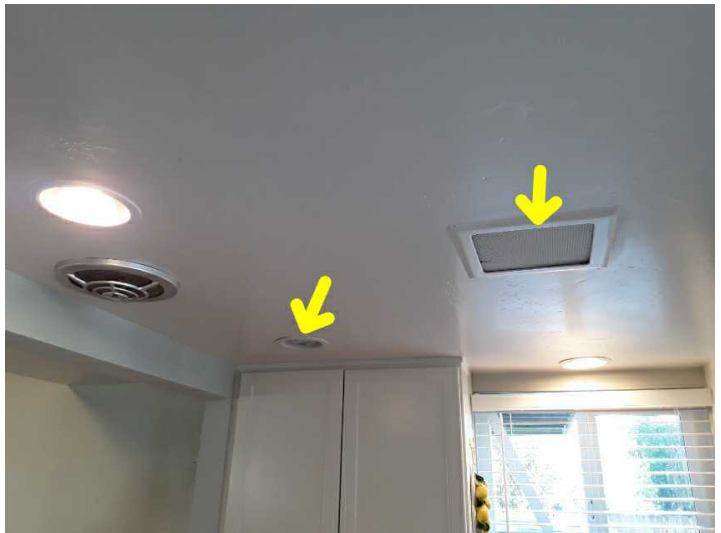
A ceiling light does not respond and should be serviced.

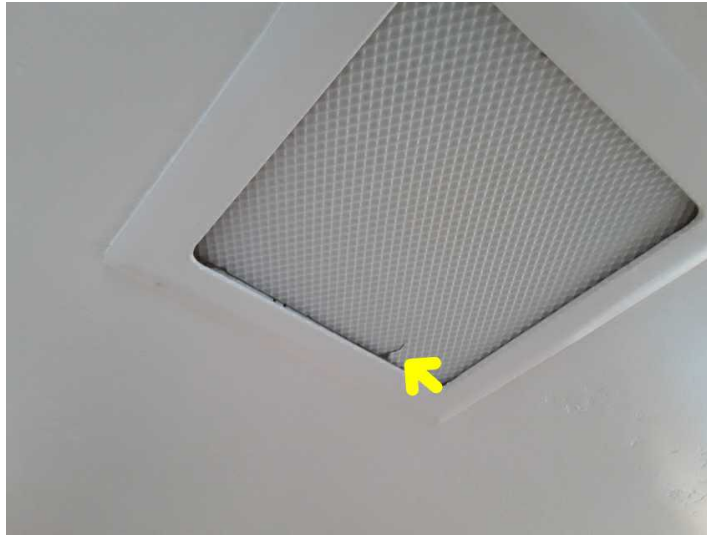
4.2. A ceiling light panel is missing or broken and you may wish to have it replaced.

A ceiling light panel is missing or broken and you may wish to have it replaced.

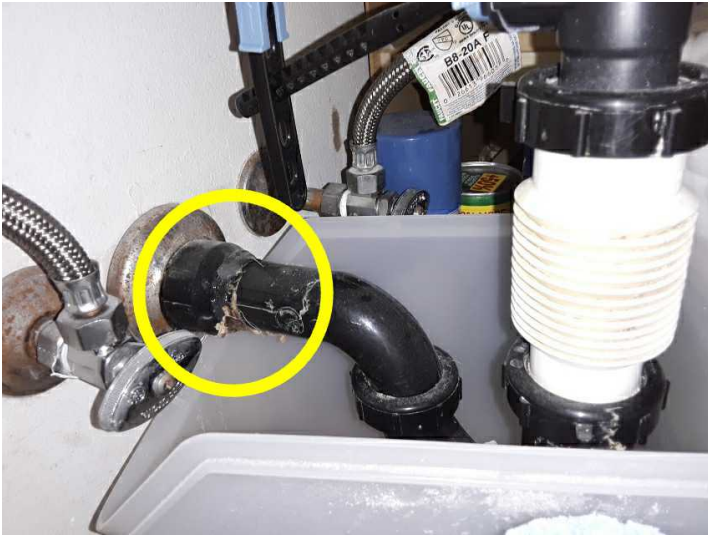
1.14. There is a leak at the trap arm below the sink, which should be repaired by a qualified plumbing contractor.

There is a leak at the trap arm below the sink, which should be repaired by a qualified plumbing contractor.

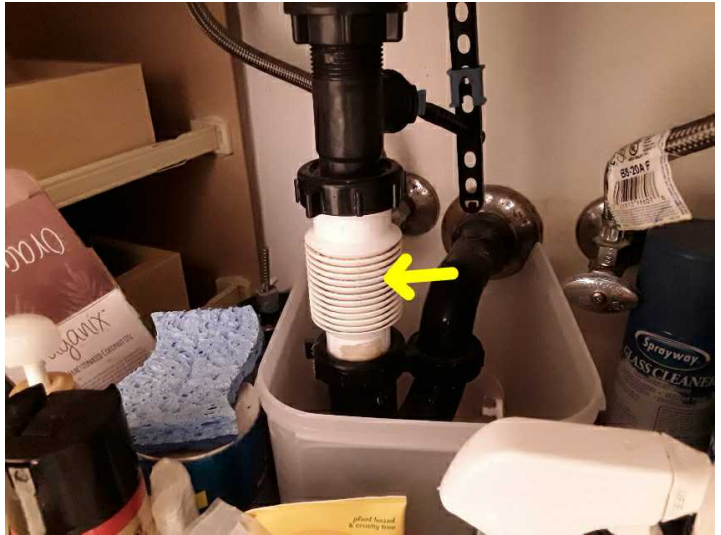
The sink employs an unconventional flexible drainpipe that could contribute to blockages.

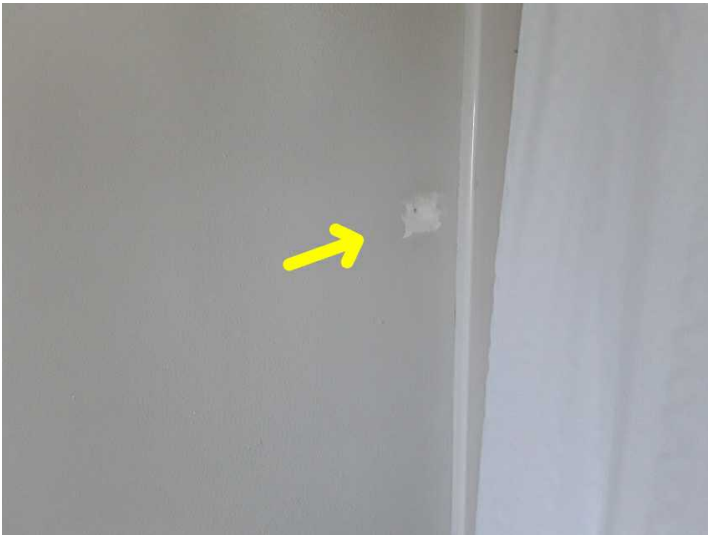
1.13. There is moisture damaged drywall adjacent to the tub or shower, which is not uncommon but should be repaired.

There is moisture damaged drywall adjacent to the tub or shower, which is not uncommon but should be repaired.

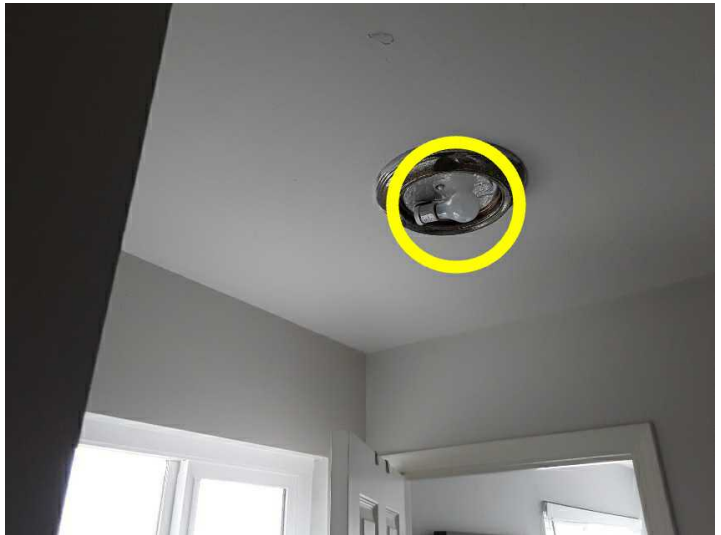
1.8. A light is missing its globe or cover and should be serviced.

A light is missing its globe or cover and should be serviced.

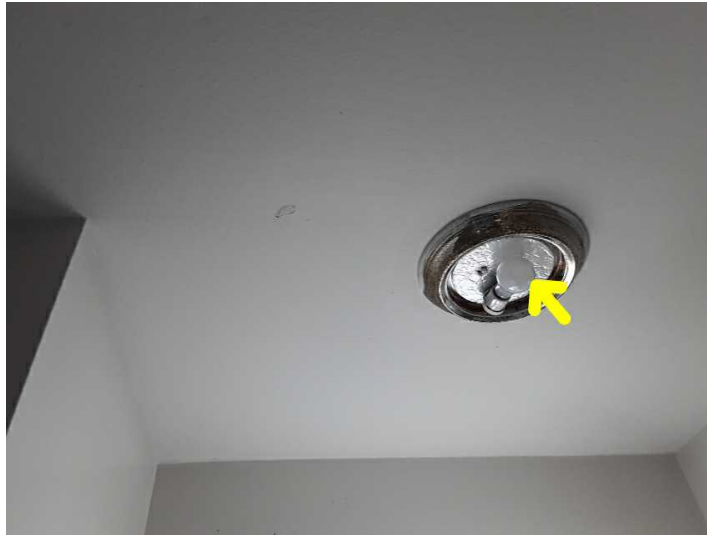
One or more ceiling lights do not respond and should be serviced.

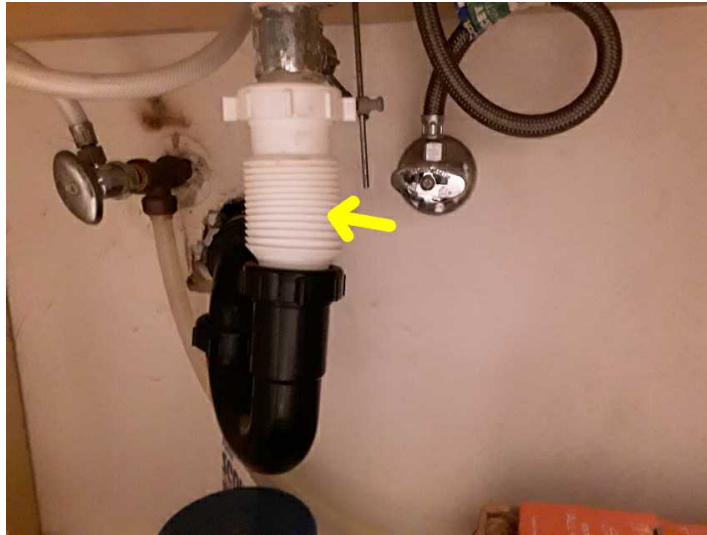
The sink employs an unconventional flexible drainpipe that could contribute to blockages.

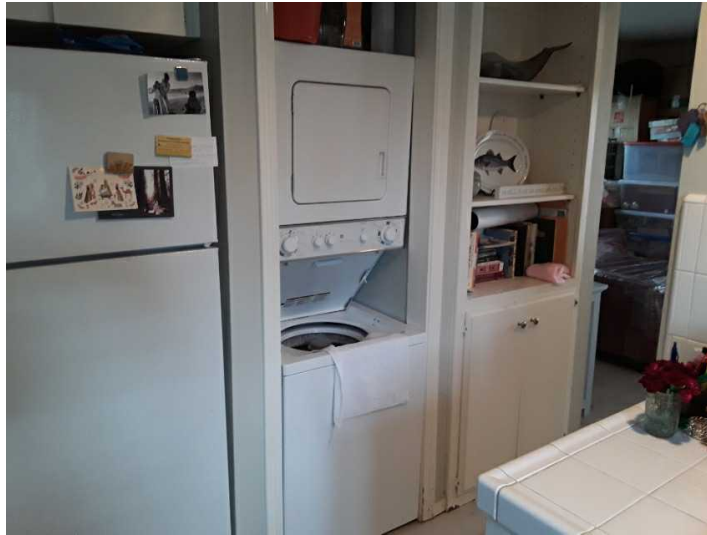
Most if not all of the components behind the washer/ dryer were obstructed from view and were not inspected.
