Inspection reference: 22001

# Confidential Inspection Report

25531 Polaris Ln  
Lake Forest CA 92630

January 5, 2022

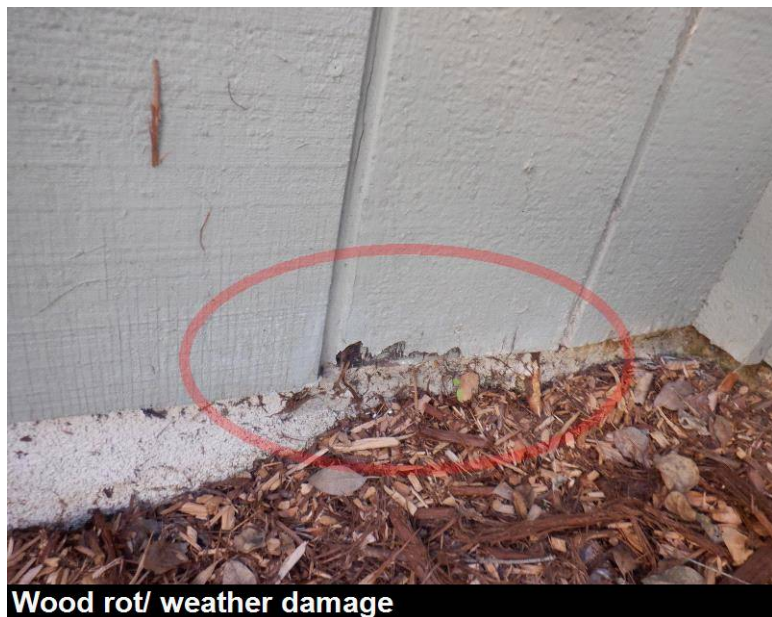
#### 2.3 Siding:

Stucco; Wood; Wood rot/ weather damage was visible at some areas of siding, see termite report for complete repair needs.

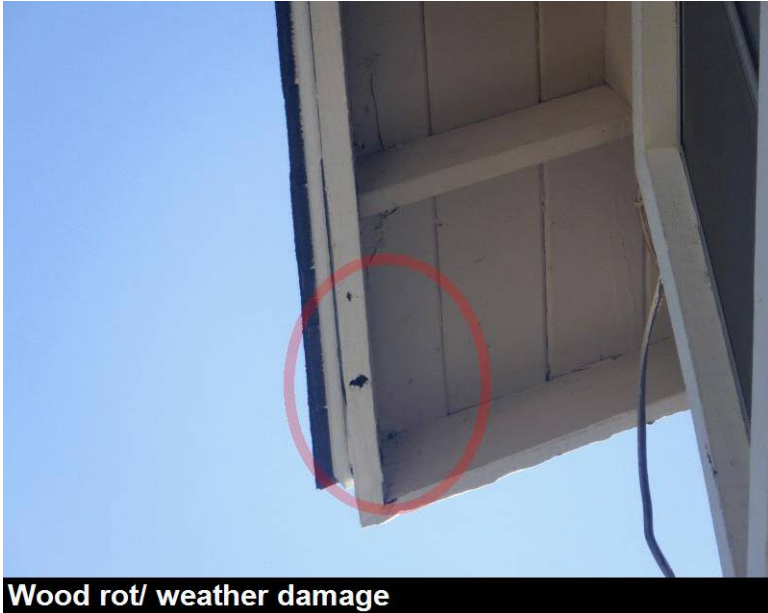
#### 2.4 Trim:

Wood; The termite inspection report should be reviewed as deteriorated wood was visible at exterior trim ( such as fascia boards, rafter tails, starter boards, window and door casings). Licensed pest control company will determine repair method and whether fumigation is necessary.

**Wood rot/ weather damage**

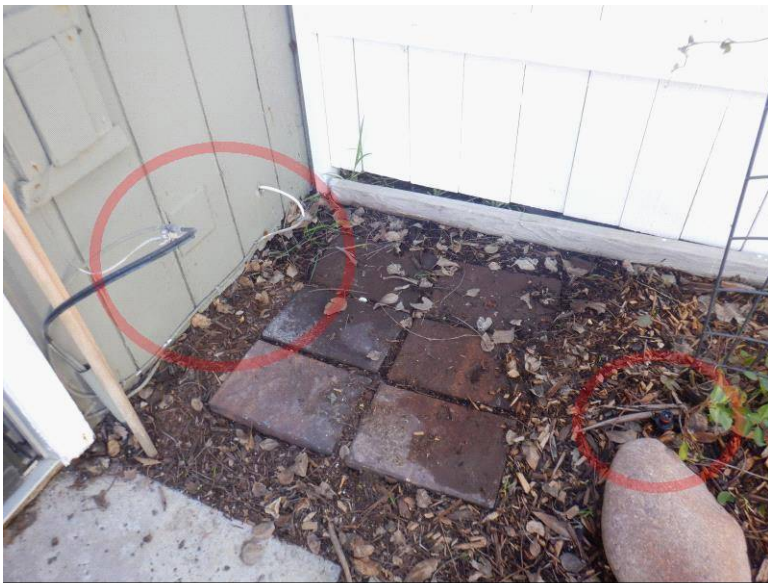
**2.8 Sprinklers:**

Exterior inspection shows some sprinkler heads are striking the structure walls, replace or re-direct these heads to prevent water damage. Moisture was detected at interior wall (rear).

**Sprinklers striking wall**

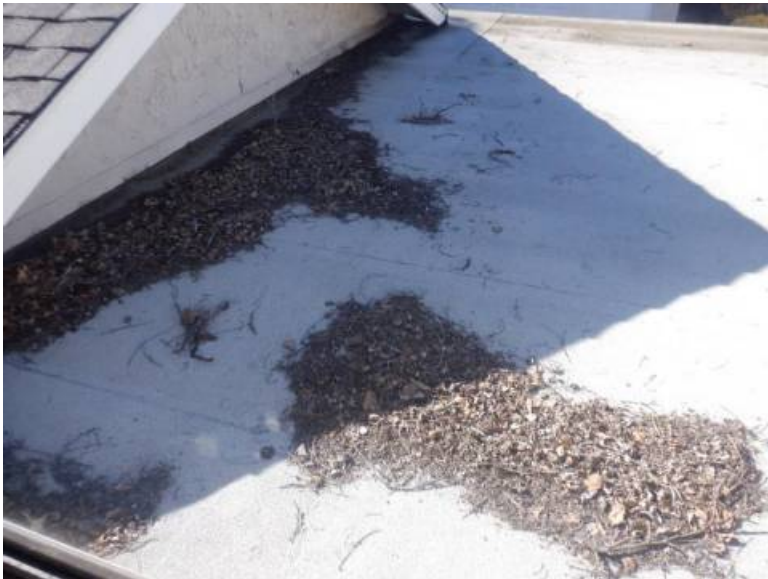
**3.3 Roof Comments:**

There is tree debris lying on the roof, remove to prevent damage and potential leakage.  
The roof may be maintained by the Homeowners Association, review the CC&R's for extent of coverage.

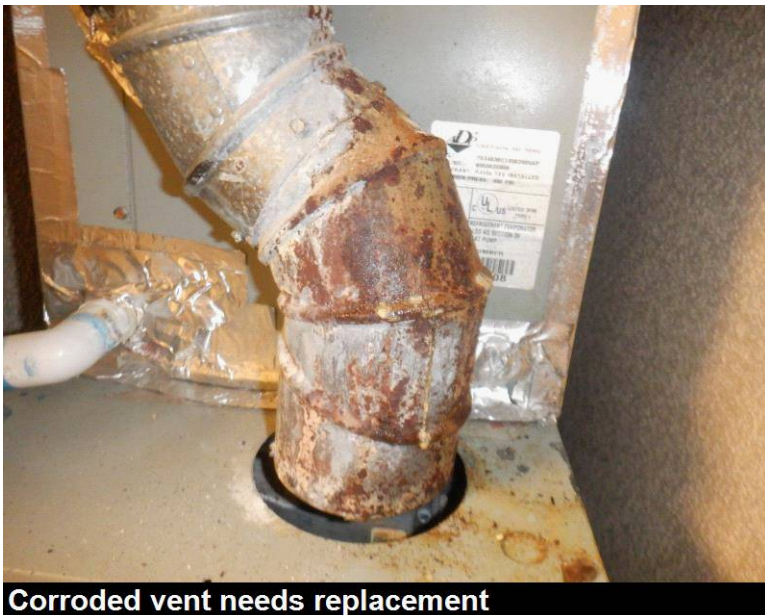
The heater venting is corroded, contact licensed contractor for review and repair as this is a safety concern due to possible carbon monoxide leakage.

**Corroded vent needs replacement**

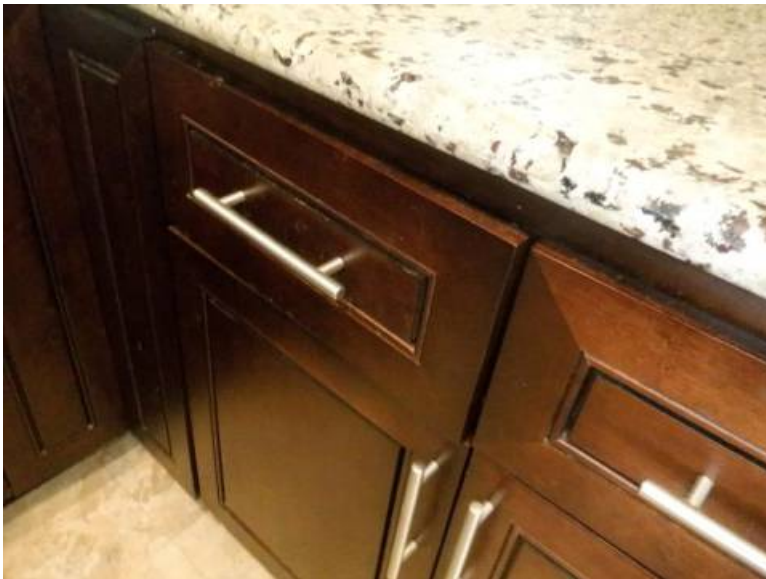
##### **9.6 Cabinetry/ Countertops Comments:**

Common wear and tear was visible at cabinetry and countertops (minor cosmetic damage).

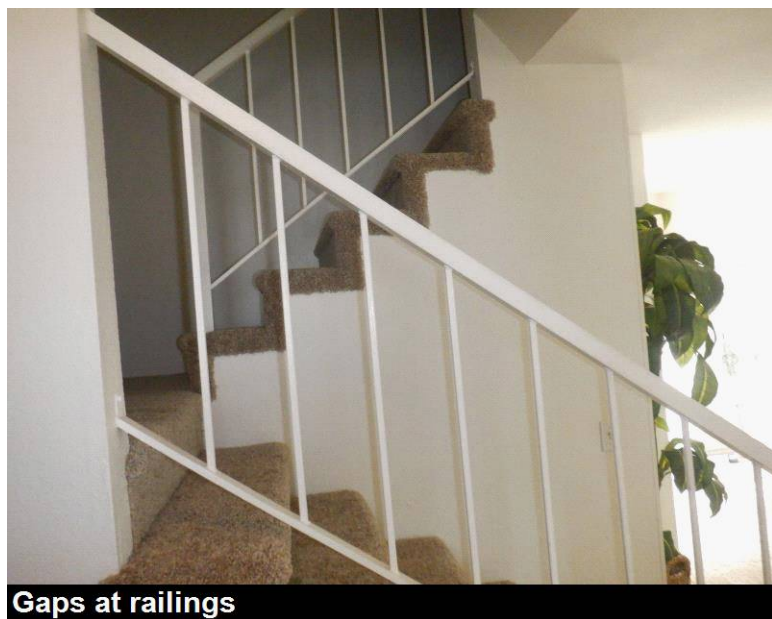
The gaps at the stairway railings are larger than allowed by current building standards. The maximum distance between balusters or between a post and baluster, in the California building code, is 4 inches. The space between the finished floor and the bottom rail must not exceed 4 inches. In addition, the minimum balustrade height is 42 inches. Though replacement of railings are not required to transfer title of property, any newly installed railings must meet current standards.

Gaps at railings

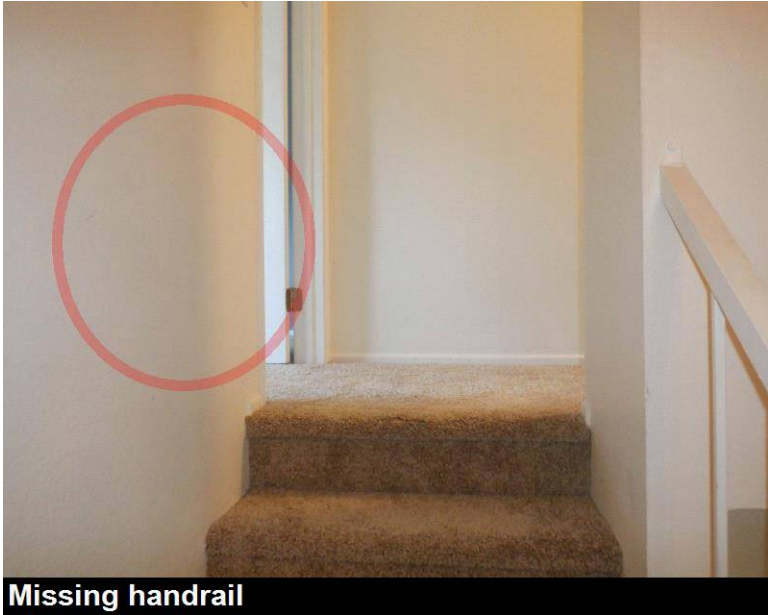
Missing the required handrail at top stairway, contact licensed contractor for installation.

Missing handrail
