Inspection reference: 3850 E. 15th St., LB, CA 90804

# **Confidential Inspection Report**

**3850 E. 15th St.**  
**Long Beach CA 90804**

**February 29, 2024**

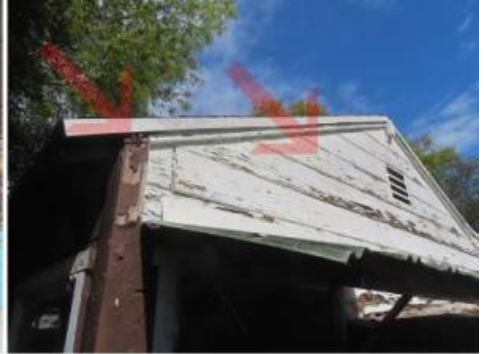
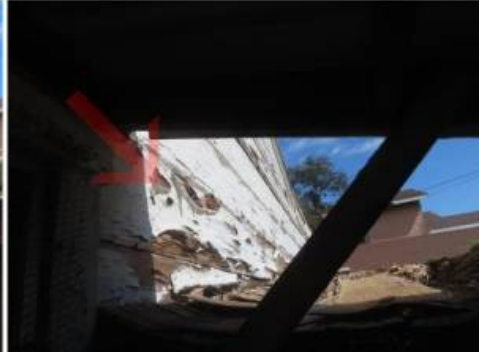
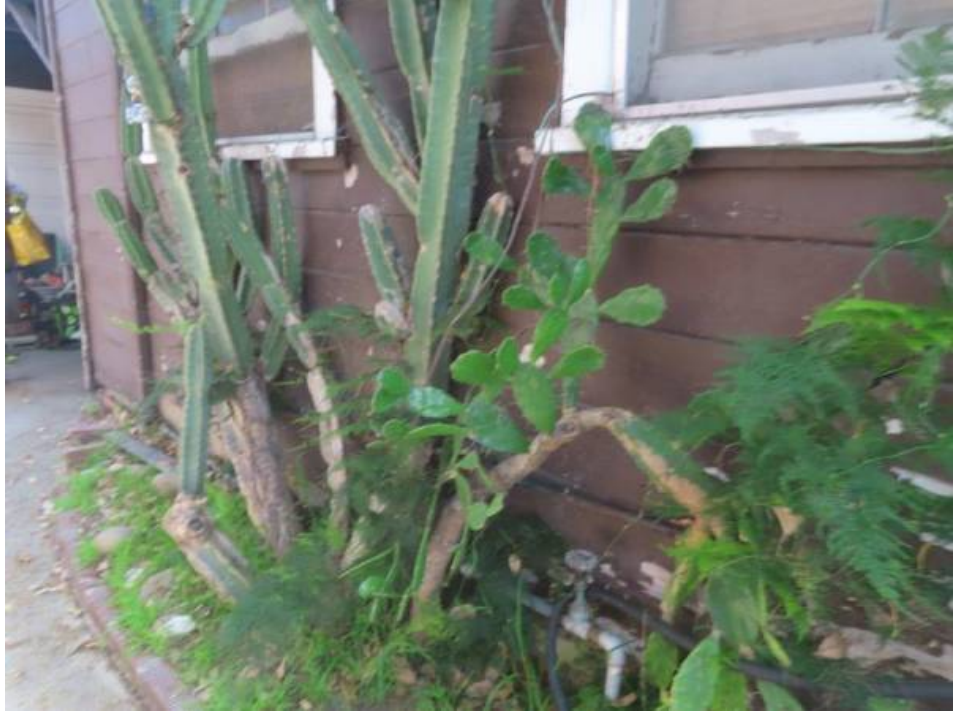
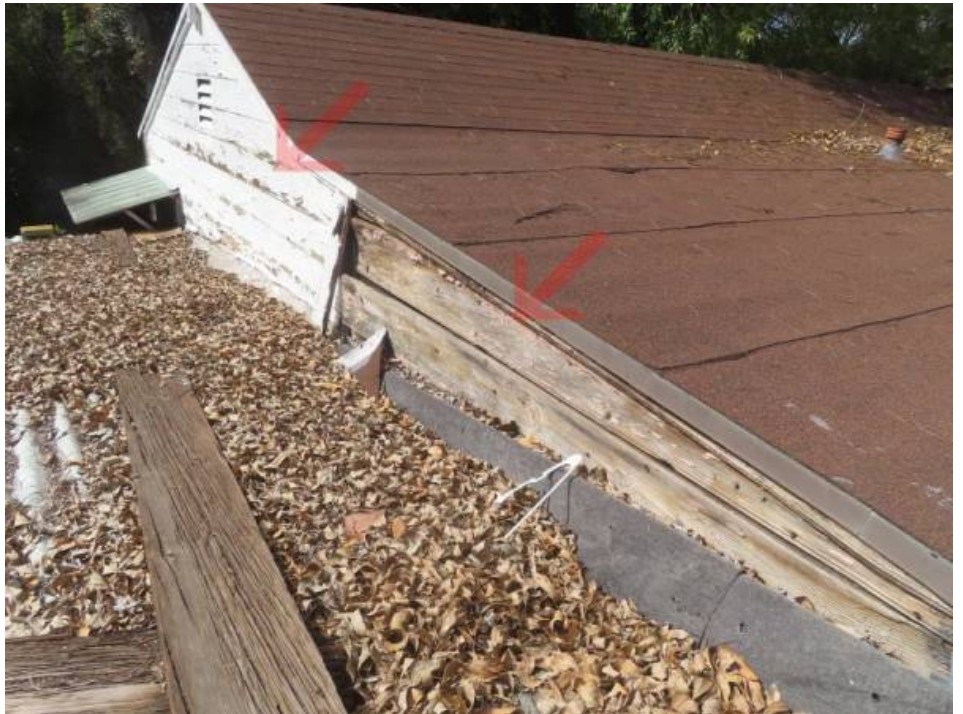
DEFERRED: Moisture damage.

MAINTENANCE: Some loose or peeling paint viewed. We recommend painting at this time to protect the wood from further deterioration and to enhance its appearance.

DEFERRED: Portions of the walls are covered with thick vegetation and were not viewed.

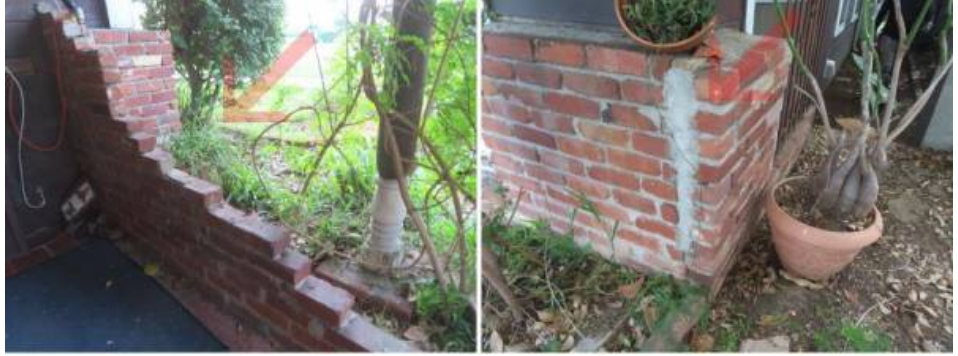
MONITOR: Entry wall has been taken down or removed.  
End of corner has been patched/repaired.

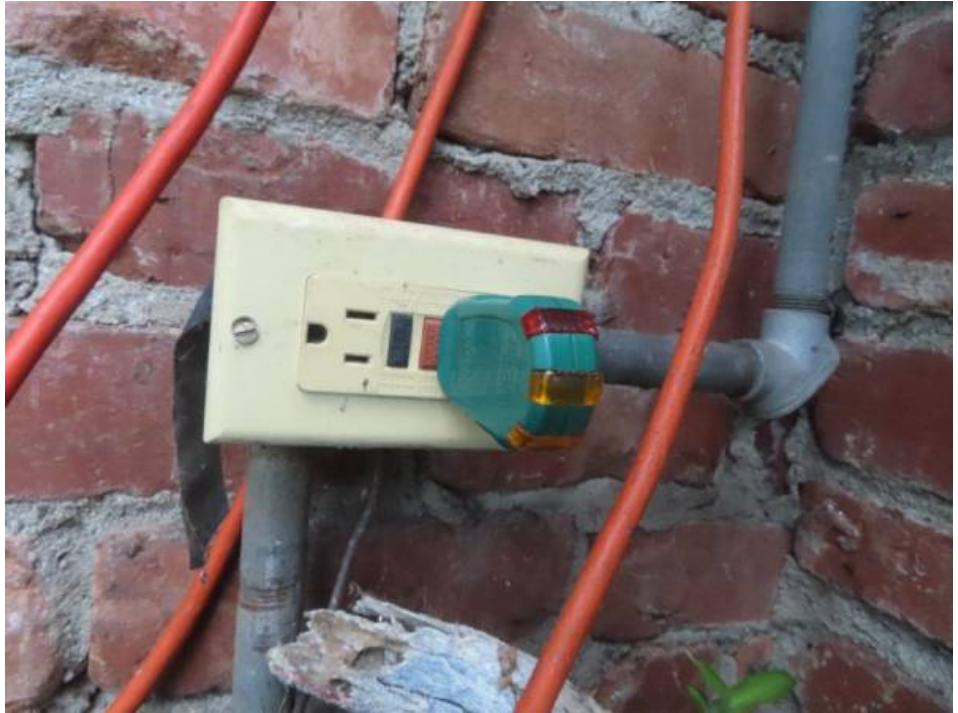
DEFECTIVE: GFCI did not respond to the test button operation at one or more locations.

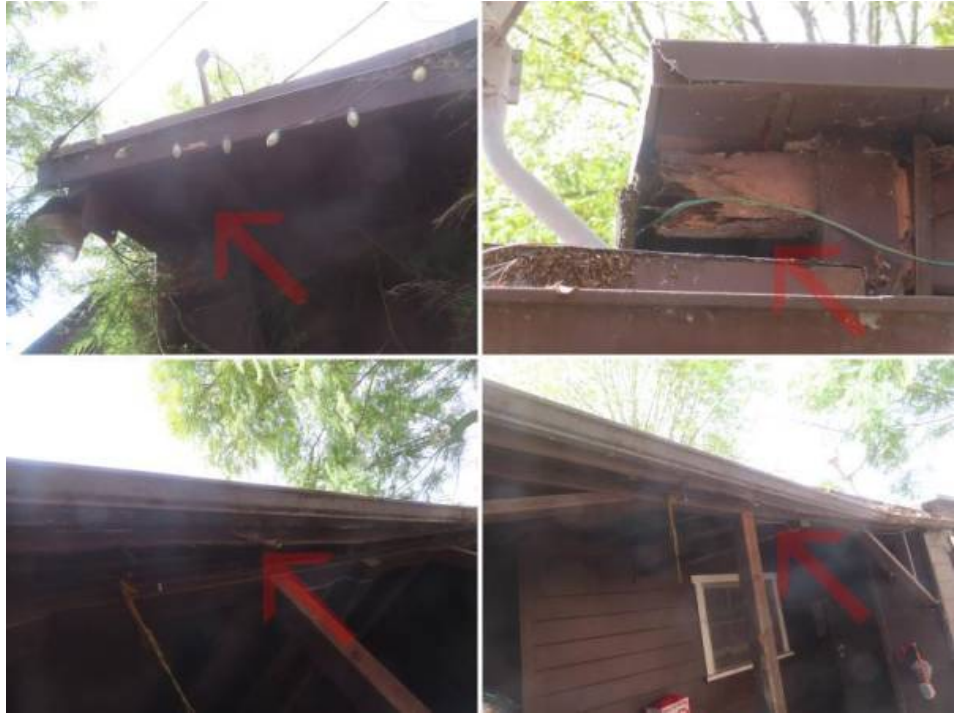
DEFERRED: Rot/insect damage viewed at one or more locations.

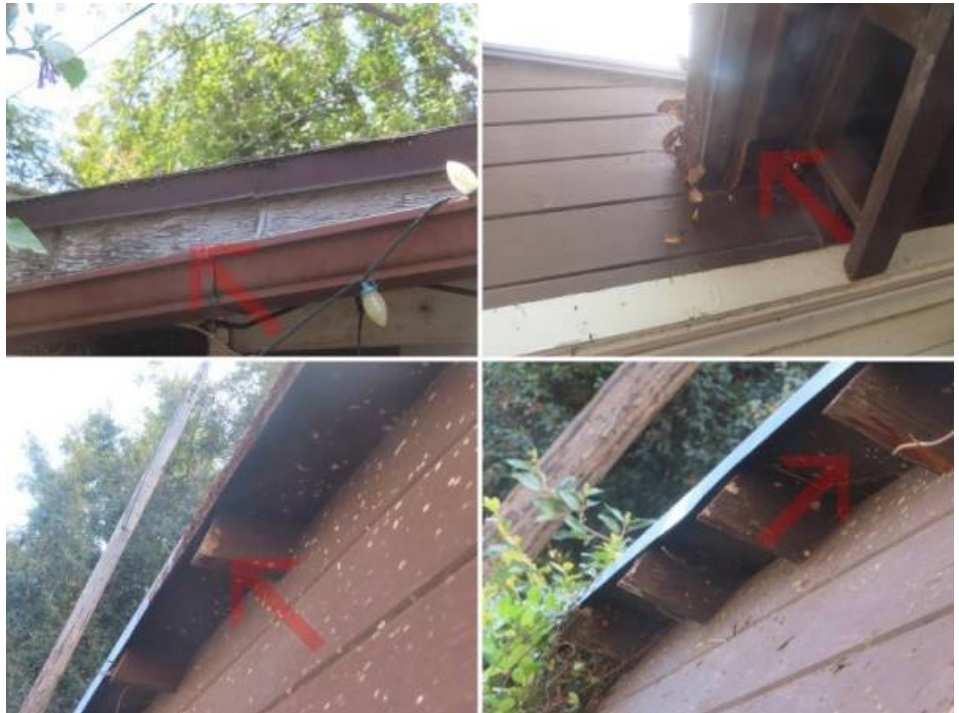
DEFERRED: Rot/insect damage viewed one or more locations.

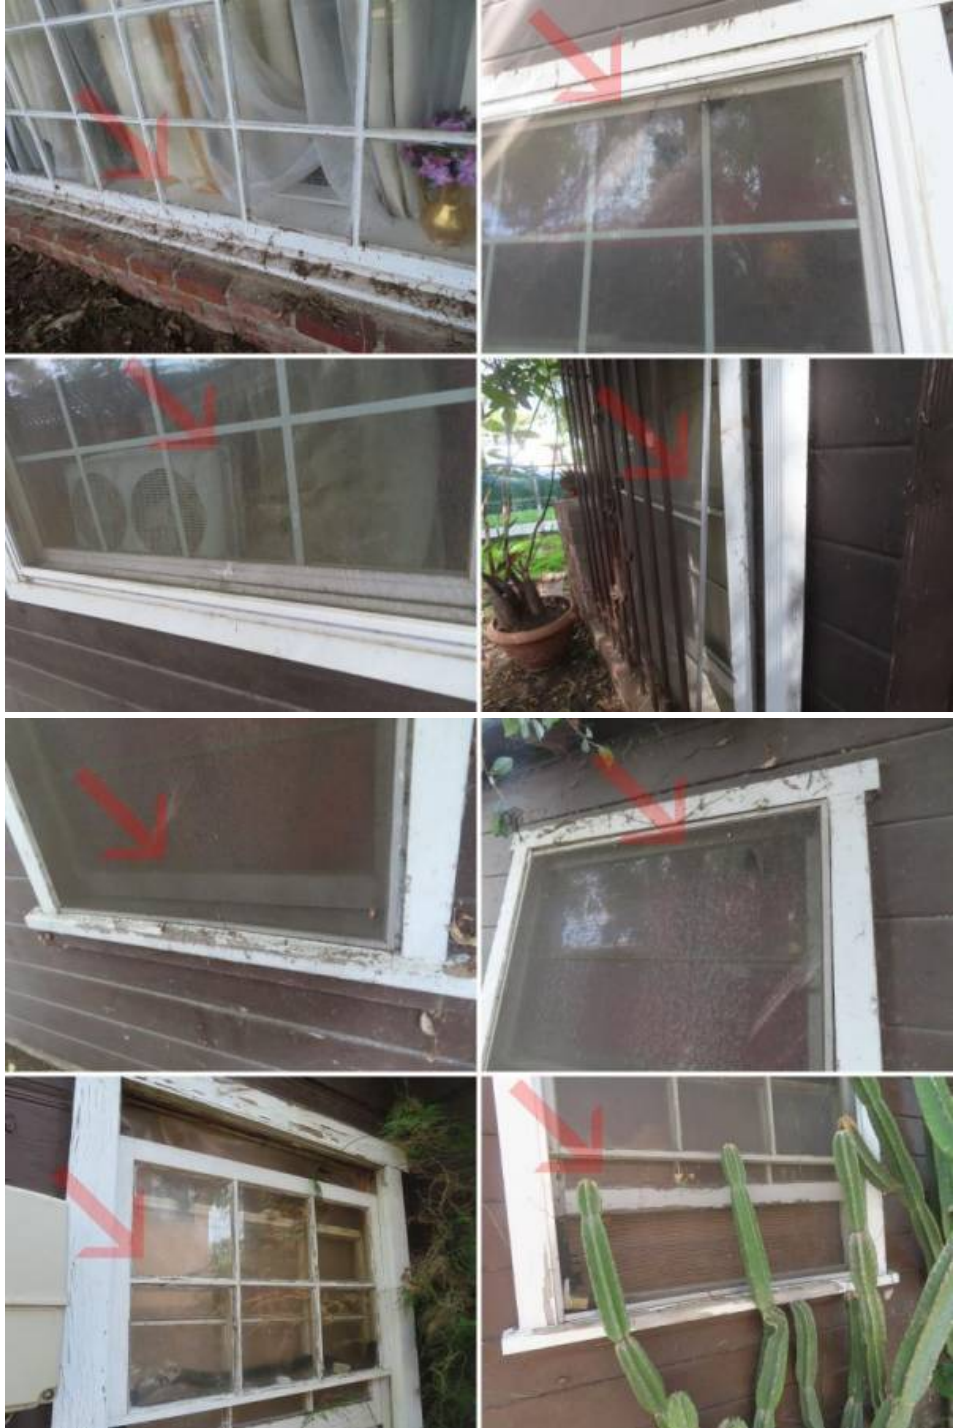
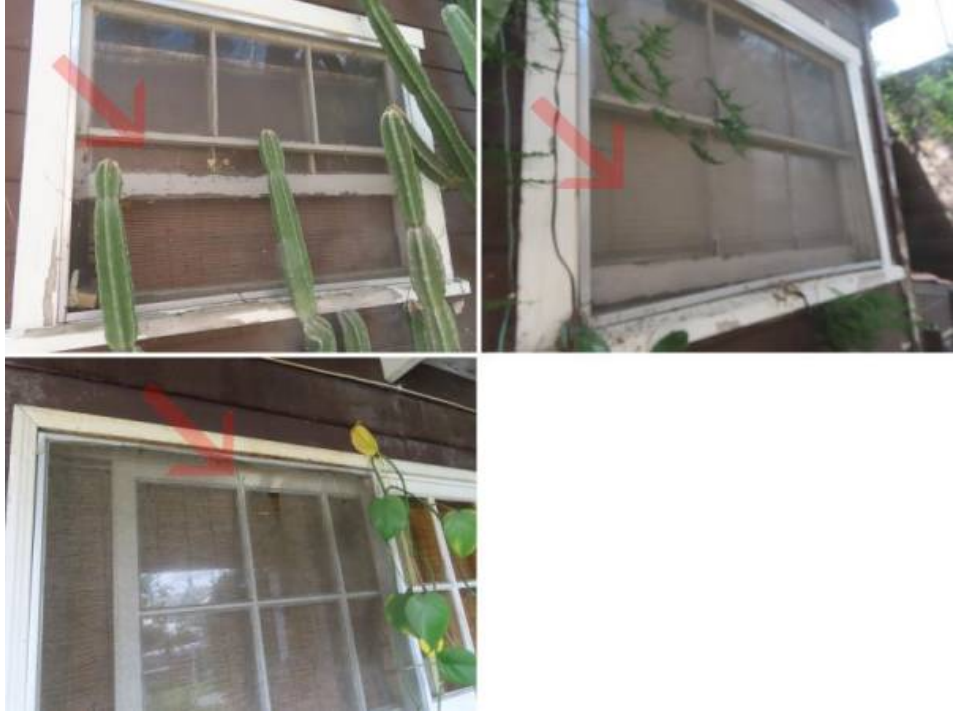
MAINTENANCE: Paint is deteriorated, loose or peeling. We recommend painting at this

time to protect the wood from further deterioration and to enhance its appearance.  
MAINTENANCE: Screen was damaged at one or more windows sampled.

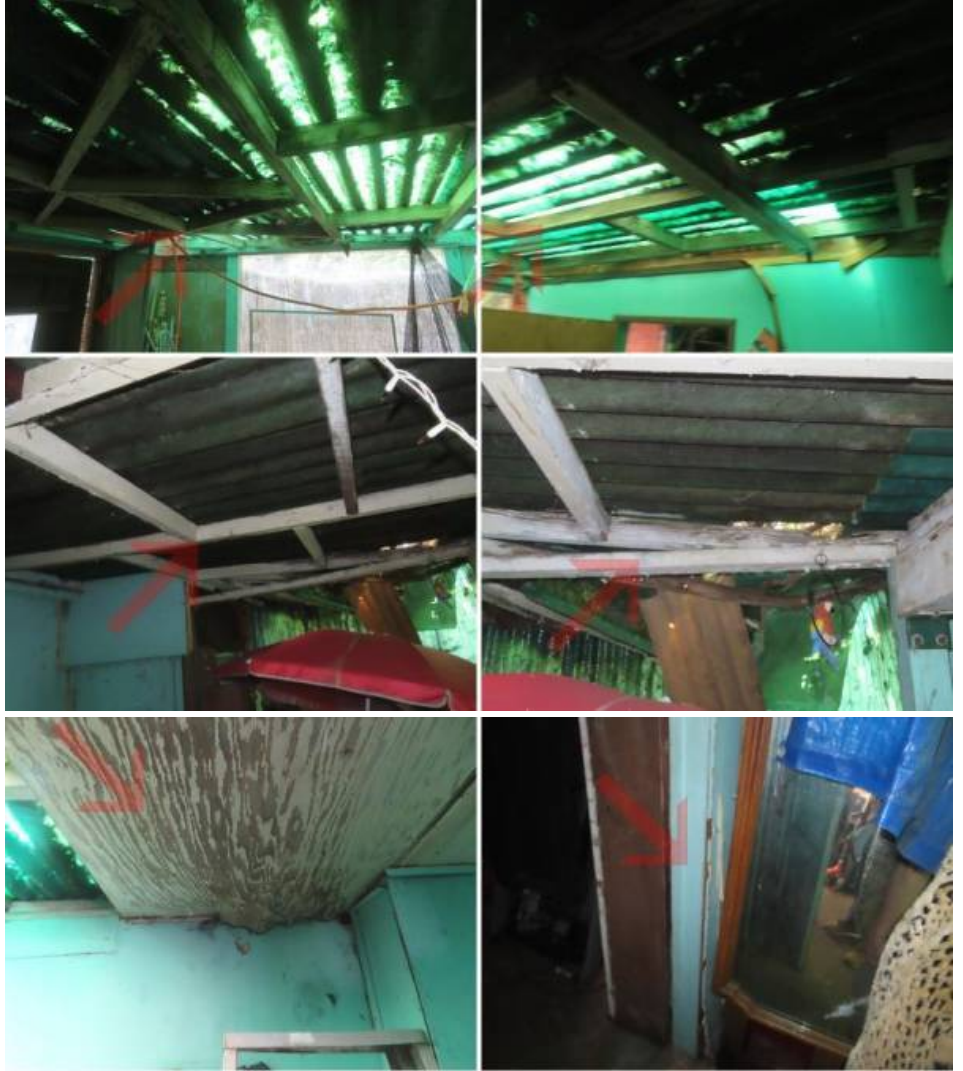
DEFERRED: Brick wall has been damaged, removed.

DEFECTIVE: Substandard construction.

DEFERRED: Moisture/insect damage viewed.

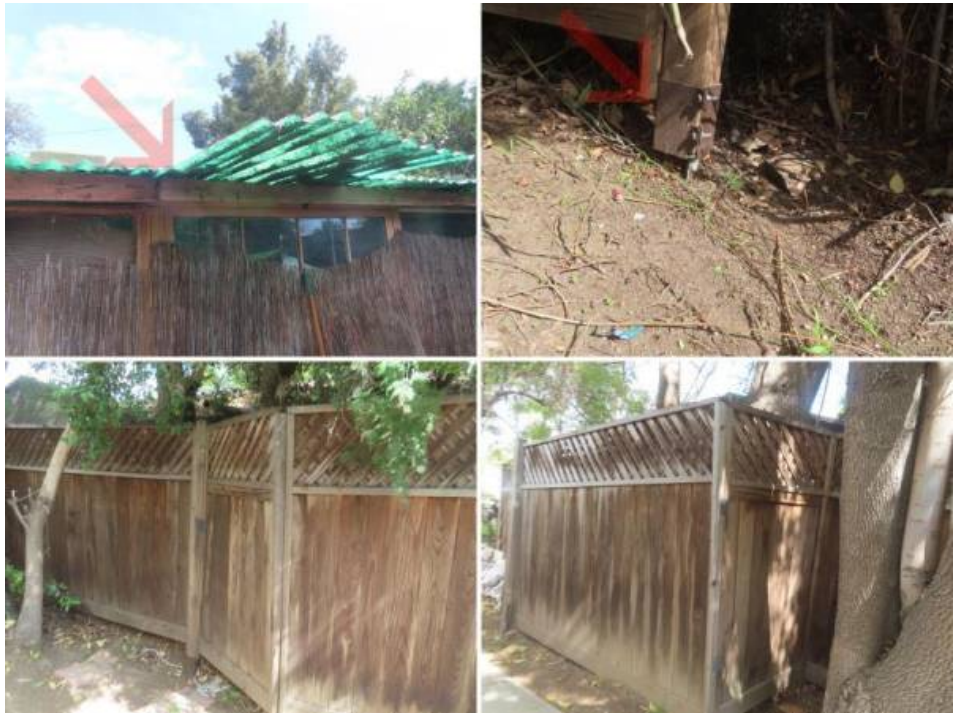
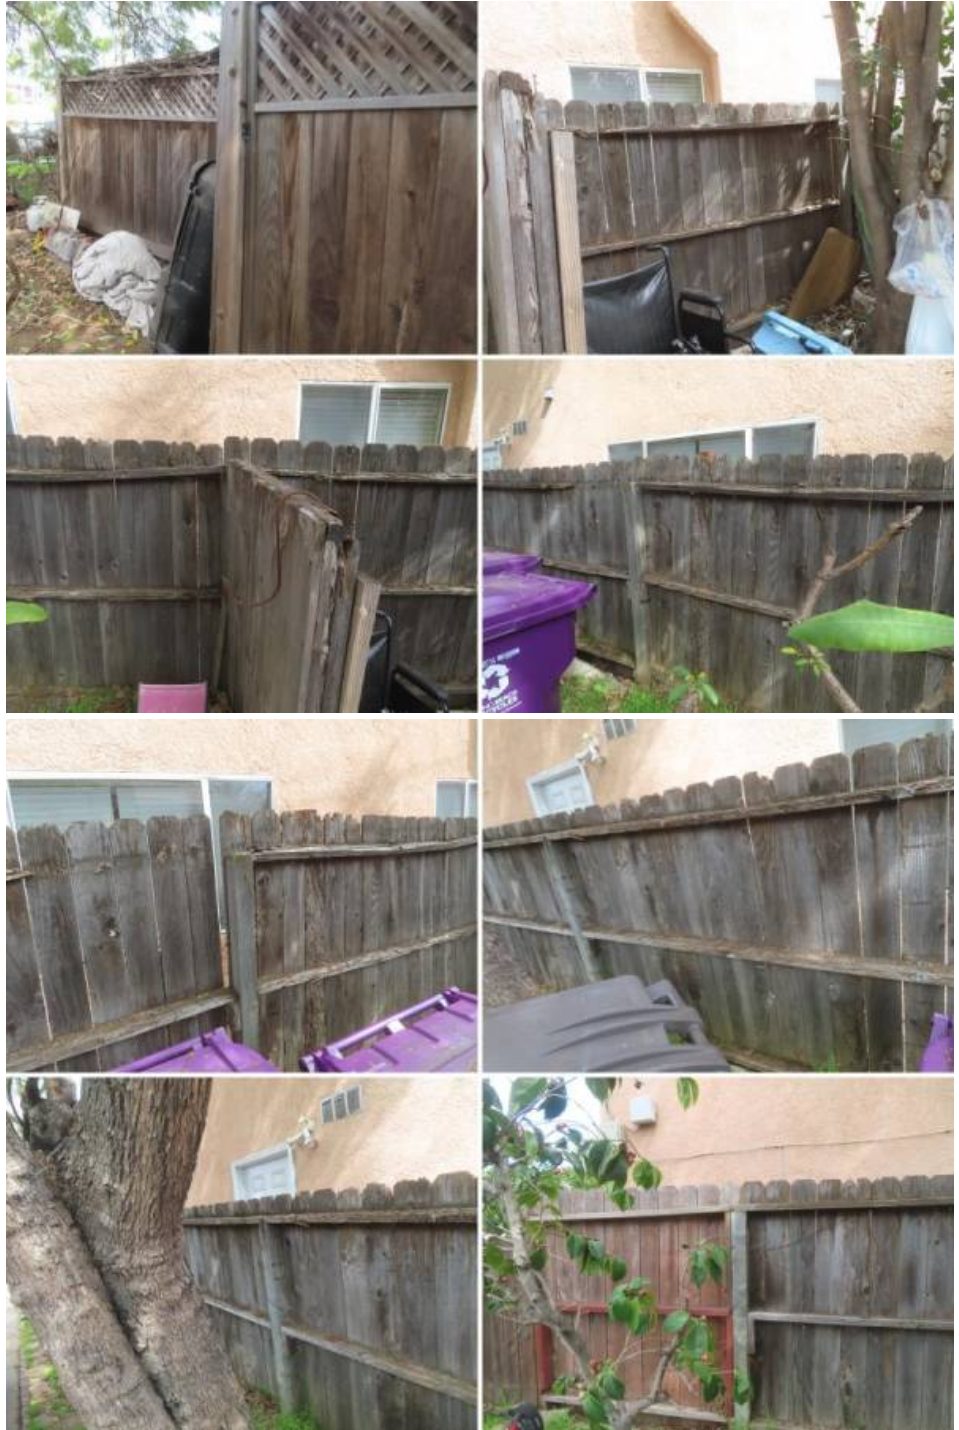
MAINTENANCE: Some loose/rotted posts and/or broken/missing boards.

DEFERRED: Insect or moisture damage viewed.

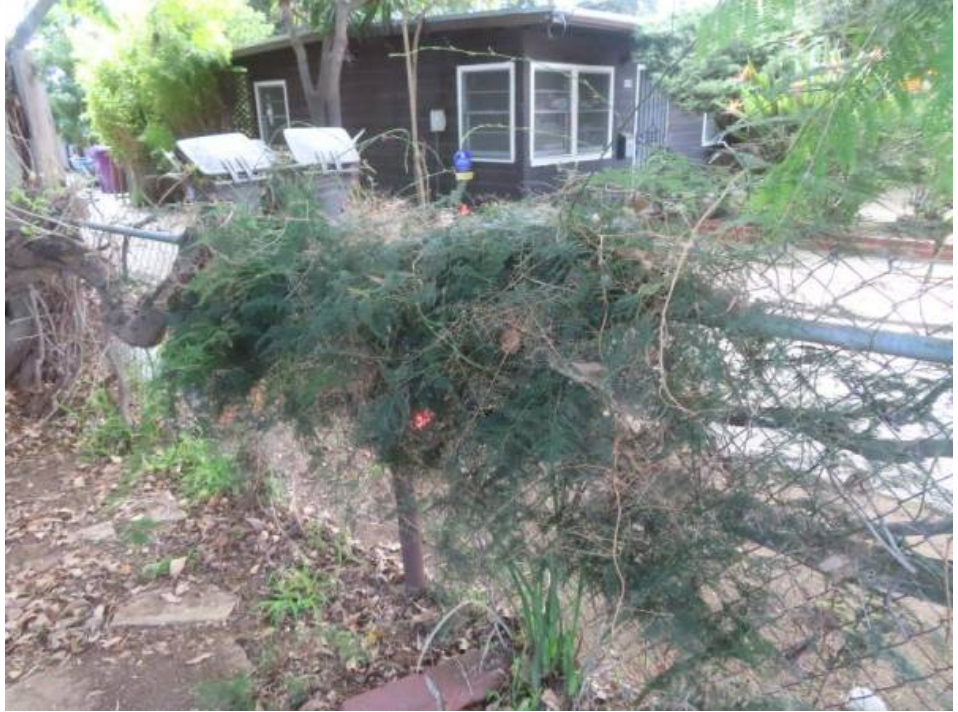
DEFERRED: Some of the fence is concealed with vegetation.  
SERVICEABLE.

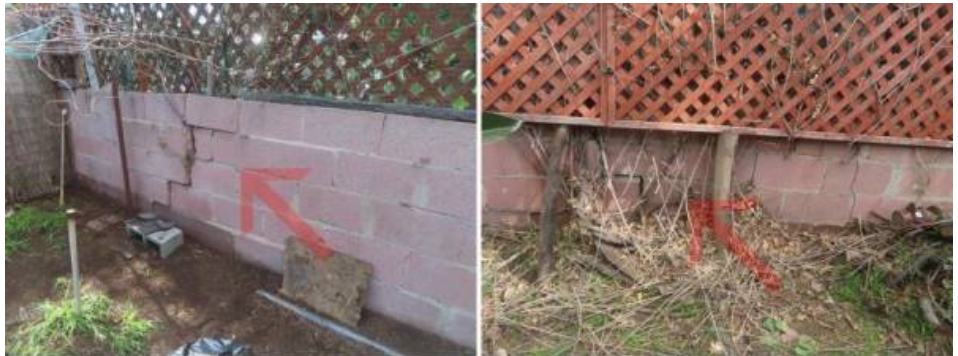
DEFECTIVE: Large cracks. We recommend further evaluation by a qualified masonry contractor.

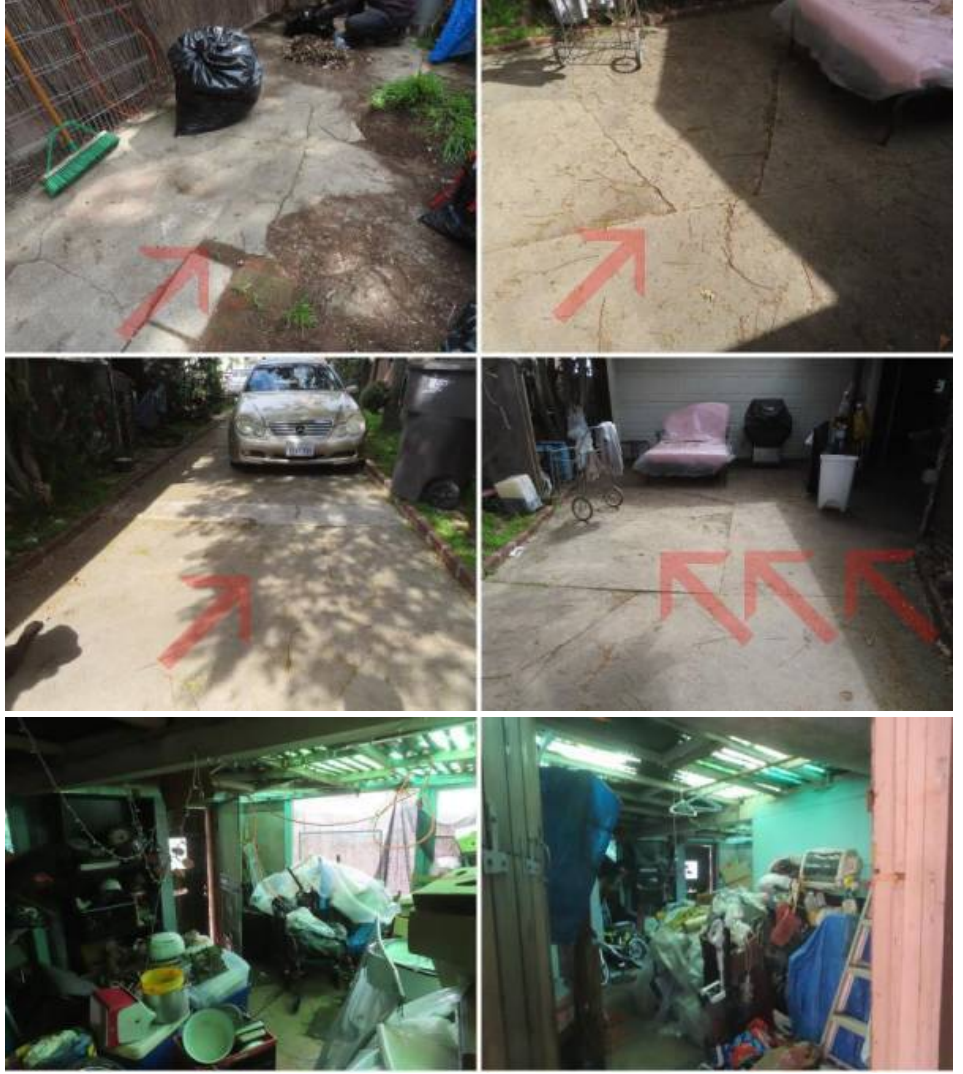
MONITOR: Small cracks viewed in the paving appear to be typical of settlement or shrinkage. We recommend monitoring cracks from time to time. Change in the size or number of cracks may be symptomatic of other conditions such as defective drainage, settlement or soil movement and should be further evaluated by a licensed masonry contractor.

DEFERRED: Appears to slope towards the parking structure. We recommend asking the owner for any knowledge of water intrusion or further evaluation by a licensed concrete contractor.

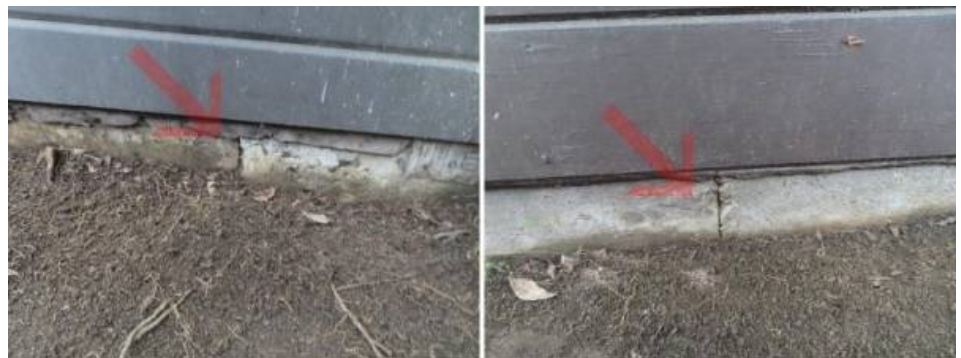
Small hairline crack(s).

Kitchen area level changes. Unable to tell if it is a crack because of the carpet. Recommend further inspection.

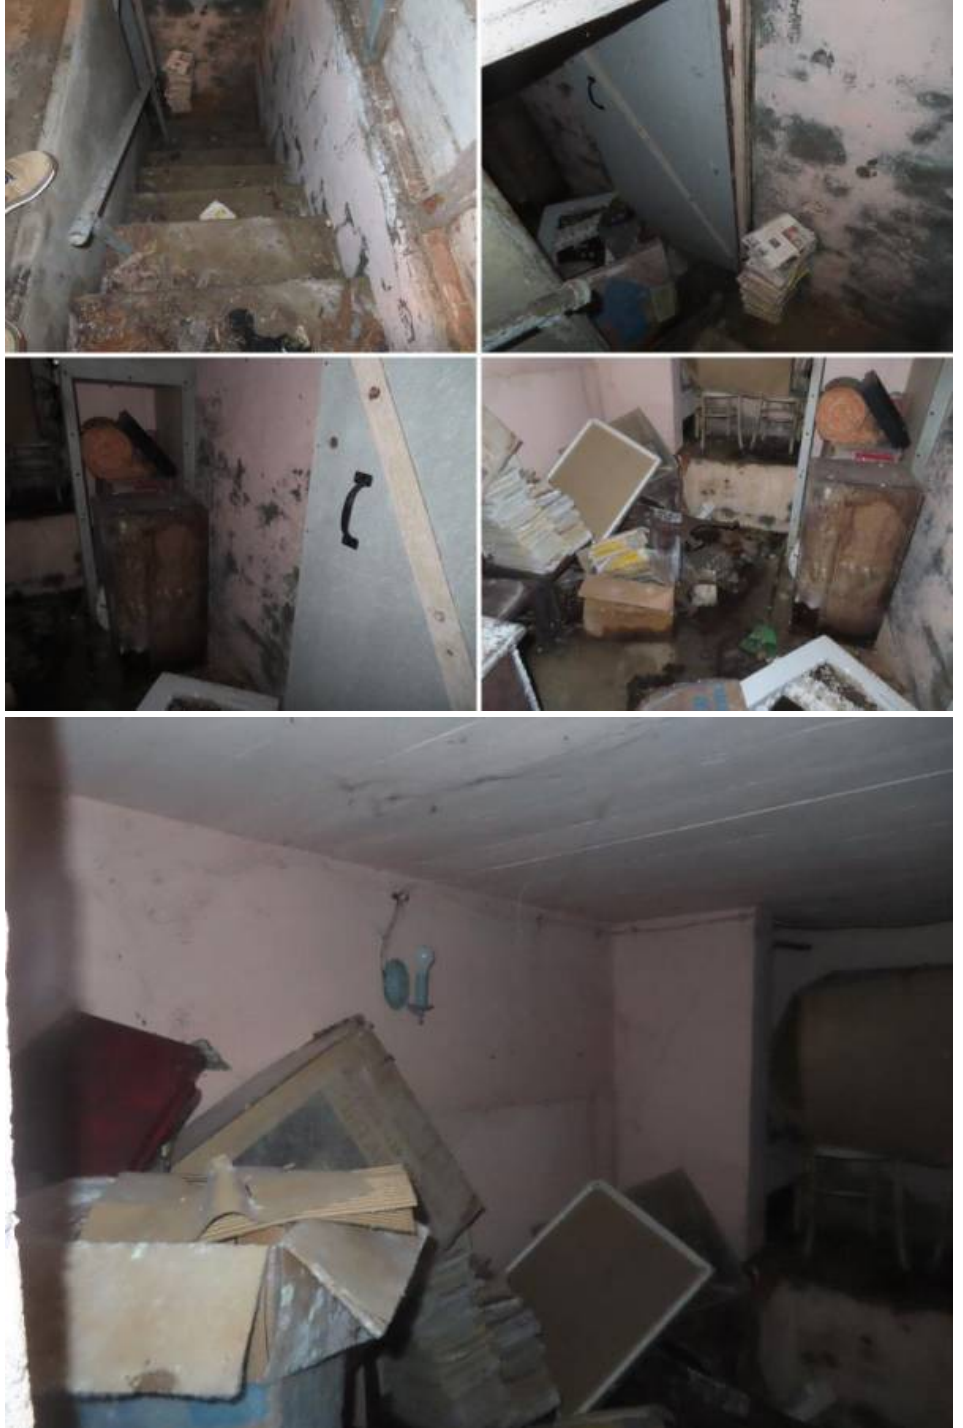
DEFERRED: Viewing was restricted by stored items and the smell and visible evidence of possible mold condition. We recommend further evaluation after items are removed.

SAFETY: Mold/mildew viewed on the walls/ceiling. Mold can cause illness in humans or pets. Babies, children, the elderly and persons with respiratory disease, allergies or compromised immune systems can be especially at risk. We recommend further evaluation by a qualified Environmentalist or Industrial Hygienist to determine if harmful microorganisms are present.

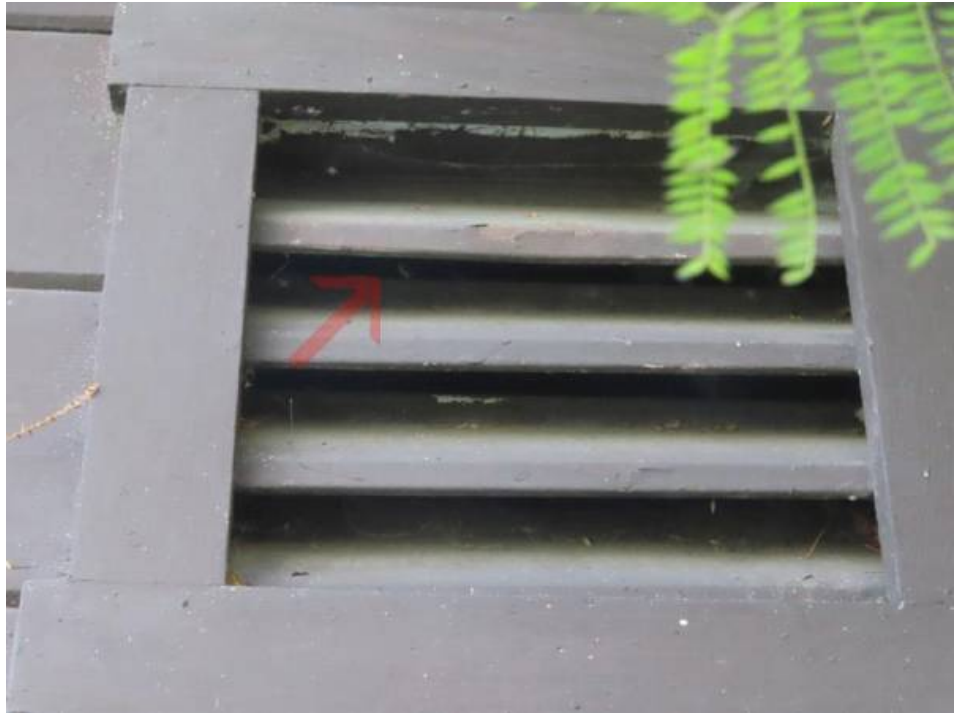
**MAINTENANCE:** Ventilation screens are damaged or missing at one or more locations. Attic space should be well ventilated to remove excessive moisture and heat, which can have an adverse affect on framing members, reduce the life expectancy of roofing materials, compress insulation reducing its efficiency and create an environment favorable for mold and mildew. We recommend repairing or replacing ventilation screens to prevent rodents, insects or birds from entering and to allow for proper air circulation.

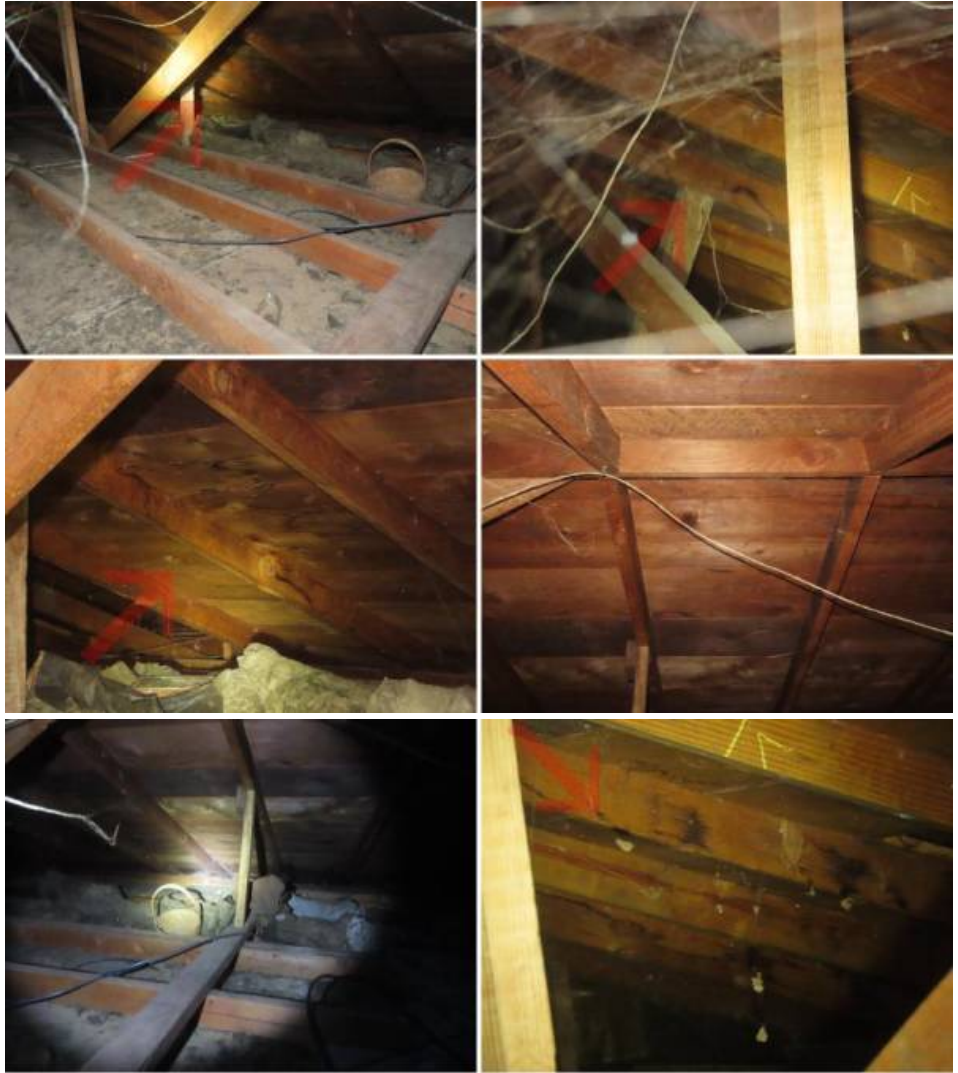
**DEFERRED:** Water stains viewed. We can't tell the age of stains from appearance, however, we suspect possible current leakage. Also see roof covering notes below for additional information.

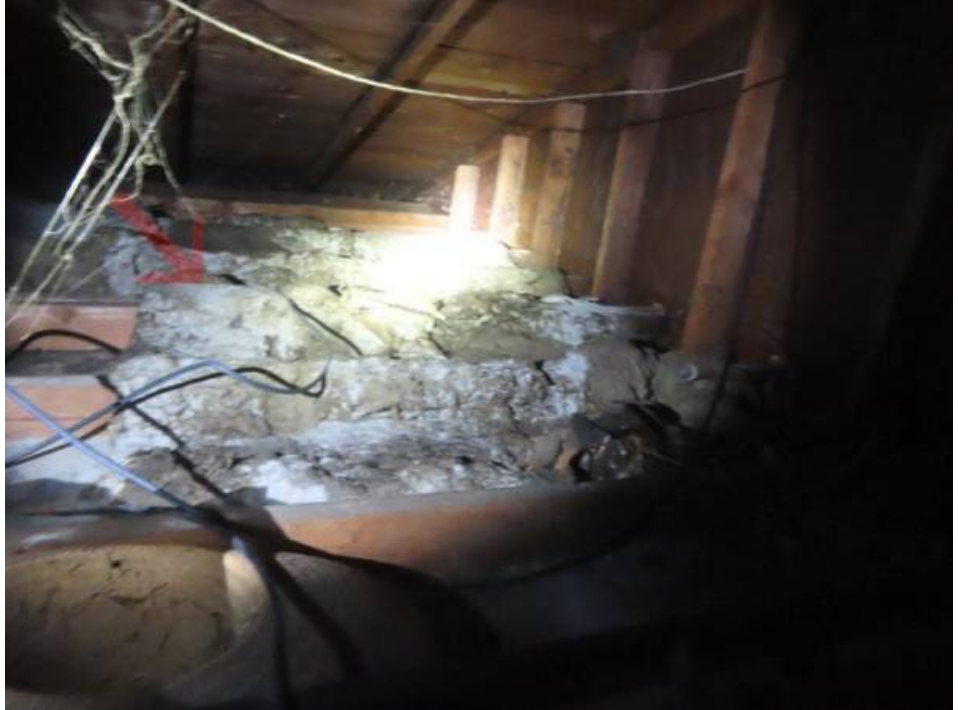
None installed. We recommend installing insulation for energy conservation reasons.  
Over front bedroom.  
Type: Fiberglass batts. Approximate thickness: 1-2 inches. Minimal insulation. We suggest installing additional insulation to reduce heat loss.

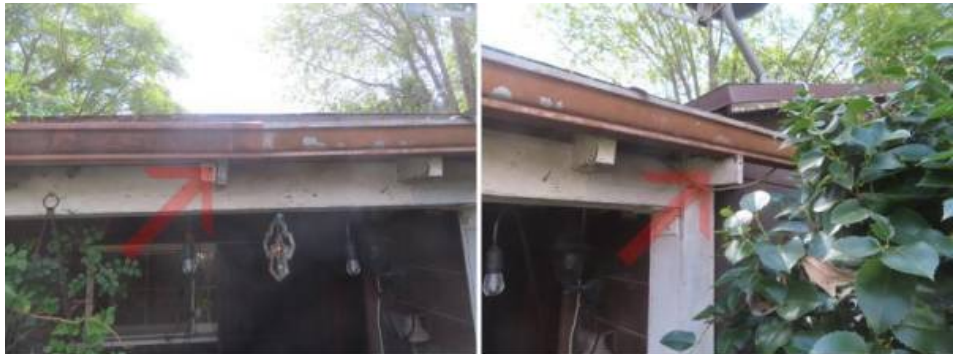
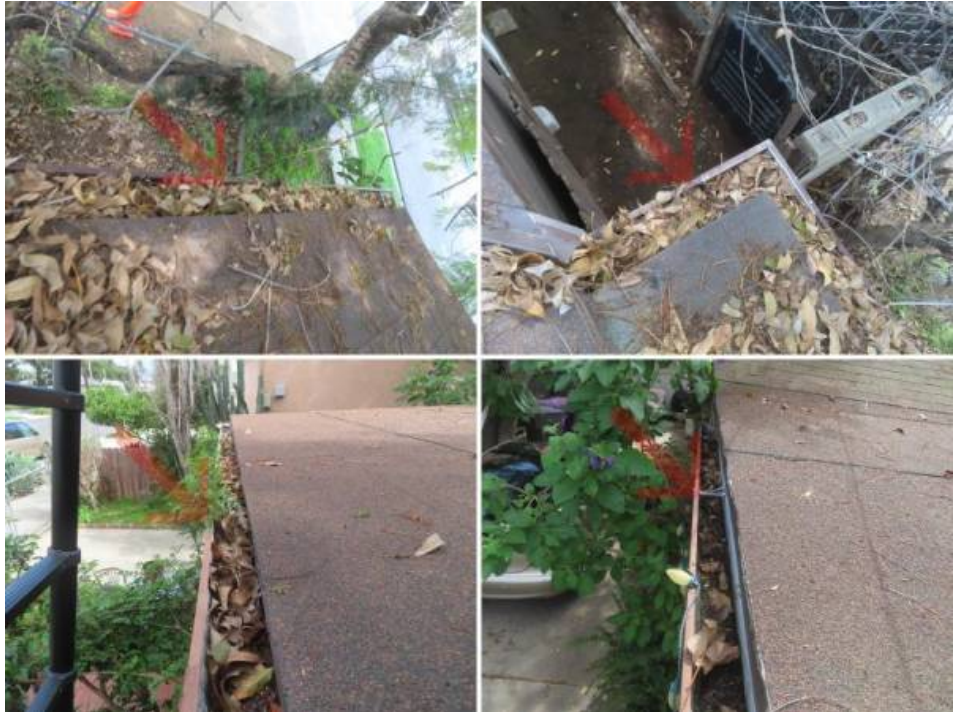
MAINTENANCE: Debris noted in the gutters. We recommend cleaning the gutters now and prior to each rainy season and periodically as needed.

MAINTENANCE: Rain gutters are improperly sloped or have come loose and do not drain properly. We recommend further evaluation and corrections as needed at this time.

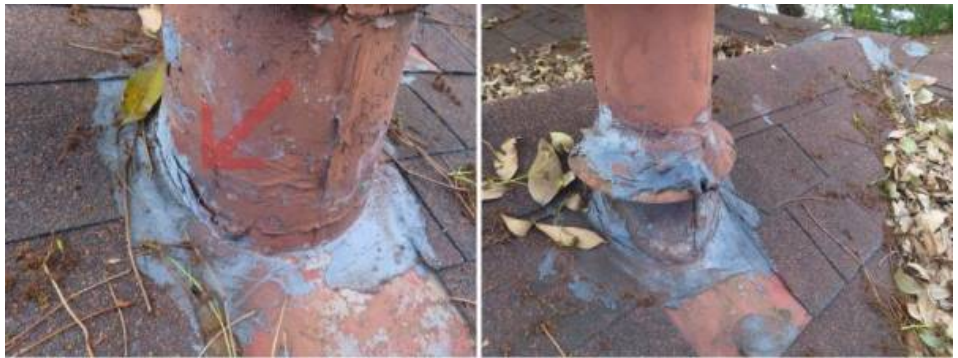
MAINTENANCE: Mastic is cracked/deteriorated at the pipe penetrations. We recommend applying fresh mastic as needed at this time to prevent leakage.

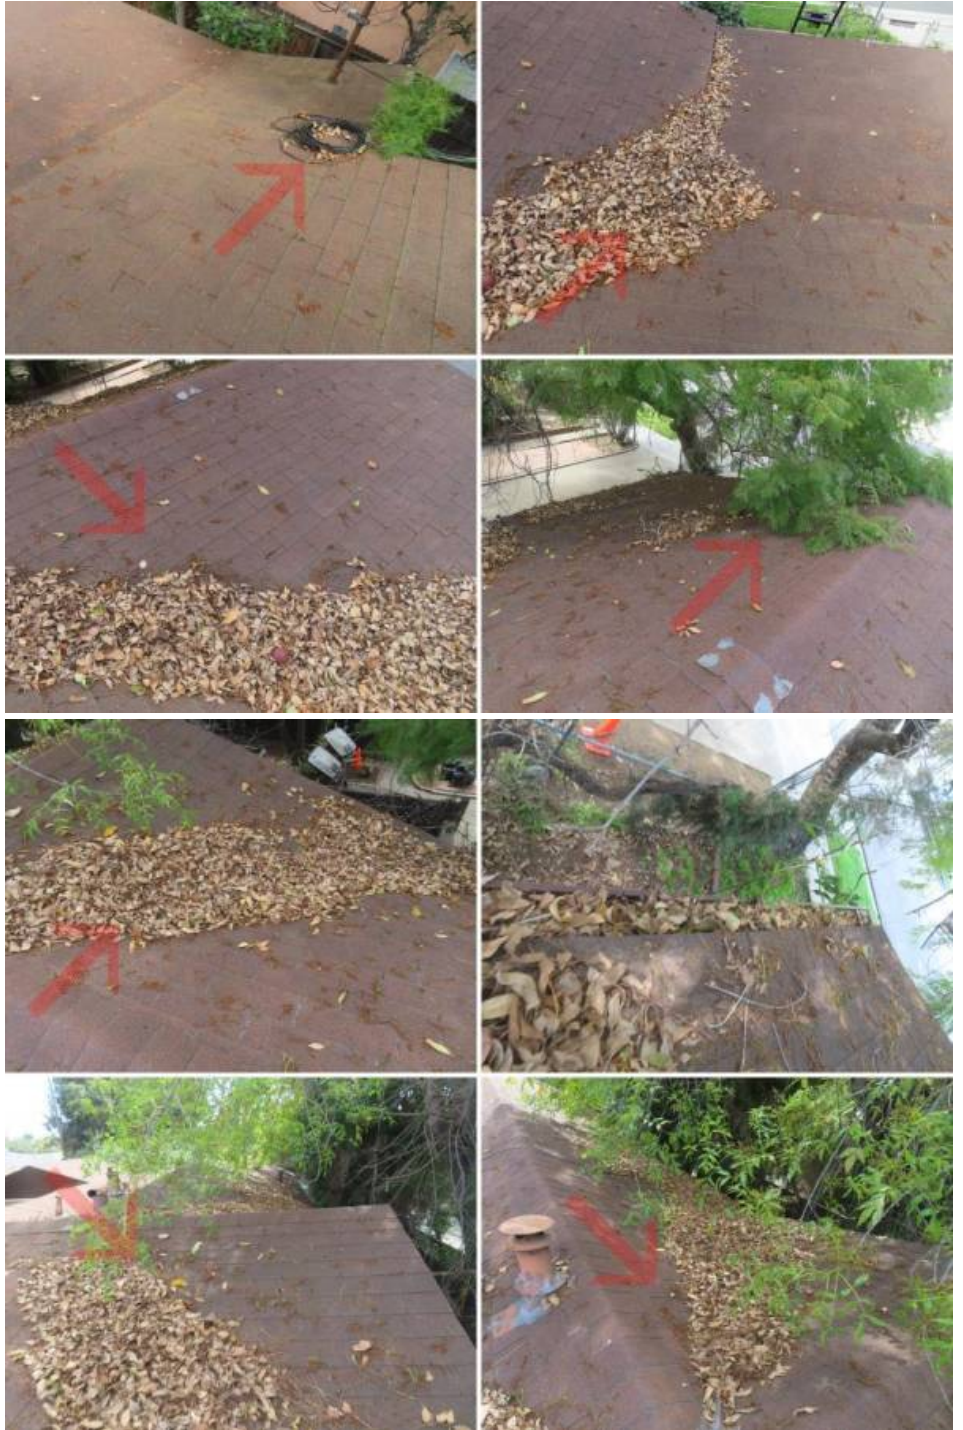
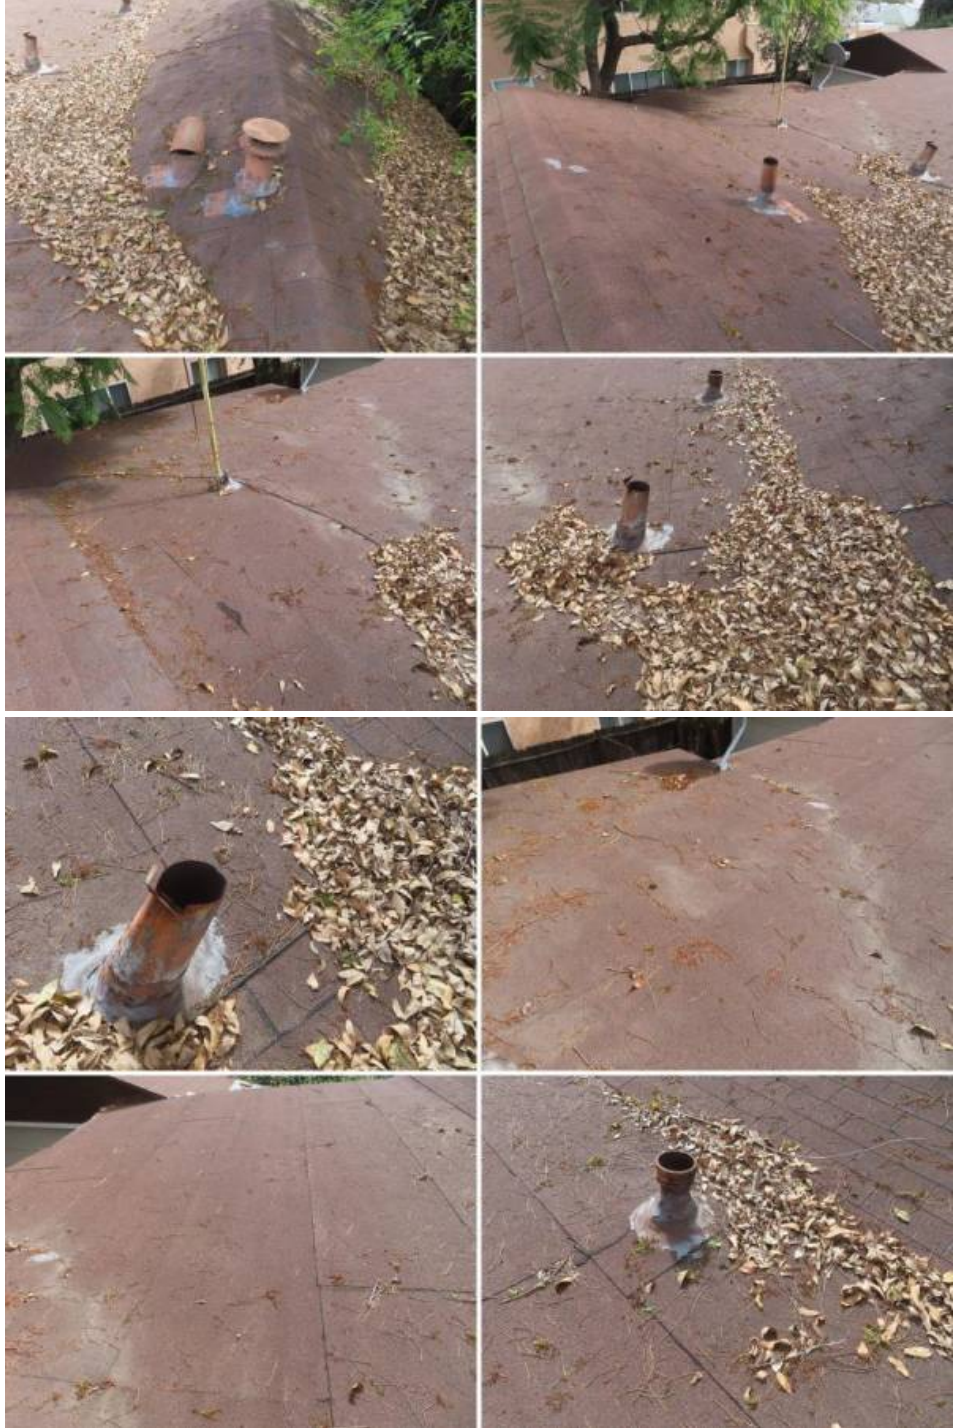
Evidence of possible leaking in garage and kitchen to back bedroom wall.

MAINTENANCE: Aging/weathering/deterioration of the ridge shingles.

MAINTENANCE: Aging/weathering, repairs needed, some cracked, broken, loose, missing or eroded shingles.

MAINTENANCE: Vegetation near or touching the roof surface. We recommend maintaining vegetation growth near the roof as needed to prevent damage to the roofing materials.

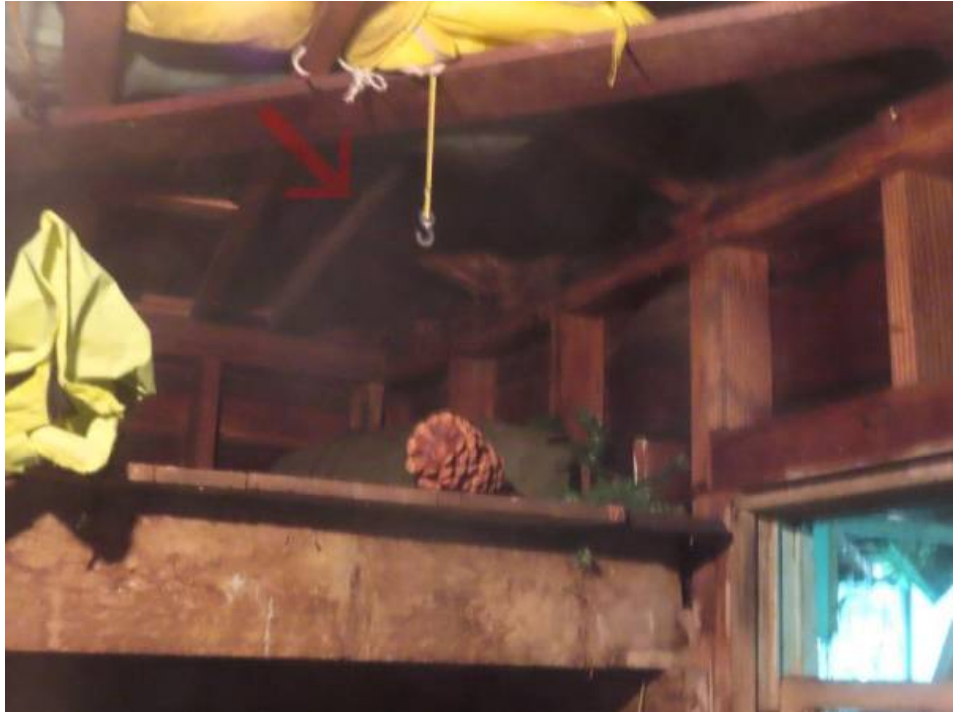
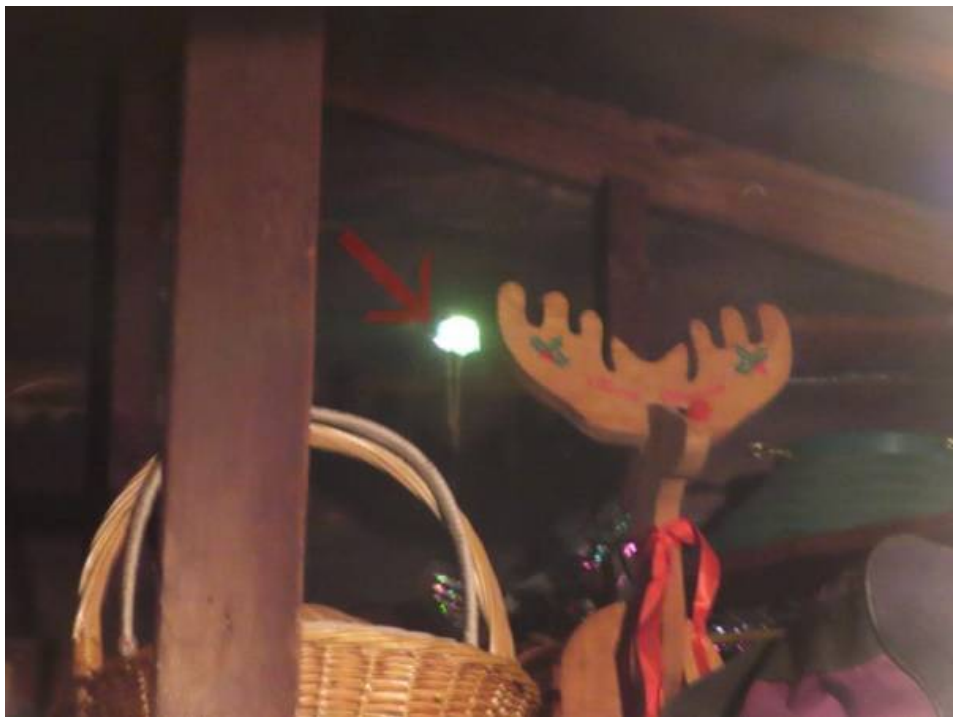
DEFERRED: Water stains observed on the framing. We are not able to determine if water stains are from active or repaired leaks.

Hole on rear wall, recommend closing hole to prevent bird entry.

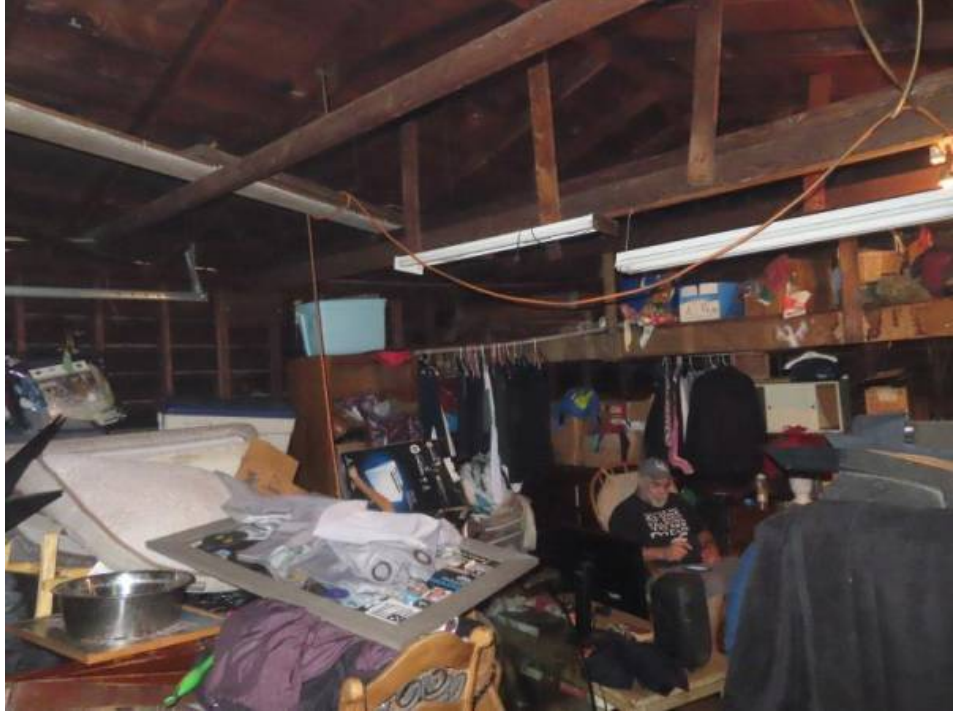
DEFERRED: The walls were heavily obscured by stored items. We recommend further evaluation after stored items have been removed and prior to the close of this transaction.
