Inspection reference: 3850 E. 15th St., LB, CA 90804

# **Confidential Inspection Report**

**3850 E. 15th St.**  
**Long Beach CA 90804**

**February 29, 2024**

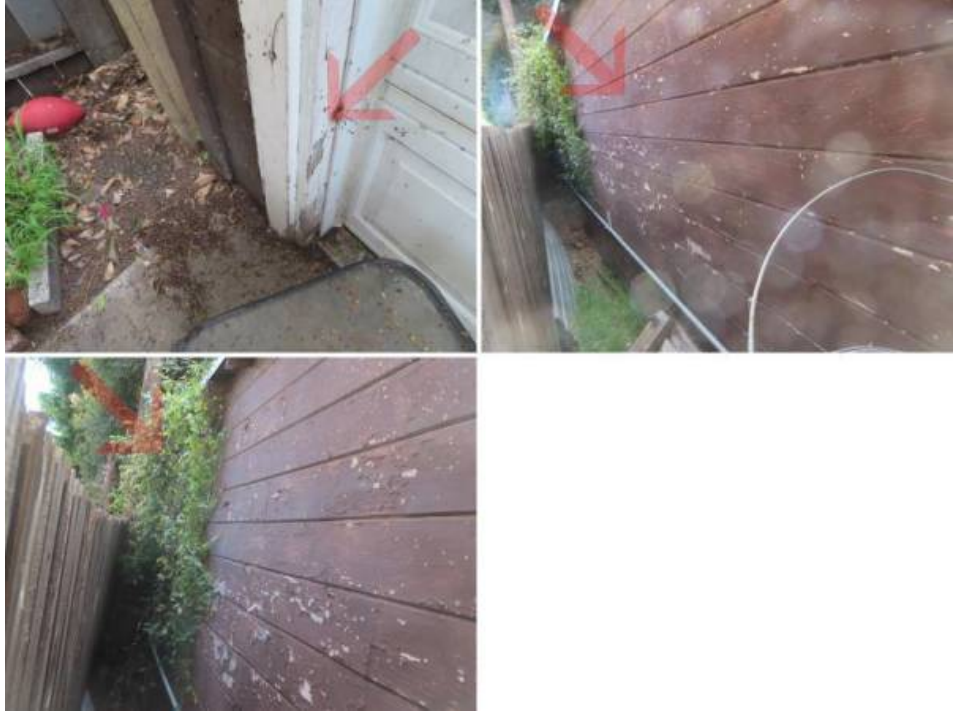
MAINTENANCE: Some loose or peeling paint viewed. We recommend painting at this time to protect the wood from further deterioration and to enhance its appearance.  
DEFERRED: Portions of the walls are covered with thick vegetation and were not viewed.

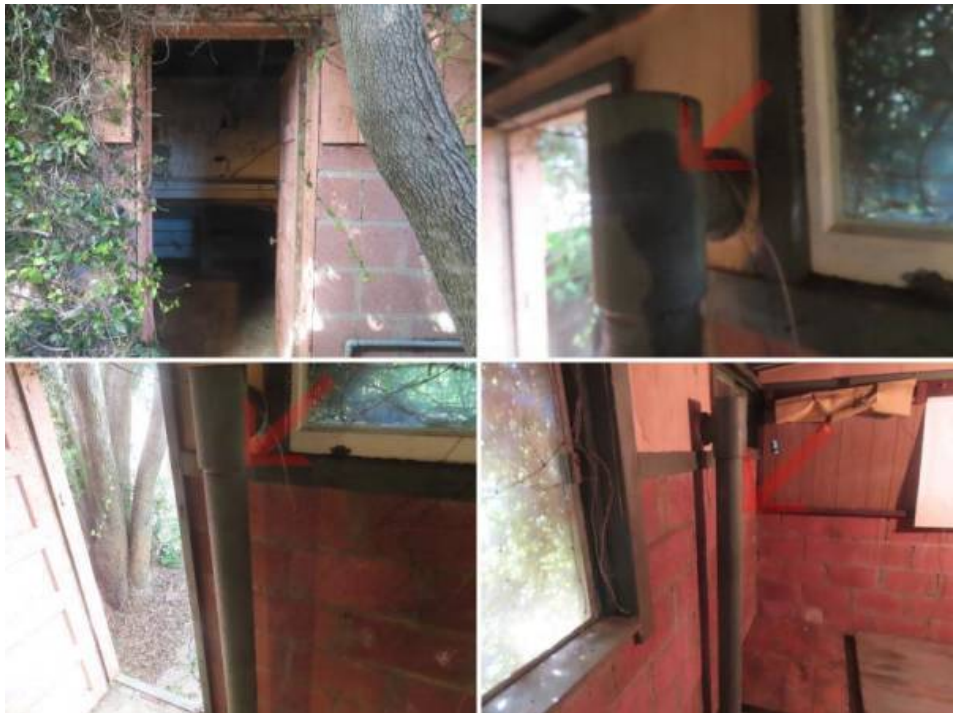
Abandoned Transite pipes noted.

SAFETY: Transite vent pipe(s) observed. Transite is known to contain asbestos and will need special handling if removed or repaired.

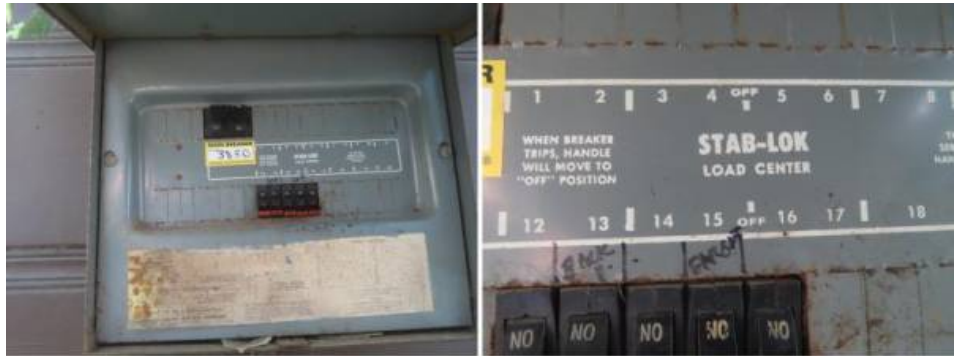
**SAFETY:** Federal Pacific or Zinsco brand panel present. Electrical panels and circuit breakers are known to deteriorate with age. Many older panels have aluminum bus bars that are susceptible to oxidization, which can compromise the electrical connections. Also, older breakers have a higher failure rate than do modern breakers. Both of these conditions can lead to arcing and overheating, sometimes resulting in an electrical fire. A visual inspection cannot determine if these panels and breakers are performing to their original design specifications. Federal Pacific and Zinsco brands in particular are problematic and we routinely recommend replacing these panels as a safety upgrade.

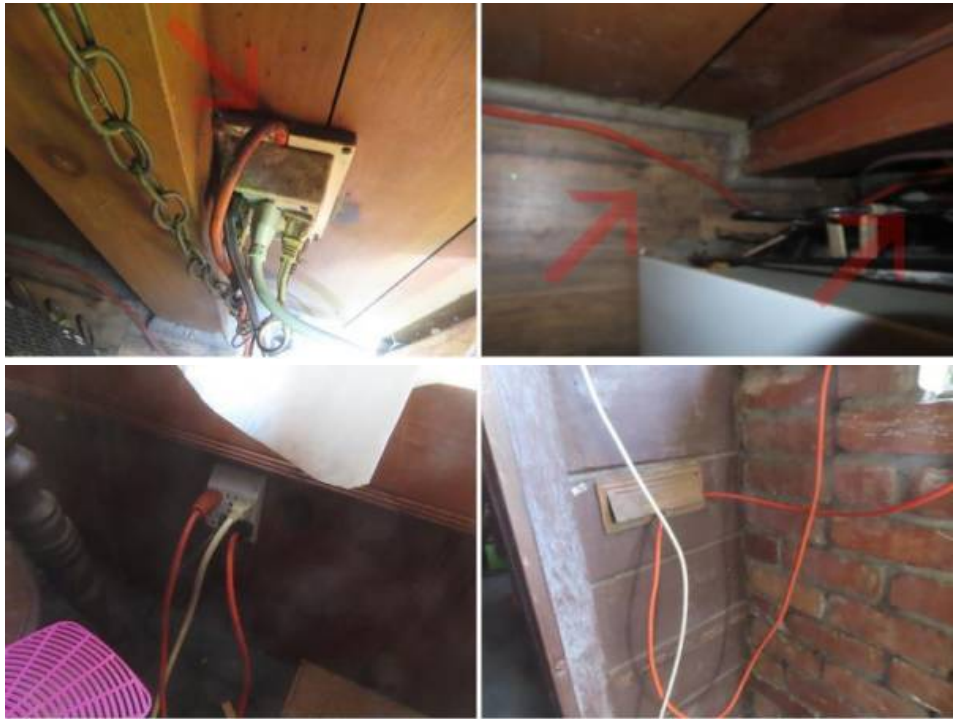
Extension cord wired improperly into and outlet junction box.

DEFECTIVE: Permanently installed (hard wired) lamp cord. This type of wire is not designed for permanent installation. Recommend further inspection and repairs as needed.

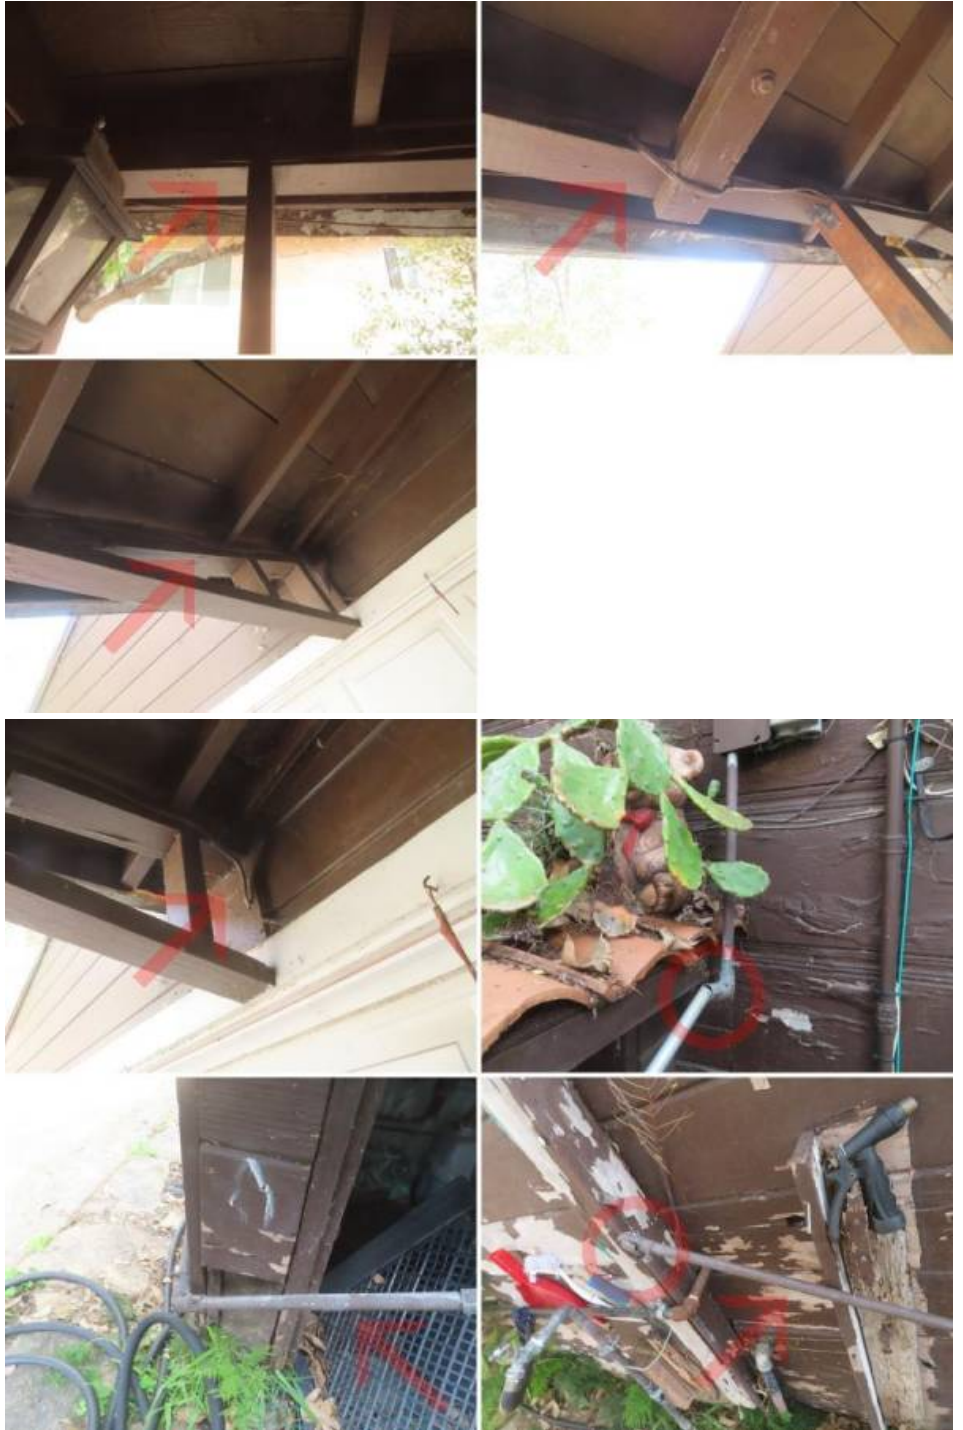
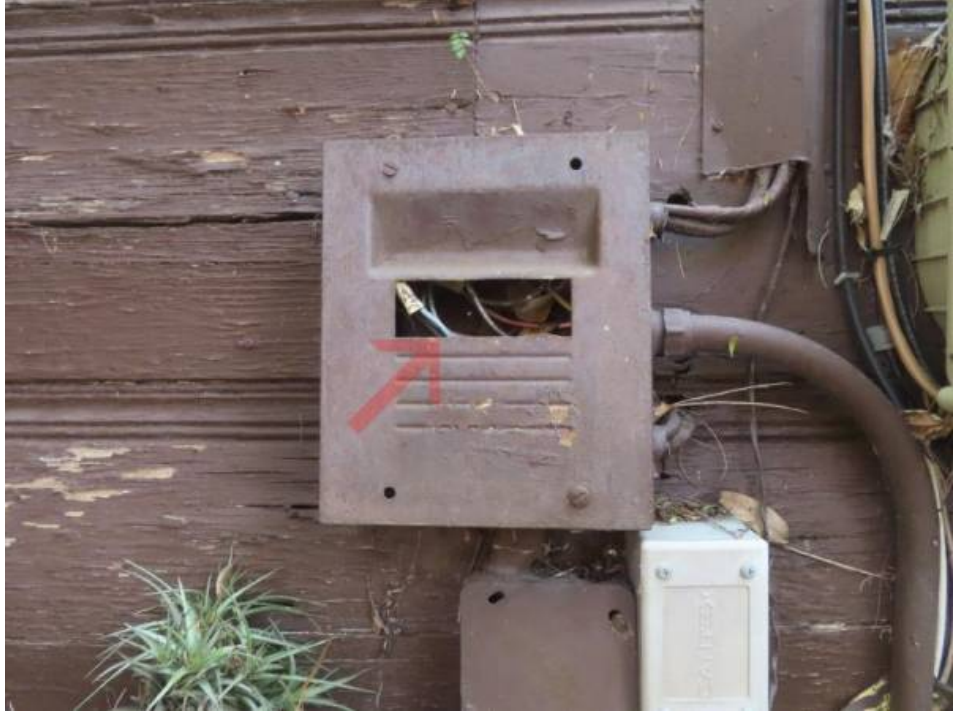
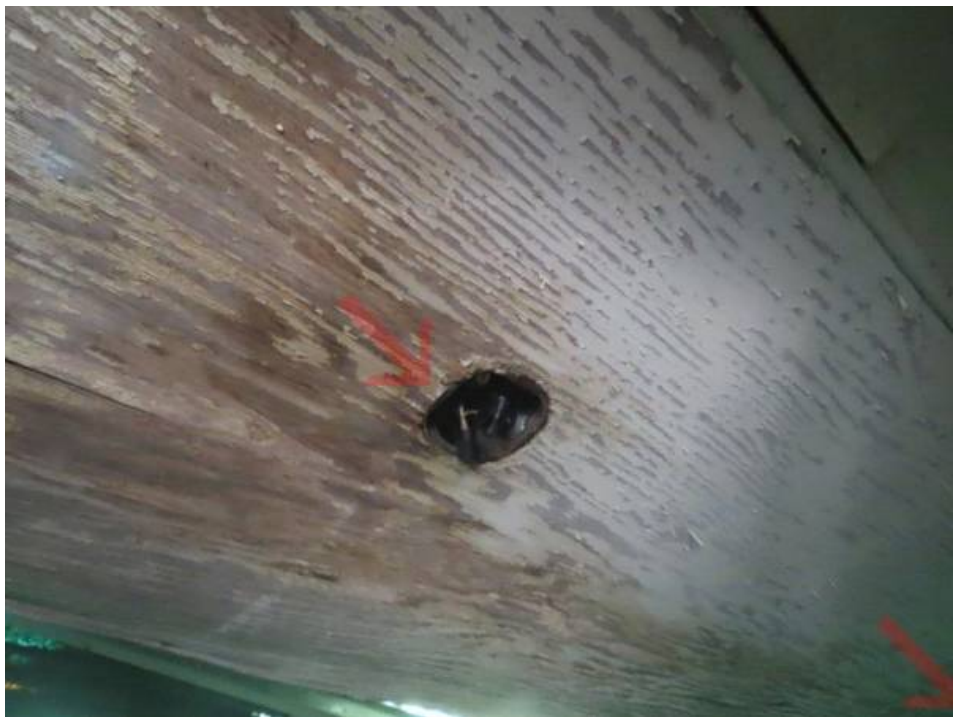
East porch to garage.

DEFECTIVE: Romex wiring is exposed to physical damage. This type of wiring is for use in concealed areas where it is not subject to physical damage.

DEFECTIVE: Conduit is separated and wires are exposed to physical damage and/or UV deterioration .

DEFECTIVE: Cover or knockout plugs missing at one or more junction boxes viewed. Covered junction boxes with no openings are required anywhere wires are spliced to contain sparks in the event of arcing at the connection.

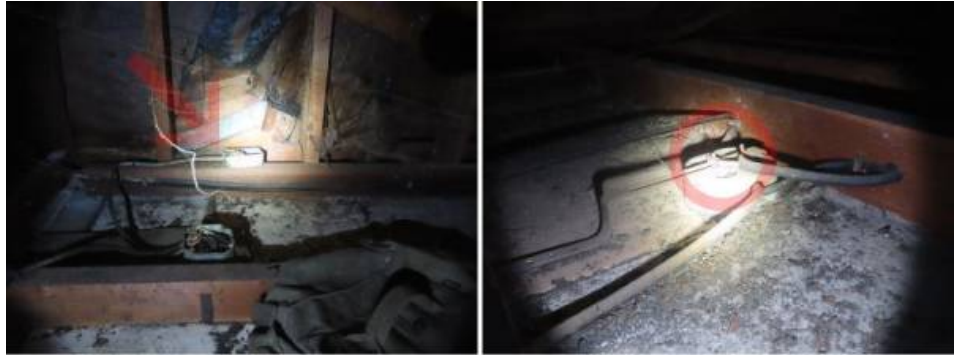
DEFECTIVE: Cover or knockout plugs missing at one or more junction boxes viewed. Covered junction boxes with no openings are required anywhere wires are spliced to contain sparks in the event of arcing at the connection.  
DEFERRED: Wiring is improperly abandoned. We did not see both ends of this wire and could not verify they were disconnected from a possible electrical source.

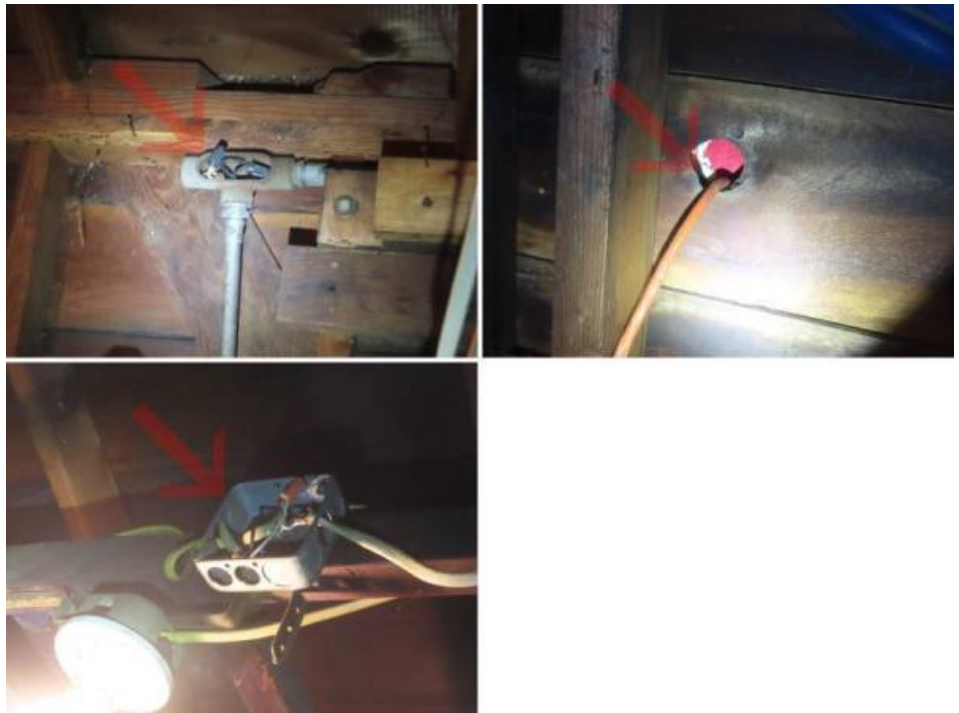
DEFECTIVE: Cover or knockout plugs missing at one or more junction boxes viewed. Covered junction boxes with no openings are required anywhere wires are spliced to contain sparks in the event of arcing at the connection.  
 DEFECTIVE: Extension cord ran through a knot hole in wall. Recommend removing cord.

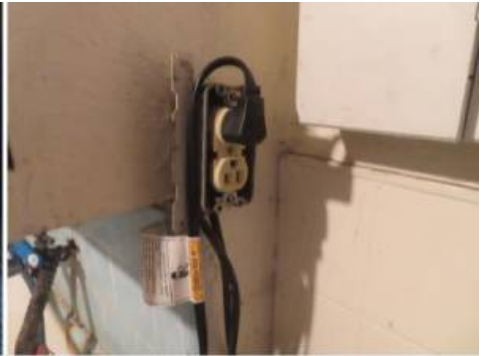
DEFECTIVE: Cover plate is missing or damaged at one or more locations. Risk of accidental contact with energized parts. We recommend installing or replacing damaged cover plates as needed at this time.

Kitchen. Stove and refrigerator share the same outlet.

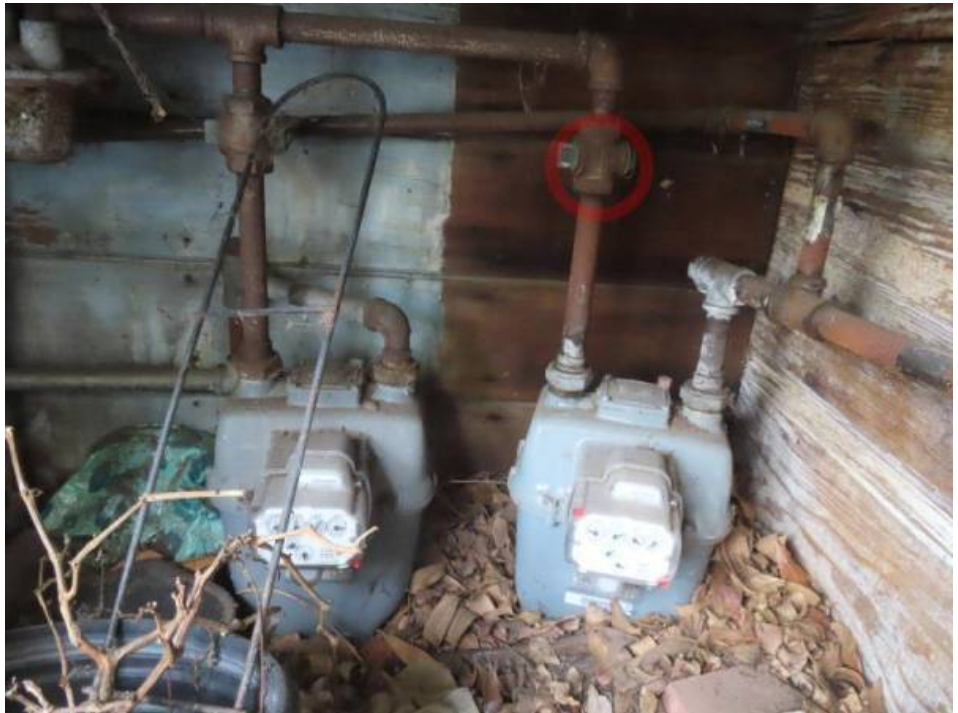
SAFETY: No seismic shutoff valve. We recommend installing a seismic shutoff valve on the gas meter for protection against fire loss in the event of a damaging earthquake. (A seismic shutoff valve is required to be installed on the gas system of residences in the City of Los Angeles prior to the transfer of title.)

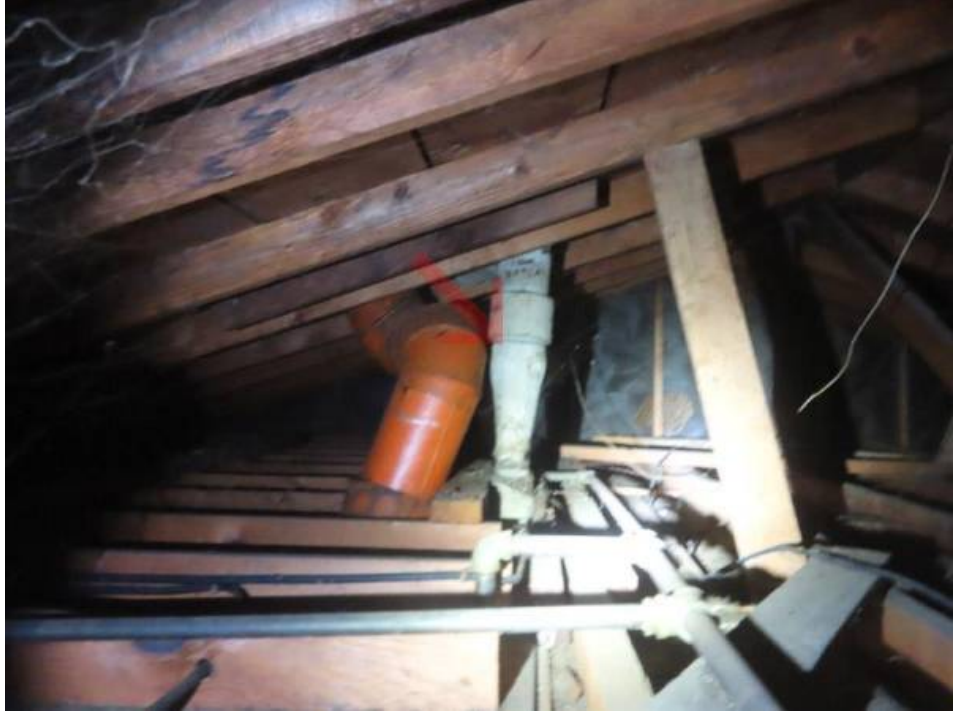
<i>Vent system</i>	<p>SERVICEABLE.</p> <p>SAFETY: Transite vent pipe(s) observed. Transite is known to contain asbestos and will need special handling if removed or repaired.</p>
--------------------	---

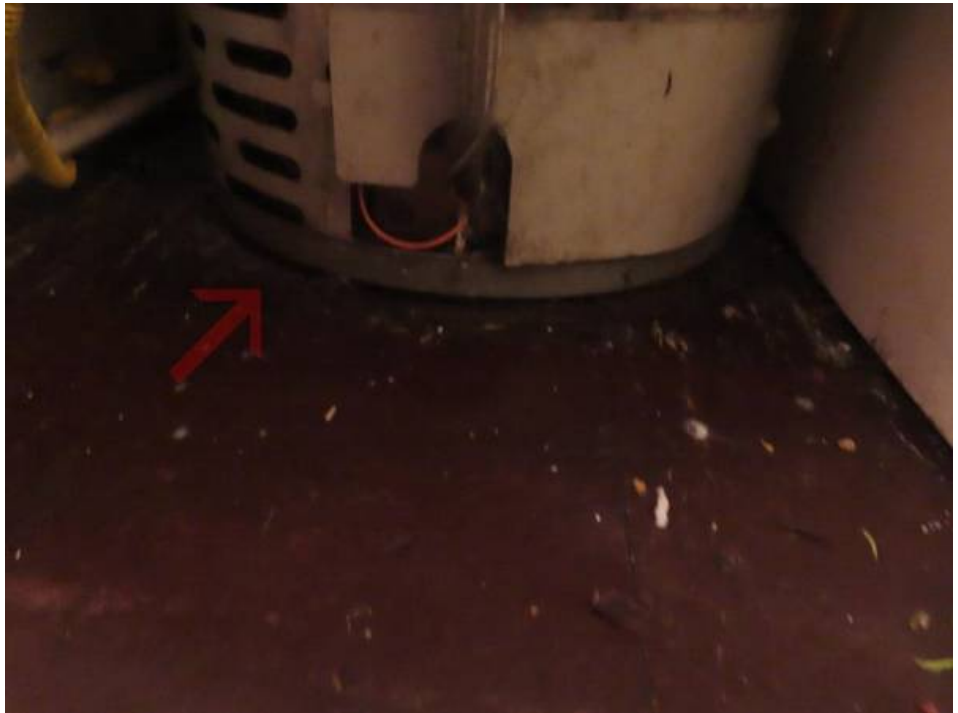
DEFECTIVE: Not raised above the surrounding grade. We recommend raising the water heater at least 3-inches above the surrounding grade to guard against corrosion of the feet.

MAINTENANCE: We recommend installing a properly sized catch pan with a drain that terminates at the exterior of the building to prevent damage to structure/belongings in the event the water heater leaks.

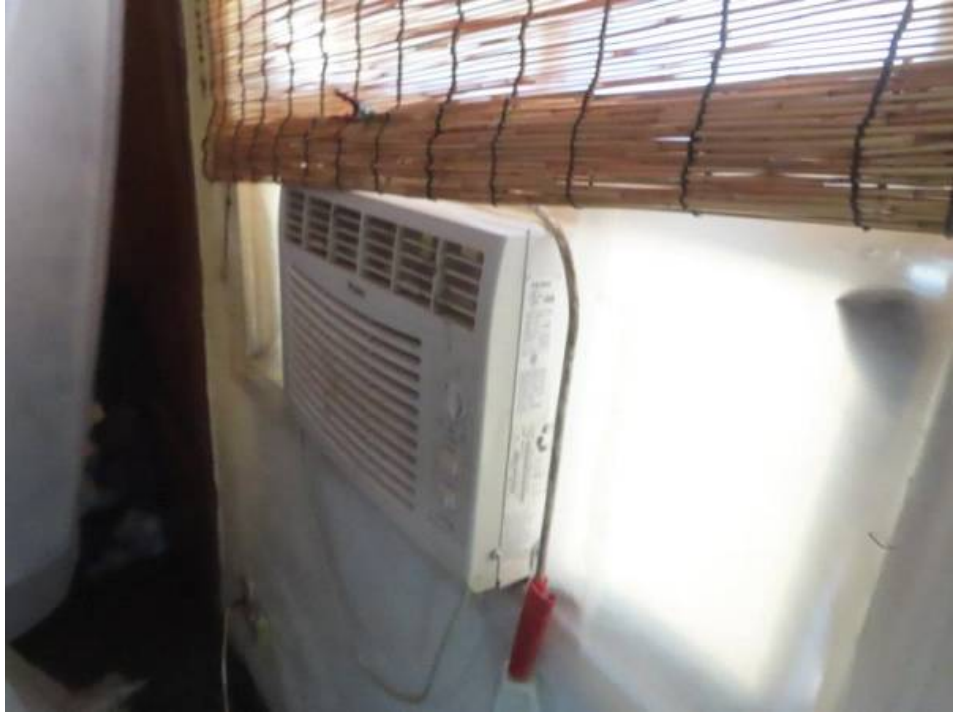
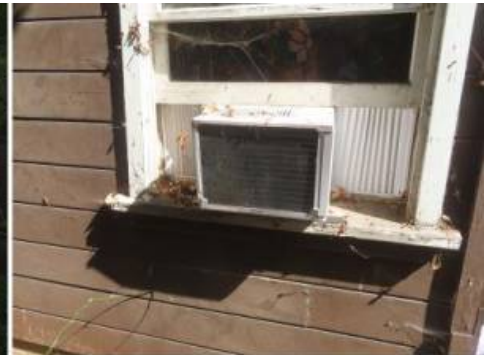
DEFERRED: Window mounted or other non central cooling present. These are not within the scope of our inspection and are not inspected.

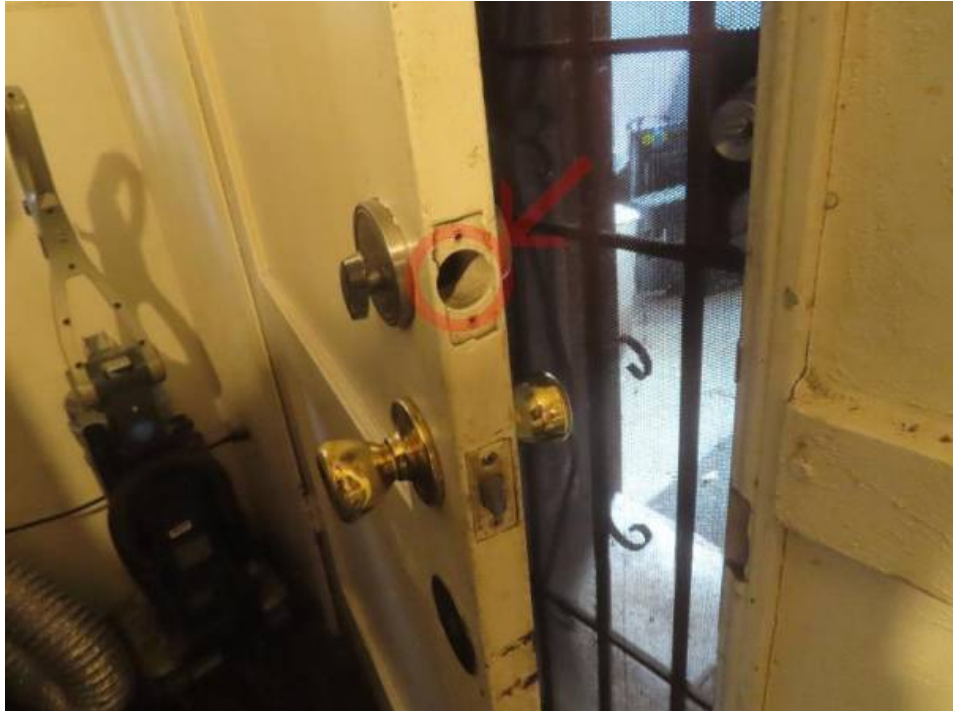
DEFECTIVE: Laundry door deadbolt missing parts.  
 MAINTENANCE: Door rubs the jamb or floor, sticks, or doesn't latch securely at one or more doors sampled. Some minor shaving/trimming/adjustment is needed.  
 DEFERRED: Door was locked or blocked and not opened at one or more doors sampled.

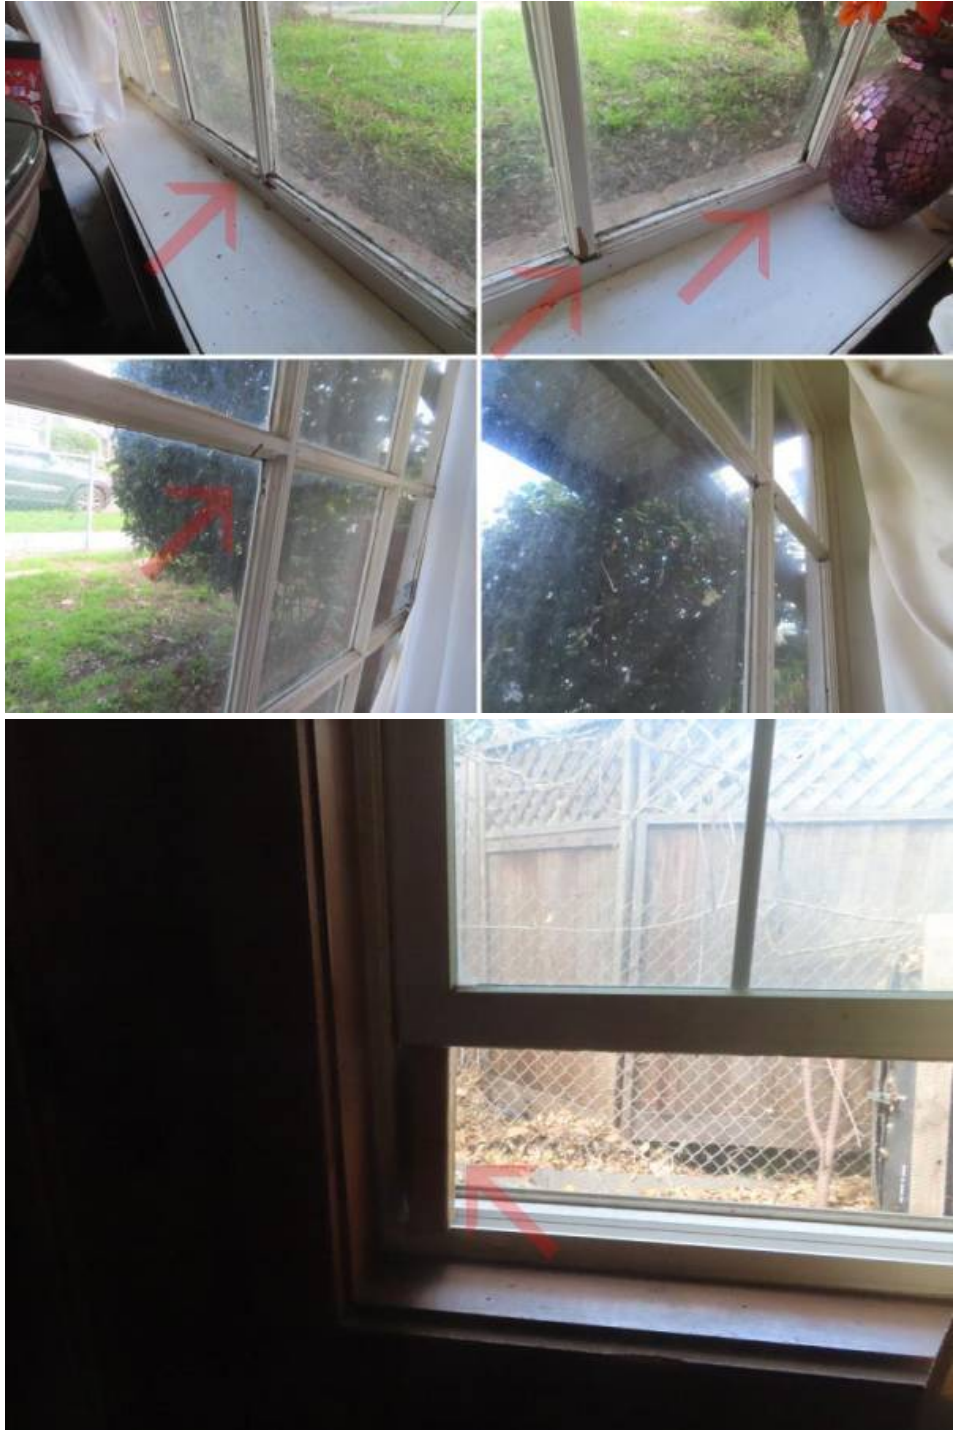
**DEFERRED:** Pane replaced with thin plexi glass.

**DEFERRED:** Water stains/damage present might indicate insect/moisture intrusion.

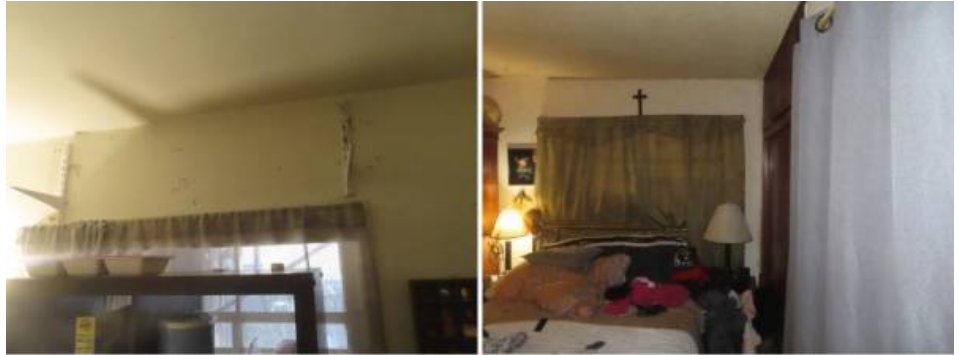
DEFERRED: Many of the walls are covered with paneling and surface is not visible.  
DEFERRED: Stored items or furnishings prevent full inspection.

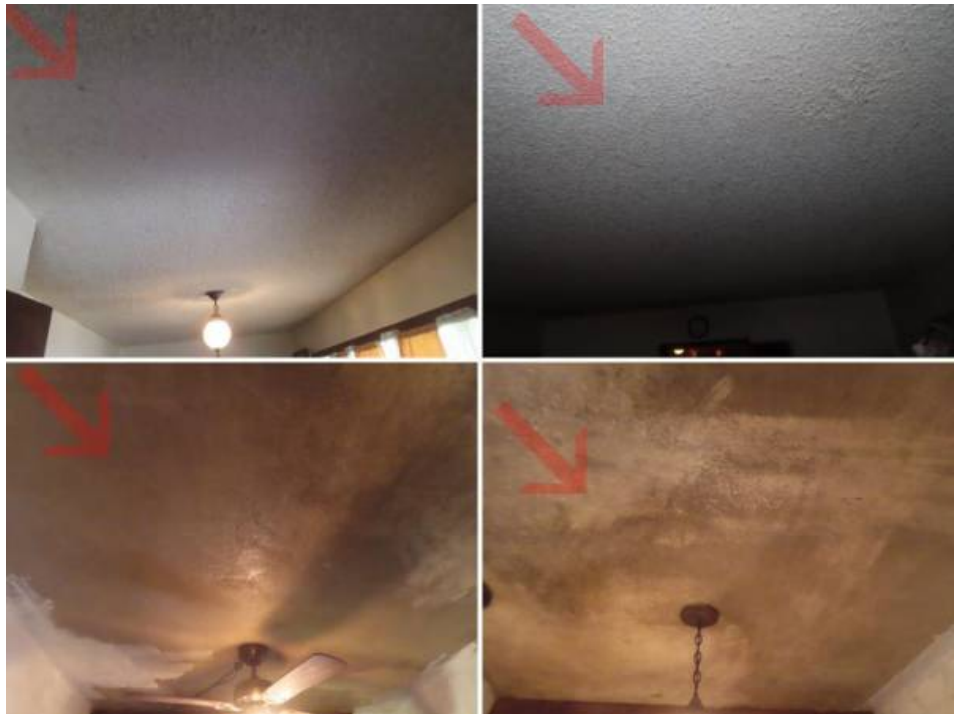
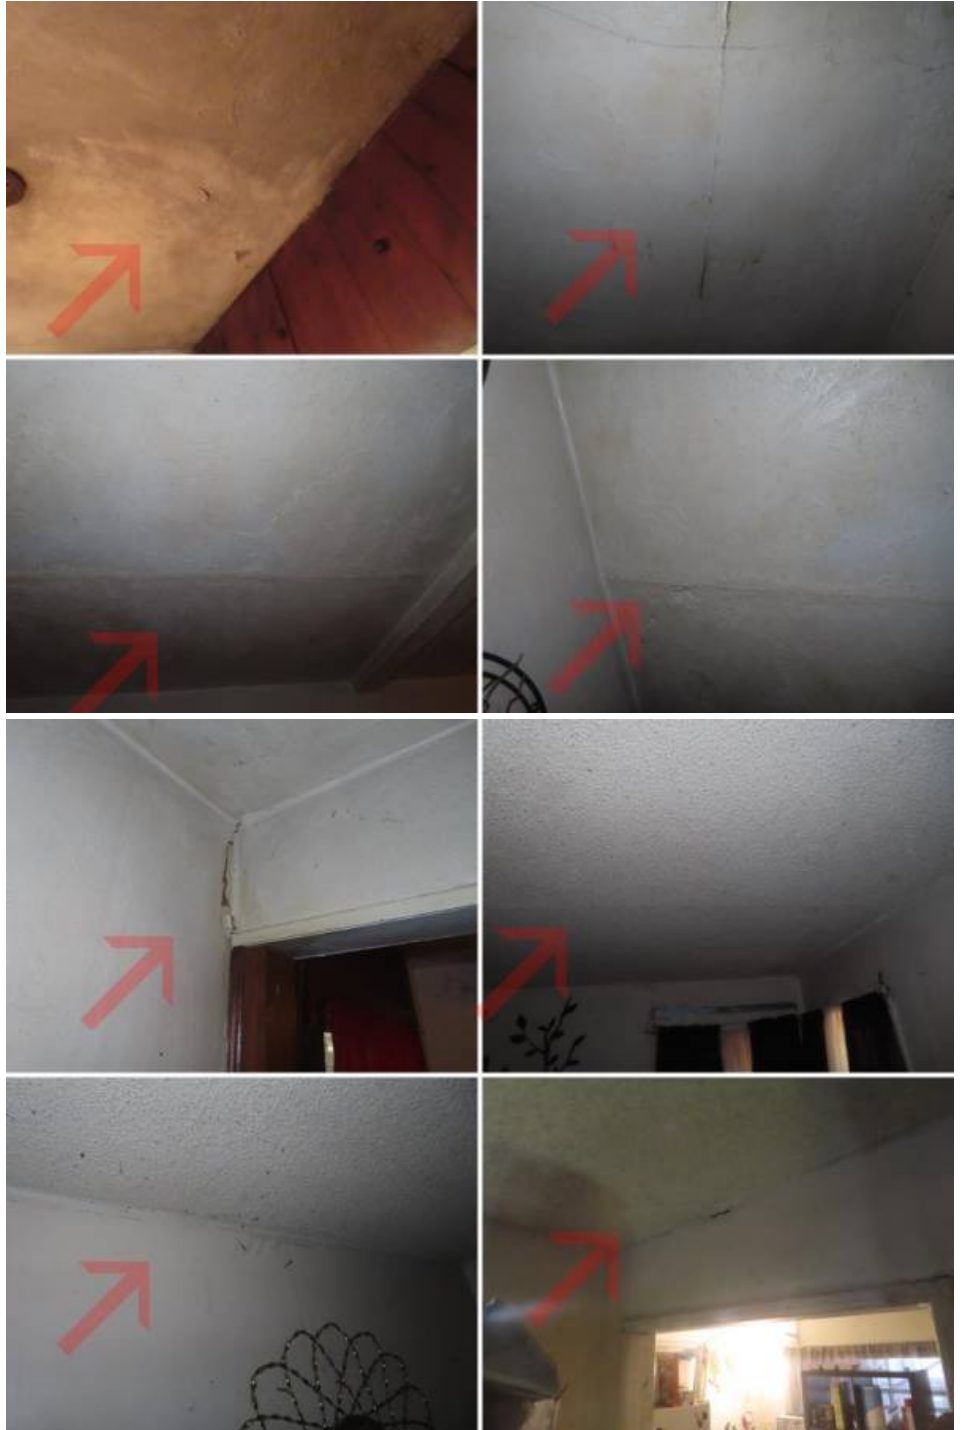
**SAFETY:** Acoustic ceilings viewed may contain asbestos. Positive identification of asbestos can only be made by a certified laboratory. The acoustic ceilings appear to be in good condition. Removal or encapsulation is not generally recommended unless the material is damaged and/or in friable condition. Asbestos was widely used in building materials prior to 1983. This material if present can pose health risks and will require special handling if disturbed. Your real estate agent may be able to provide you with the pamphlet "Asbestos In The Home" (CPSC Document #453) or you may obtain one yourself from the Consumer Products Safety Commission by calling them at (800) 638-CPSC, or it can be found at their web site: [www.cpsc.gov](http://www.cpsc.gov). We also have that document available as a .pdf file, which we will e-mailed to you upon request.

**MONITOR:** Some cracks in the walls and ceilings viewed at various locations likely indicate moderate settlement/movement or seismic racking. We suggest monitoring and if any changes are observed we recommend further evaluation by a structural engineer.

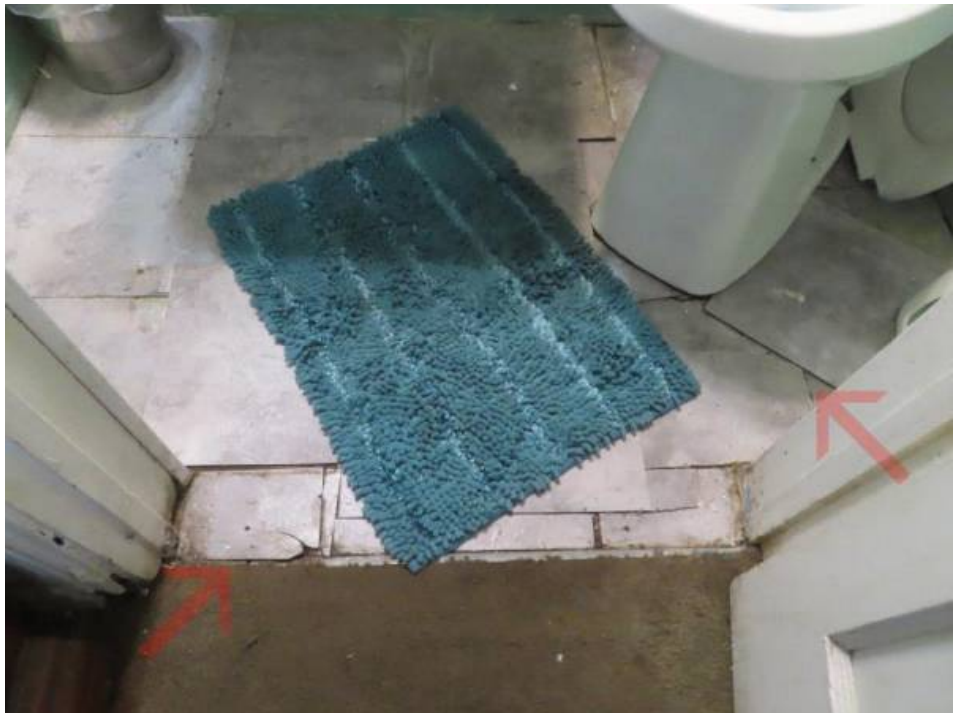
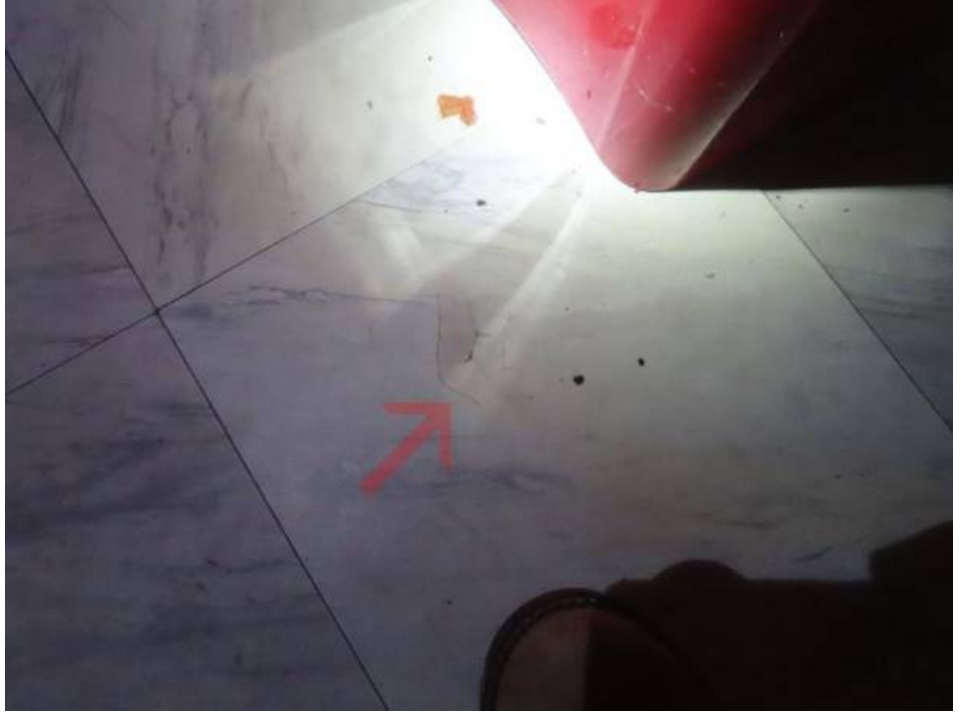
DEFERRED: Older tiles may contain asbestos, recommend further inspection by a licensed asbestos company.

MAINTENANCE: Loose, displaced or damaged tile at one or more locations.

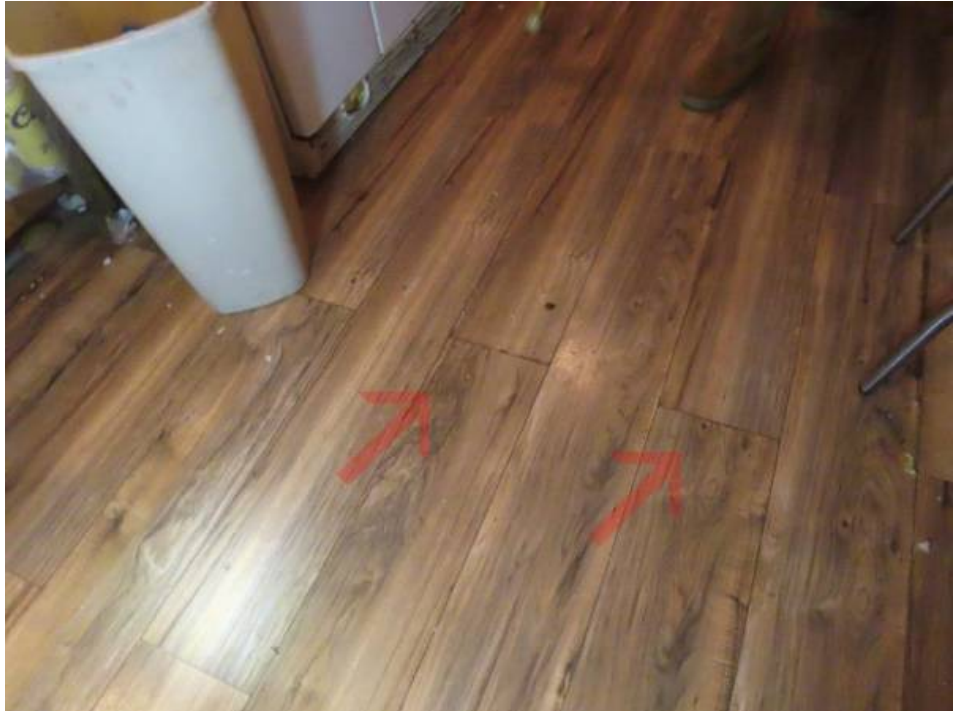
DEFERRED: Buckled wood or open joints indicate excessive moisture.

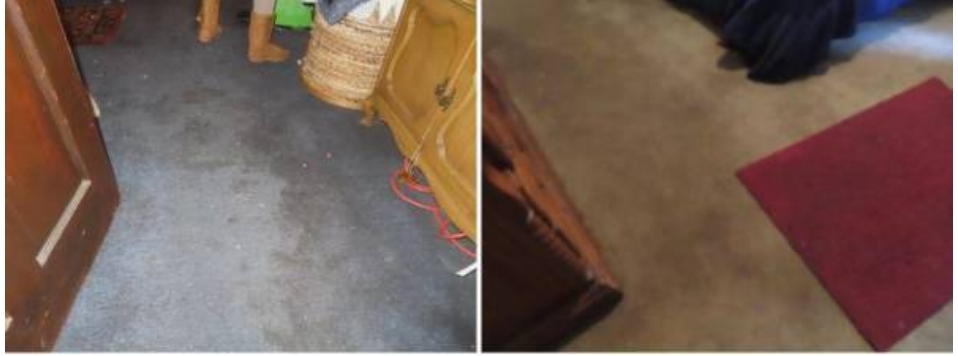
MAINTENANCE: Possible stains/discoloration viewed.  
MAINTENANCE: Carpet is noticeably worn with some damage.

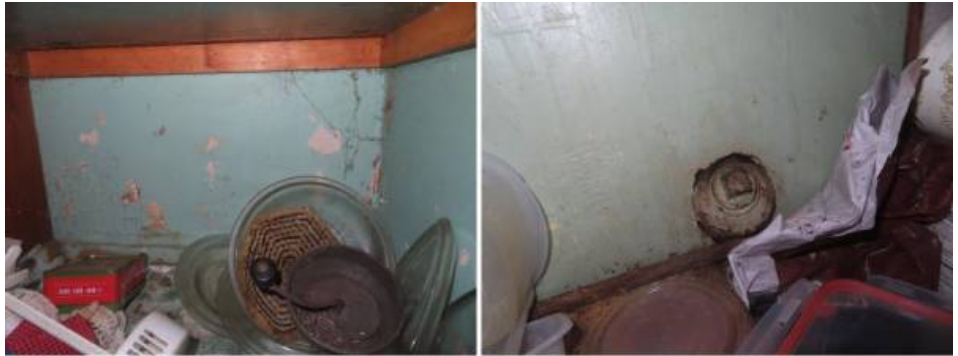
MAINTENANCE: Moderate to heavy wear. Some hinges or doors may be damaged, or do not latch securely, or drawer guides/slides are worn or in disrepair.

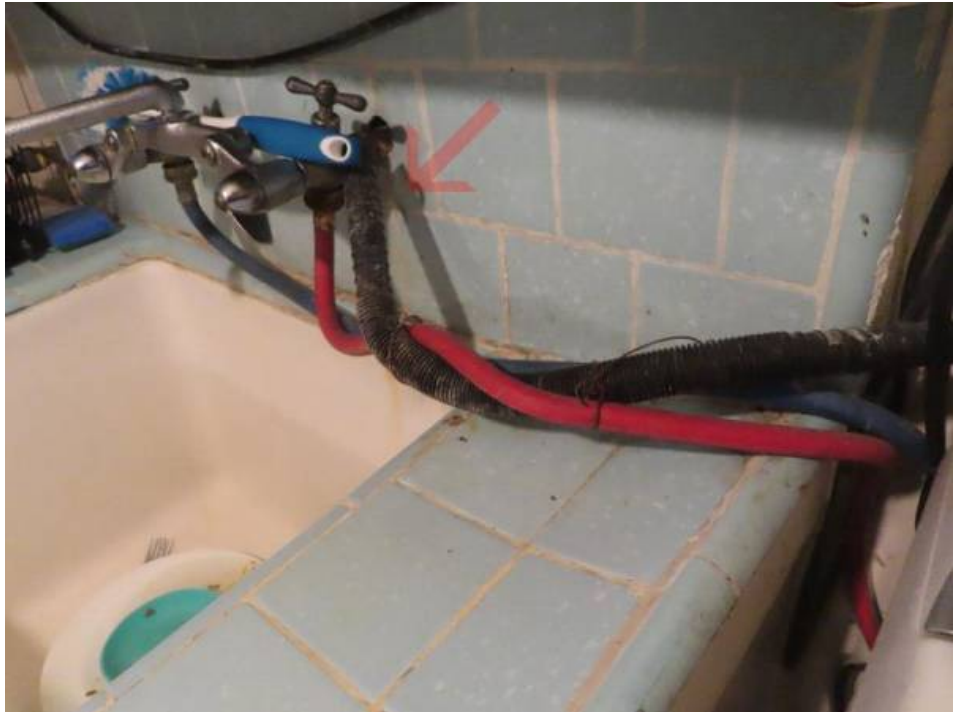
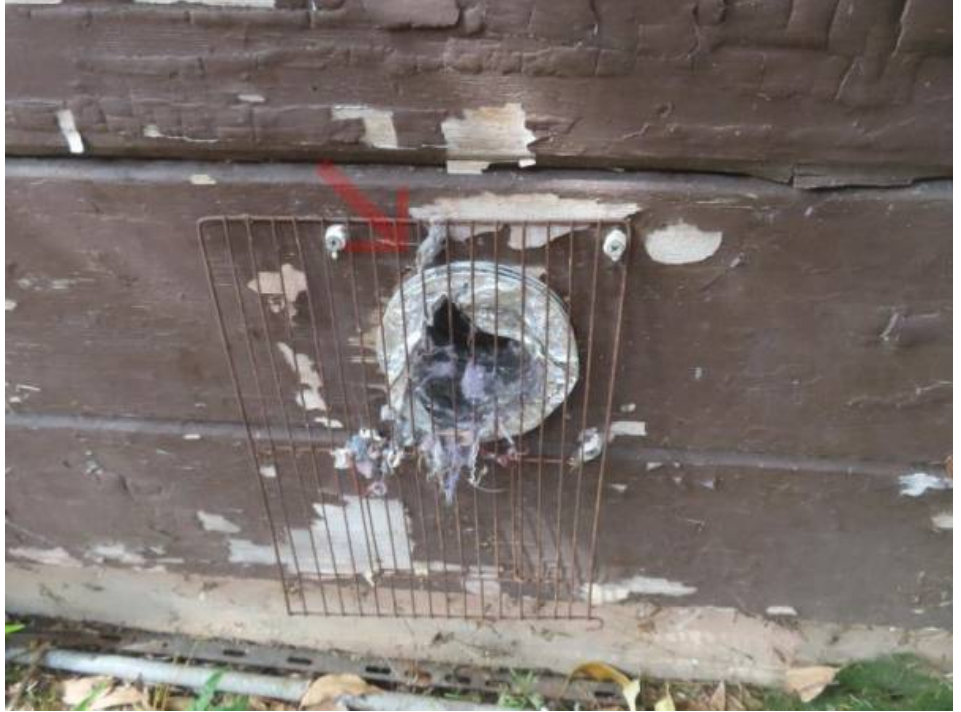
SAFETY: 120 volt electrical outlet is an non grounded type receptacle. We recommend installing a grounded receptacle at this location or properly grounding the washer and dryer to the cold water pipes as per the appliance manufacturer's instructions to protect against electric shock or electrocution.

MAINTENANCE: Draft diverter flapper valve at the exterior dryer vent hood is missing or does not close properly. These valves are for energy conservation and serve to prevent rodent entry.

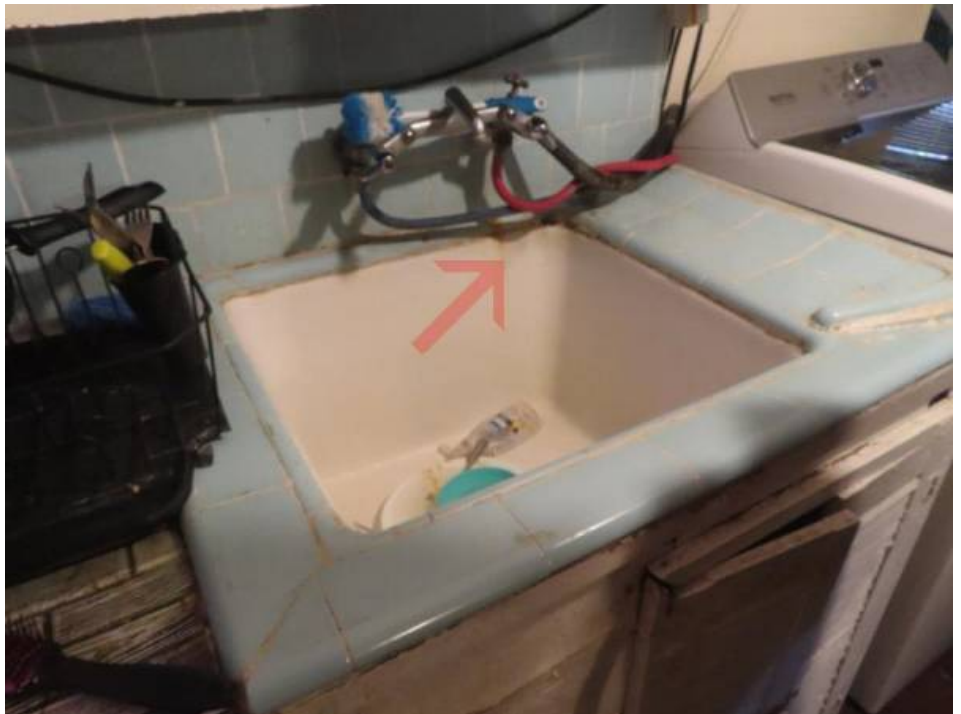
MAINTENANCE: Deteriorated caulking at the counter connection. We recommend re-caulking as needed to prevent water intrusion and subsequent damage.

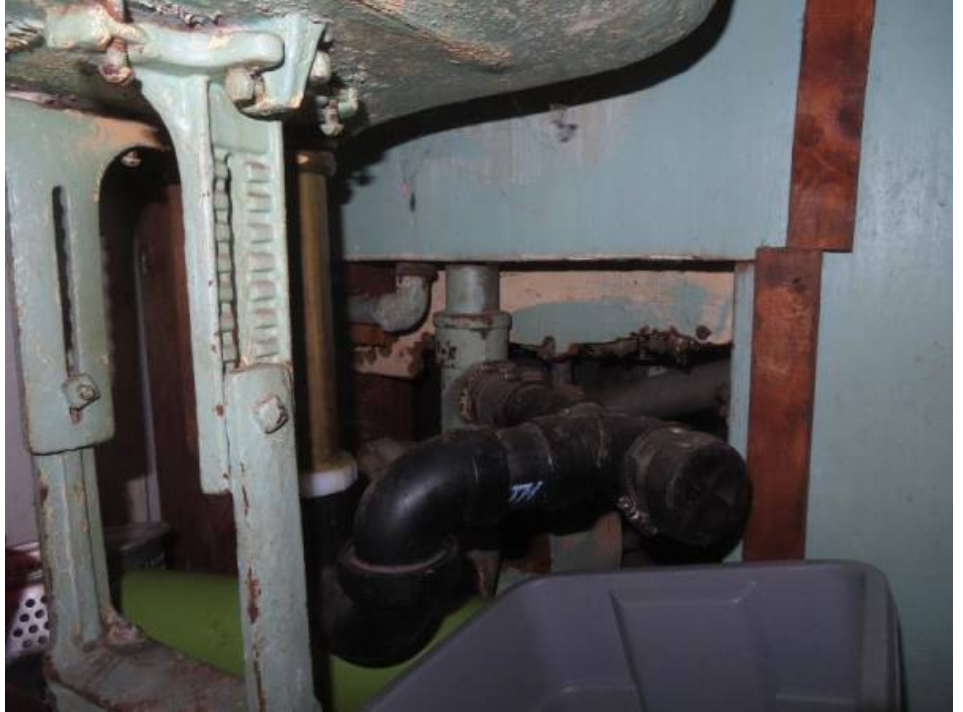
MAINTENANCE: Wall has been opened for repairs/modifications and has not been properly closed/patched.

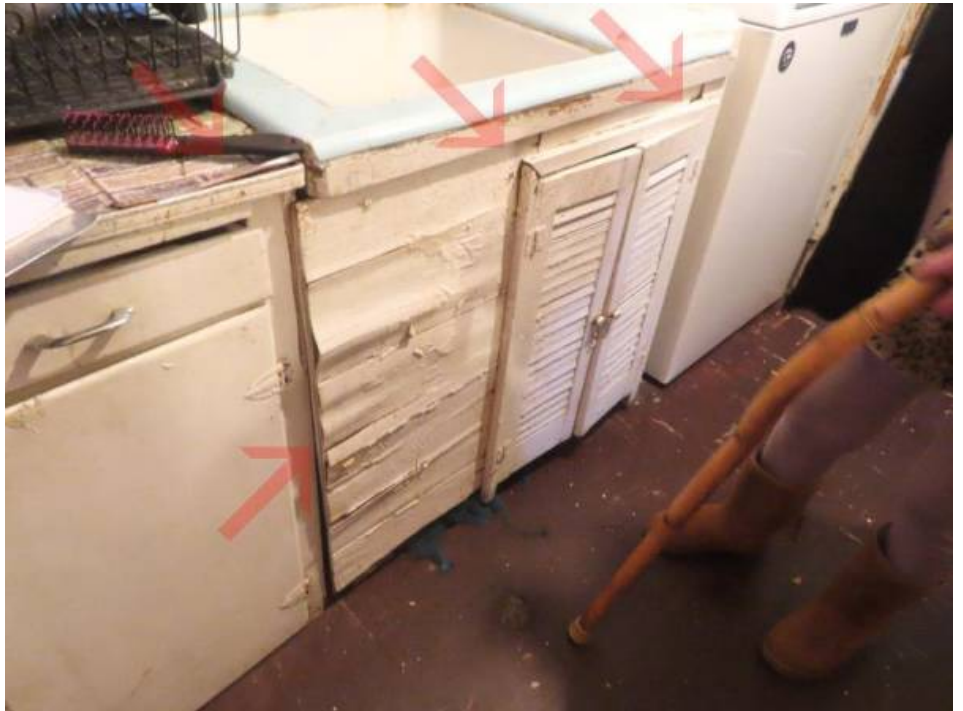
MAINTENANCE: Moderate to heavy wear. Some hinges or doors may be damaged, or do not latch securely, or drawer guides/slides are worn or in disrepair.

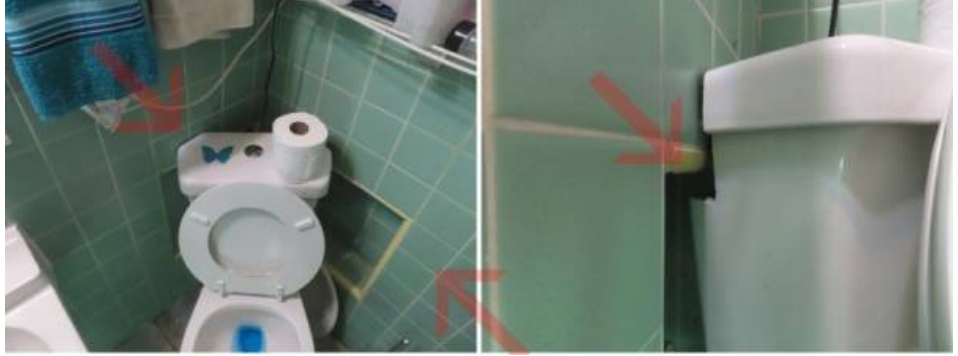
DEFECTIVE: Toilet tank has been improperly cut/modified to fit into the corner. Recommend further inspection and repairs as needed.

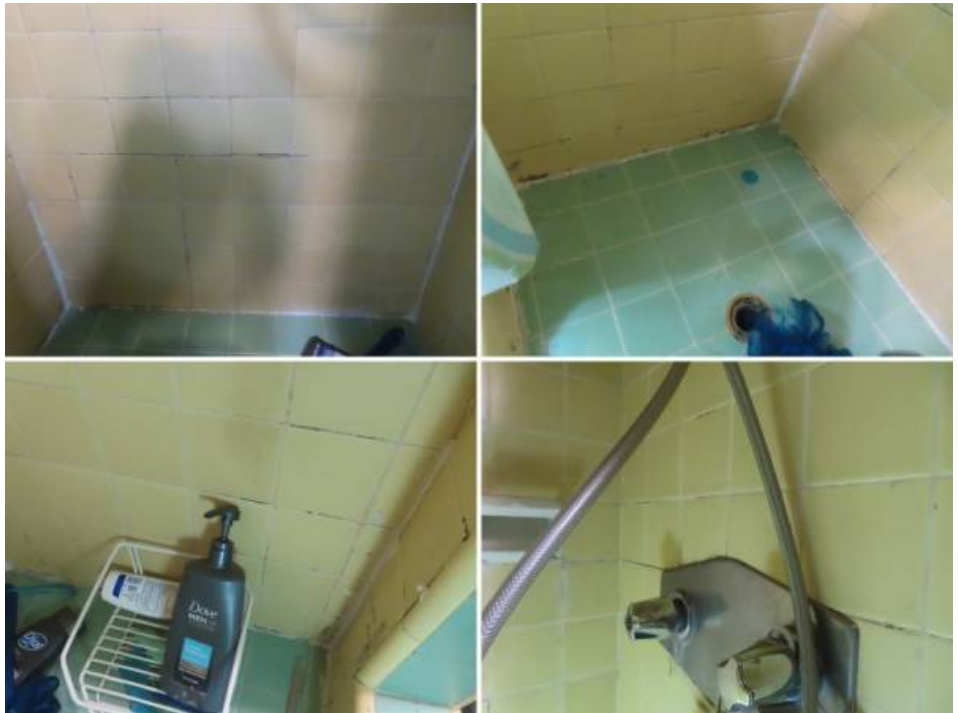
MAINTENANCE: Missing drain cover.
