Inspection reference: 3850 E. 15th St., LB, CA 90804

# **Confidential Inspection Report**

**3850 E. 15th St.**  
**Long Beach CA 90804**

**February 29, 2024**

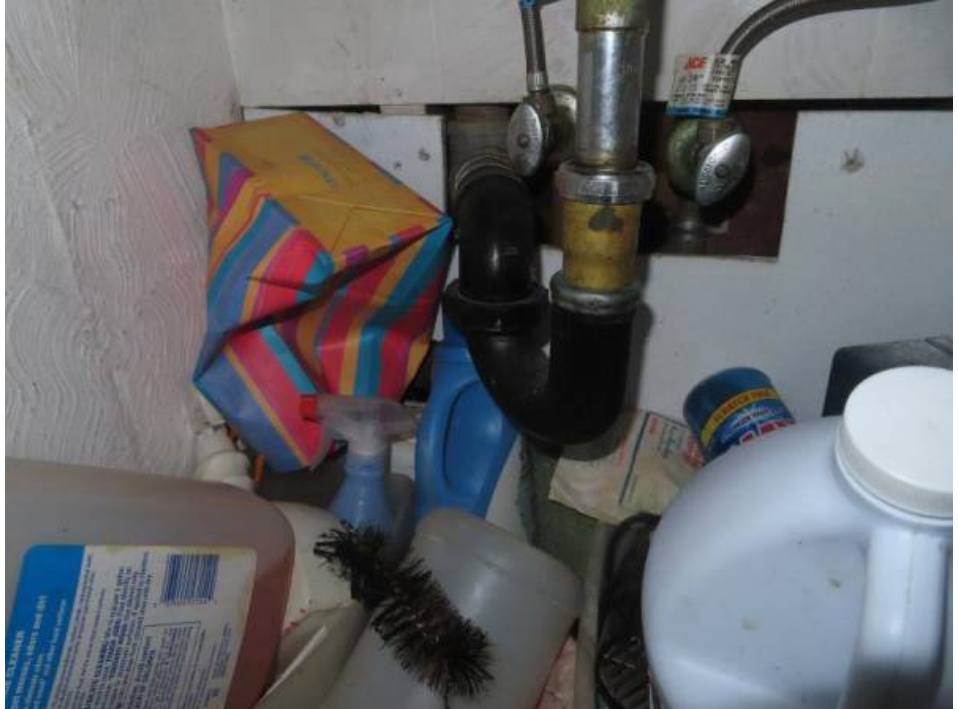
*Plumbing below sink* SERVICEABLE.  
MAINTENANCE: Wall has been opened for repairs/modifications and has not been properly closed/patched.

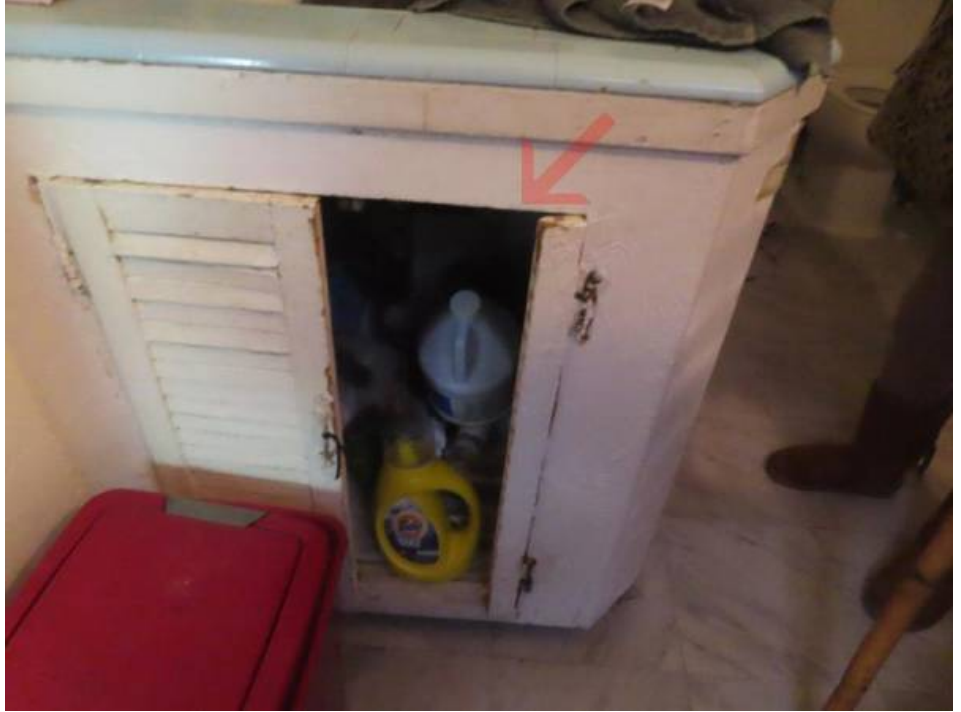
*Cabinets* Master bath.  
MAINTENANCE: Moderate to heavy wear. Some hinges or doors may be damaged, or do not latch securely, or drawer guides/slides are worn or in disrepair.

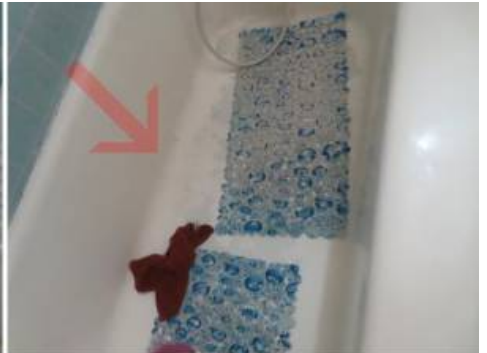
SERVICEABLE. Finish is chipped, peeling or possibly stained.  
Tub only, no shower installed.
