2214 Curtis Ave, Redondo Beach, CA 90278
Inspection prepared for: Mario & Florence Furtado
Real Estate Agent: Bill Baird - Berkshire Hathaway

Date of Inspection: 3/31/2022 Time: 2:00 PM
Age of Home: 1986 Size: 2064
Order ID: 279804

Summary Page

Sewer Camera Inspection

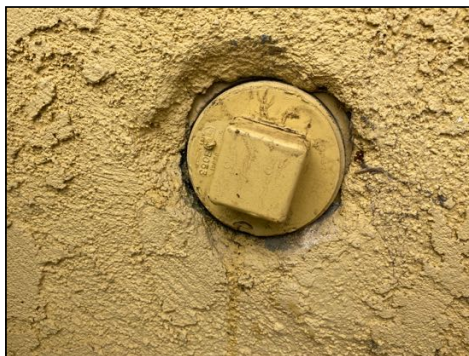
Clean out cap has normal wear for age with no major visible defects at the time of the inspection

Clean out used for inspection

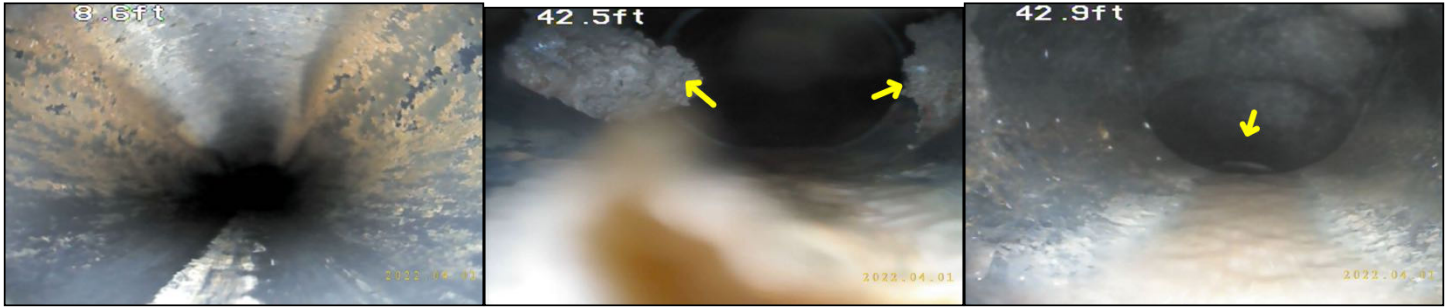
Root intrusions were found in the sewer line at approximate distances of: 42 feet

Condition of sewer line upon entry at 8 feet Root intrusion observed at 42 feet Transition turn observed at 42 feet

We recommend that you consult with a licensed plumber for further evaluation, cleaning and any repairs needed

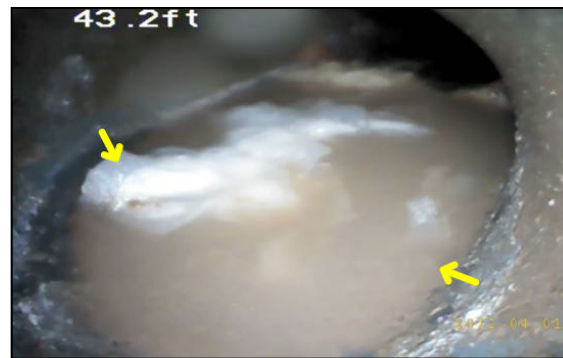
Debris/foreign material found in drain line at approximate distance of: 43 feet

The sewer camera was unable to reach the main city connection due to the conditions within the sewer line that are preventing the camera from being pushed to its full length; further evaluation is recommended by a licensed plumber

Standing water was found in areas of the sewer line and may be caused by lack of proper drain pitch; a periodical sewer cleaning/maintenance is suggested; further evaluation by a licensed plumber may be needed if standing water problem worsens

Final Distance/ Standing water/ Debris was present in the sewer line at an approx distance of 43 feet
