# INSPECTION REPORT

For the Property at:  
**1085 COLORADO DRIVE**  
MERCED, CA 95340

Inspection Date: Wednesday, September 24, 2025

RE: Report No. 8446  
1085 Colorado Drive  
Merced, CA  
95340

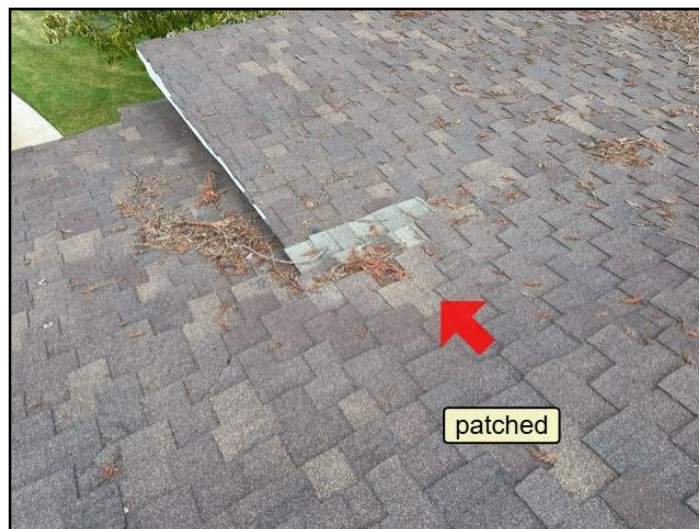
5. Patched

#### 1. Condition: • [Patched](#)

Recommend further evaluation and repairs if needed by a licensed roofing contractor.

**Implication(s):** Chance of water damage to structure, finishes and contents

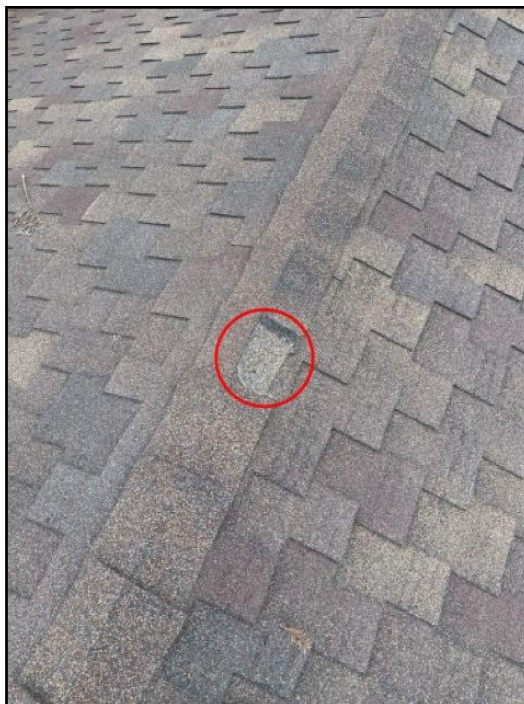
6. Damage

#### 2. Condition: • [Damage](#)

Repairs recommended by a qualified handyman or a licensed contractor.

**Implication(s):** Chance of water damage to structure, finishes and contents

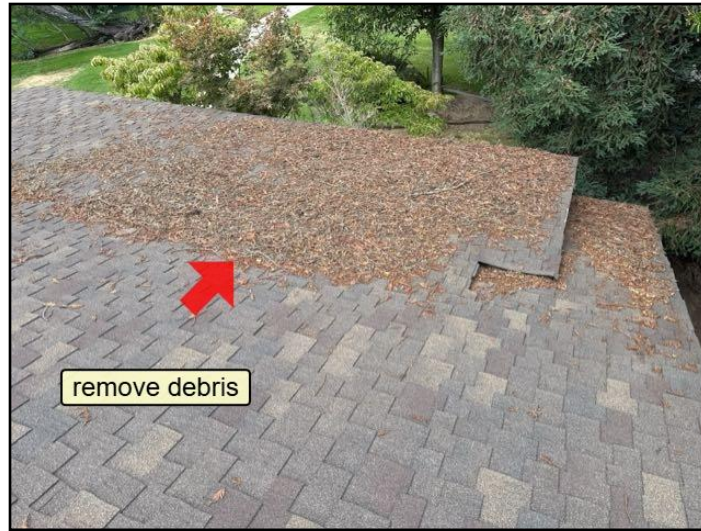
7. Debris/moss

**3. Condition:** • Debris/moss

Recommend removal of moss and debris to prevent damage and possible water damage to structure. Repair is recommended by a licensed roofer.

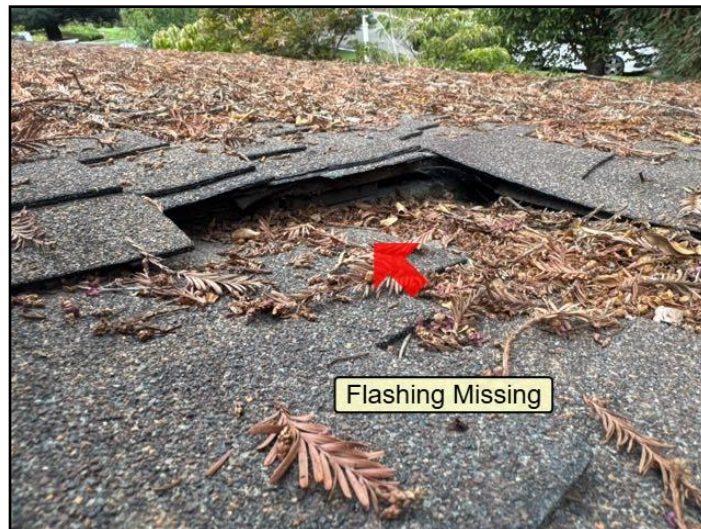
8. Flashing missing

**4. Condition:** • Flashing missing

Openings will allow rain to enter into structure. Repairs recommended by licensed contractor.

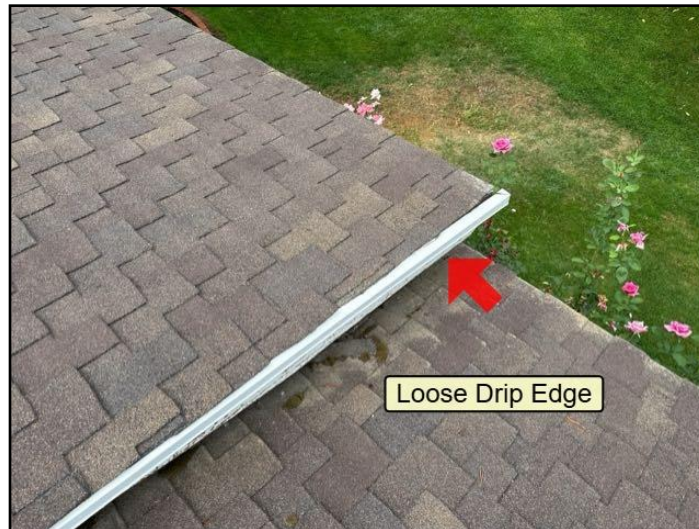
9. Loose

**5. Condition:** • [Loose](#)

Repairs recommended by a licensed roofing contractor.

**Implication(s):** Chance of water damage to structure, finishes and contents

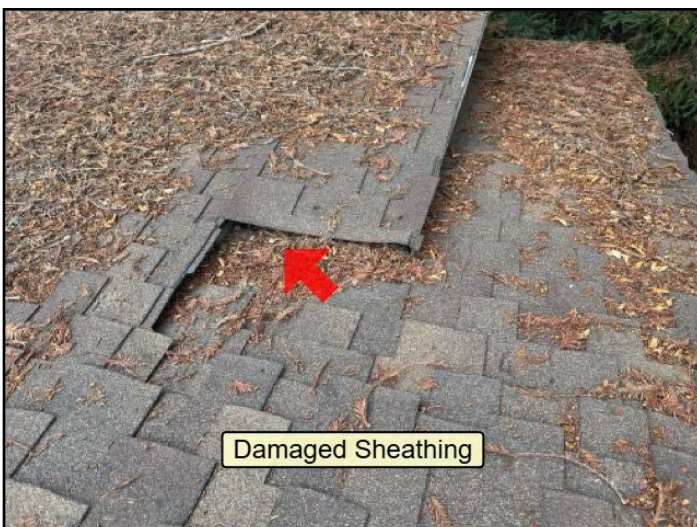
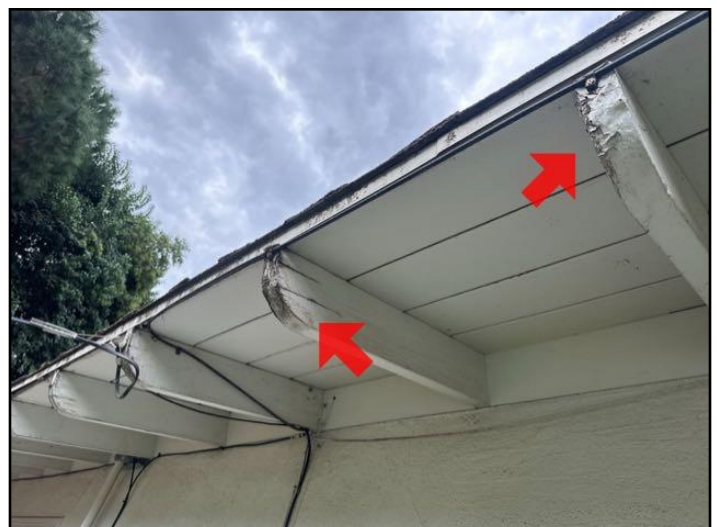
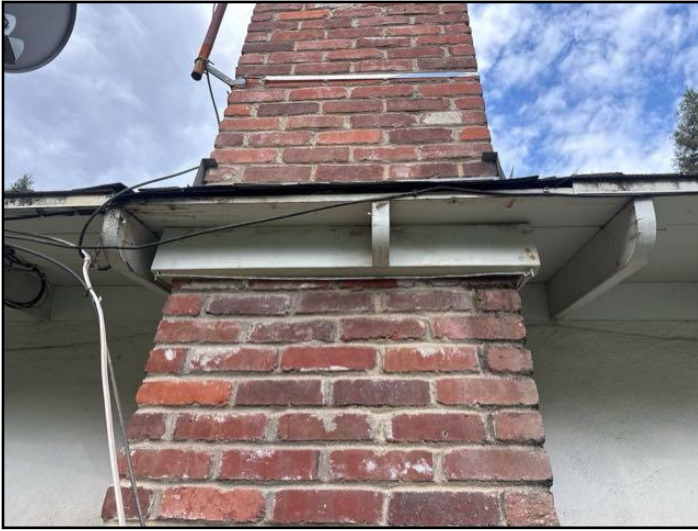
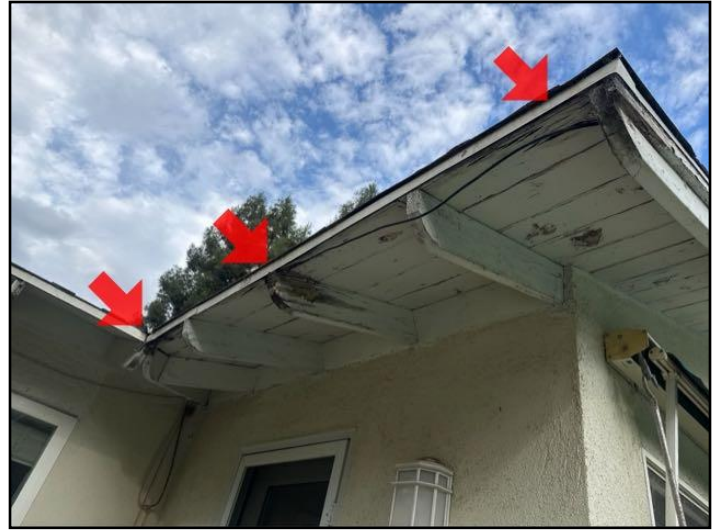
#### 6. Condition: • [Damage](#)

Repairs recommended by a qualified handyman or a licensed contractor.

**Implication(s):** Chance of water damage to structure, finishes and contents

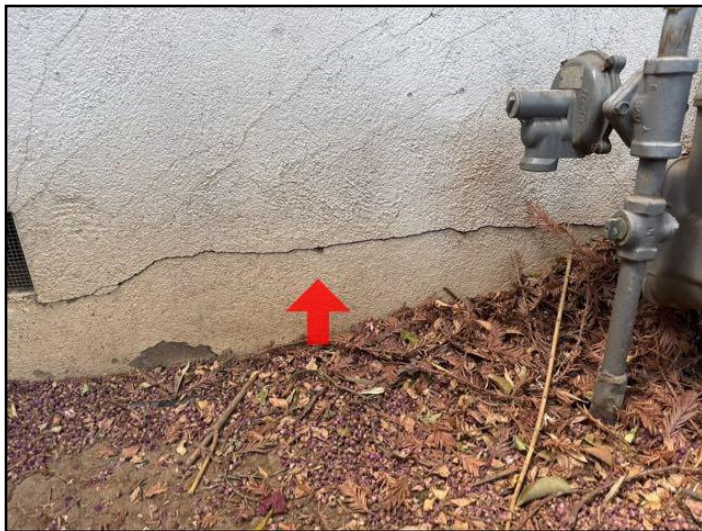
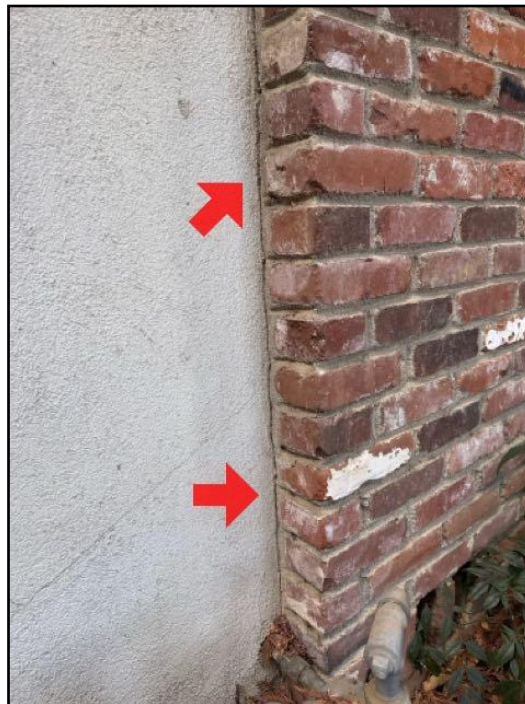
### 7. Condition: • [Cracked](#)

Seal cracks to prevent water intrusion. Repairs recommended by a qualified handyman or a licensed contractor.

**Implication(s):** Chance of water damage to structure, finishes and contents | Material deterioration

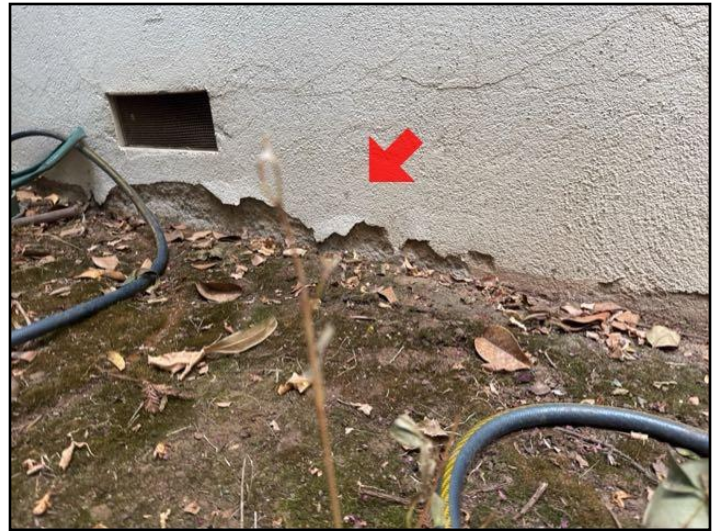
27. Crumbling

## 8. Condition: • [Crumbling](#)

Repairs recommended to prevent moisture damage to structure. Repairs recommended by a licensed contractor.

**Implication(s):** Chance of damage to contents, finishes and/or structure | Material deterioration

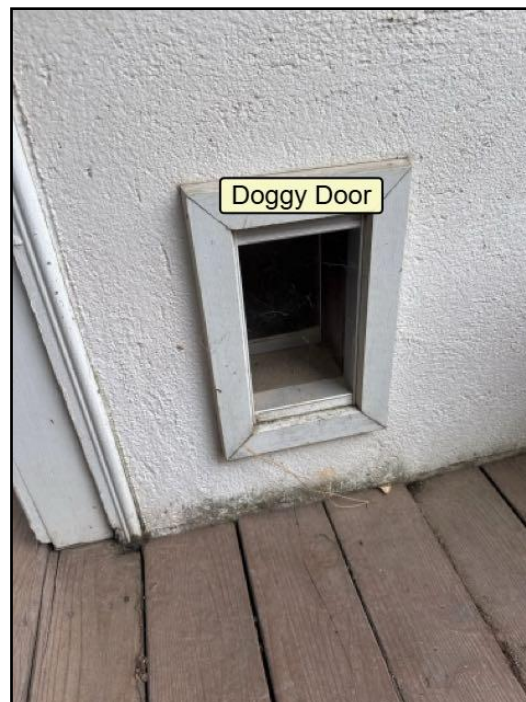
28. Opening in stucco.

## 9. Condition: • Opening in stucco.

Repairs recommended to prevent moisture or pest intrusion into structure. Repairs recommended by a licensed contractor.

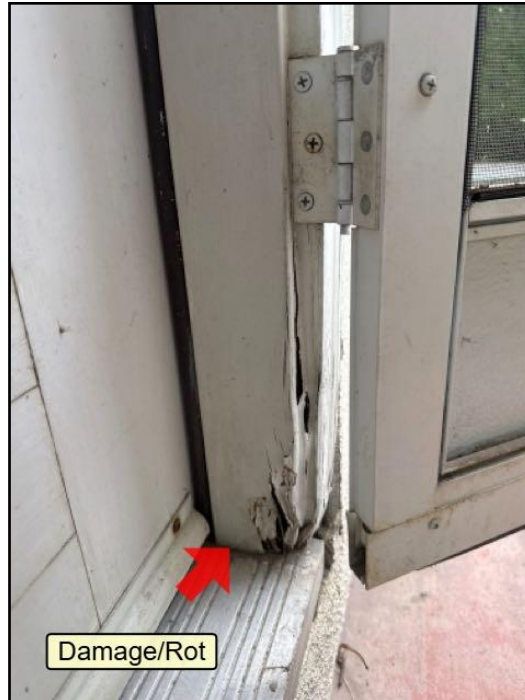
29. Damage

### 10. Condition: • [Damage](#)

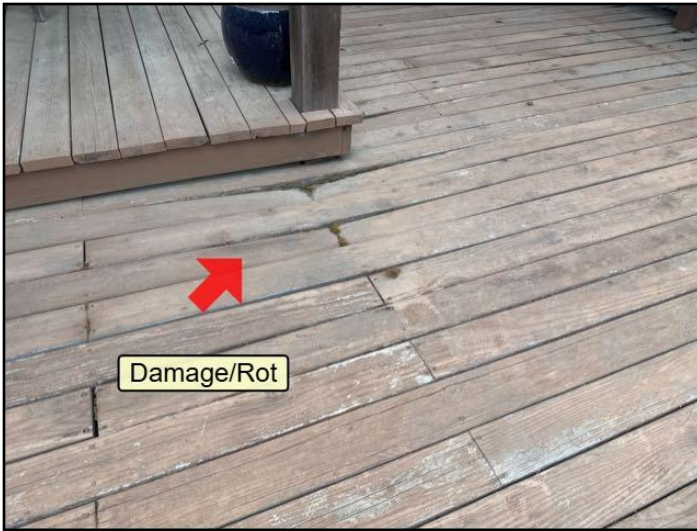
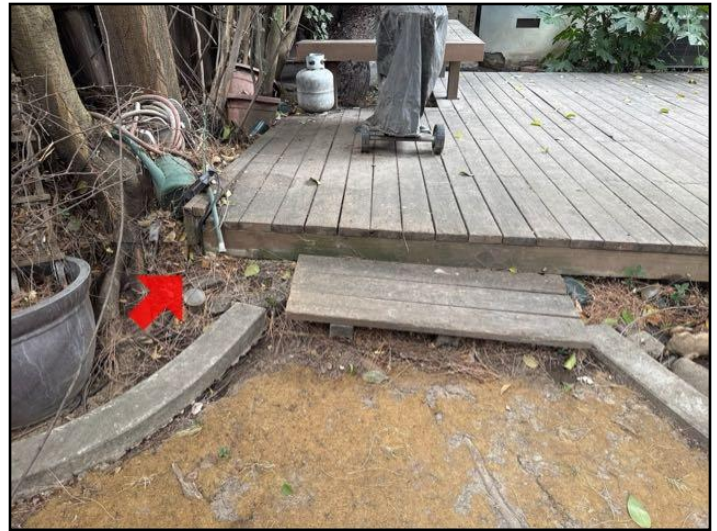
**Condition:** • [Rot](#)

Recommend further evaluation by a licensed contractor. Refer to pest report

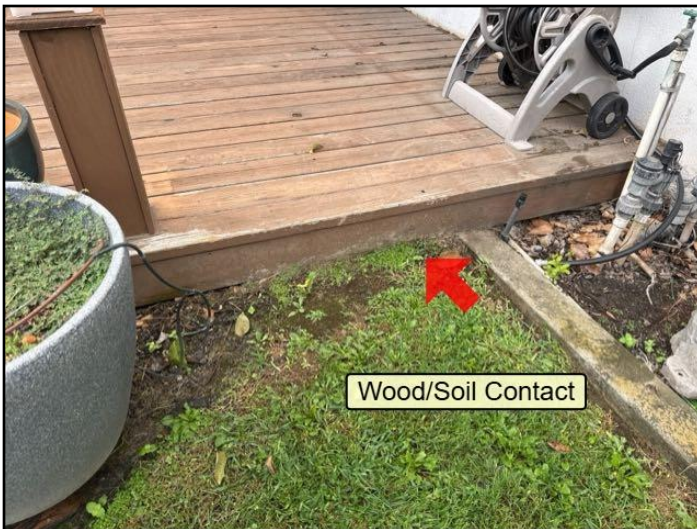
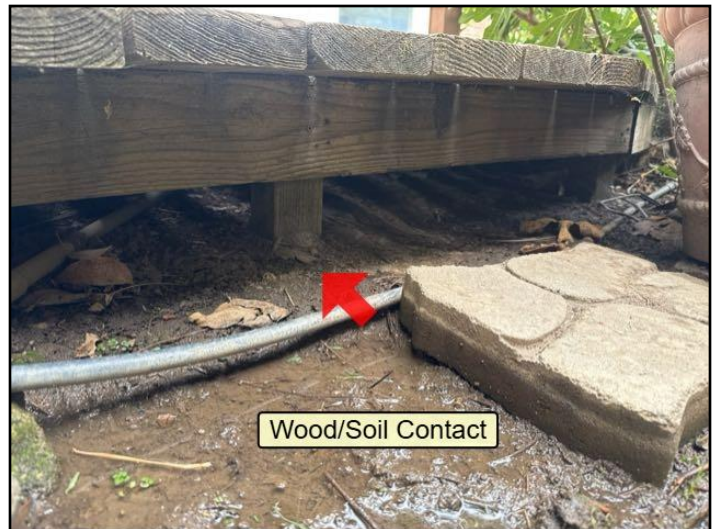
## 12. Condition: • [Wood/soil contact](#)

Recommend removal of all soil from around any wood frame structure and repairing any damage or replacing with pressure treated wood. Check with pest report for further evaluation and or repairs.

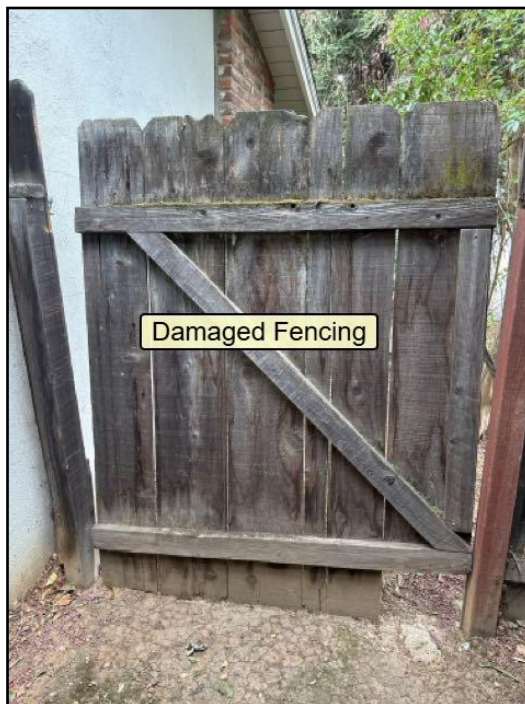
Various areas of the fence were damaged/rotted. Recommend repairs by a qualified handyman or a licensed contractor.

**34.** Boards damaged

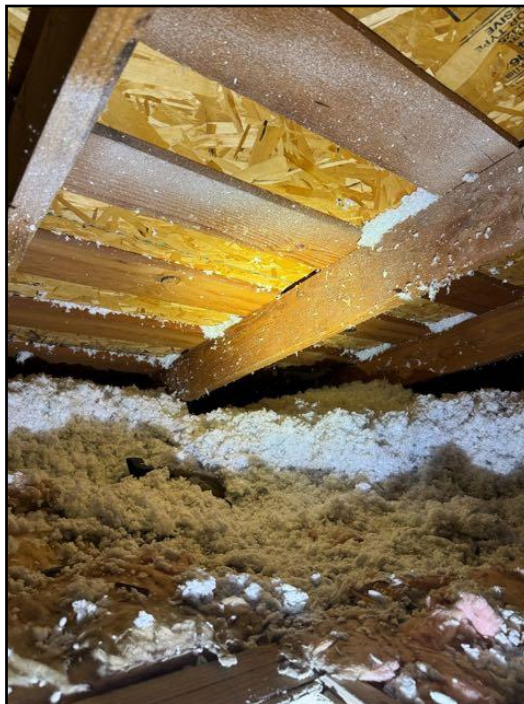
39. Rodent droppings noted in attic.

Recommend further evaluation and treatment if needed by a licensed Pest Inspector.

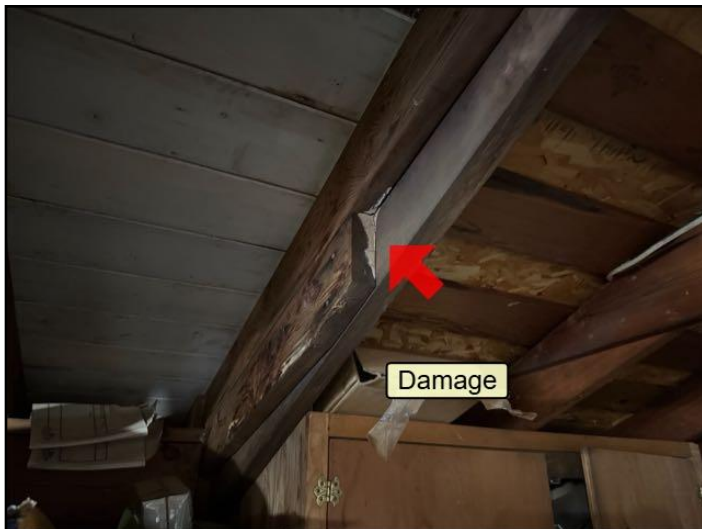
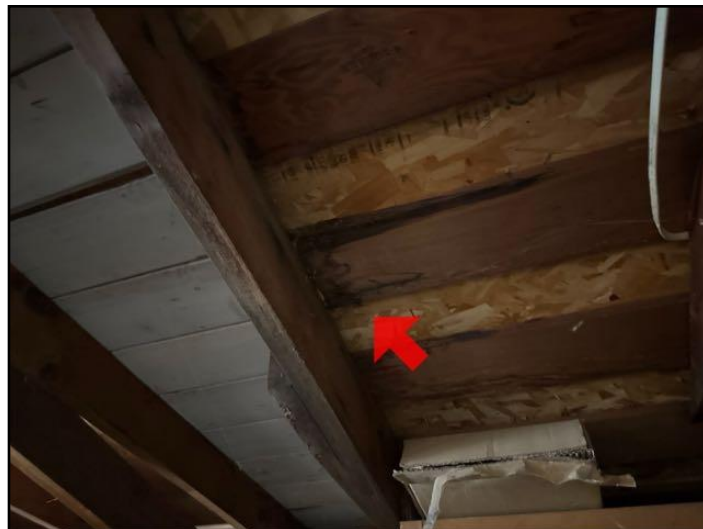
**Condition:** • Damage

Further evaluation and repairs recommended by a licensed contractor.

**Implication(s):** Chance of water damage to structure, finishes and contents | Weakened structure

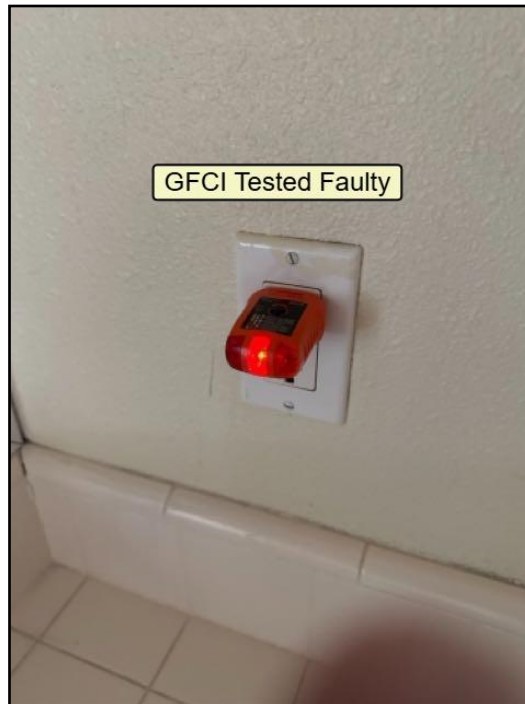
A ground fault circuit interrupter (GFCI) electrical receptacle did not respond to testing, did not re-set, was slow to re-set or made a buzzing sound when re-set. Repairs recommended by a qualified handyman or a licensed electrical contractor.

45. Test faulty on GFCI/GFI (Ground Fault...

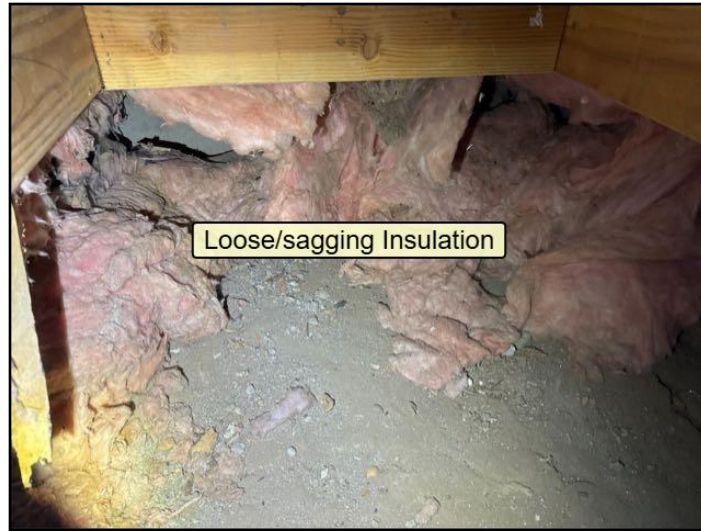
Falling/missing insulation noted in crawl space. Repairs recommended by a licensed contractor.

**63.** *Loose, sagging or voids*

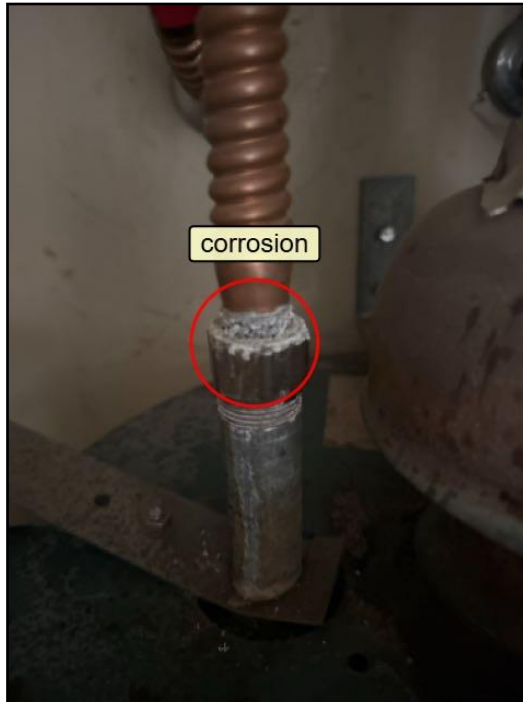
71. Corrosion

**Condition:** • Corrosion

Further evaluation and repairs recommended by a licensed plumber.

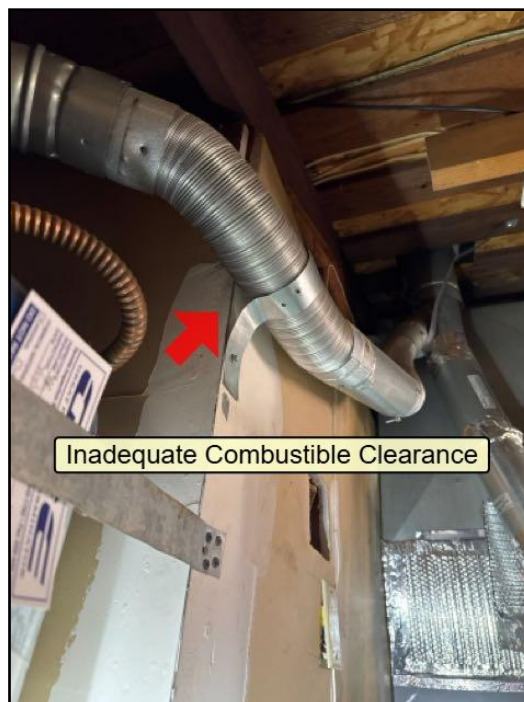
72. Combustible clearance

The exhaust flue for this gas-fired water heater had inadequate clearance from combustibles. This type of exhaust flue requires 1-inch clearance from combustible materials. This condition is a potential fire hazard and should be corrected by a licensed contractor.

**Implication(s):** Fire hazard

Inadequate Combustible Clearance

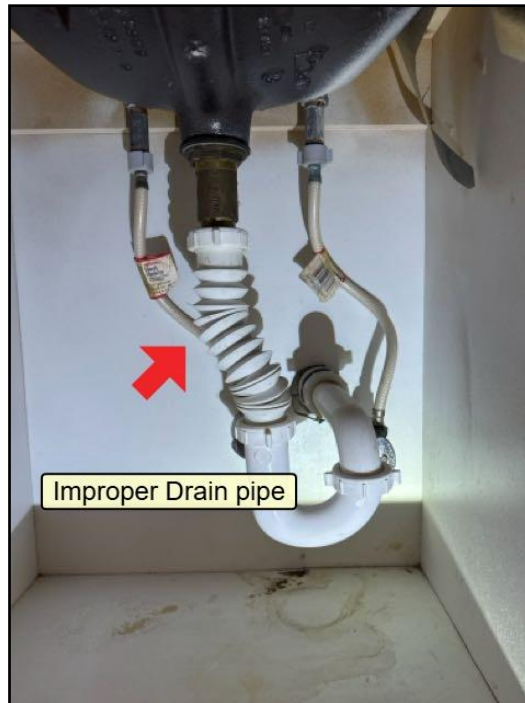
This type of drain line pipe will lead to debris build-up. Repairs recommended by a qualified handyman or a licensed plumbing contractor.

73. Nonstandard materials and patches

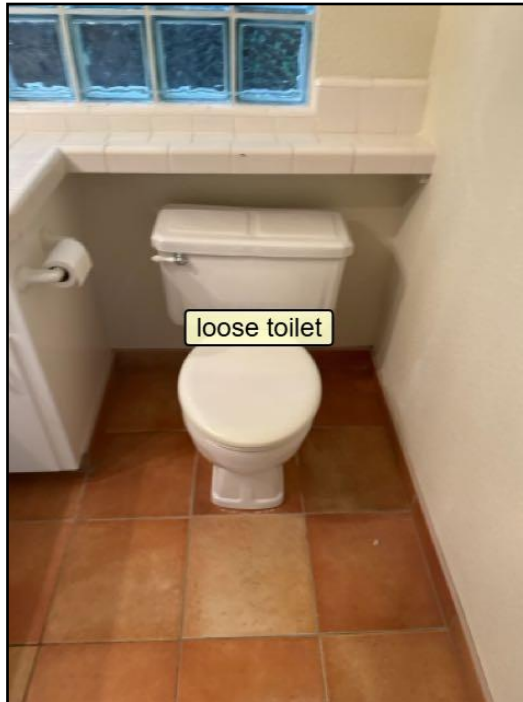
Bathroom toilet was loose on the floor, indicating that the anchors designed to secure the toilet to the floor have pulled loose. A variety of solutions may be available, depending on the exact nature of the problem. We recommend re-attaching by a qualified handyman or a licensed plumbing contractor.

**75.** Toilet is loose on floor.

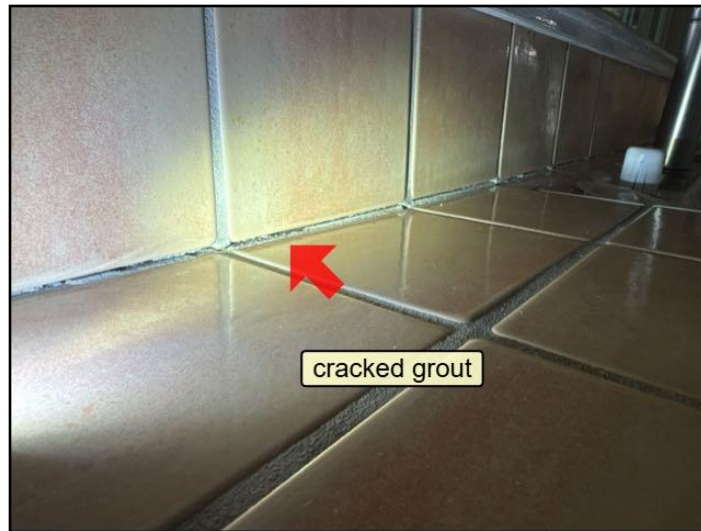
Seal counter to prevent water intrusion into cabinet. Repairs recommended by a licensed contractor.

84. Grout loose or missing

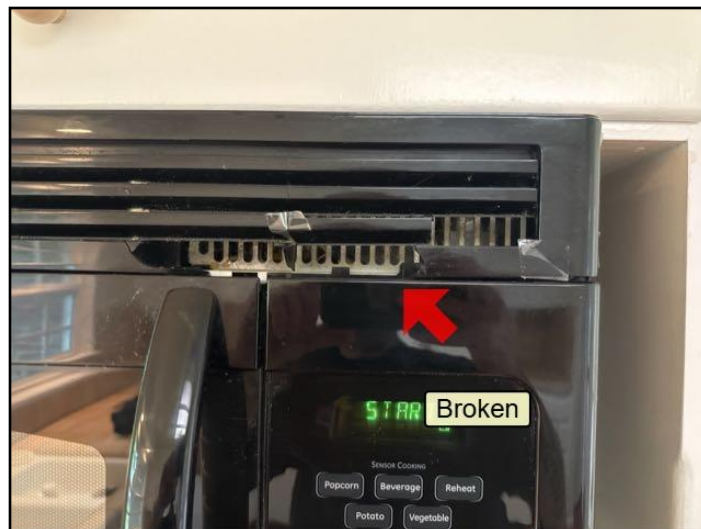
85. Parts broken/missing

Repairs recommended by a qualified handyman or a licensed contractor.

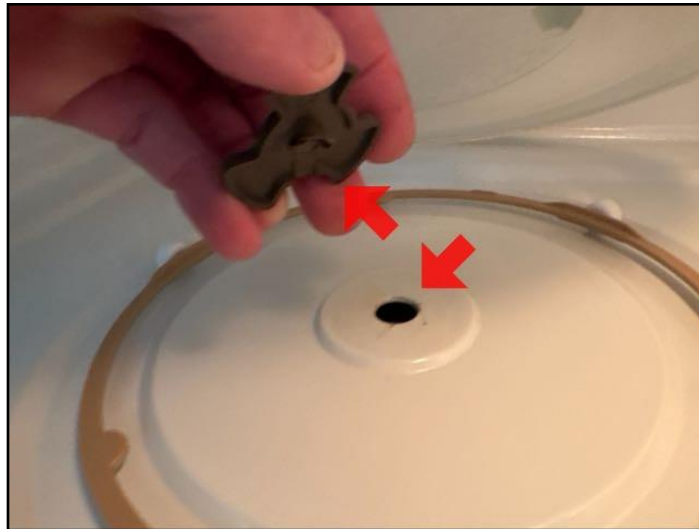
**31. Condition:** • Carousel tray damaged.

**86.** *Carousel tray damaged.*

Recommend repairs by a licensed contractor.

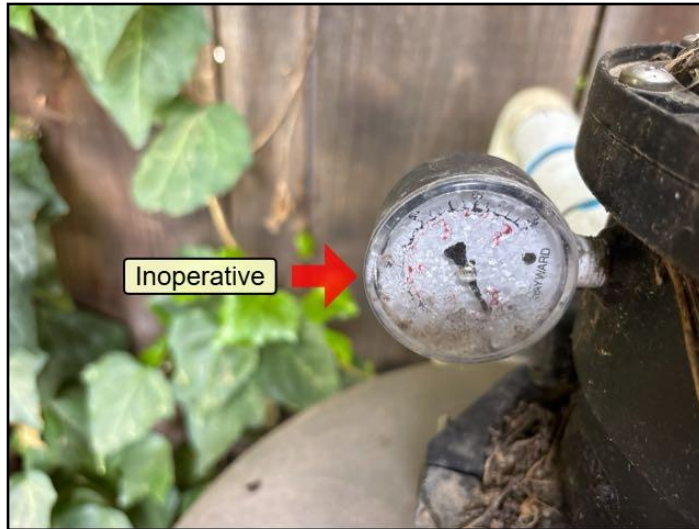
90. Inoperative

**Condition:** • Inoperative

Repairs recommended by a licensed pool contractor.

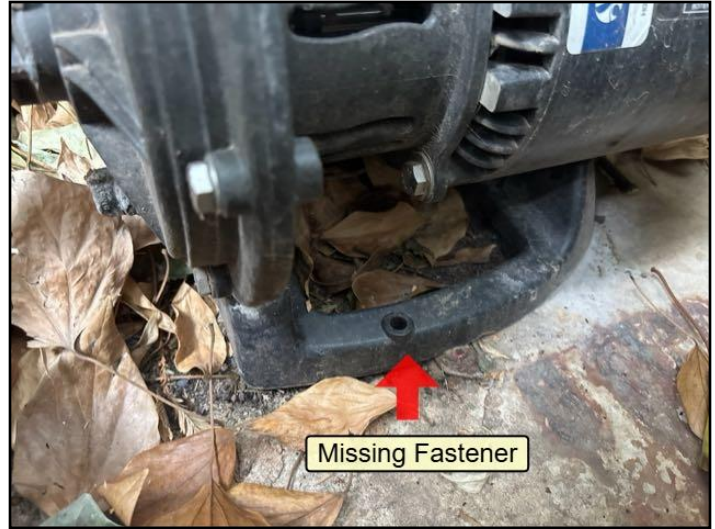
36. Condition: • Pump has no attachment

93. Pump has no attachment

Repairs recommended by a qualified handyman or licensed pool contractor.

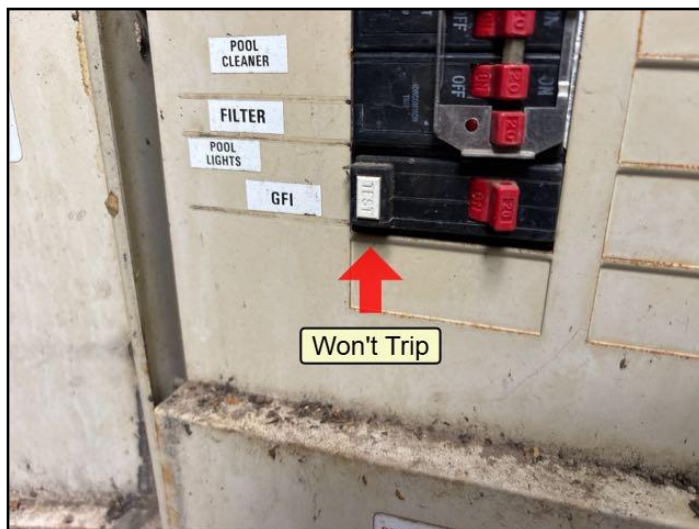
95. Inoperative

**Condition:** • Inoperative

Repairs recommended by a licensed electrician.

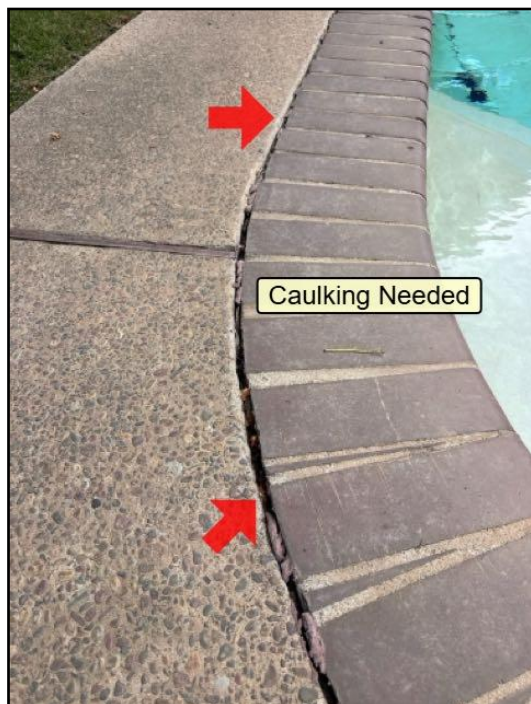
**Condition:** • Caulking

98. Caulking

Recommend caulking cracks to prevent water intrusion. Repairs recommended by a qualified handyman or a licensed pool contractor.
