# **Inspection Report**

**2248 Braeburn Avenue**

**Fullerton, CA 92831**

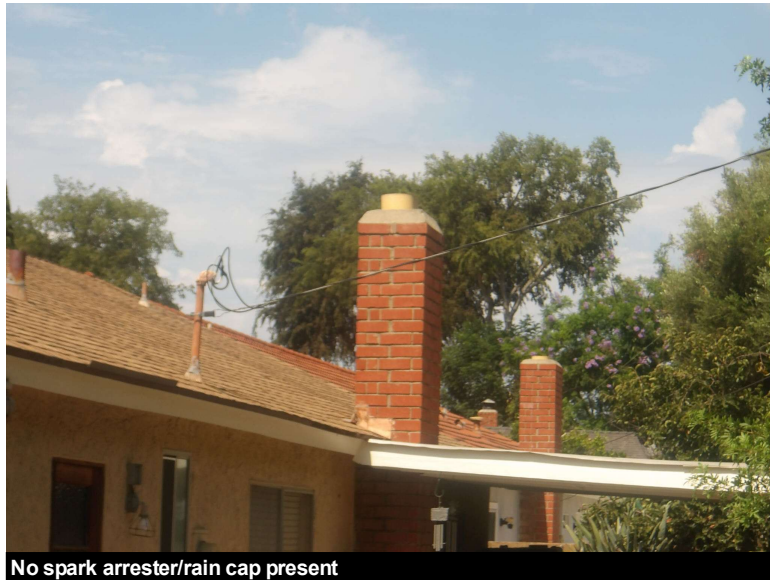
No spark arrester/rain cap present

Appears serviceable with wear and condition consistent with the age of material. **Spark arrester is recommended. None present now**, Recommended only, not required due to age of home.

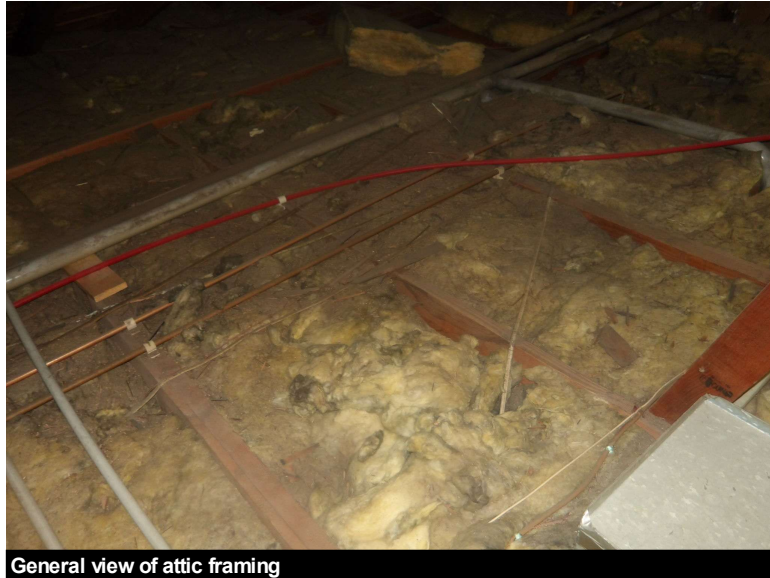
General view of attic framing

Attic is partial, Conventional framing supporting roof present, Partial access to attic only, Viewing was limited, To observing from access hatch areas only, No walk boards are provided, Minor moisture stains are noted and common for areas observed around vent openings.

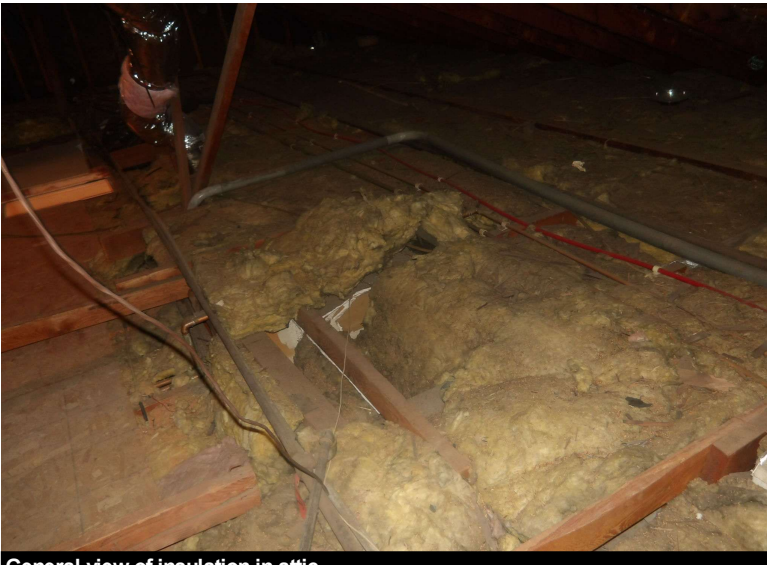
| <b>DEPTH</b> | <p><b>General view of insulation in attic</b></p> <p>5-6 inches, Insulation is somewhat compacted and the true R-factor at this point in time may be substantially less than that originally installed. Installation of additional insulation is recommended.</p> | |

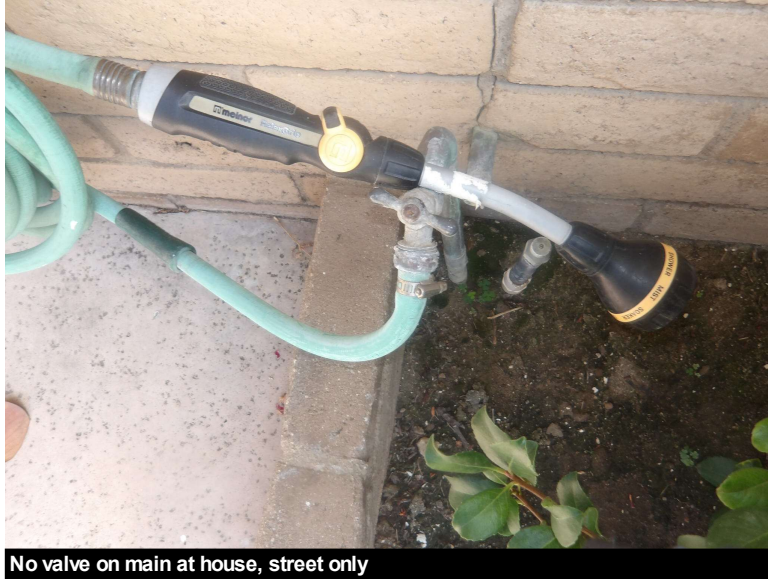
No valve on main at house, street only

Lines not fully visible. Underground water supply lines not visible or not in operation at the time of inspection are not covered by this inspection. **No shut off valve is present on main supply at structure, recommend installing a shut off valve at structure.**

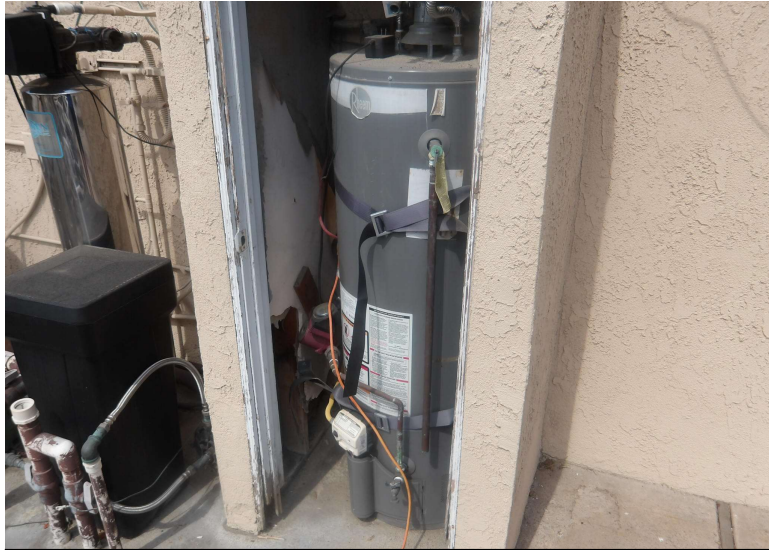
**General view of water heater side yard**

**LOCATION:**Water heater is located on the exterior of the home, Exterior closet accessible from patio, deck or yard. **Damage noted to water heater closet door.****EARTHQUAKE  
STRAPPING:**Water heater is strapped to California Earthquake Guideline.  
**properly installed and lagged into the 4 inch side of 2x4.****Water heater strapping is not****PLUMBING FIXTURES:**

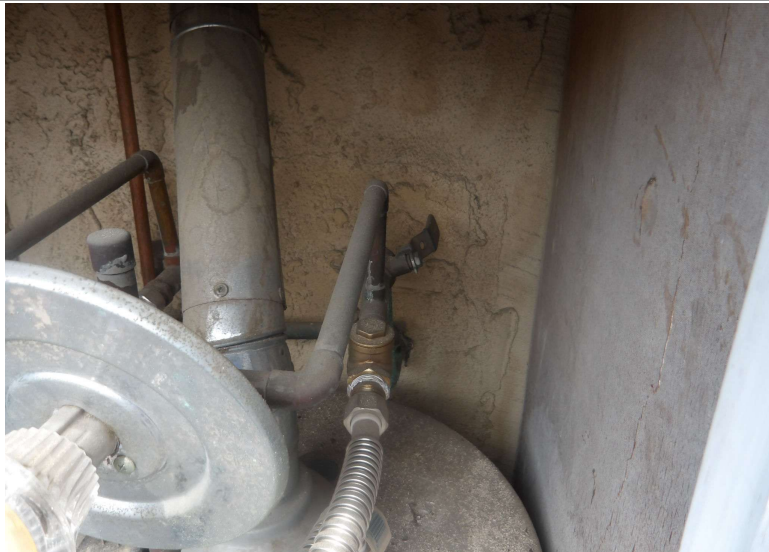
**General view of ball valve shut off**

A water ball valve shutoff is installed and operates properly.

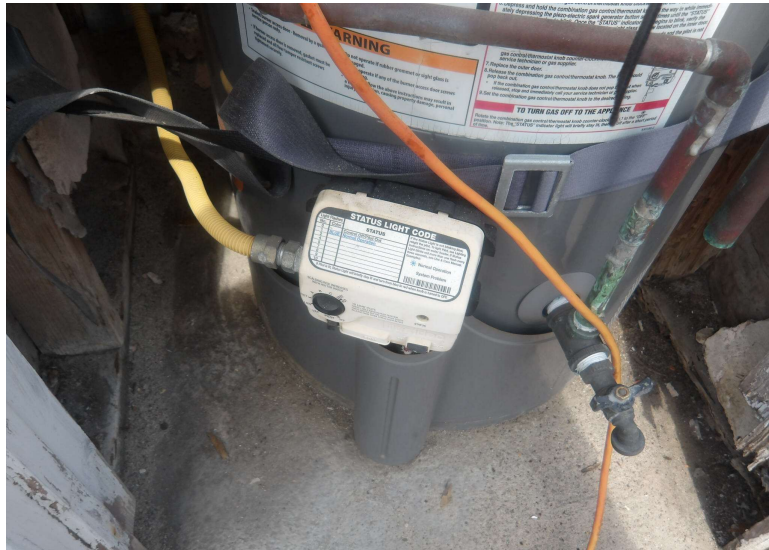
**No sediment trap on gas to controls**

No Sediment Trap or Drip Leg is present on the natural gas supply to burner controls for the water heater, this is a safety issue and recommend installing in accordance with Building and Safety standards for natural gas appliances. See Addendum Page for correct installation of a Sediment Trap for use on a Tank Style water heater.

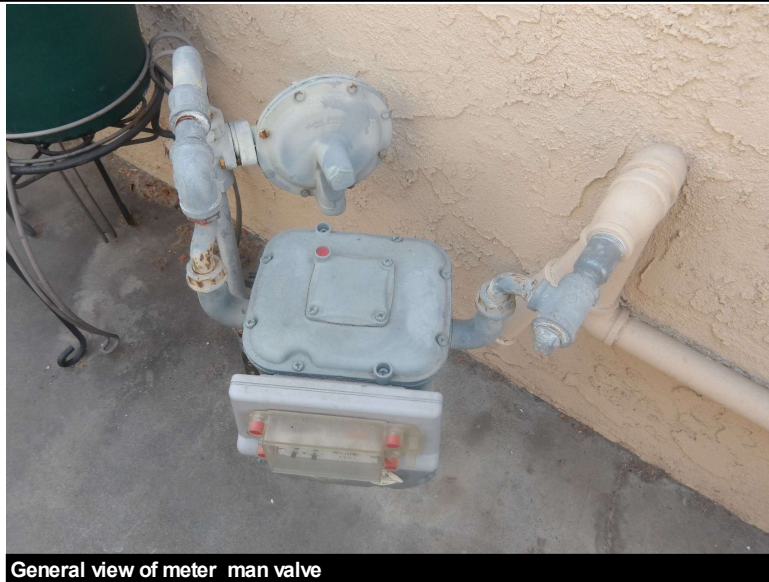
**General view of meter man valve**

Lines not fully visible. Underground gas leaks or damaged gas supply lines not visible or not in operation at the time of inspection are not covered by this inspection. System appears serviceable. Meter located at exterior of home with access to meter and valve located above ground accessible from the yard.

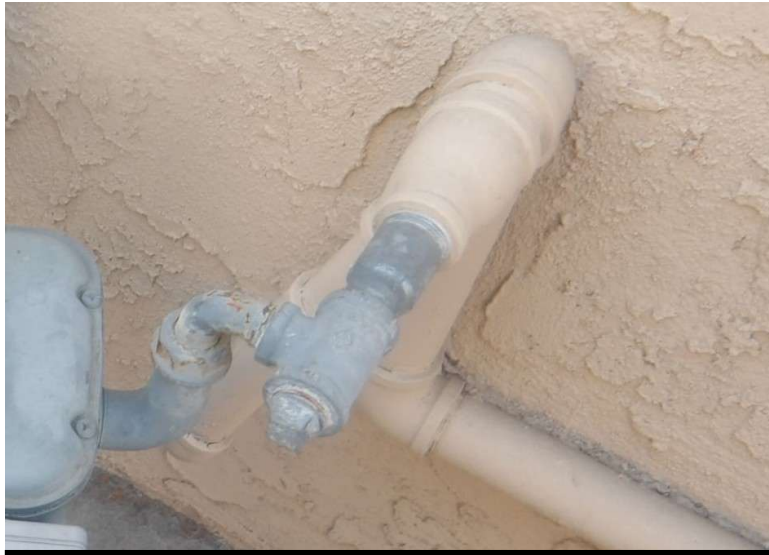
**No isolation valve on pool heater gas line**

Secondary gas supply line is installed on the primary natural gas supply line from the meter to the appliances inside the home. There is **NO** isolation valve installed on the secondary gas line run, before it goes underground, this is required for safety and a further evaluation by a licensed contractor is recommended for repairs or replacement to restore normal operation.

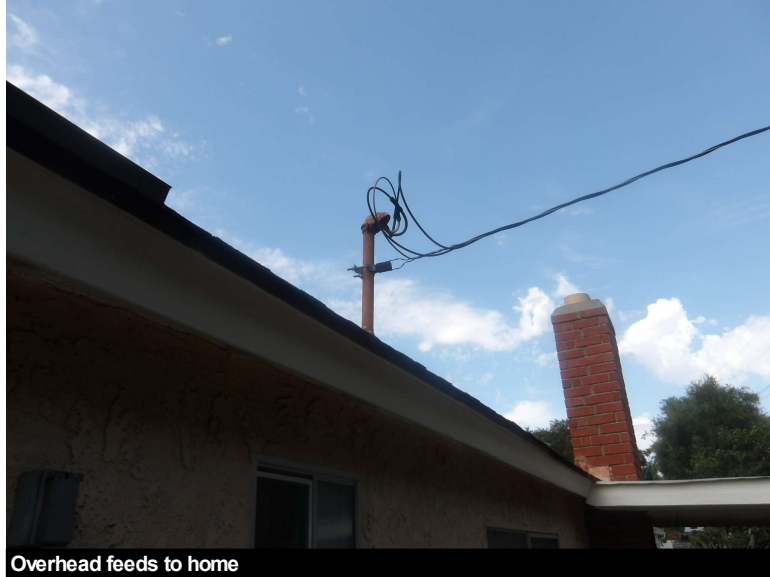
Overhead feeds to home

Overhead, 110/220 Volt, Circuit breakers, Appears serviceable.

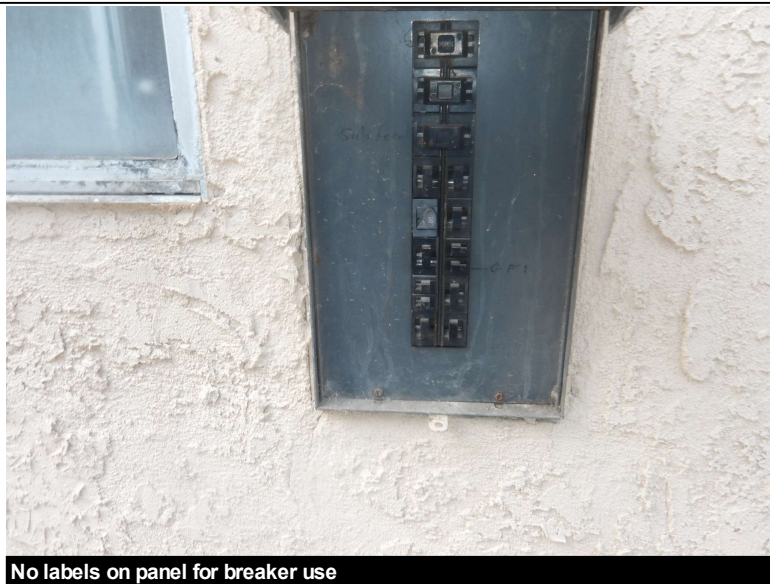
No labels on panel for breaker use

Exterior of house, Appears serviceable, 100 amp main breaker.

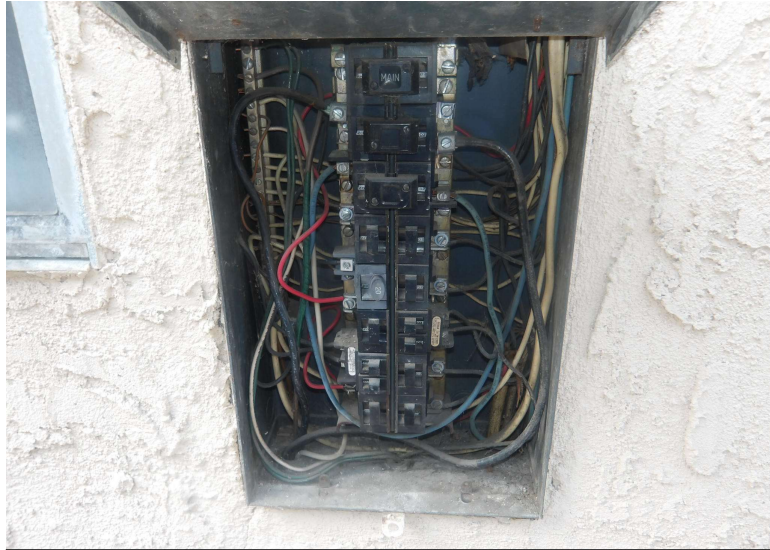
**General view of breaker wiring in panel**

Circuit and wire sizing correct so far as visible, Grounding system is present, **This is a Federal Pacific sub panel and these have a manufactures defect that can and has caused fires when breakers did not trip as designed. The breakers for this panel are no longer manufactured and cannot be replaced. Recommend further evaluation by a licensed contractor for replacement to restore normal and safe conditions.**

CPSC recommends getting this type of panel inspected by a qualified electrician "to look for any signs of overheating or malfunction among the circuit breakers." However, after testing over 4,000 breakers, Aronstein states that you can only identify a defective Stab-Lok breaker by first removing it and then testing it. This process can be more expensive than installing a new, less risky Federal Pacific Electrical panel or any other brand. In many cases, it makes more sense to replace an FPE Stab-Lok panel.

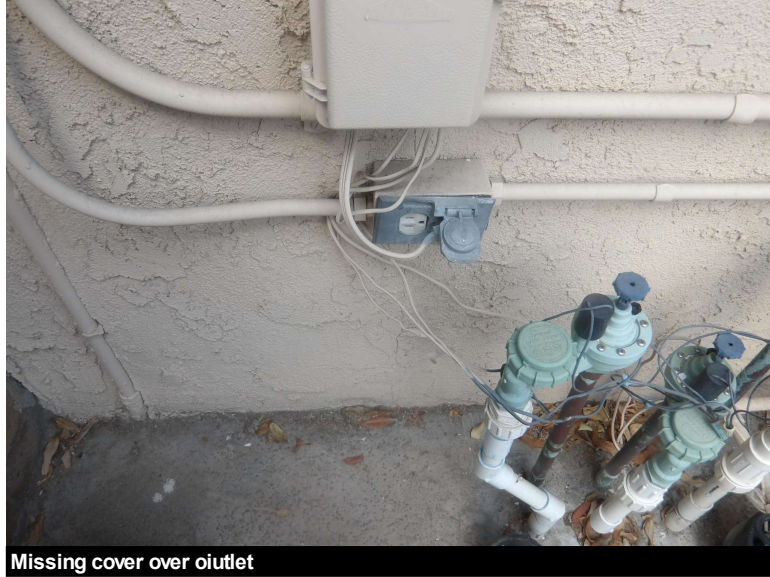
Missing cover over outlet

NOTE: Low voltage lighting systems are not inspected, Timers and light sensitive fixtures are not included in the scope of this inspection. **Exterior outlets are missing weather tight covers.**

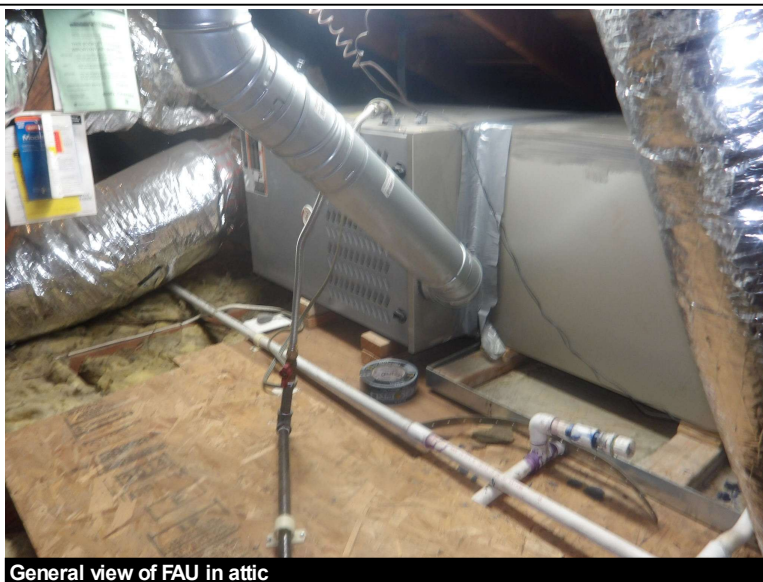
General view of FAU in attic

Attic for the interior living area of the home.

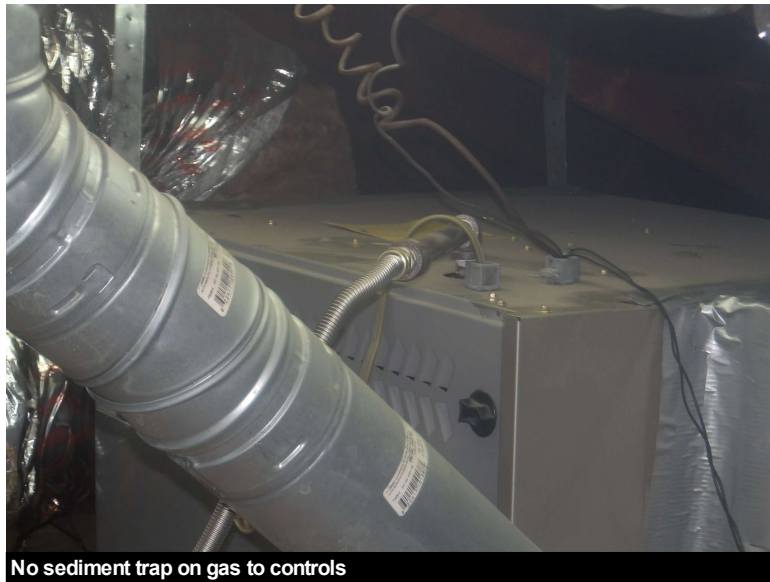
No sediment trap on gas to controls

Natural Gas Electronic ignition is provided No Sediment Trap or Drip Leg is present on the Natural Gas supply to burner controls for the Forced Air Unit (FAU) aka Heater, this is a safety issue and recommend installing in accordance with Building and Safety standards for natural gas appliances. See Addendum Page for correct installation of a Sediment Trap for use on a Forced Air Unit (FAU) aka Heater.

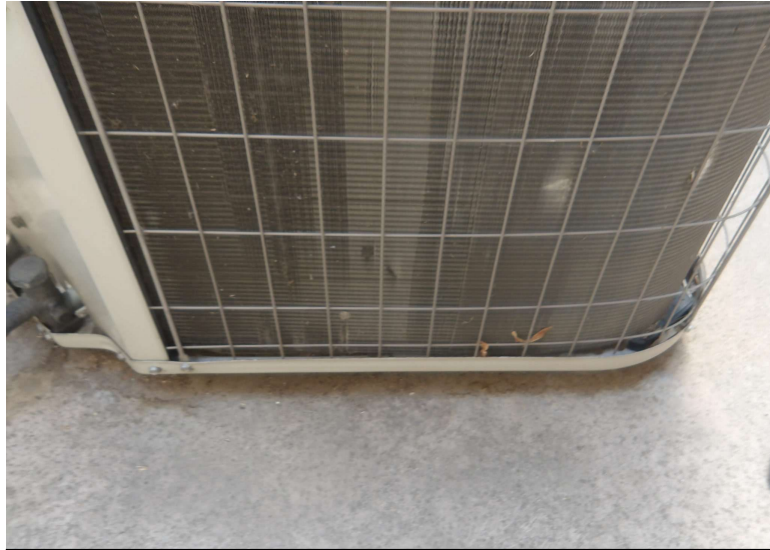
**No pad under AC on side yard**

Central two-part/split system air conditioning, with a condensing coil or compressor outside and the evaporator coil attached to the FAU inside the home. AC Compressor/Condensing Coil were operational at time of inspection with operation consistent for the age of material and system.

AC sits on the ground and does not have the required pad to lift it off the ground and be strapped in place to this pad to prevent movement from vibration which could cause damage and leaking to the refrigerant lines , Damaged or missing straps securing AC Compressor to pad .

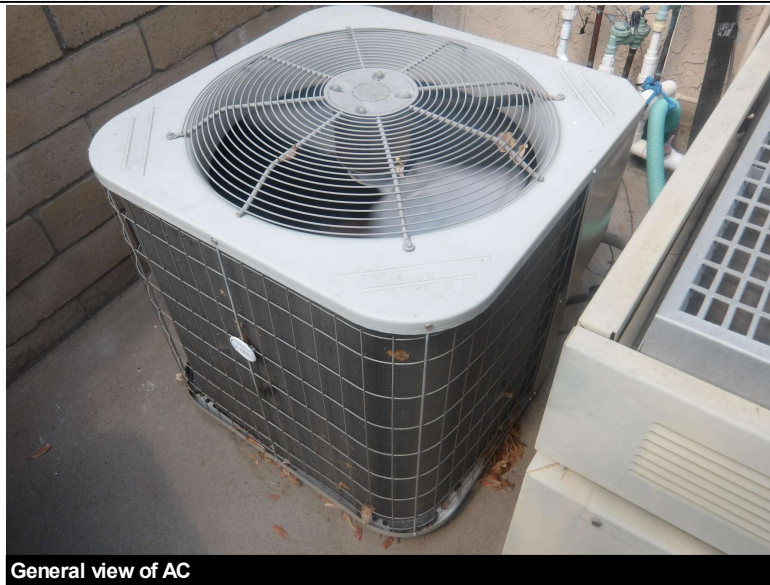
**General view of AC**

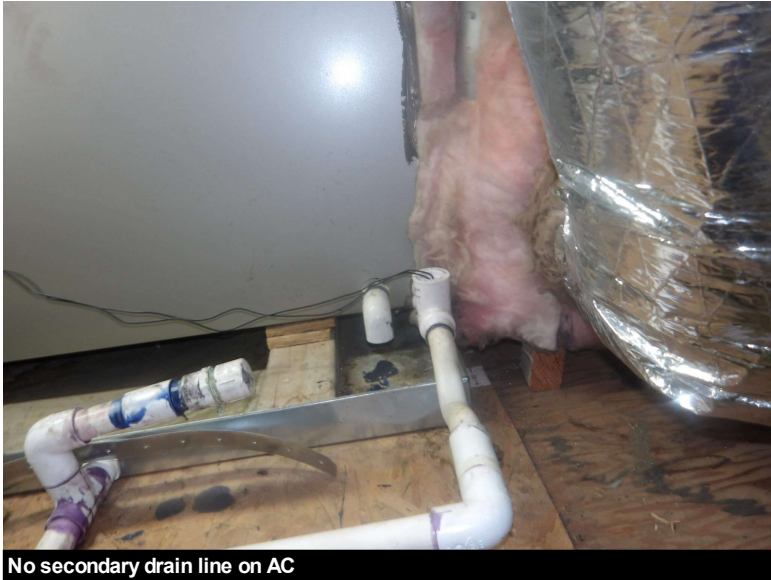
| <b>CONDENSATE LINE:</b> | <p><b>No secondary drain line on AC</b></p> <p>No secondary condensation line is installed on AC condenser coil attached to FAU in attic or second floor, recommend further evaluation by a licensed contractor</p> |

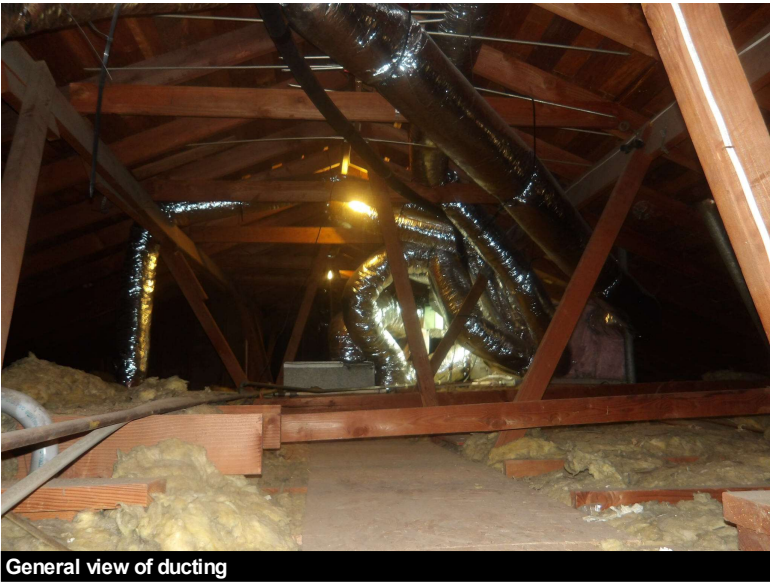
General view of ducting

Appears serviceable.

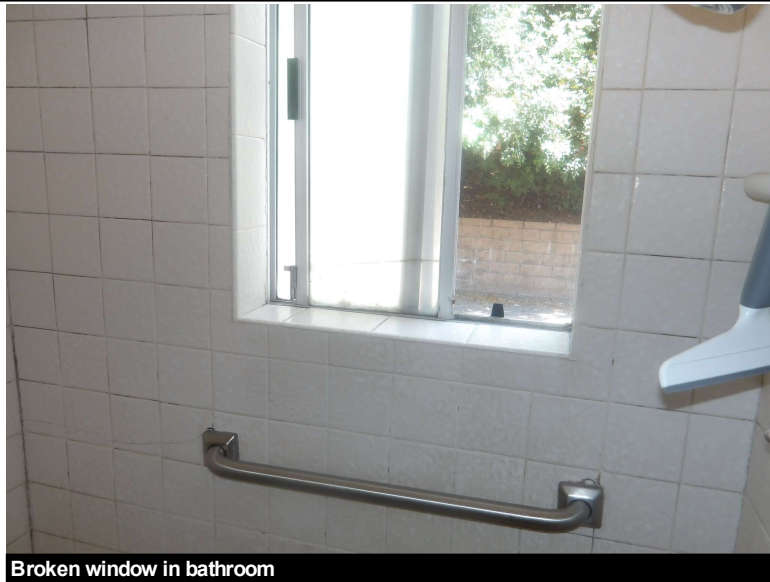
**Broken window in bathroom**

Aluminum frame windows, Single pane glass present in window frames. Sliding, Sliding window tracks and weep holes need cleaning as part of normal maintenance, Casement, fixed or stationary glass windows **Cracked, missing or broken glass present on window in the master shower.**

Window is not operational due to broken glass and repairs are needed to restore normal and safe conditions.

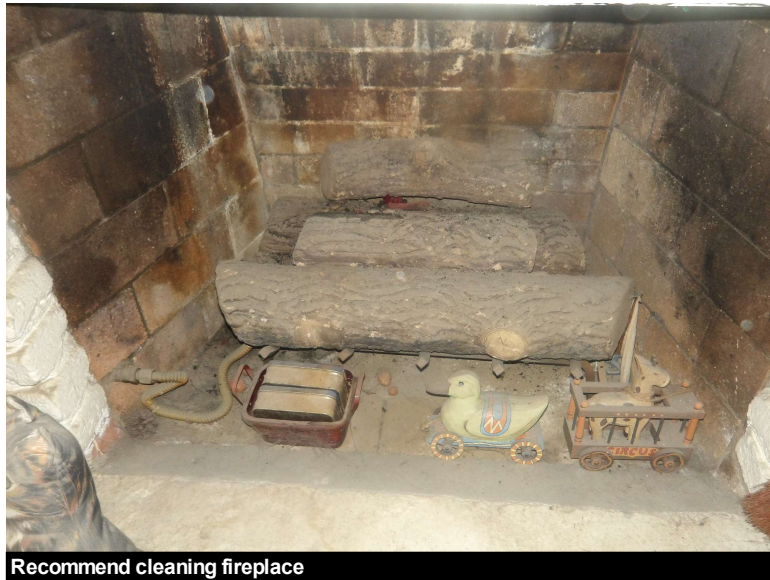
**Recommend cleaning fireplace**

Masonry, Damper is operational, Recommend cleaning before use. No glass doors or fire screens present in front of firebox opening.

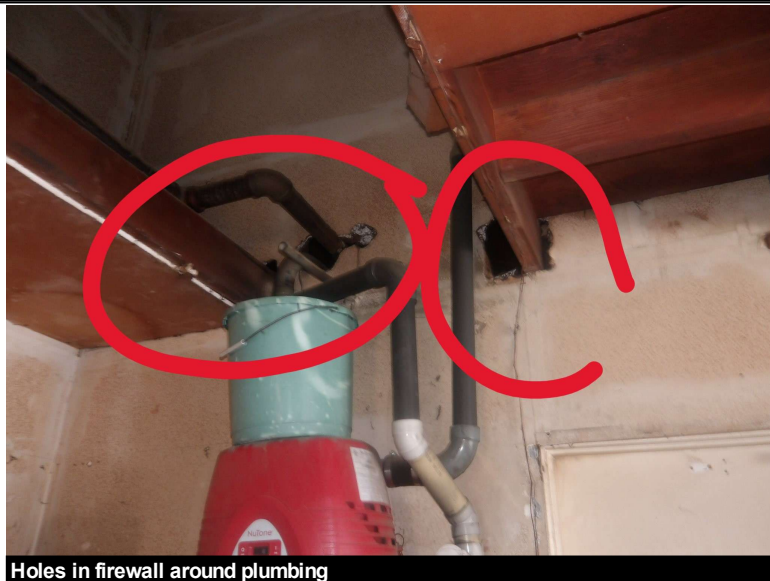
Holes in firewall around plumbing

Stored items restrict viewing of the garage walls, Unable to fully view garage firewall, any openings with approved materials to restore its fire rating , Holes in firewall , Material installed on firewall is not a firewall rated material. This is a Fire Safety Issue and a further evaluation by a licensed contractor is recommended to repair or restore firewall rating. Repair

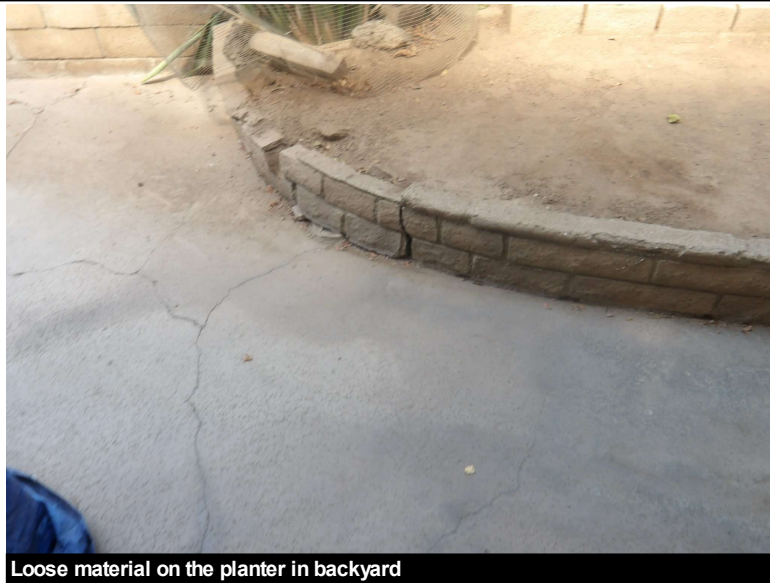
**Loose material on the planter in backyard**

Damage/Displacement noted, Loose or missing masonry material on planter. Cracks typical.

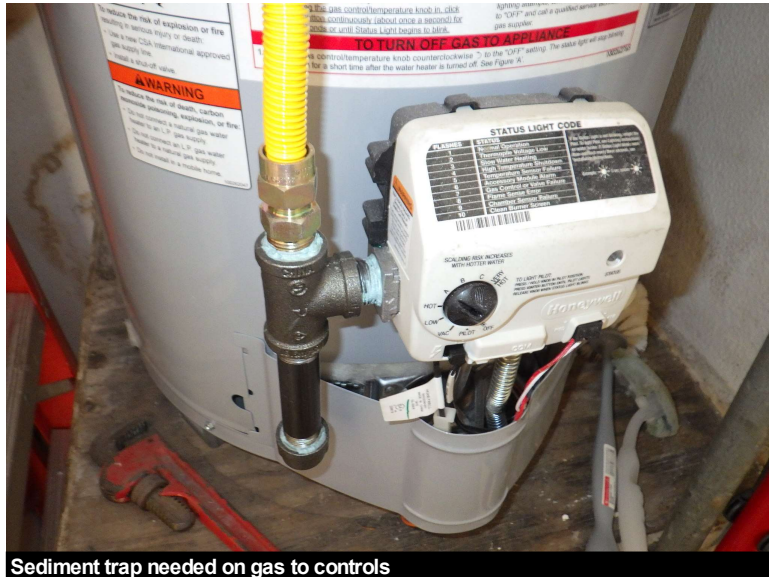
### PICTURE #1:

**Sediment trap needed on gas to controls**

This is the proper installation of a Sediment Trap or Drip Leg for use on a Natural Gas supply line to the controls for a Tank Style water heater. Natural Gas flexible supply line should terminate into the Top opening of a black iron gas (T) fitting so the Natural Gas supply will make a 90 degree turn into the control valve and the Lower opening of this (T) will have a 4 inch capped nipple present for the H<sub>2</sub>O present in the Natural Gas to drop into as required for this appliance.

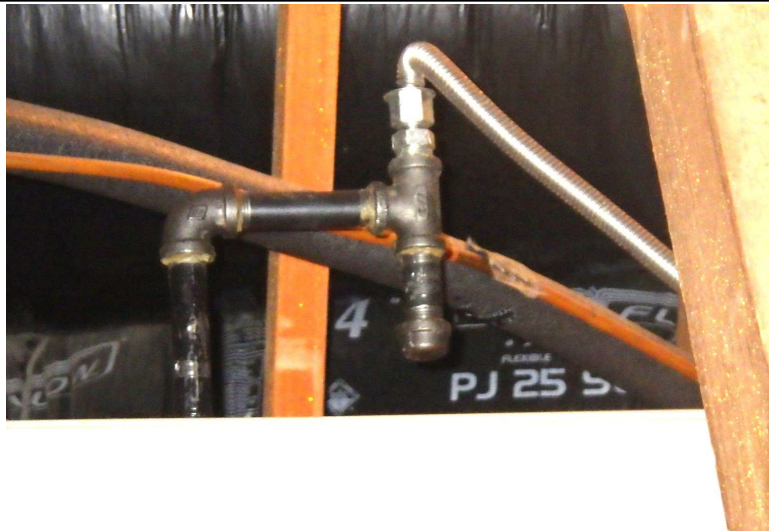
### PICTURE #2:

**Sediment trap needed on gas to controls**

This is the proper installation of a Sediment Trap or Drip Leg for use on a Natural Gas supply line to the controls for a Force Air Unit (FAU) aka Heater. Natural Gas flexible supply line should terminate into the Top opening of a black iron gas (T) fitting so the Natural Gas supply will make a 90 degree turn into the control valve and the Lower opening of this (T) will have a 4 inch capped nipple present for the H<sub>2</sub>O present in the Natural Gas to drop into as required for this appliance.

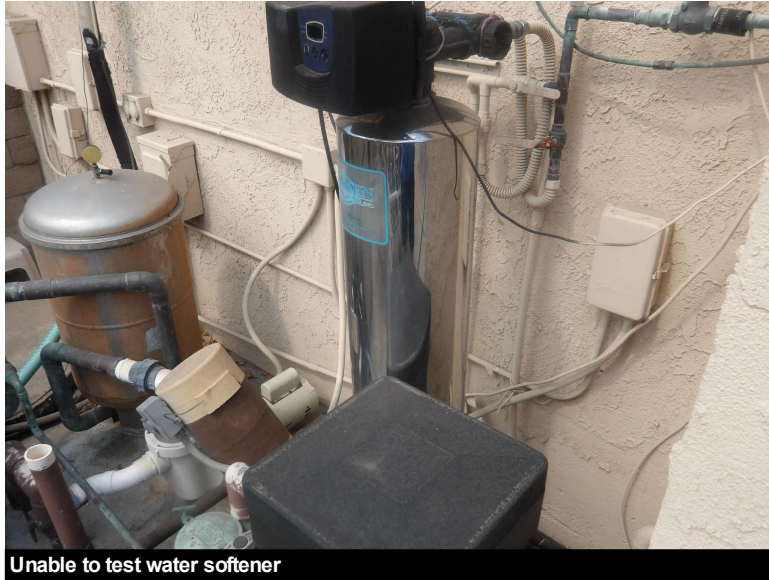
**PICTURE #3:**

Water softener installed - NOT PART OF THIS INSPECTION - Consult seller for operation and maintenance of system currently installed.
