INSPECTION REPORT

For the Property at:
27356 ALPEN DR
LAKE ARROWHEAD, CA 92352

Inspection Date: Friday, August 27, 2021

RE: Report No. 1107
27356 Alpen Dr
Lake Arrowhead, CA
92352

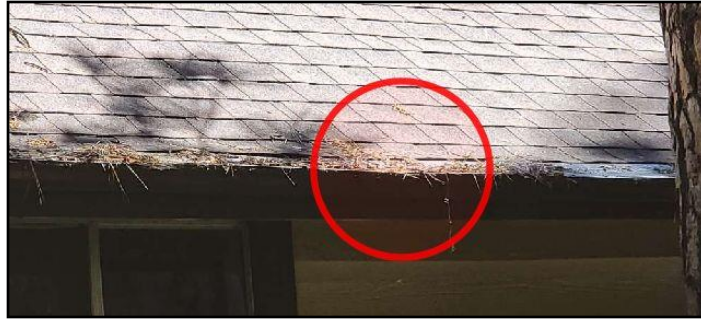
4.

1. **Condition:** • Recommend to remove debris from roof and gutters

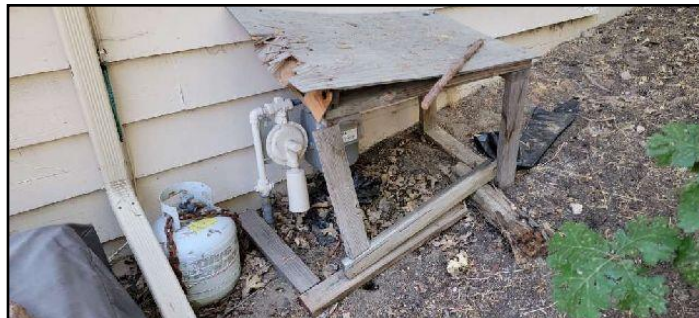
Small structure over gas meter in disrepair

17. Other

Task: Repair or replace

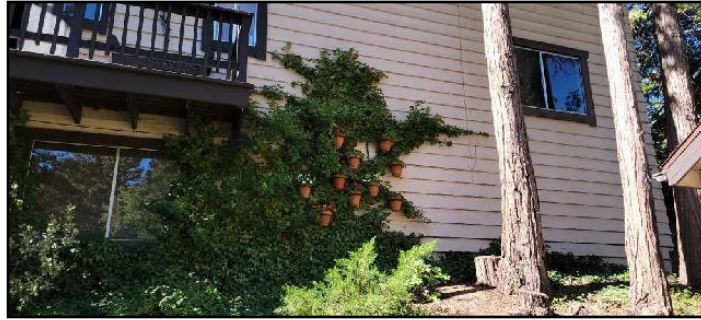
18.

4. Condition: • Vines on wall , recommend to remove to prevent wood rot and potential fire danger

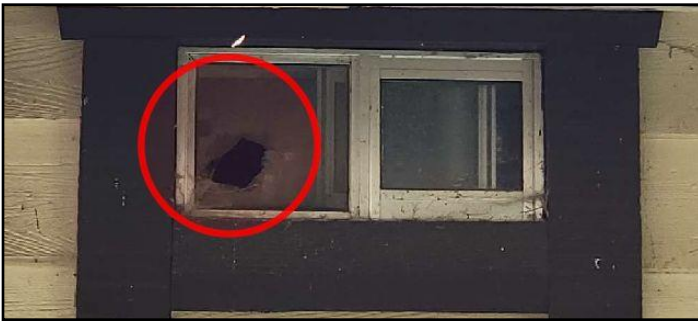
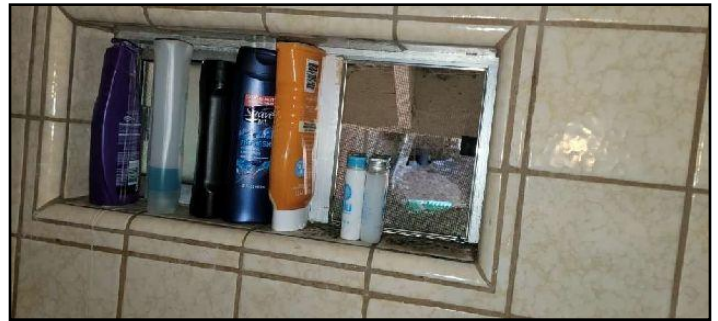
5. **Condition:** • [Torn or holes](#)

19. *Torn or holes*

20. *Torn or holes*

Task: Repair or replace

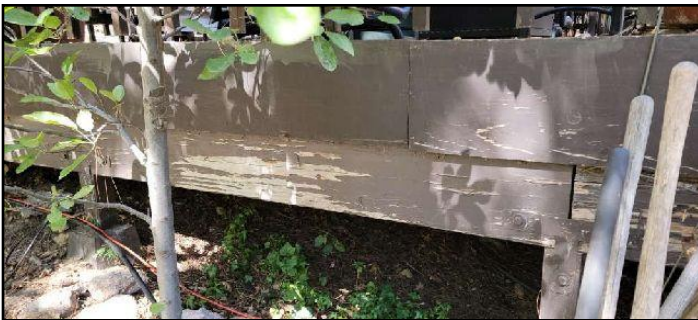
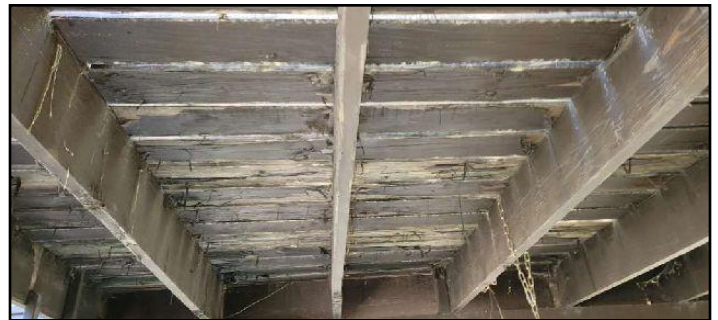
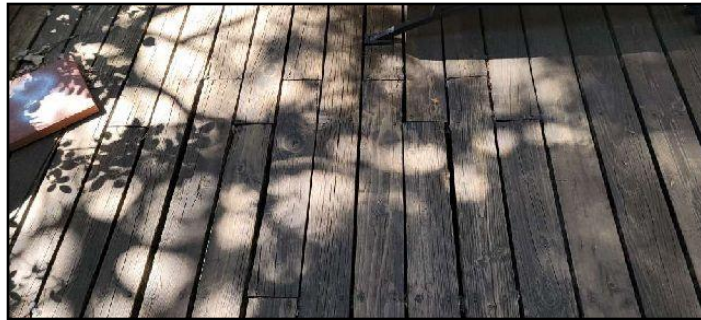
6. **Condition:** • Deck has normal wear and tear , should be painted/stained to prevent any rot or sun damage

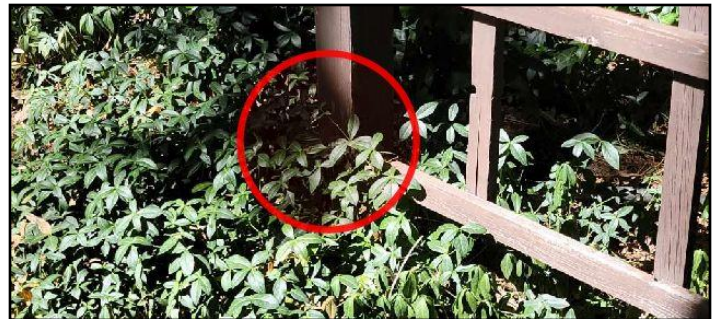
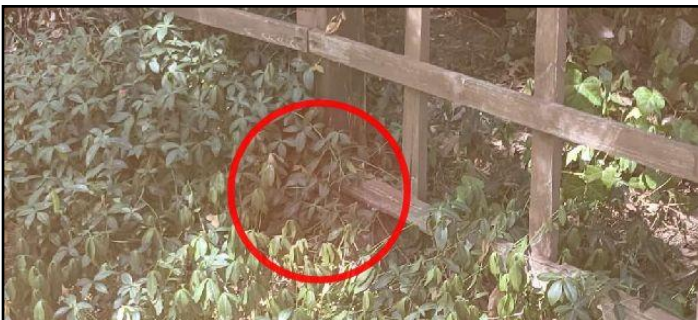
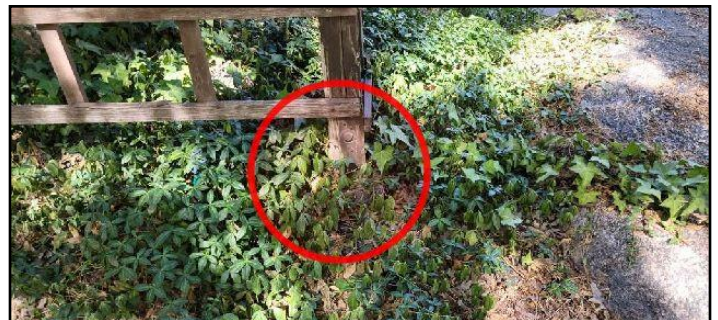
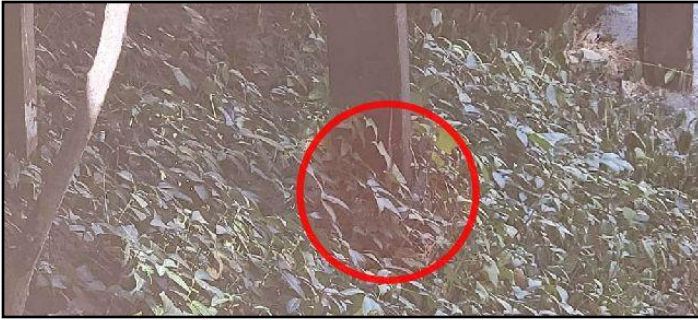
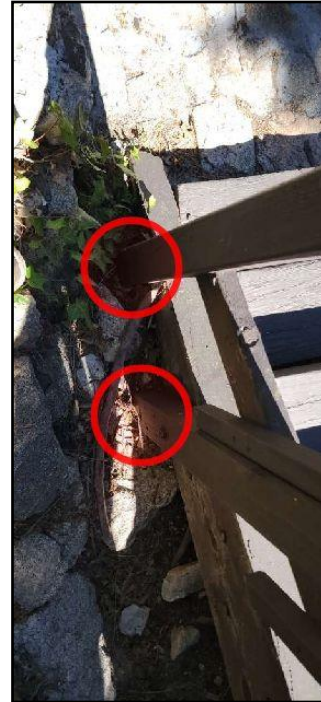
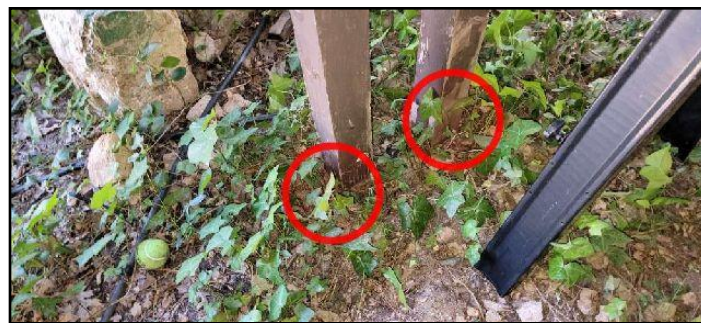
7. Condition: • [Wood/soil contact](#)

Remove dirt and plants from post

25. Wood/soil contact

26. Wood/soil contact

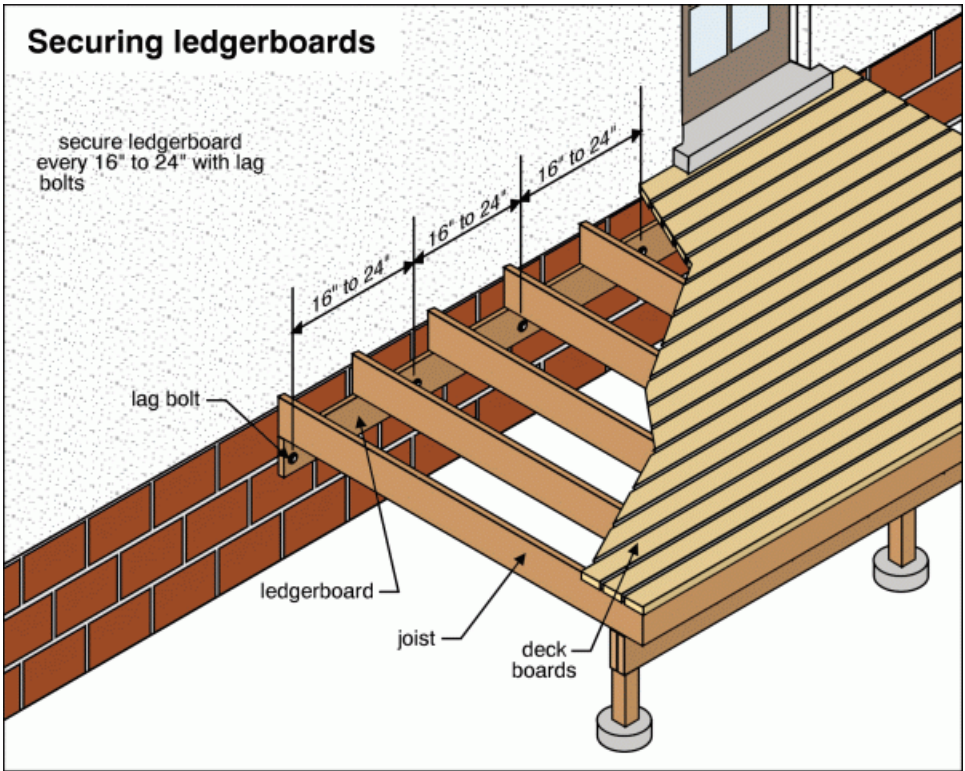
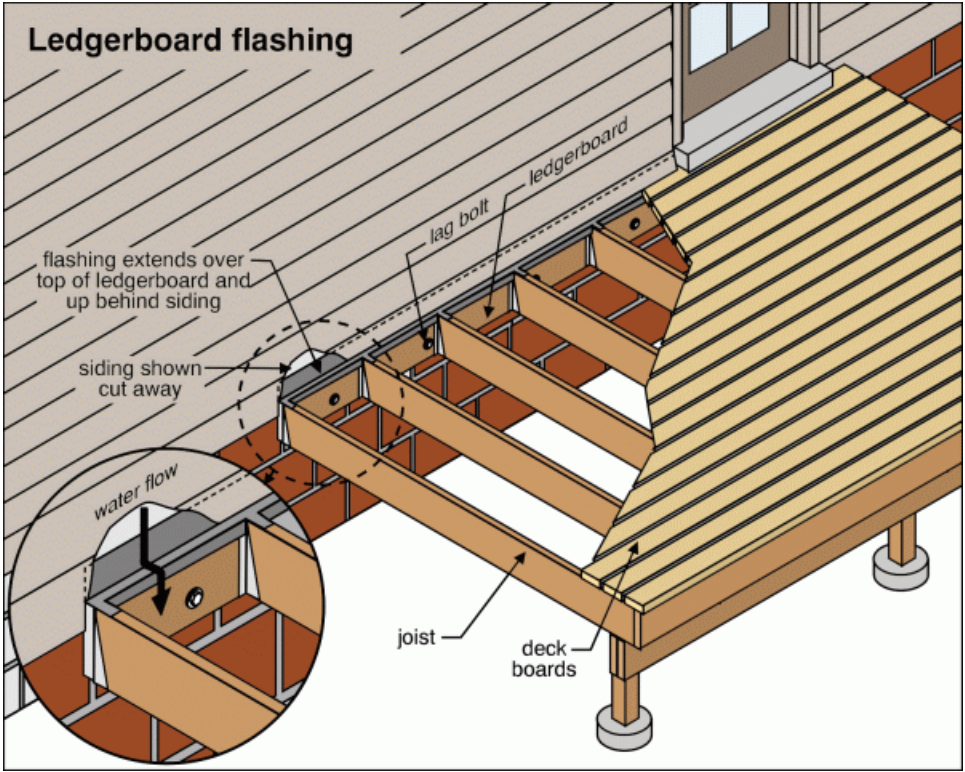
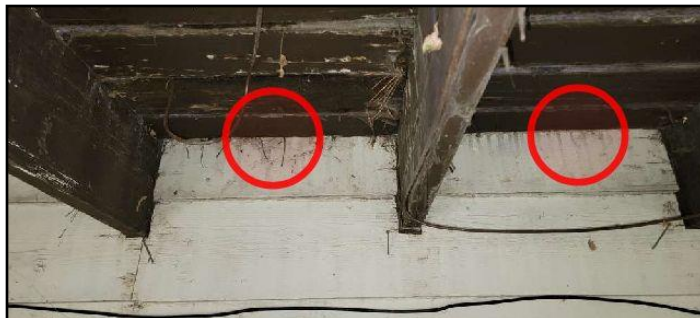
8. Condition: • [Missing flashing at deck connection](#)

Not a standard in homes built at this time

31. Missing flashing at deck connection

Task: Provide

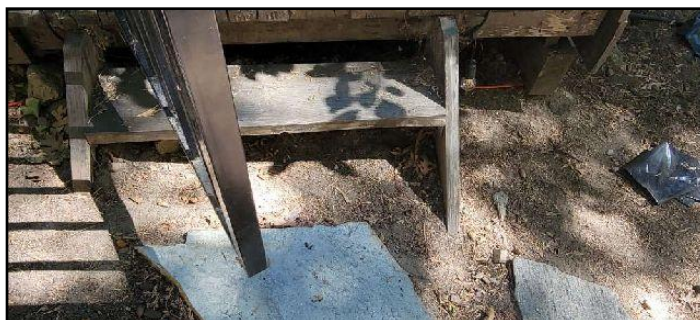
32.

9. Condition: • Earth to wood contact , remove dirt from contact with deck. To prevent rot

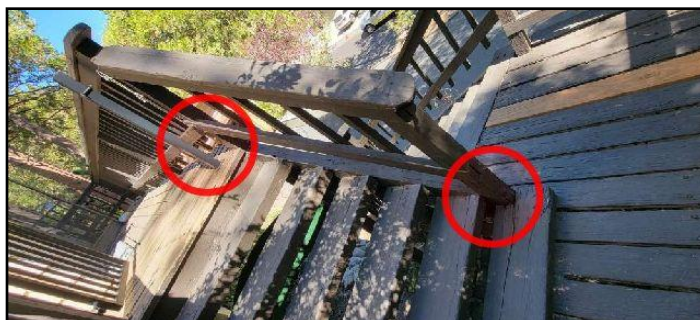
Condition: • [Rot or insect damage](#)

10. Condition: • [Rot or insect damage](#)

Fall risk

33. Rot or insect damage

Task: Repair or replace

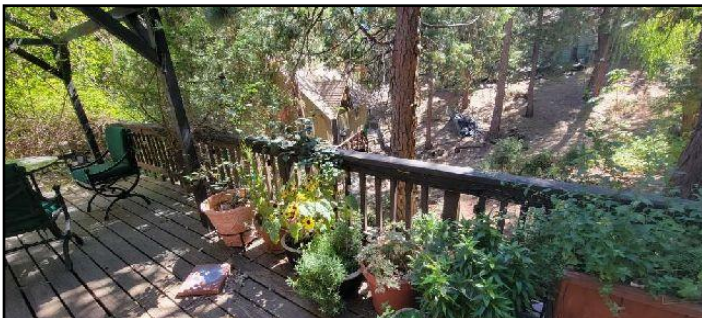
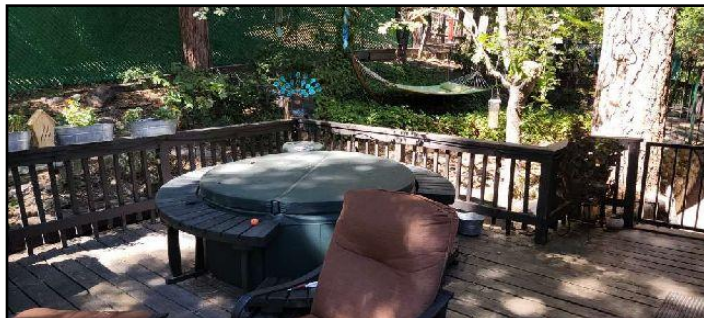
Condition: • [Loose](#)

11. Condition: • [Loose](#)

Fall risk

34. Loose

35. Loose

Task: Correct

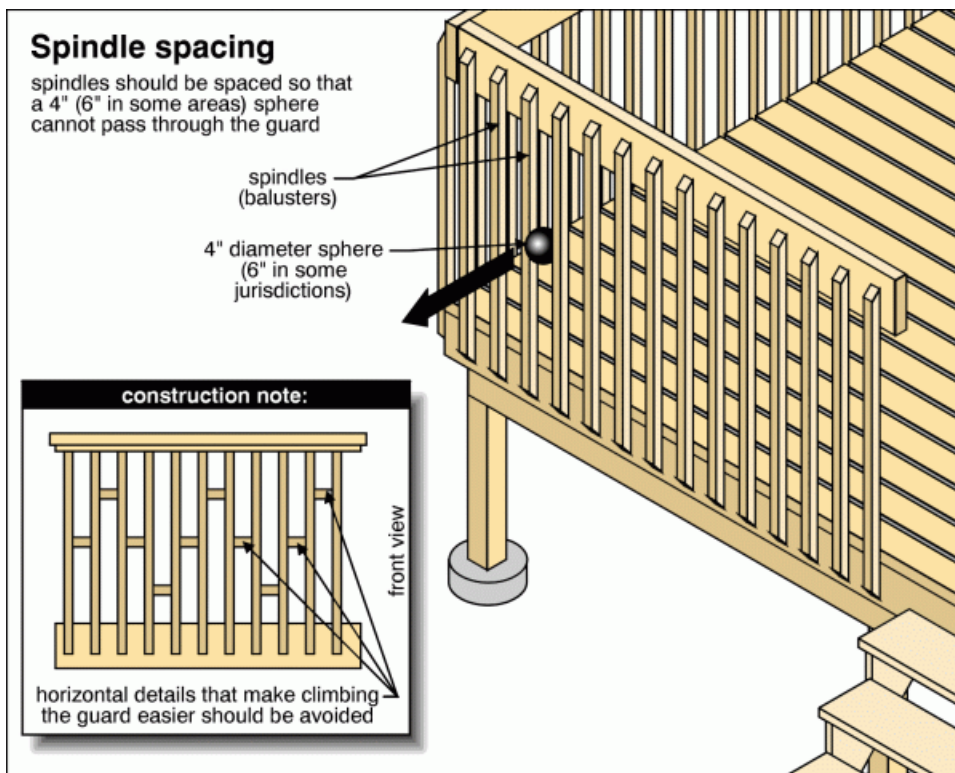
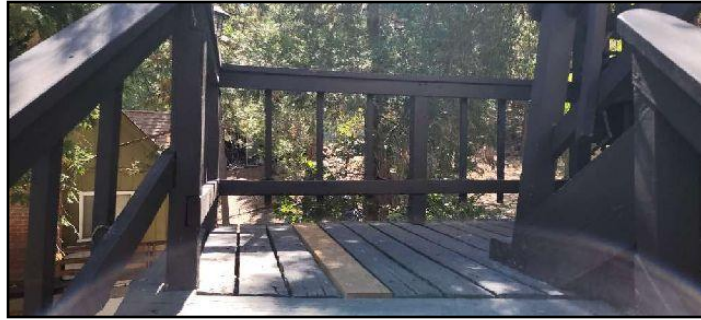
Condition: • [Openings between spindles \(balusters\) too large](#)

12. Condition: • [Openings between spindles \(balusters\) too large](#)

Fall risk

36. *Openings between spindles (balusters) too...*

Task: Improve

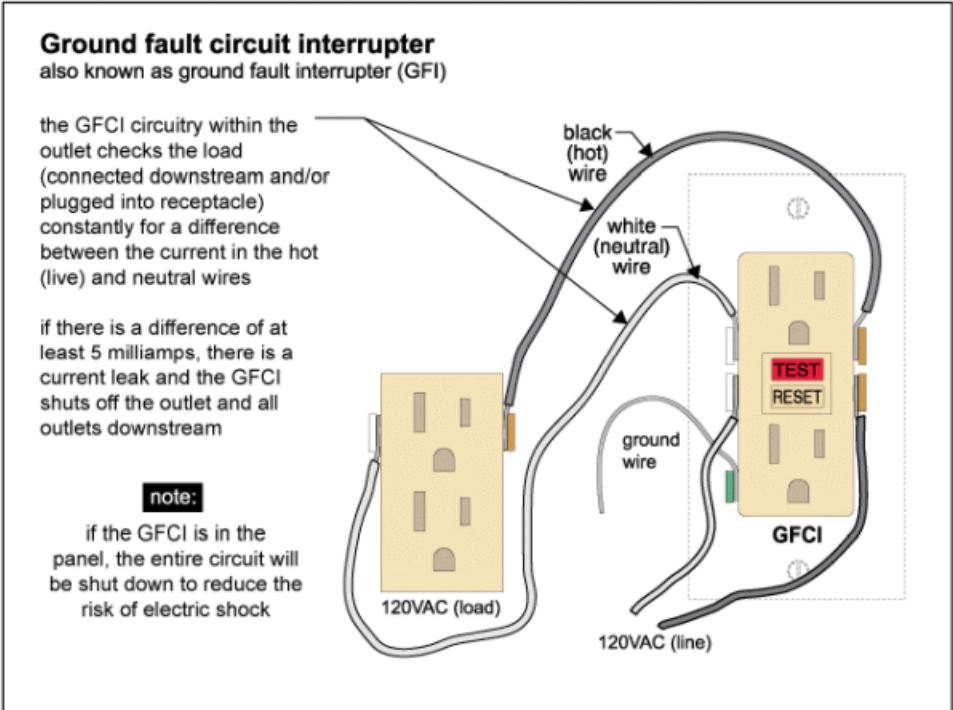
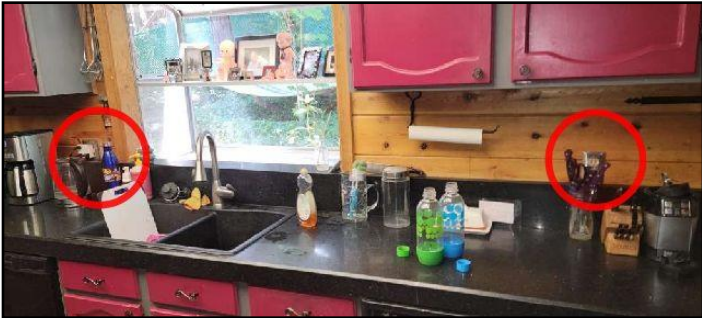
Condition: • [GFCI/GFI needed \(Ground Fault Circuit Interrupter\)](#)

13. Condition: • [GFCI/GFI needed \(Ground Fault Circuit Interrupter\)](#)

45. GFCI/GFI needed (Ground Fault Circuit...

Task: Provide

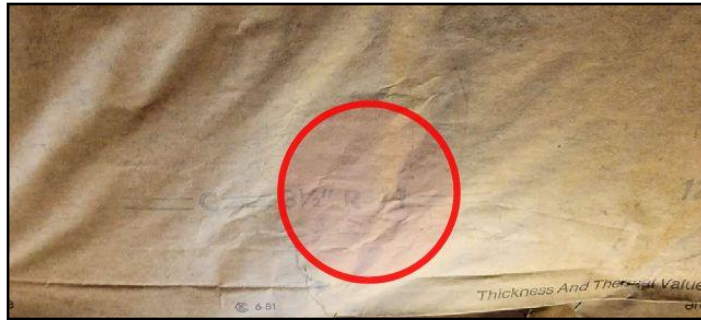
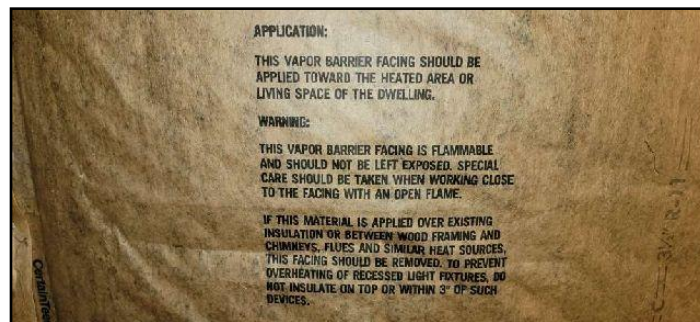
Condition: • [No vapor barrier](#)

Missing vapor barrier, insulation installed reversed

16. Condition: • [No vapor barrier](#)

59. No vapor barrier

Task: Provide

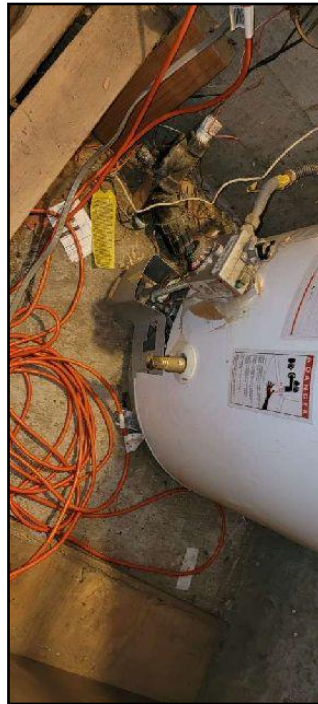
17. **Condition:** • Safety pan and drain missing

68. Safety pan and drain missing

Task: Provide

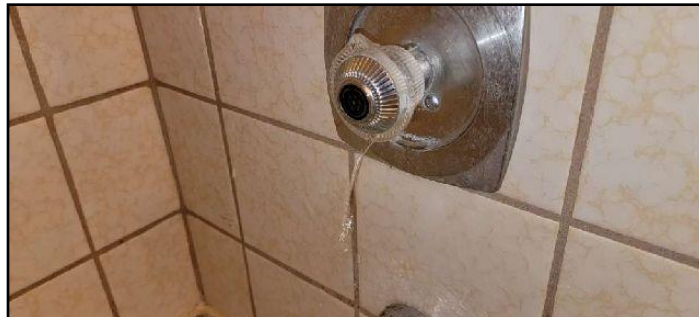
18. Condition: • [Drip, leak](#)

69. Drip, leak

Task: Repair or replace

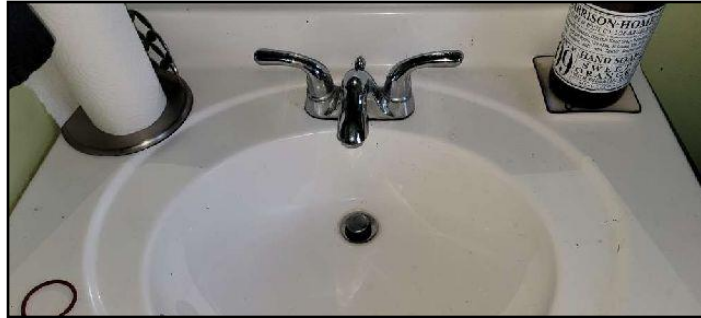
19. Condition: • Drain stop ineffective

Drain stop not working

70. Drain stop ineffective

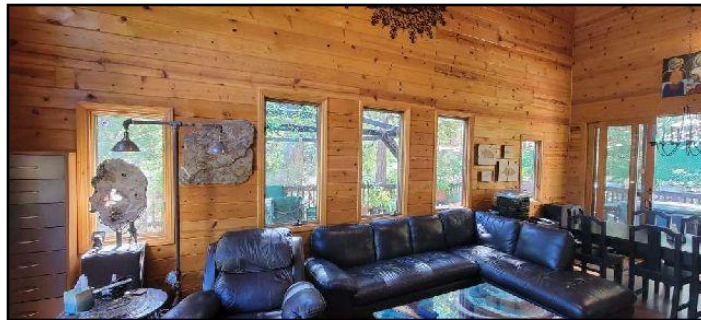
20. Condition: • [Missing](#)

75. Missing

Task: Provide
