File No.: 240106

December 14, 2024

SUBJECT: Site Geologic Reconnaissance Report for Existing Residential Property at 32203 Schooner Drive, Rancho Palos Verdes, California

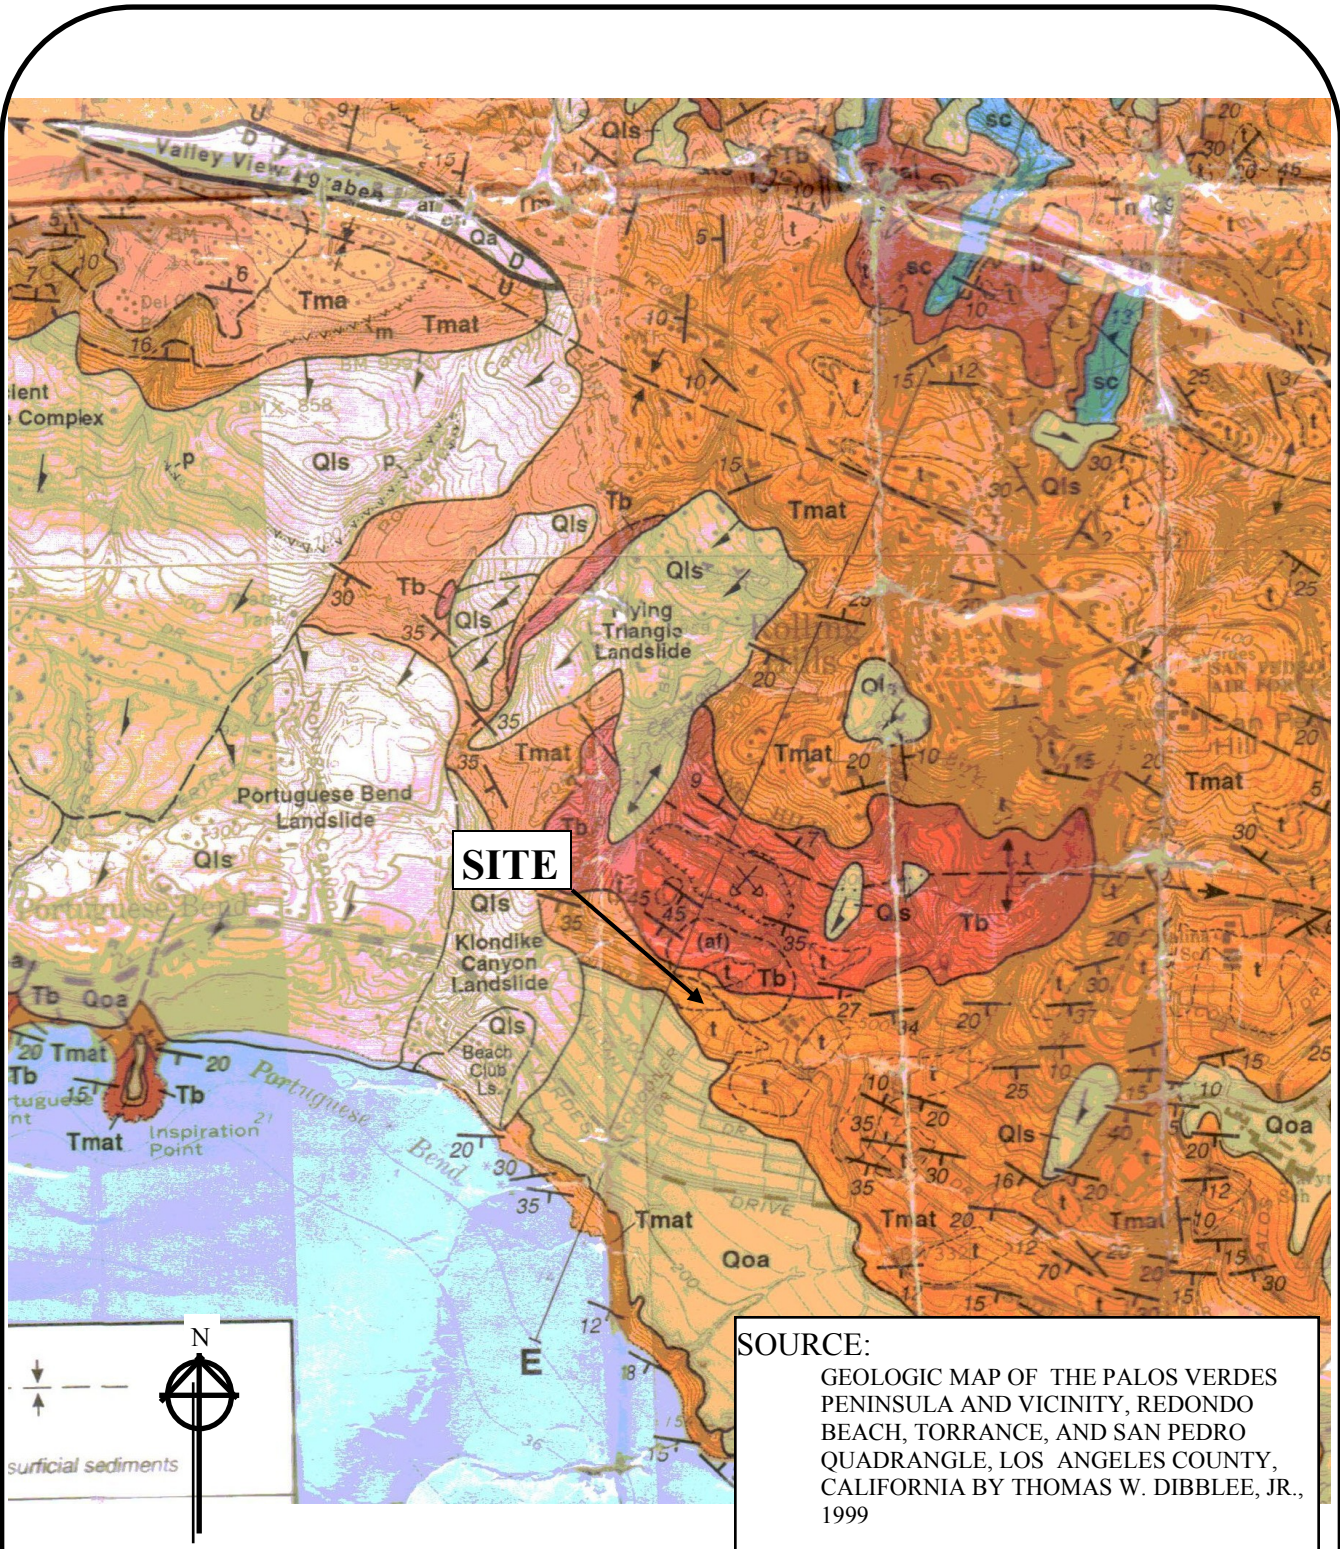
PLATE 1

In review of the geologic map by Dibblee, Plate 1, the subject site is covered with bedrock and terrace deposits. The off-site ascending slope above the subject site is covered with basalt. Basalt bedrock is considered to be very stable bedrock material. Klondike Landslide is located approximately 700 feet westerly of the subject site. The geologic map by Robert Stone and Associates shows the relationship between Klondike Landslide and subject site, Plate 3. The subject site is not located in Klondike Landslide.

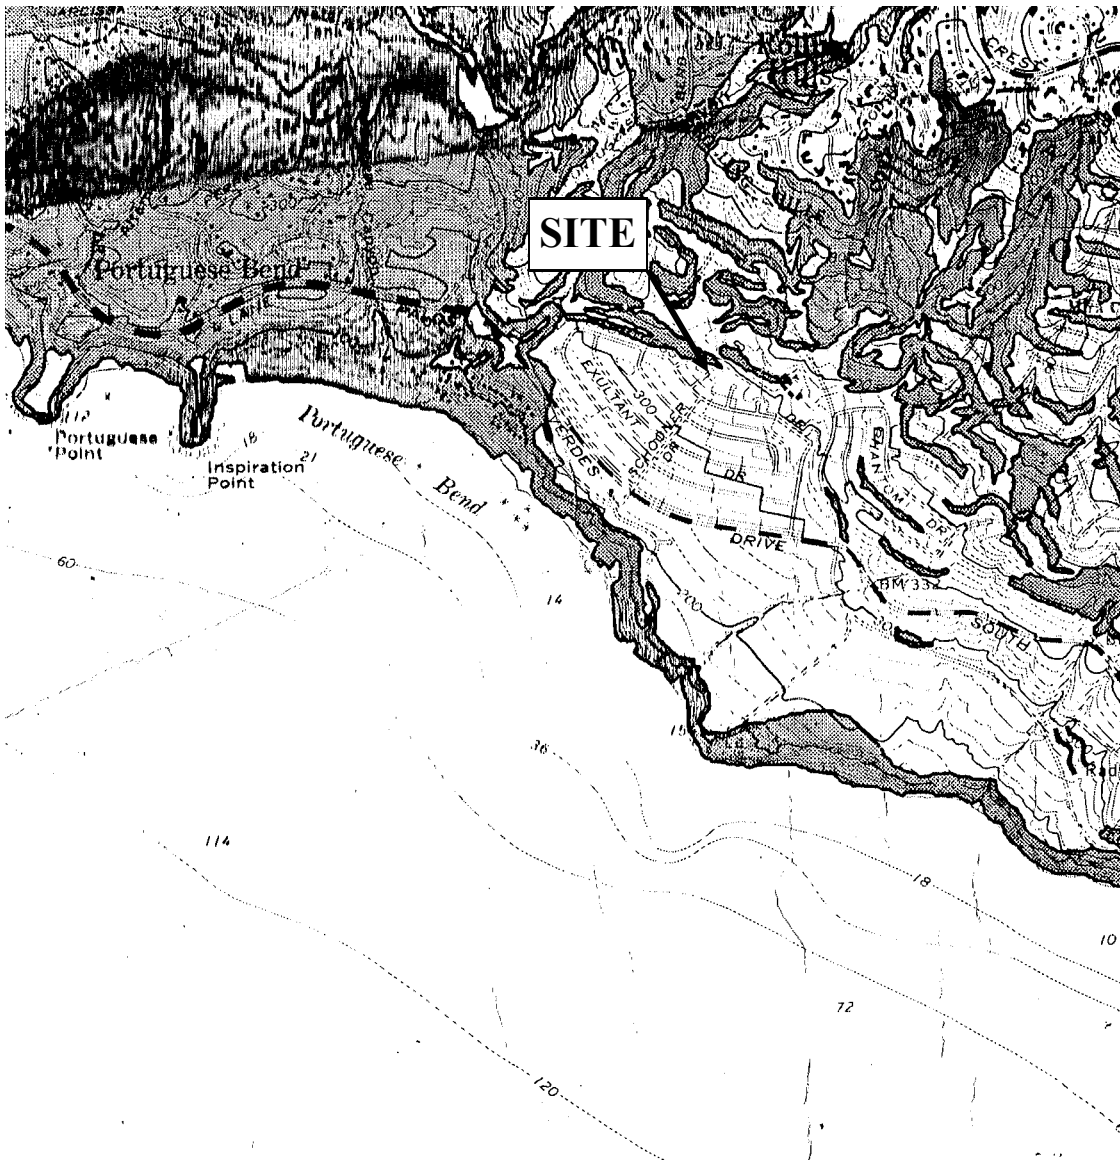
PLATE 2

9. The subject site is not located within the potential seismic hazard zones (liquefaction zones) mapped by the State as shown on Plate 2. However, the upper northern slope is located in a seismically-induced landslide hazard zone as shown on Plate 2. The existing residential building is not located in the seismically-induced landslide hazard zone. The rear ascending slope is a graded, certified fill slope. It is our opinion that a potential of the seismically induced landslide to affect the existing residential building is to be minimal.

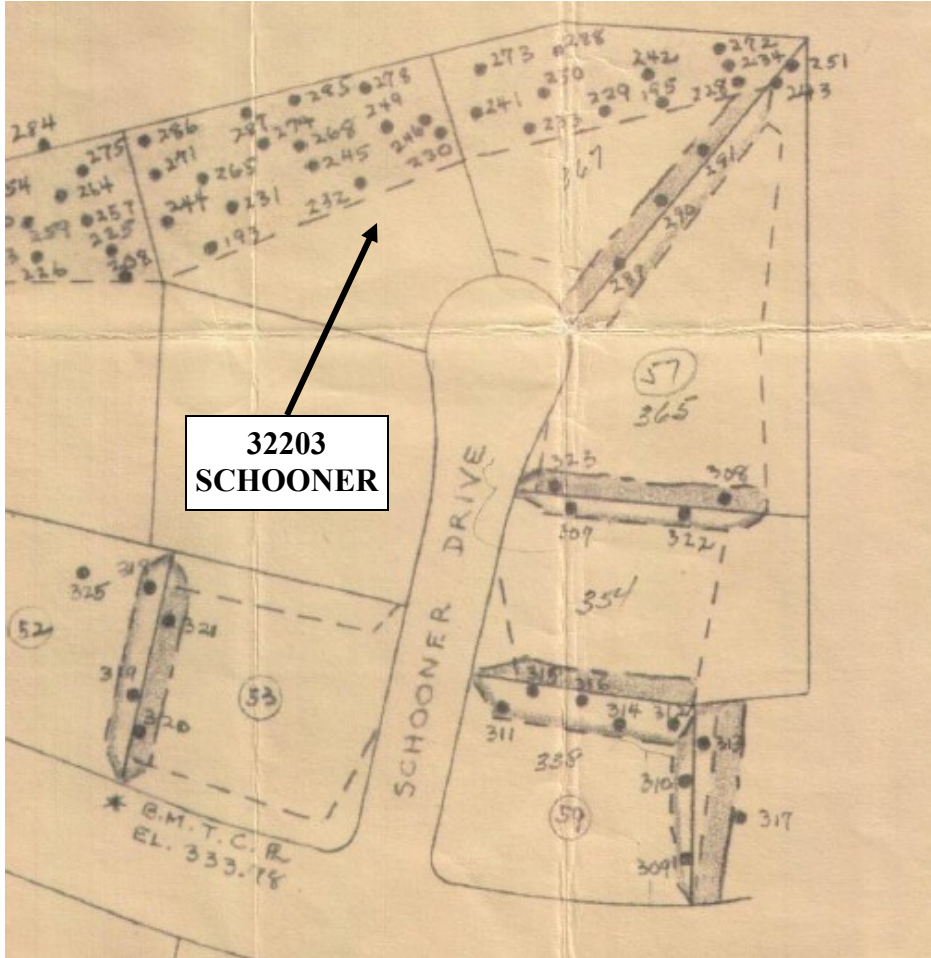
PLATE 4

Tract grading of the subject site was observed, tested, and inspected by Donald R. Warren in 1960. Reviews of the past grading by Donald R. Warren, the rear ascending slope was graded with fill as shown on Plate 4. The tract grading map by Donald R. Warren shows that no fill grading was performed in the existing level building pad. However, based upon our site observation on December 10, 2024, it appears that the fill grading was performed on the south and southwest sides of the subject site, respectively.

3. The northern ascending slope is a graded fill slope. The fill slope was certified by Donald R. Warren in 1960. Neither surficial nor deep-seated instability was observed on the northern ascending slope.
