**KEYS  
PROPERTY INSPECTIONS**

# Inspection Report

**Property Address:**  
6557 Babcock Ave  
North Hollywood CA 91606

<b>Date:</b> 6/5/2024	<b>Time:</b> 09:00 AM	<b>Report ID:</b> 2024060501
<b>Property:</b> 6557 Babcock Ave North Hollywood CA 91606	<b>Customer:</b> Casey Covenant	<b>Real Estate Professional:</b> Casey Covenant

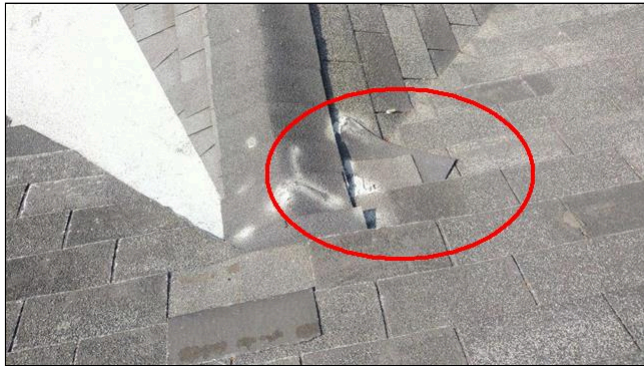
1.0 Item 1(Picture)

📌 (2) Areas of temporary repairs, missing / damaged roofing material, uplifted roofing material and general wear observed at rooftop surfaces. Maintenance and further review by a qualified roofer is recommended at this time.

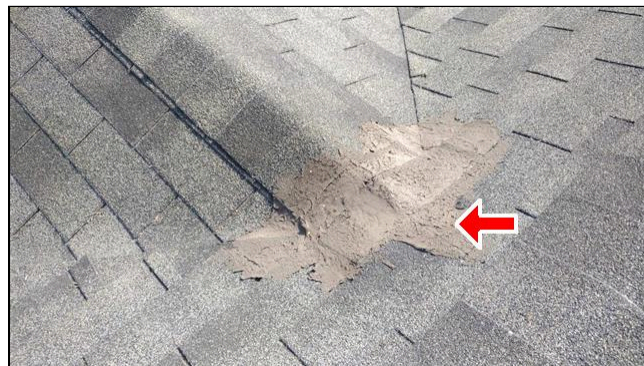
1.0 Item 5(Picture)

(3) Evidence of repairs observed. We are unable to determine the cause or effectiveness of these repairs.

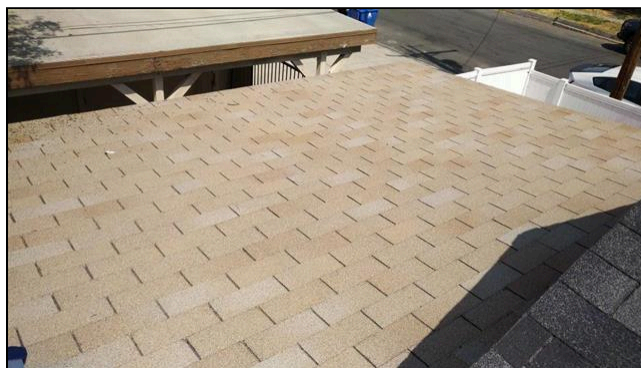
1.0 Item 7(Picture)

🏠 (4) Improper shingle installation observed at low sloped rear bonus area rooftop. Recommend correcting or verifying installation with a qualified roofer.

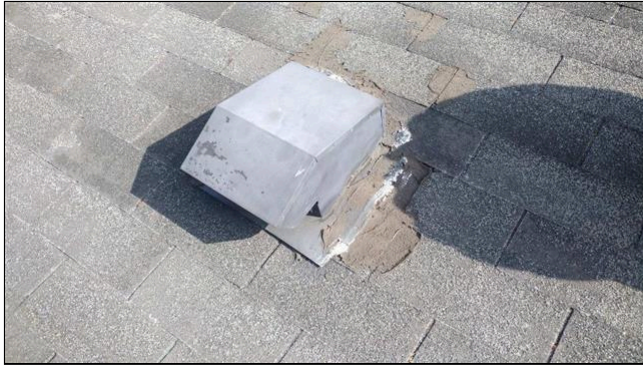
1.1 Item 1(Picture)

🏠 Improper flashing installations observed in a number of areas. Recommended correcting.

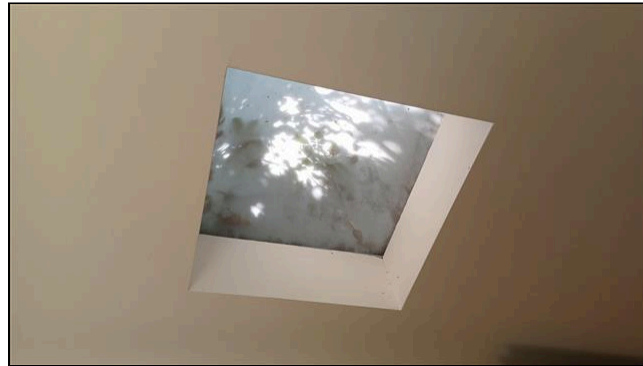
1.2 Item 1(Picture)

Skylight observed at the rear shed, there were no signs of leakage at the time of the inspection. Suggest monitoring for changes in condition.

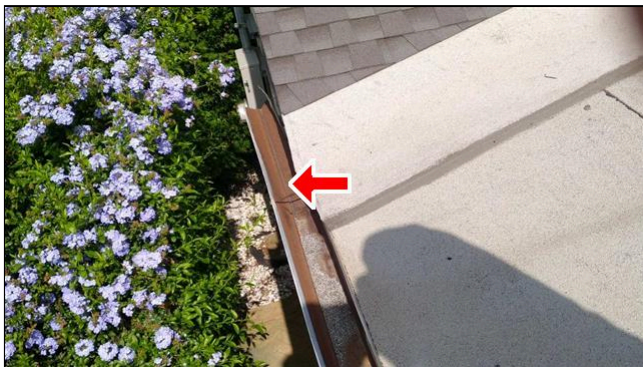
1.3 Item 1(Picture)

🏠 (1) Rear gutter is rusted / deteriorated and missing end cap. Recommend maintenance.

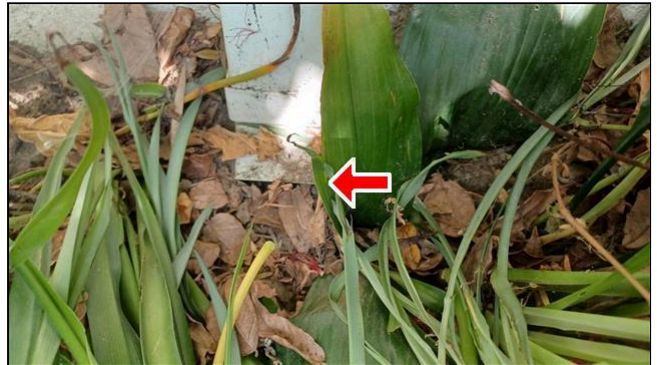
1.3 Item 6(Picture)

🏠 (3) Kickouts are not installed to divert water away from the structure. Recommend installing.

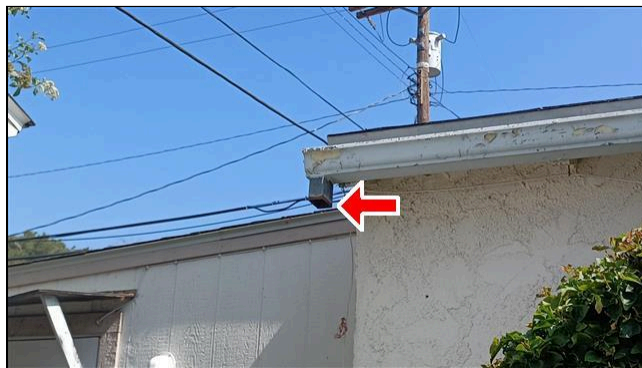
1.3 Item 7(Picture)

🏠 (4) Missing downspout observed at the garage rear gutter. Recommend correcting.

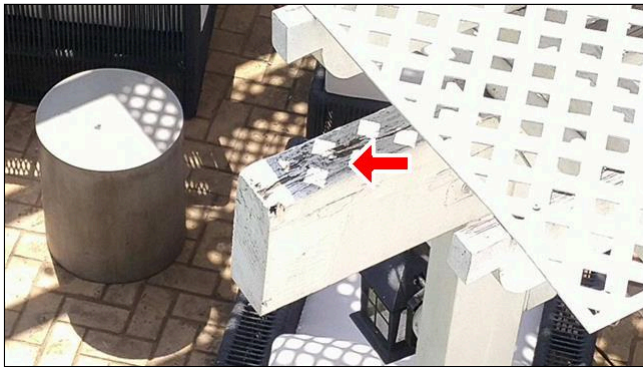
2.3 Item 1(Picture)

(1) Deterioration/damaged observed at patio trellis framing and cover. Recommend repairs.

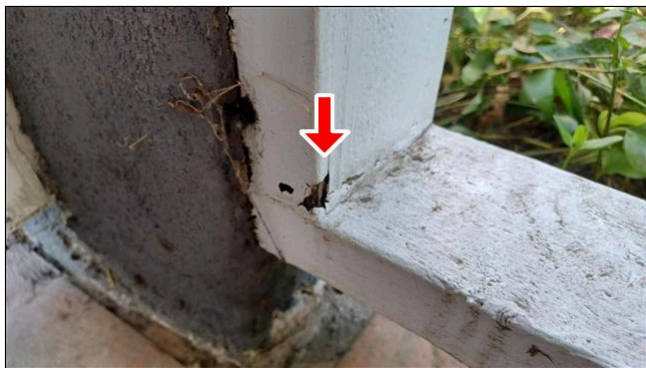
2.3 Item 3(Picture)

📍 (2) Deterioration observed at the front porch railings. Recommend correcting.

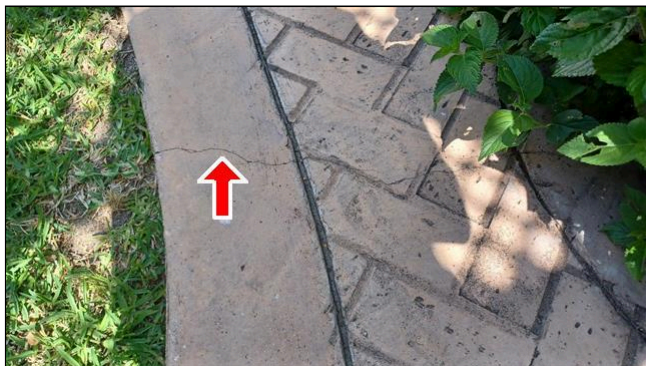
2.4 Item 1(Picture)

📍 (1) Inadequate slope observed at front, rear, sides, and garage. This can cause or contribute to water intrusion or deterioration. I recommend correcting landscape or the installation of area drains to divert moisture away from structure.

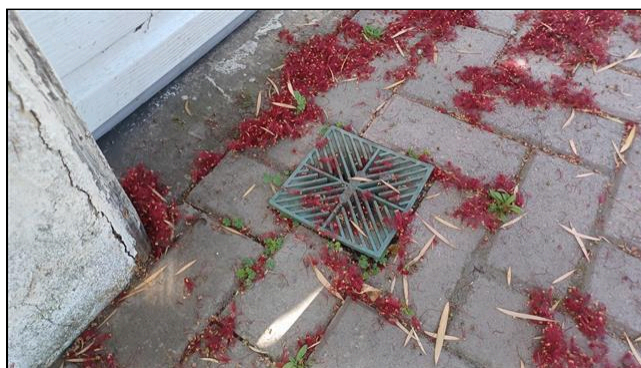
2.4 Item 3(Picture)

(3) Sub-surface lot drainage system is present. The client is advised to have a qualified drainage contractor verify its overall condition.

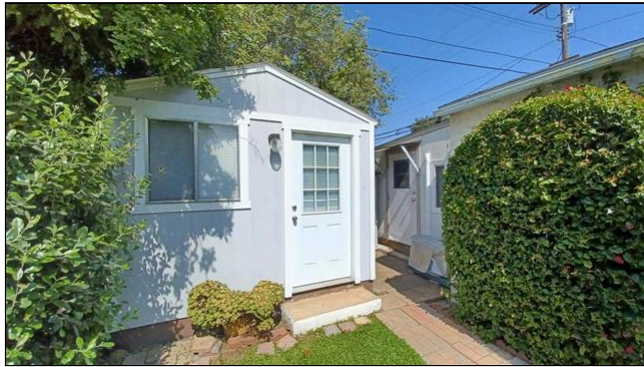
2.7 Item 1(Picture)

🏠 (2) Inspection of outbuildings and storage sheds are beyond the scope of this inspection. However deterioration was observed at the rear studio doors, wood siding, windows frame, and overhang. Recommend repairs.

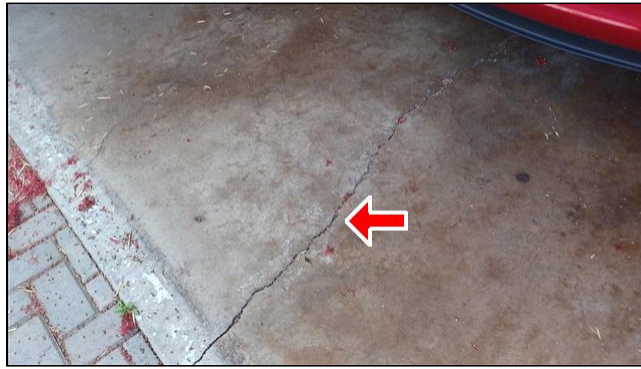
3.2 Item 1(Picture)

Cracks observed at garage slab. Suggest sealing/repairs.

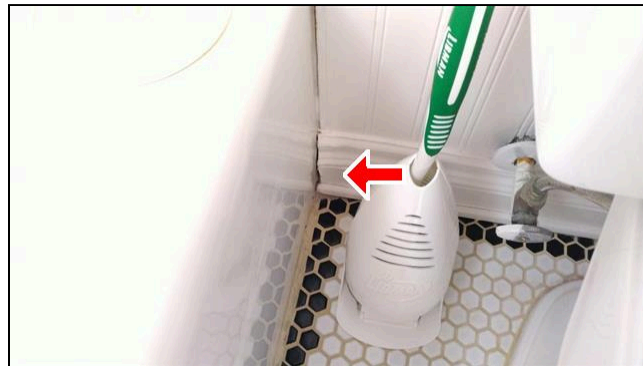
4.1 Item 1(Picture)

(2) Minor deterioration observed at hallway bathroom floor trim next to tub. Suggest maintenance.

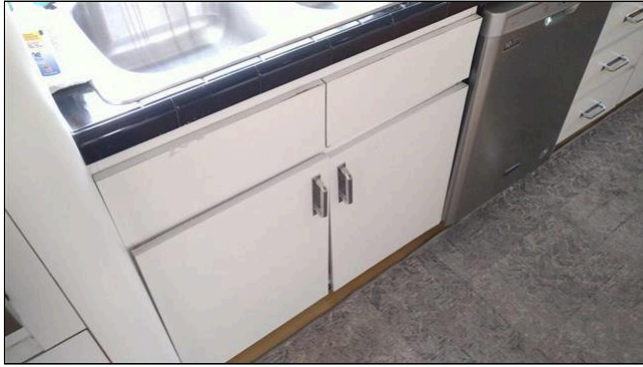
4.2 Item 2(Picture)

(2) The cabinetry is older and generally worn. Suggest maintenance or updating.

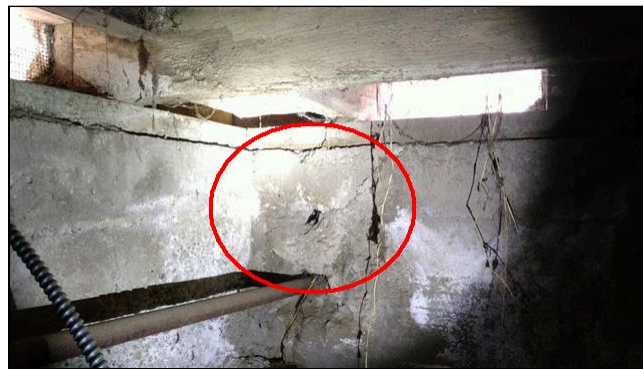
5.0 Item 1(Picture)

(1) Damaged section of stem wall observed at front left side. Recommend maintenance.

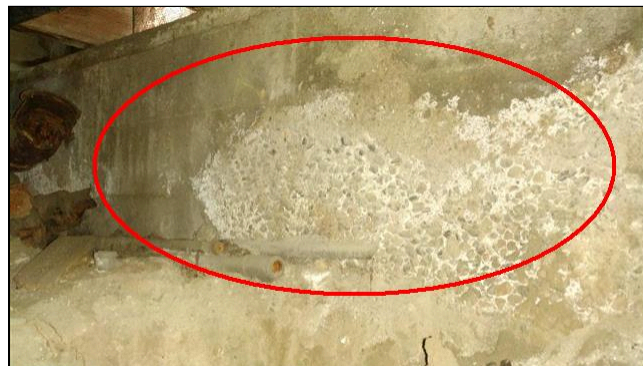
5.0 Item 2(Picture)

(2) Deterioration observed in areas. Recommend maintenance.

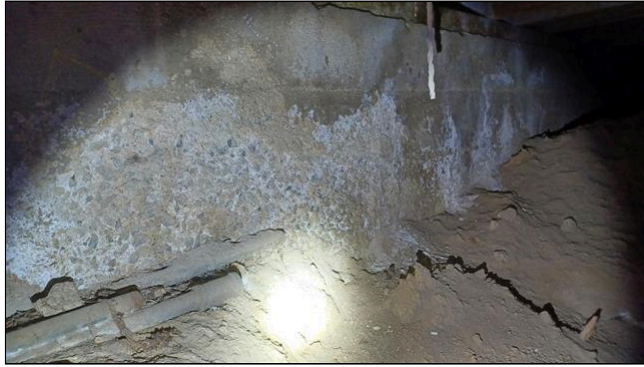
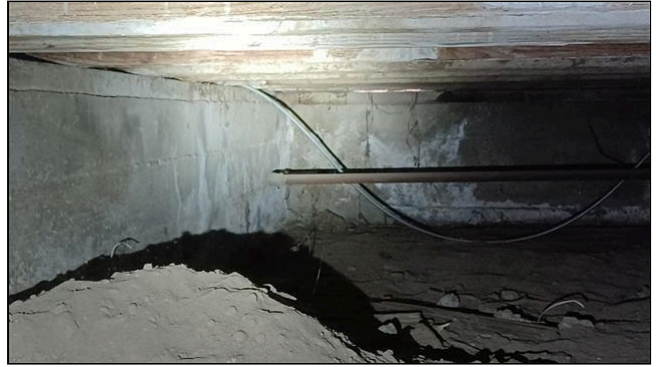
5.0 Item 3(Picture)

(3) Efflorescence observed at foundation stem walls. See exterior drainage category.

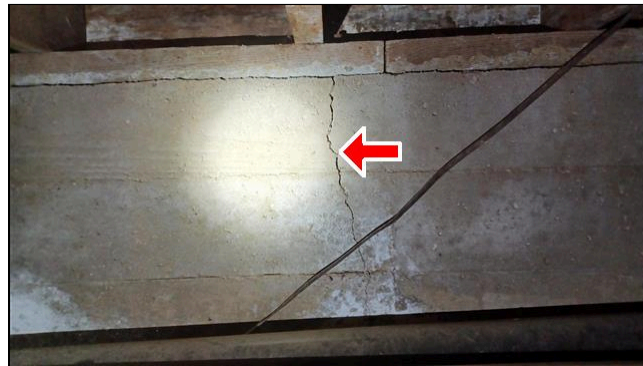
5.0 Item 5(Picture)

(5) Hairline cracks observed at foundation stem wall. Suggest repairs/sealing.

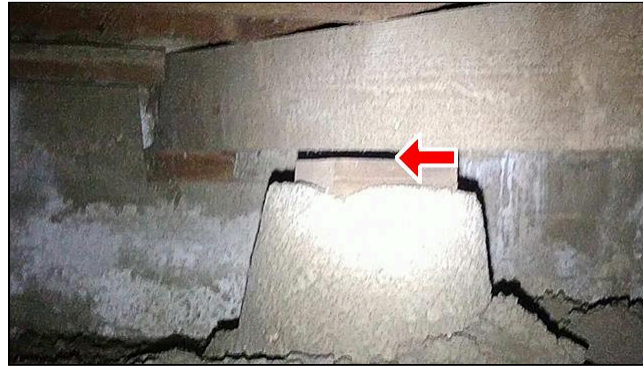
5.1 Item 1(Picture) Kitchen

Inadequate floor support/gap observed between floor beam and pier at rear left post. Suggest correcting.

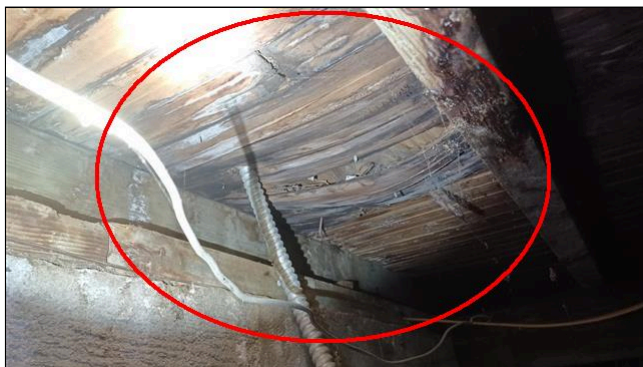
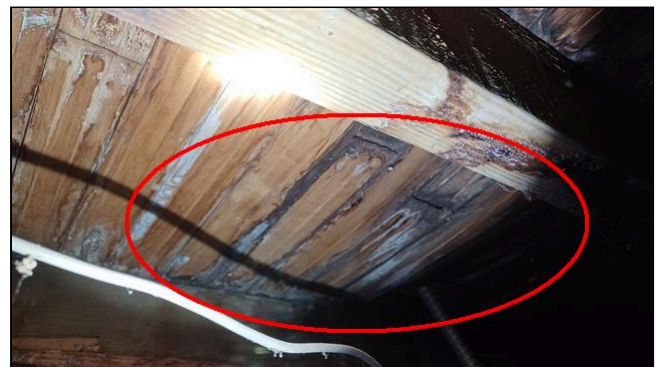
5.2 Item 2(Picture)

📌 (2) Moisture damage/deterioration observed at the subfloor. Recommend repairs.

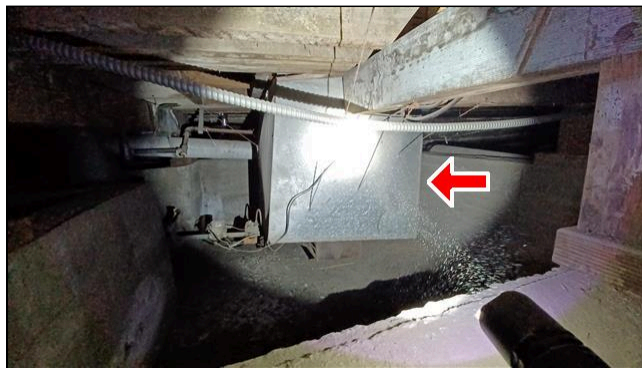
5.3 Item 1(Picture)

(1) Abandoned furnace observed at the crawlspace. Suggest removal.

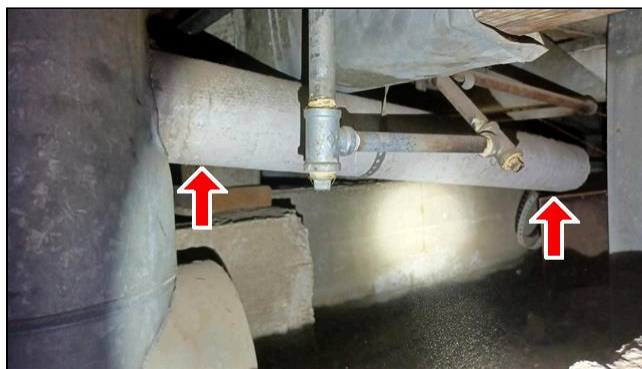
5.3 Item 2(Picture)

(2) Abandoned transite (asbestos) material observed in the crawlspace. Suggest removal.

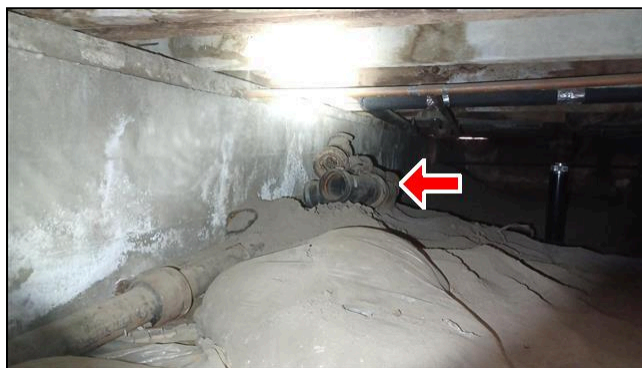
5.3 Item 3(Picture)

(3) Debris observed in the crawlspace. Suggest removal.

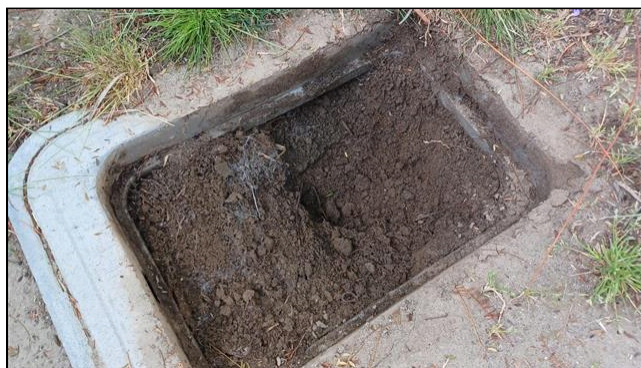
6.0 Item 1(Picture)

The water meter at the curbside was partially buried. Suggest exposing and verifying condition.

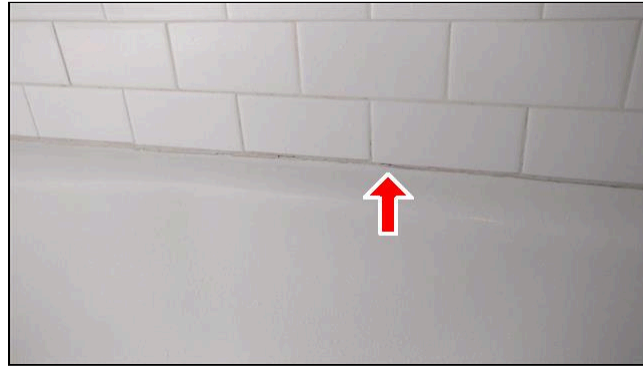
6.4 Item 2(Picture)

(2) Deteriorated sealant/caulking observed at hallway bathroom tub surround. Suggest maintenance.

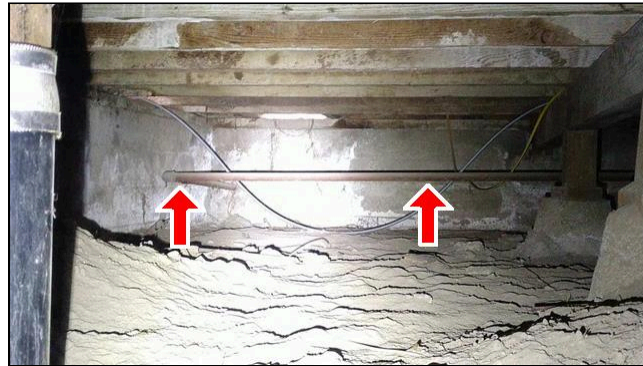
6.5 Item 1(Picture)

🏠 (1) Gas lines are not properly secured at crawlspace. Recommend correcting.

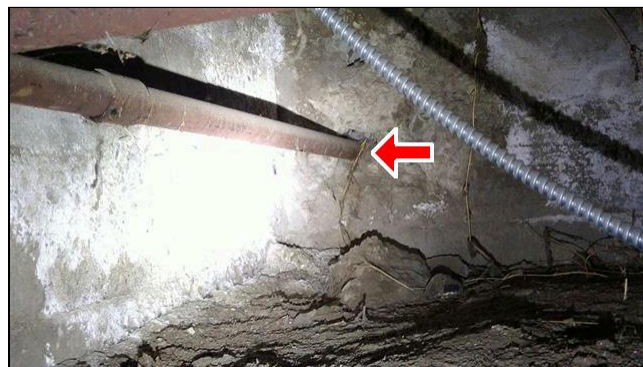
6.5 Item 2(Picture)

🏠 (2) Gas piping is installed through concrete or foundation walls without protection. Recommend correcting.

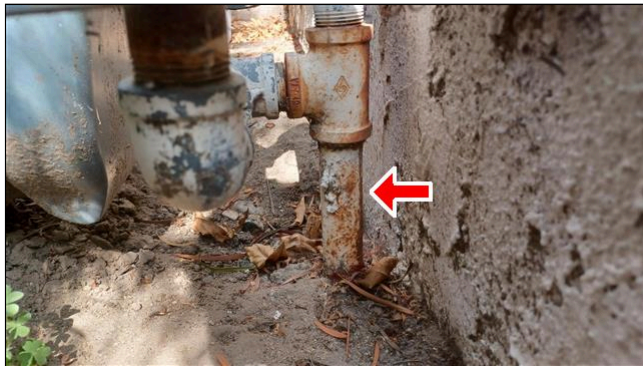
6.5 Item 4(Picture)

(4) Gas piping is corroded at a number of areas. Suggest maintenance.

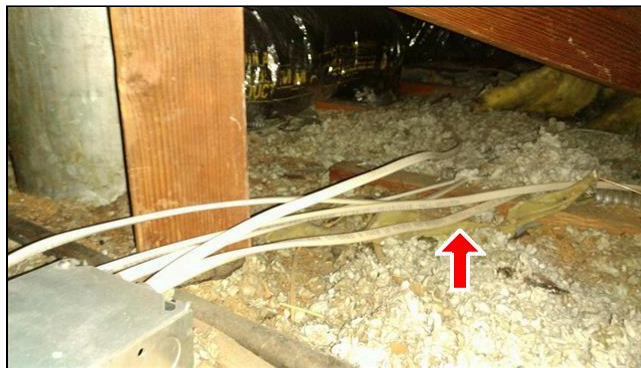
7.2 Item 1(Picture)

(1) Electrical wiring is improperly secured in the attic. Suggest correcting.

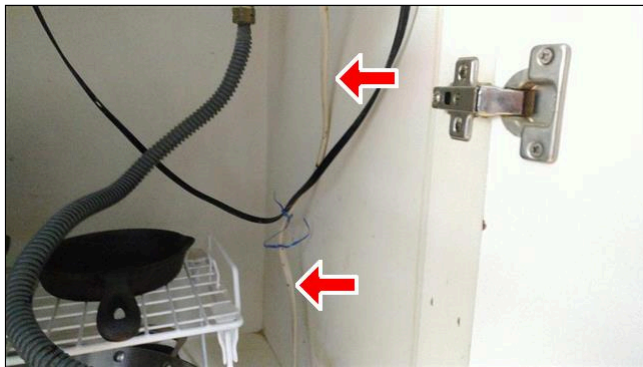
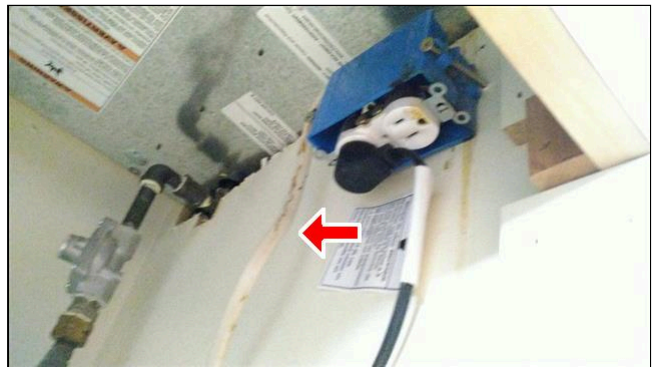
7.2 Item 2(Picture)

📌 (2) Exposed/unprotected wiring observed at kitchen stovetop cabinet. Recommend correcting.

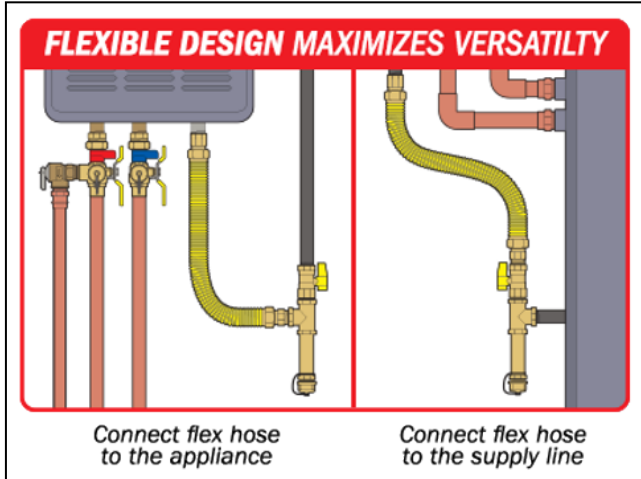
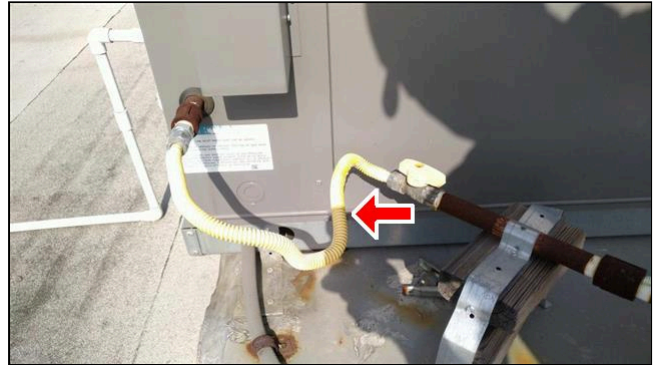
9.0 Item 1(Picture) Sed trap

(2) Sediment trap is not installed at the gas line. Installation is advised.

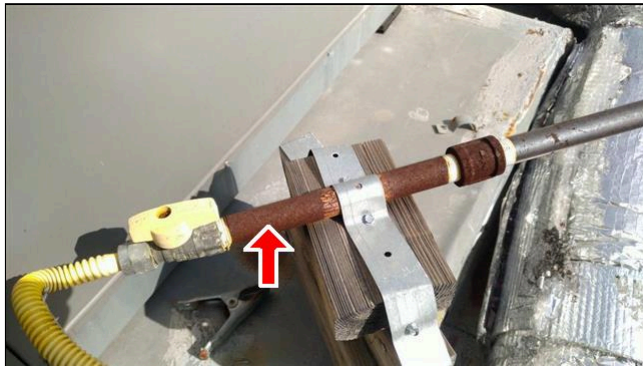
9.0 Item 3(Picture)

(3) Gas line connection at rooftop is rusted. Suggest updating.

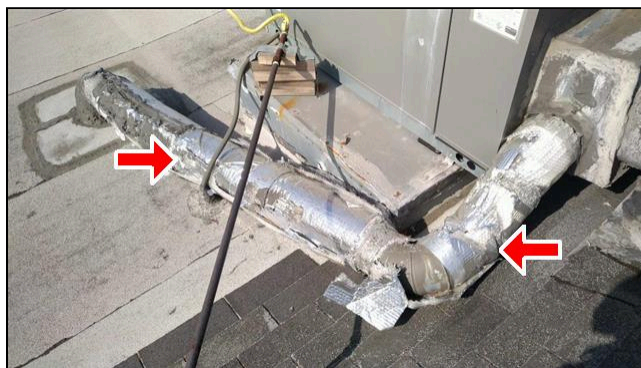
9.3 Item 1(Picture)

(2) Ductwork is deteriorated and improperly supported at rooftop. Recommend correcting.

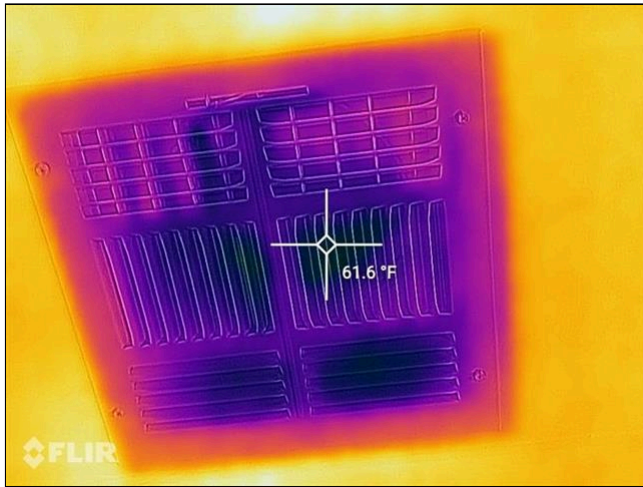
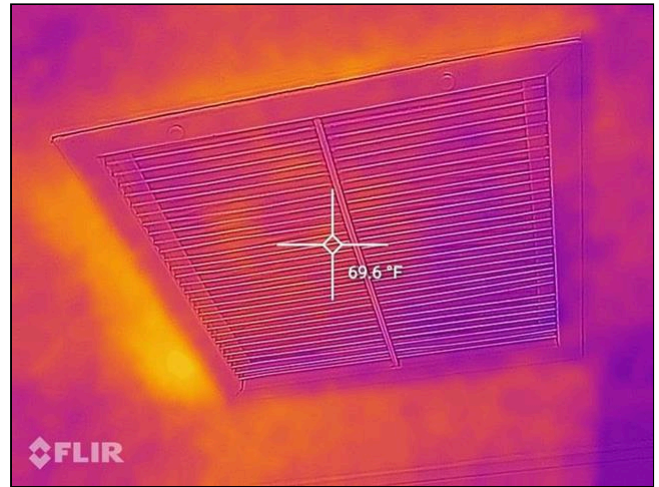
9.5 Item 2(Picture)

🏠 (3) The central air conditioning unit was not cooling to an adequate temperature (less than 15 degrees fahrenheit measured from the return air duct to supply registers). Recommend servicing and further review by a qualified HVAC specialist.

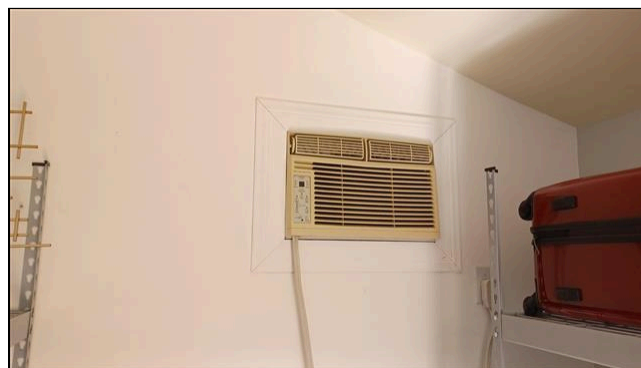
9.5 Item 5(Picture)

(5) Testing AC window unit is beyond the scope of this Inspection. Suggest verifying operation and condition.

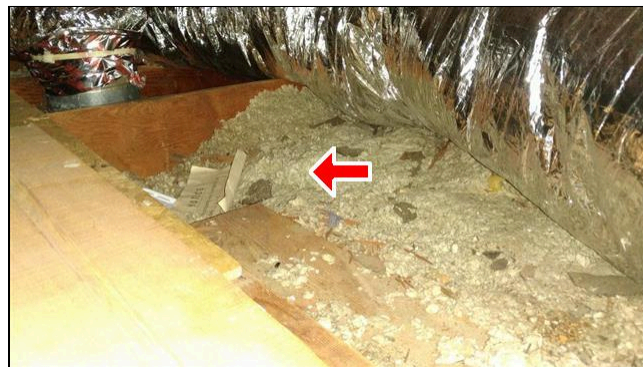
10.0 Item 1(Picture)

The attic insulation is outdated and generally worn/matted down in areas. Suggest updating.

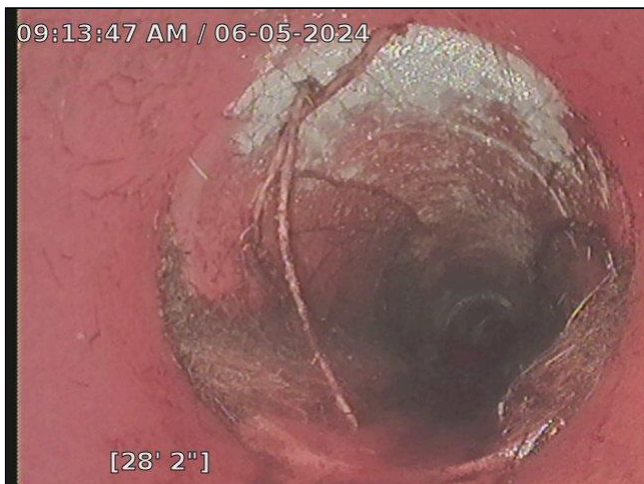
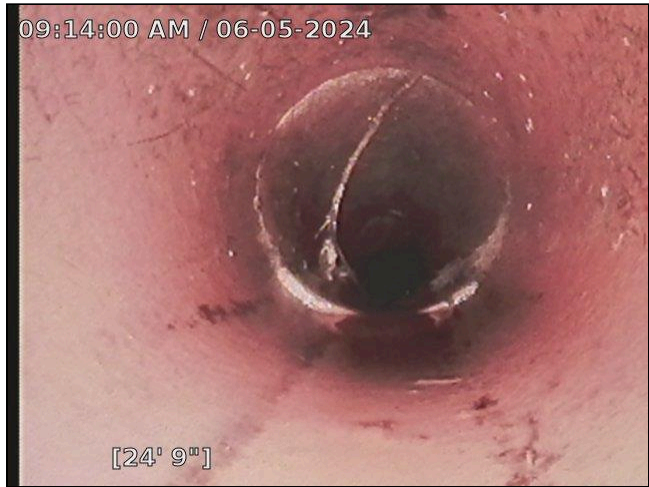
12.2 Item 1(Picture)

Root intrusion observed at joints of the sewer line. Roots are not causing blockage at the time of inspection, hydro jetting is not recommended, but will be required in the future. Root intrusion is an ongoing issue and continual maintenance will be required.

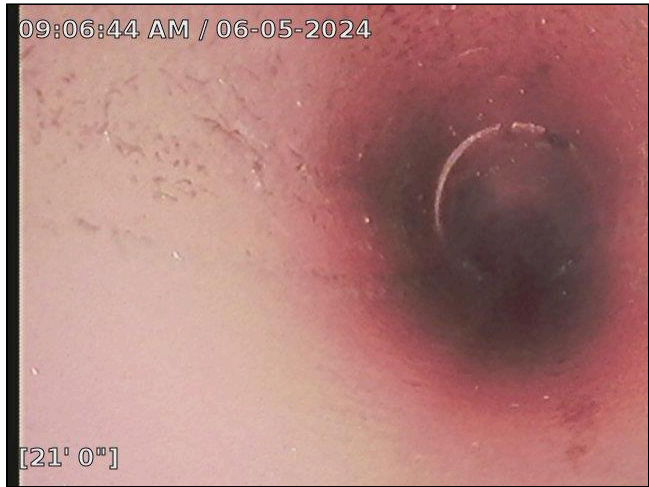
12.3 Item 1(Picture)

(1) A portion of the main drain line is composed of clay piping. The estimated service life of clay piping is approximately 100 years depending on site conditions. Clay drain lines are predisposed to offsets, root intrusion and cracking. These lines should be checked annually for any changes in condition.

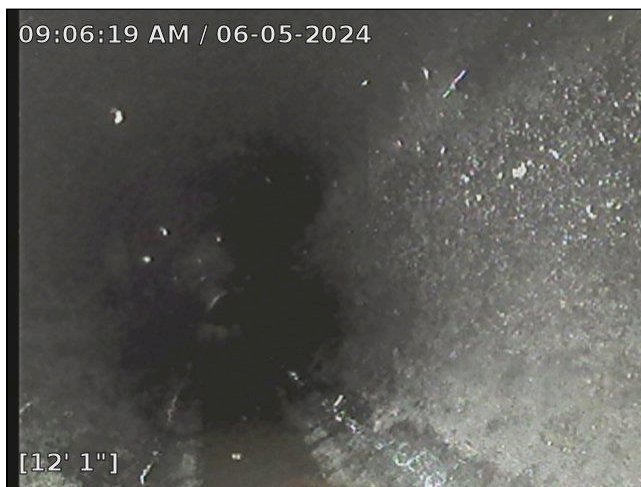
12.3 Item 2(Picture)

(2) Acrylonitrile-Butadiene-Styrene (ABS) piping was observed for a portion of the drain line. ABS is made from a thermoplastic resin. This is considered a modern building material. The estimated service life of ABS is 50+ years, depending on site conditions. Due to the flexible nature of ABS piping, bellies in the line can develop from inadequately compacted soil. ABS drain lines should be checked annually for any changes in condition.
