#### **Shawn Foster Inspections**

# Confidential Inspection Report 71 Cresta Verde Rancho Palos Verdes CA 90274

October 6, 2025

Prepared for: Raymond F. Destabelle Trust

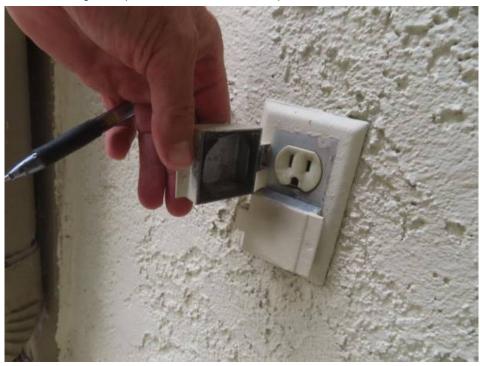
Ground Fault Circuit Interrupters (GFCI)

SAFETY: One or more receptacles are not GFCI protected. We recommend installing and maintaining GFCI protection at all exterior receptacles.

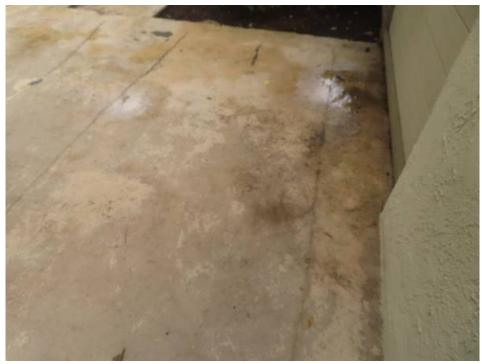
Concrete

MONITOR: Small cracks viewed in the paving appear to be typical of settlement or shrinkage. We recommend monitoring cracks from time to time. Change in the size or number of cracks may be symptomatic of other conditions such as defective drainage, settlement or soil movement and should be further evaluated by a licensed masonry contractor.

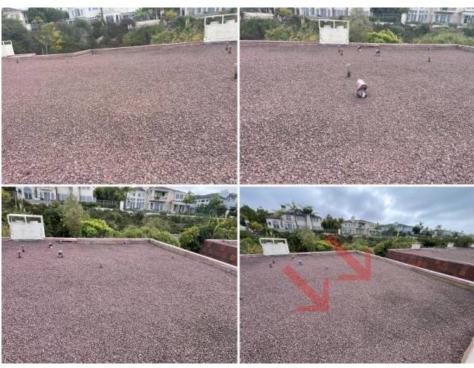
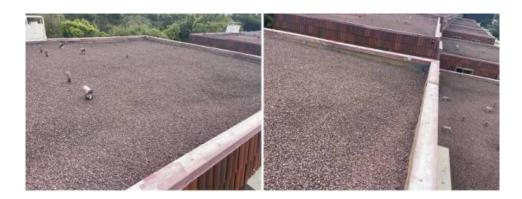
Over west/front bedroom.

DEFECTIVE: Evidence of possible pooling. This condition can reduce the service life of the roof.

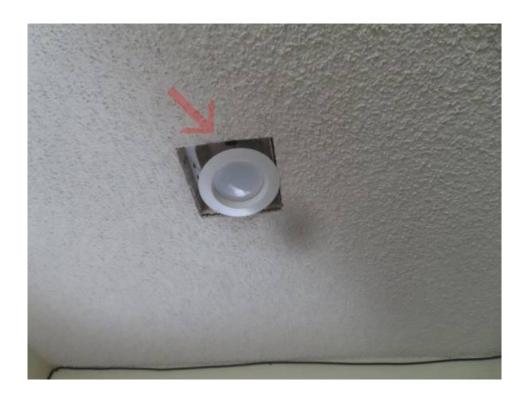
Entry light. Recommend proper installation.

DEFECTIVE: Light fixture is broken, missing the globe, or is not installed at one or more locations.

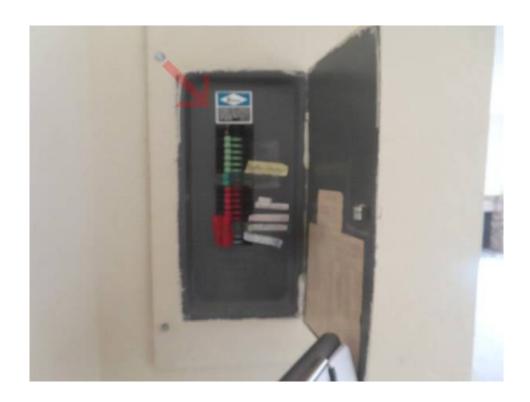
Circuit breakers.

SAFETY: Federal Pacific or Zinsco brand panel present. Electrical panels and circuit breakers are known to deteriorate with age. Many older panels have aluminum bus bars that are susceptible to oxidization, which can compromise the electrical connections. Also, older breakers have a higher failure rate than do modern breakers. Both of these conditions can lead to arcing and overheating, sometimes resulting in an electrical fire. A visual inspection cannot determine if these panels and breakers are performing to their original design specifications. Federal Pacific and Zinsco brands in particular are problematic and we routinely recommend replacing these panels as a safety upgrade.

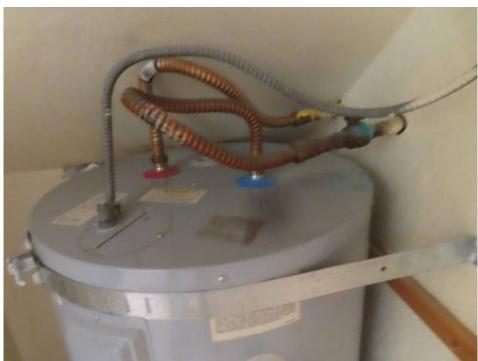
Safety relief valve

DEFECTIVE: No discharge line. A discharge that terminates below the controls and at the exterior of the building or other approved location is required on safety valves.

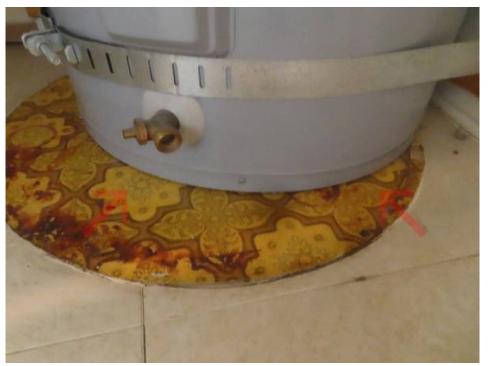
MAINTENANCE: We recommend installing a properly sized catch pan with a drain that terminates at the exterior of the building to prevent damage to structure/belongings in the event the water heater leaks.

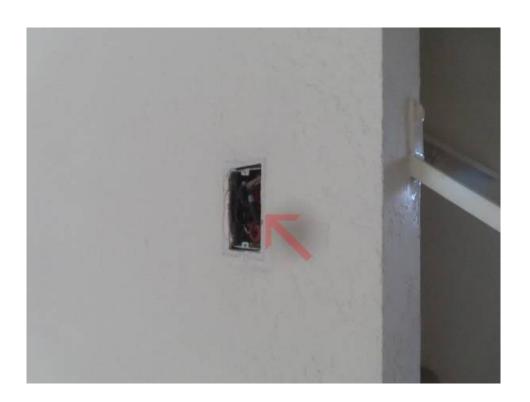
Thermostat

DEFECTIVE: No thermostat present, not tested.

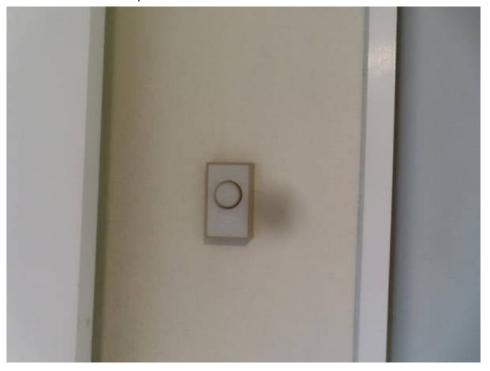
Kitchen.

DEFERRED: Did not respond to user controls.

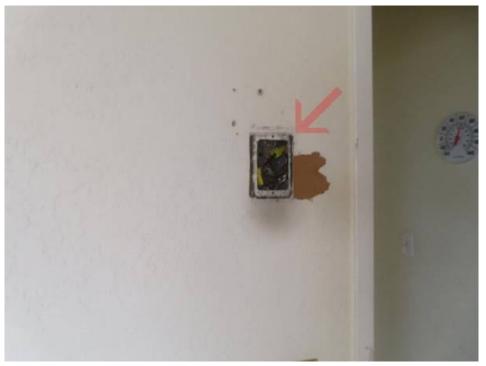
West bedroom.

No thermostat present, not tested.

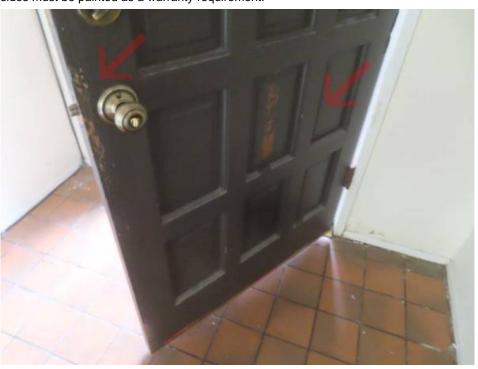
Paint worn.

MAINTENANCE: Door finish is weathered or not painted on all sides. We recommend refinishing at this time to preserve the wood. Most door manufacturers require that all six sides must be painted as a warranty requirement.

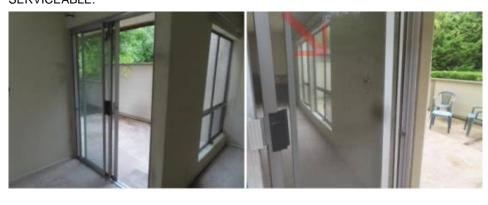
Sliding glass doors

DEFERRED: Metal frame corroding from the elements.

MAINTENANCE: Screen door is damaged or missing at one or more doors sampled.

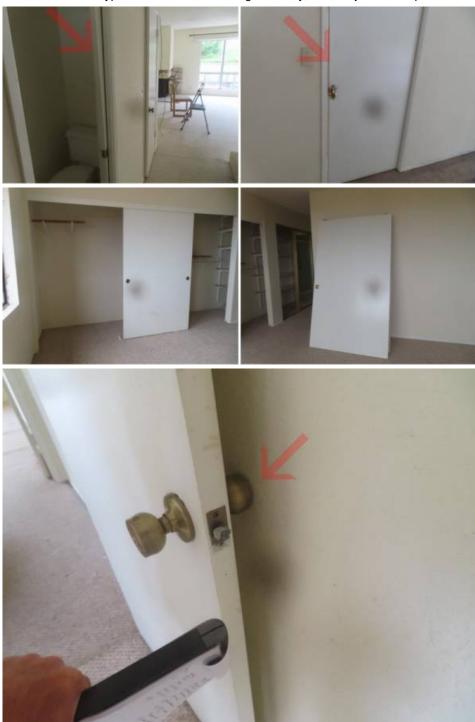
Interior doors

MAINTENANCE: Pocket door/s stick; hardware may need adjustment or repair or door

may need to be trimmed or replaced.

MAINTENANCE: Some doors are missing bumpers and knobs hit the wall.

West bedroom closet doors off the glide.
MAINTENANCE: Bypass closet doors do not glide easily, need adjustment/repair.

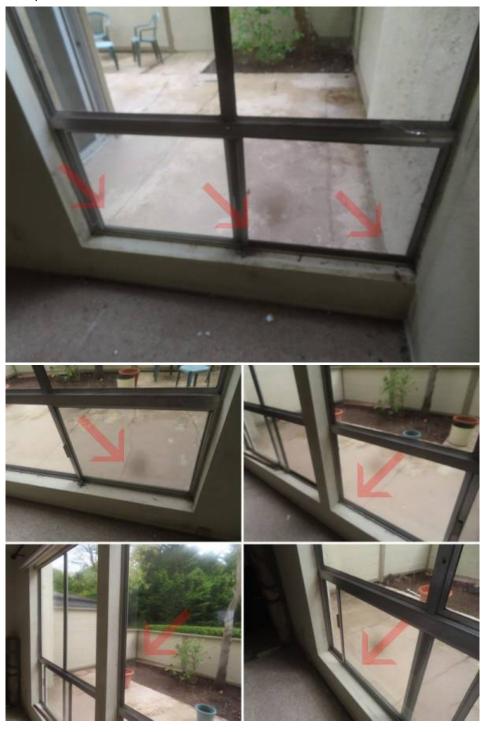
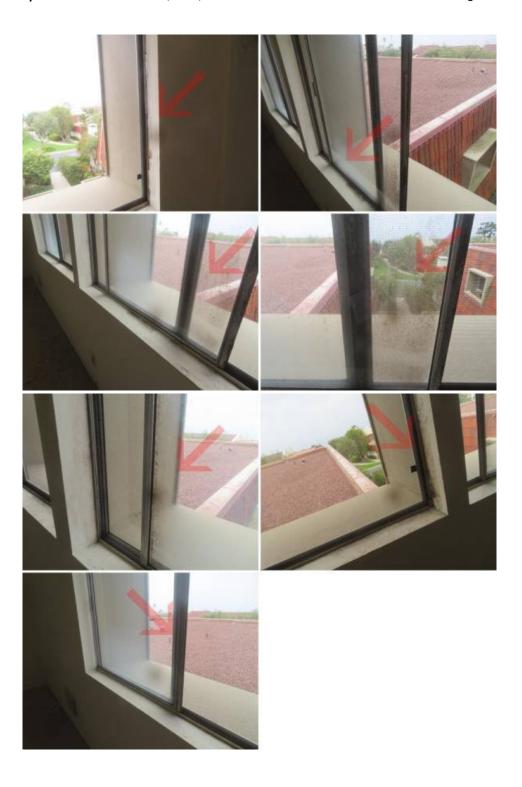
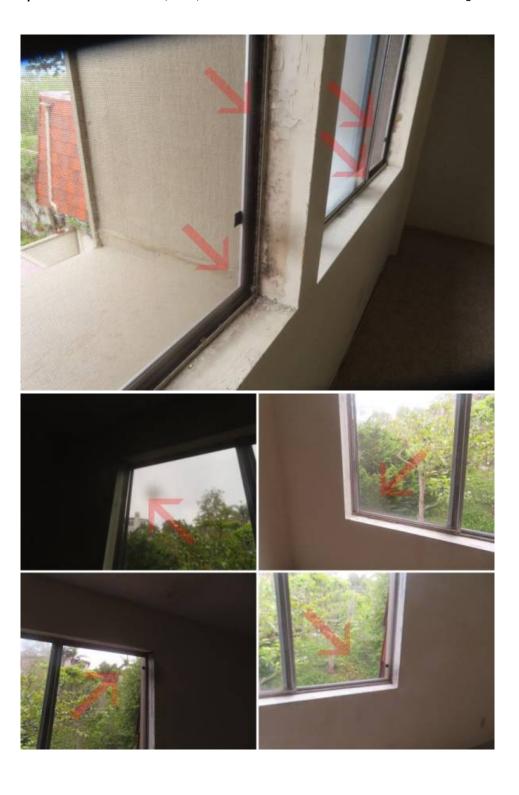
DEFERRED: The window sills were sealed up to prevent air intrusion. Some windows have possible mold and corrosion.

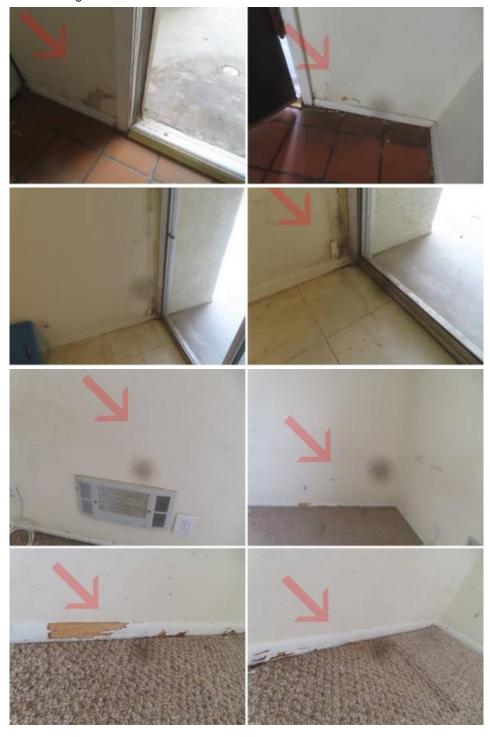
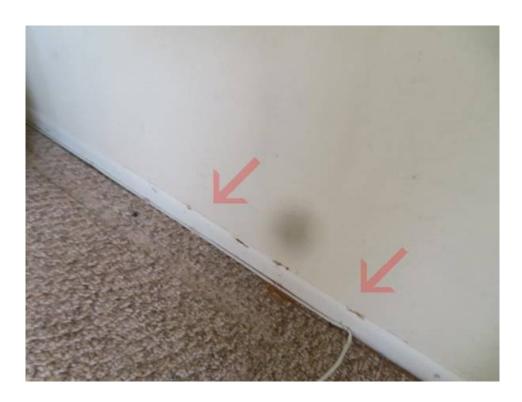
MAINTENANCE: Some holes or damaged drywall needs repairing.

SAFETY: Mold/mildew viewed on the walls/ceiling. Mold can cause illness in humans or pets. Babies, children, the elderly and persons with respiratory disease, allergies or compromised immune systems can be especially at risk. We recommend further evaluation by a qualified Environmentalist or Industrial Hygienist to determine if harmful microorganisms are present.

Insect damage on baseboards in the bedrooms.

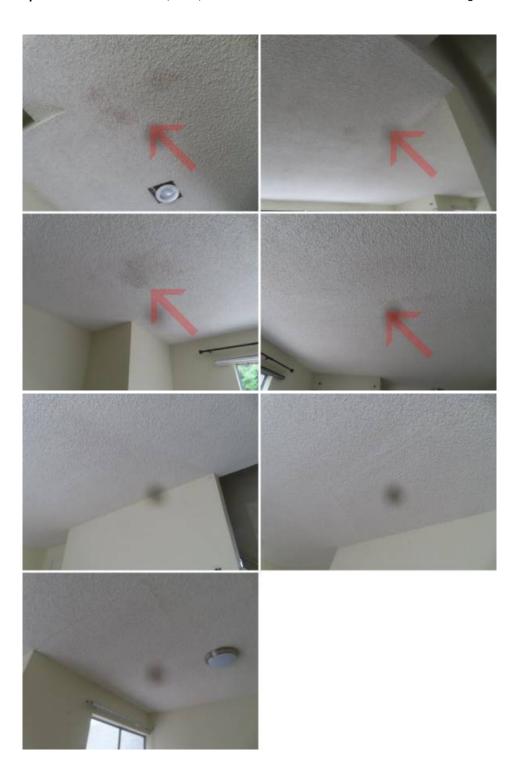
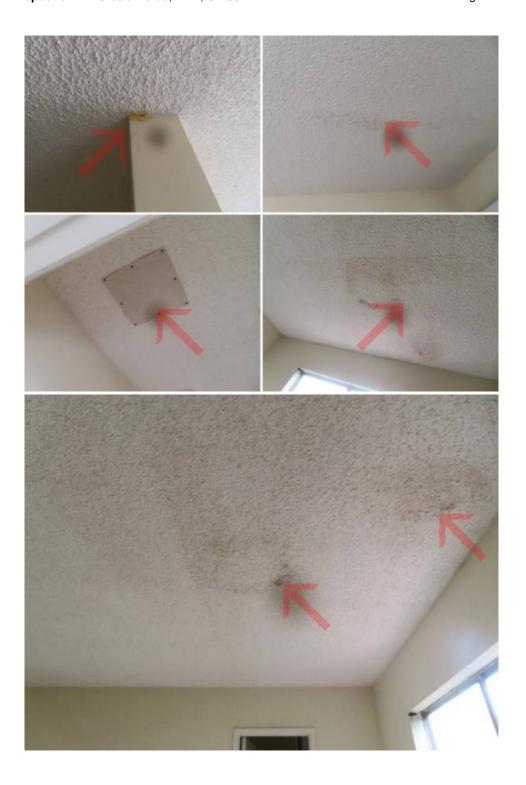
SAFETY: Acoustic ceilings viewed may contain asbestos. Positive identification of asbestos can only be made by a certified laboratory. The acoustic ceilings appear to be in good condition. Removal or encapsulation is not generally recommended unless the material is damaged and/or in friable condition. Asbestos was widely used in building materials prior to 1983. This material if present can pose health risks and will require special handling if disturbed. Your real estate agent may be able to provide you with the pamphlet "Asbestos In The Home" (CPSC Document #453) or you may obtain one yourself from the Consumer Products Safety Commission by calling them at (800) 638-CPSC, or it can be found at their web site: <a href="www.cpsc.gov">www.cpsc.gov</a>. We also have that document available as a .pdf file, which we will e-mailed to you upon request. Living room, east bedroom.

DEFERRED: Moisture stains noted on the ceiling were dry at the time of our inspection and could be from a repaired or intermittent leak. We suggest asking the current owner for any knowledge or history of leakage and monitoring from time to time. West bedroom.

Repair noted.

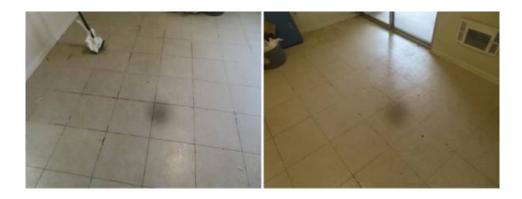
Kitchen. MAINTENANCE: Excessive wear viewed at various locations.

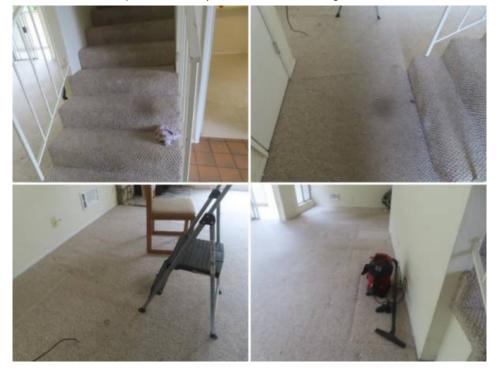
#### Carpeting

MAINTENANCE: Possible stains/discoloration viewed.
MAINTENANCE: Carpet is noticeably worn with some damage.

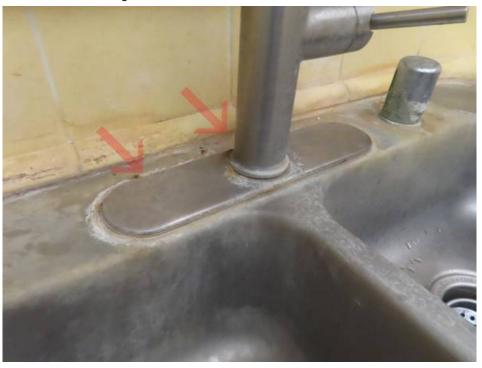
Faucet

DEFERRED: Corroding.

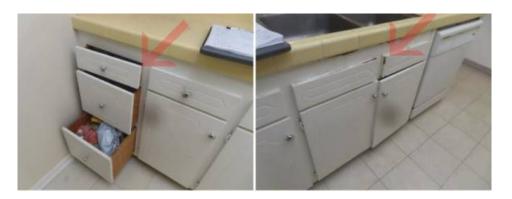
Cabinets

MAINTENANCE: Moderate to heavy wear. Some hinges or doors may be damaged, or do not latch securely, or drawer guides/slides are worn or in disrepair.

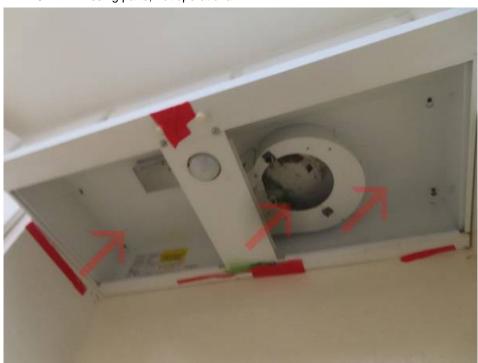
Range vent

DEFECTIVE: Missing parts, not operational.

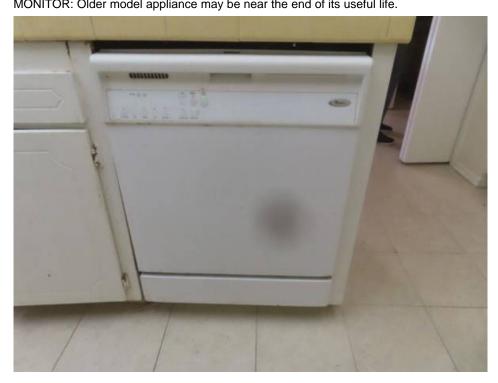
MAINTENANCE: Dishwasher sluggish, makes unusual noise. We recommend further evaluation by a licensed appliance repair person.
MONITOR: Older model appliance may be near the end of its useful life.

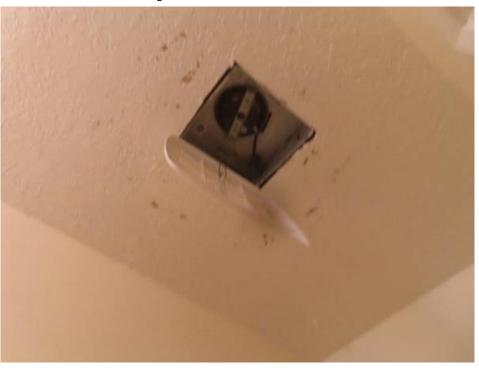
MAINTENANCE: Fan missing holder for cover.

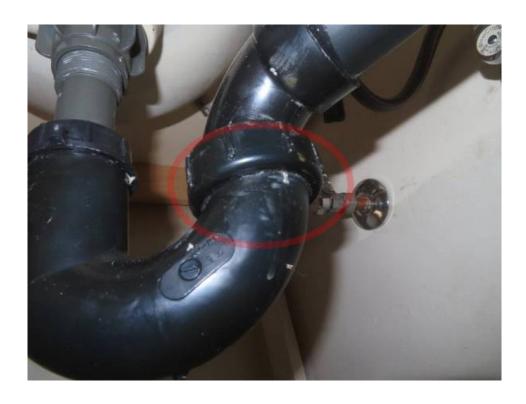
MAINTENANCE: Active leak viewed in the drain line. We recommend further evaluation and repairs as needed by a licensed plumber at this time. Recommend cleaning O ring

washer.

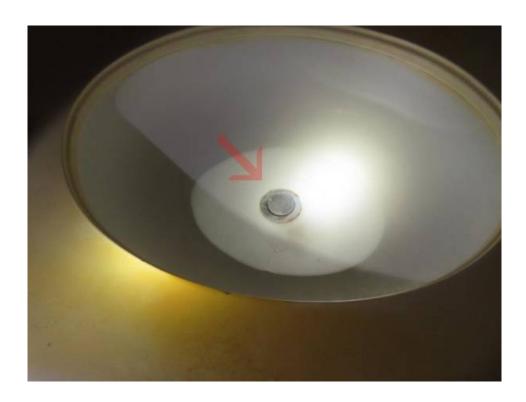
MAINTENANCE: Pop-up stopper needs adjustment or repair.

MAINTENANCE: Drain is restricted. This is likely due to a local restriction at the pop-up stopper or trap. We recommend further evaluation and correction as needed at this time

by a licensed plumbing contractor.

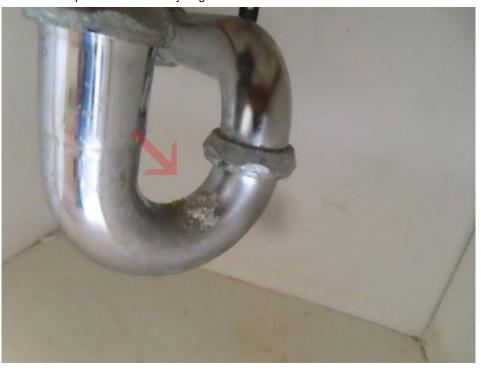
West bedroom. MAINTENANCE: Moderate corrosion on the drain line. We recommend replacing corroded components before they begin to leak.

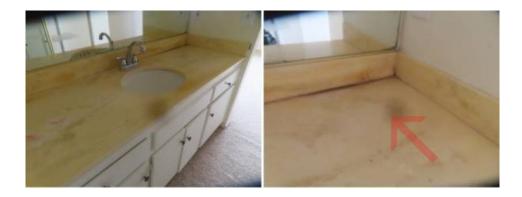
West bedroom.

Marble. Moderate to heavy wear, nicks, scratches or cracks etc.

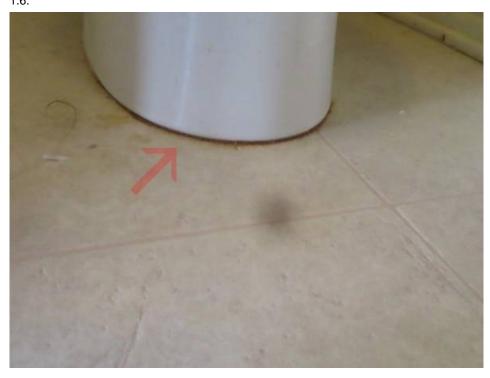
MAINTENANCE: We recommended caulking at the base of the bowl to prevent sewer gases from escaping into the bathroom if the primary wax seal fails.

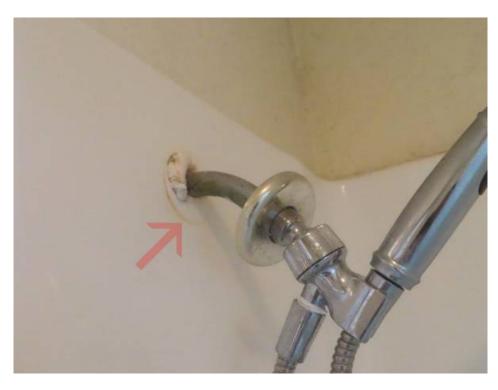
Stall shower

MAINTENANCE: Faucet trim is corroded, damaged or missing. Trim can often be replaced.

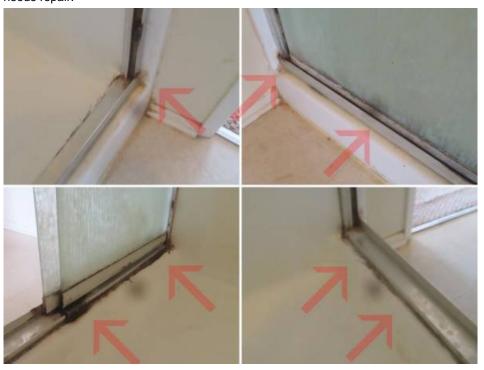
Shower enclosure

West bedroom. MAINTENANCE: Needs general re-caulking or the vinyl strip at the bottom of the door needs repair.

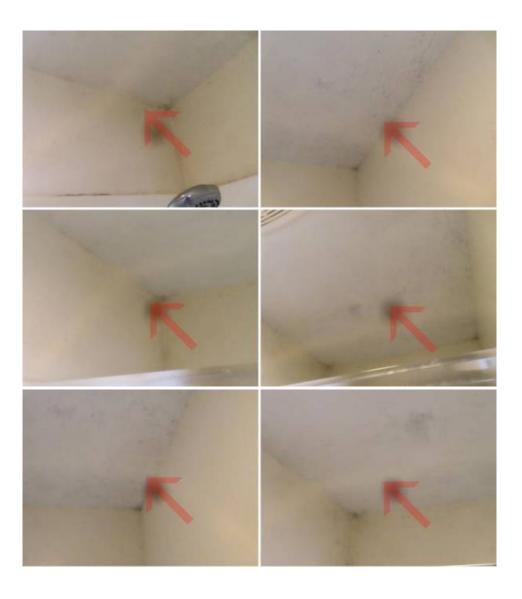
West bedroom.

DEFERRED: Mildew-like or mold-like spots viewed on the ceiling or walls might indicate excessive moisture or inadequate ventilation.

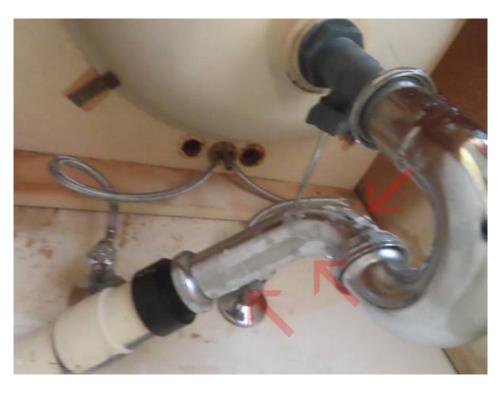
MAINTENANCE: Moderate corrosion on the drain line. We recommend replacing

corroded components before they begin to leak.

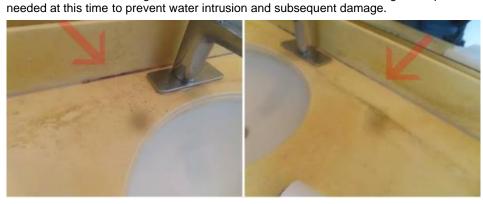
East bedroom.

Marble. Moderate to heavy wear, nicks, scratches or cracks etc. MAINTENANCE: Caulking is deteriorated. We recommend re-caulking backsplash as

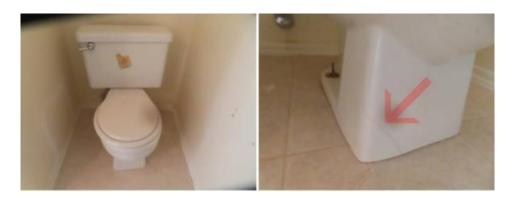
DEFECTIVE: Bowl/base is cracked. A cracked/base bowl may suddenly fail; we recommend replacing the toilet at this time.

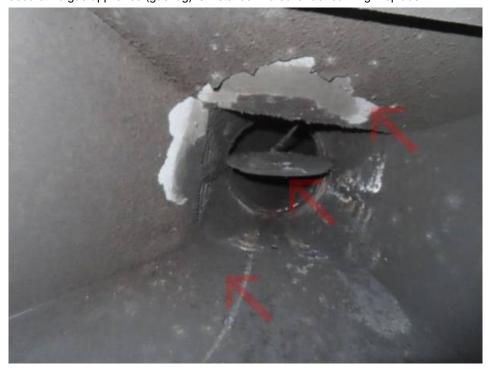
Firebox observations

DEFECTIVE: Damper is not permanently blocked open. Damper must be blocked open a sufficient amount to prevent spillage of combustion products into the room when a decorative gas appliance (gas log) is installed in a solid fuel-burning fireplace.
