## WOOD DESTROYING PESTS AND ORGANISMS INSPECTION REPORT

| Building Address:<br><b>6128 Hawarden Dr, Riverside, CA 92506</b> | | Date of Inspection<br><b>07/09/2024</b> | Number of Pages<br><b>7</b> |
| General Description:<br>Two story stucco residence | | Inspection Tag Posted:    Attic | |

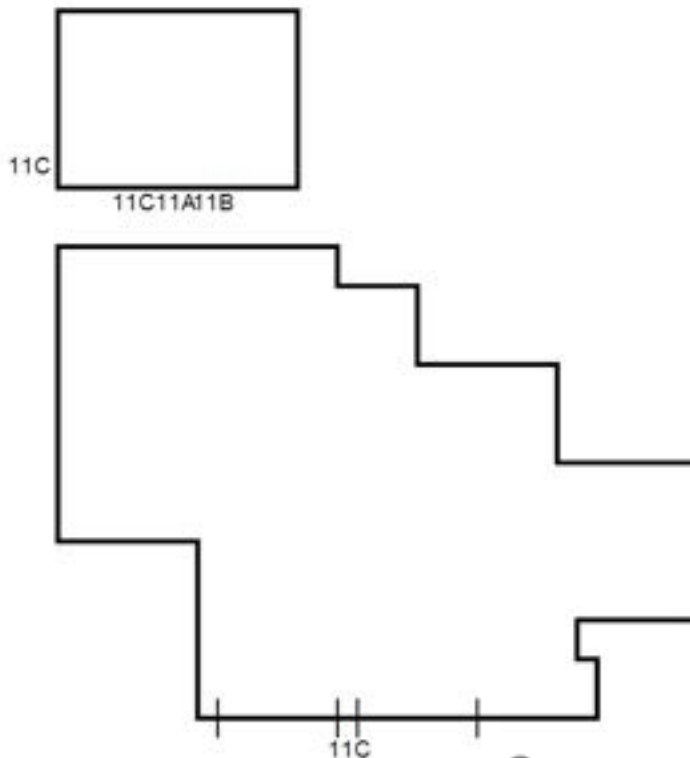
This Diagram is not to scale

- 11A PRICE: \$595.00 (Section I)  
FINDINGS: Evidence of drywood termite infestation.  
RECOMMENDATION: Eliminate visible and accessible drywood termite infestation by using a non-repellant chemical suspended foaming agent to provide a continuous treatment zone to voids and galleries in wood and walls. Remove or cover pellets as needed.

- 11B PRICE: \$995.00 (Section I)  
FINDINGS: Evidence of termite damaged wood members noted at time of inspection.  
RECOMMENDATION: Repair or replace dry-wood termite damaged wood members as necessary. Coastline Termite is not responsible for any damage to roofing materials that may occur during repairs made to roof eave members. Primer is included in this estimate. If additional adverse conditions are uncovered during repairs, further inspection will be recommended and a supplemental report will be issued indicating any infection, or additional repairs.

- 11C PRICE: See 11B (Section I)  
FINDINGS: Dry-rot wood members found at time of inspection.  
RECOMMENDATION: Replace dry-rot damaged wood members as necessary. Primer is included in this estimate. Coastline Termite is not responsible for any damage to roofing materials that may occur during repairs made to roof eave members. If additional adverse conditions are uncovered during repairs, further inspection will be recommended and a supplemental report will be issued indicating any infection, or additional repairs.
