WOOD DESTROYING PESTS AND ORGANISMS INSPECTION REPORT

Building Address: 1208 W. Bloomwood Rd., Ranch Palos Verdes, CA 90275		Date of Inspection 06/14/2023	Number of Pages 6
REDX Termite & Pest Control Company 731 E 110th St. Los Angeles CA 90059 Phone: (323) 360-1728 Fax:		Report # W8215	
		Lic. Registration # PR 8523	
		Escrow #	
Ordered by: Suraiya Sikora	Property Owner and/or Party of Interest: Mohammed F. Anwar 1208 W. Bloomwood Rd. Ranch Palos Verdes, CA 90275	Report Sent to: Suraiya Sikora	
COMPLETE REPORT <input checked="" type="checkbox"/> LIMITED REPORT <input type="checkbox"/> SUPPLEMENTAL REPORT <input type="checkbox"/> REINSPECTION REPORT <input type="checkbox"/>			
General Description: Two story single family residence, stucco on wood frame, furnished & occupied, attached two car garage, slab foundation. Fumigation size: 35,000 cubic feet.		Inspection Tag Posted: Garage	
		Other Tags Posted: None	
An inspection has been made of the structure(s) shown on the diagram in accordance with the Structural Pest Control Act. Detached porches, detached steps, detached decks and any other structures not on the diagram were not inspected.

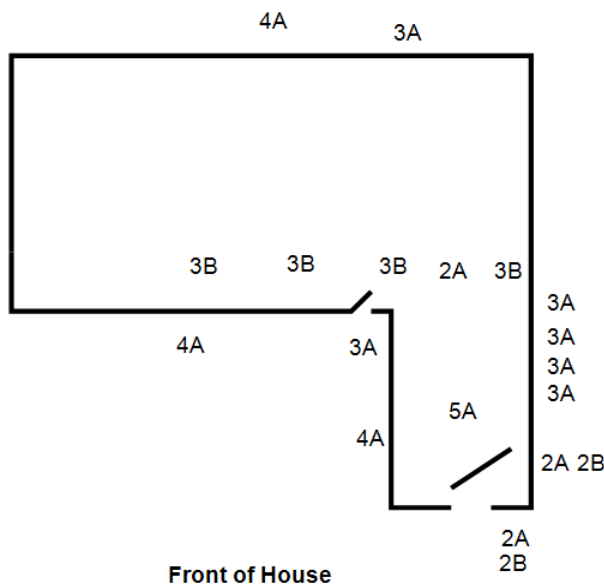
This Diagram is not to scale

Drywood: At attic access frame, outlooker, and rafter tail.

2A PRICE: \$2,450.00 (Section I)
FINDINGS: Evidence of drywood termite infestation at attic access frame, outlooker, and rafter tail as indicated on the diagram.
RECOMMENDATION: Vacate the premises and seal the structure for fumigation with Vikane Gas. Remove or cover accessible evidence of infestation. Fumigation warranted for two years. Fumigation awareness notice must be signed prior to fumigation. See fumigation notice for terms and liabilities.

2B PRICE: \$1,925.00 (Section I)
FINDINGS: Evidence of termite damaged wood members noted at time of inspection at outlooker and rafter tail as indicated on the diagram.
RECOMMENDATION: Remove and replace 1) 2"x4"x2' outlooker and 1) 2"x4"x6" rafter tail. One coat of primer is included in this estimate.

Fungus / Dryrot: At second story corbels, rafter tails, shiplap, and fascia board.

3A PRICE: See 2B (Section I)
FINDINGS: Dry-rot wood members found at time of inspection at fascia board, rafter tails, and shiplap, as indicated on the diagram.
RECOMMENDATION: Remove and replace 1) 2"x8"x20' fascia board, 1) 1"x8"x4' shiplap, 4) 2"x4"x6" rafter tails. One coat of primer is included in this estimate.

3B PRICE: See 2B (Section I)
FINDINGS: Dry-rot wood members found at time of inspection at second story corbel beams as indicated on the diagram.
RECOMMENDATION: Remove and replace 4) 4"x12"x3' corbel beams. No painting is included in this estimate.
