HOME INSPECTION REPORT

952 S Walnut St, Anaheim, CA 92802

Inspection Date: 4/25/2023

Report Number: 20230425-952-S-Walnut-St

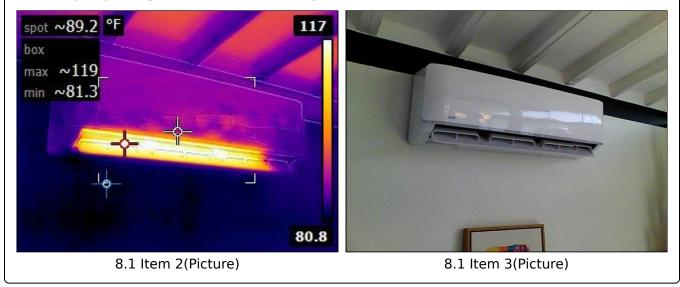
(3) Mini split unit was tested using normal operating controls and provided heat at the service registers. Changing the air filters, servicing and regular maintenance of the components is necessary to prolong the service life of the system.

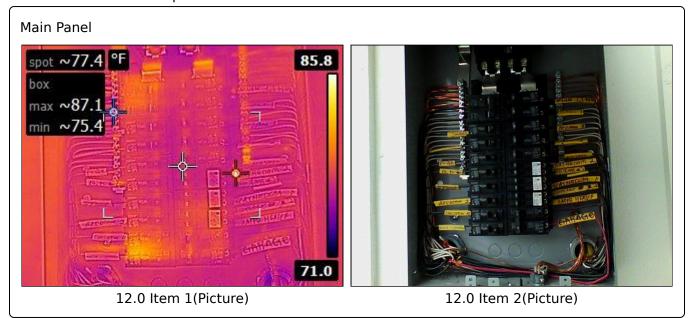
12.0 MAIN & SUB PANELS

Comments: Limited Inspection

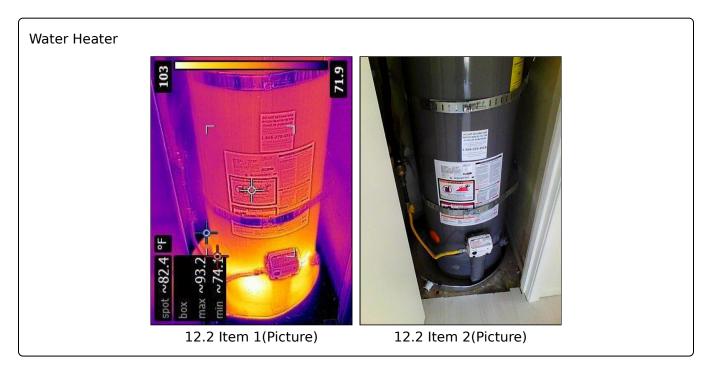
Comments: Limited Inspection

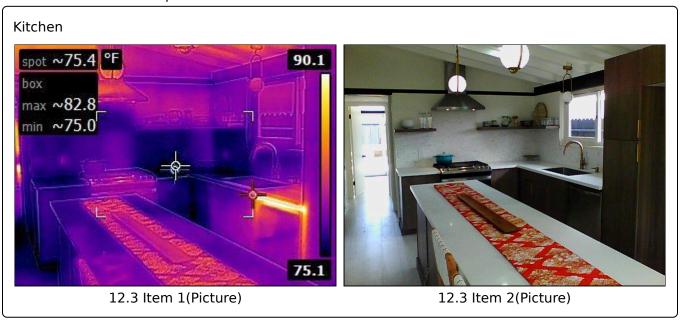
12.3 KITCHEN AREAS

Comments: Limited Inspection

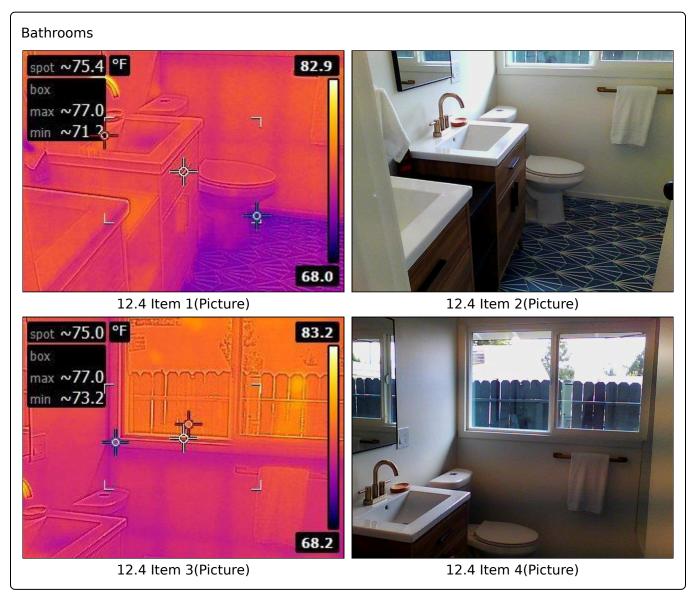
12.4 BATHROOM AREAS

Comments: Limited Inspection

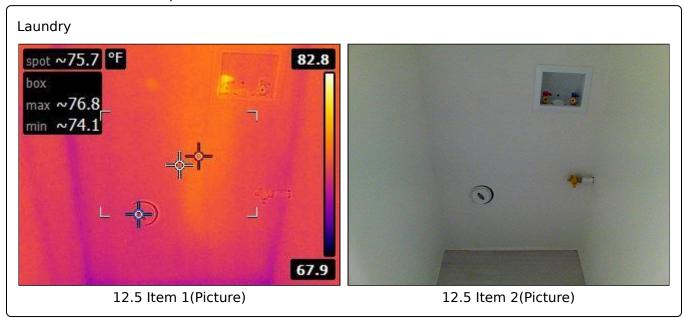
12.5 THERMAL COMMENTS

Comments: Limited Inspection
