WOOD DESTROYING PESTS AND ORGANISMS INSPECTION REPORT

| Building No. | Street | City | Zip | Date of Inspection | Number of Pages |
|---|---|---|---|---|---|
| 441 | Gould Ave | Hermosa Beach | 90254 | 04/14/2025 | 1 of 8 |

| | | Smart Pest Control 2323 Main Irvine, CA 92614 855-305-2226 Registration No. PR8607 | | Report Number: 440309 | |

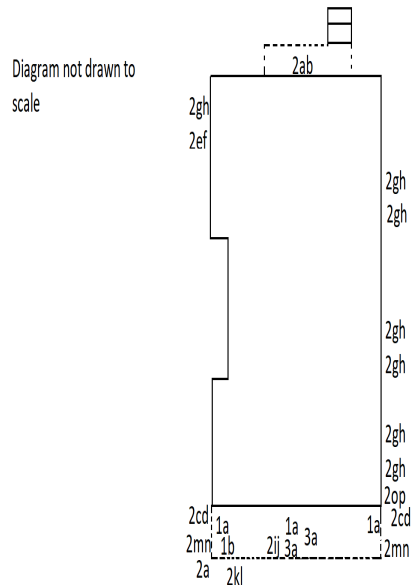
| Key: 1 = Subterranean Termites 2 = Drywood Termites 3 = Fungus/Dryrot 4 = Other Findings 5 = Further Inspection DRAWING NOT TO SCALE | | | | | |

| Item | Finding | Recommendation |
|---|---|--|
| 1A | FINDING: Subterranean termites noted at garage door jamb marked on diagram. | Drill and chemically local treat Drywood or Subterranean Termite infested timbers with registered chemical in visible and accessible areas for the eradication and control of Drywood Termites or Subterranean Termites. Remove and replace subterranean termite damaged timbers, as necessary. (Patch minor damage caused by subterranean termites where possible and practical). |
| 2A | FINDING: Evidence of drywood termites where noted at second story fascia beam as marked on diagram. ***rain gutters | Due to the nature of these infestations, it will be necessary to seal the entire structure and fumigate it with Vikane (Sulfuryl Fluoride), using Chloropicrin as a warning agent. The entire structure must be vacant for at least 72 hours for this process. We will contact The Gas Company to shut off the natural gas to this structure prior to fumigation, after this is scheduled it will be the owners responsibility to contact the gas company to restore when the fumigation is complete. We will use all due caution in our operation; however, we assume no liability for any damage to the roof covering, solar panels, TV antenna or plantings adjacent to the structure. The occupants must sign the Occupant's Fumigation Notice and comply with all of the instructions. The fumigation will not be done in high winds or heavy rain. The job will have to be rescheduled as weather permits. We will remove or cover evidence of drywood termites. A roof release must be signed for tile and sensitive roofs. ****HAS A THREE YEAR WARRANTY ON FUMIGATION**** |
| 2B | FINDING: Evidence of drywood termite infestation and damage was noted at second story fascia beam as marked on diagram. | Remove and replace fungus infected/fungus damaged and drywood termite damaged timbers, as necessary. (Patch minor damage caused by drywood termites and fungus infection, where possible and practical). Special order materials may take up to 5 working days for delivery. |
| 2C | FINDING: Evidence of drywood termites was noted at second story beam as marked on diagram. | See fumigation recommendation for the extermination of all drywood termite infestations. |
| 2D | FINDING: Evidence of drywood termite infestation and damage was noted at where marked on diagram second story fascia | Remove and replace fungus infected/fungus damaged and drywood termite damaged timbers, as necessary. (Patch minor damage caused by drywood termites and fungus infection, where possible and practical). Special order materials may take up to 5 working days for delivery. |
| 2E | FINDING: Evidence of drywood termite infestation and damage was noted at where marked on diagram second story fascia | See fumigation recommendation for the extermination of all drywood termite infestations. |
| 2F | FINDING: Evidence of drywood termite infestation and damage was noted at where marked on diagram Second story fascia | Remove and replace fungus infected/fungus damaged and drywood termite damaged timbers, as necessary. (Patch minor damage caused by drywood termites and fungus infection, where possible and practical). Special order materials may take up to 5 working days for delivery. |
| 2G | FINDING: Evidence of drywood termites were noted where marked on second story rafter beam as marked on diagram. | See fumigation recommendation for the extermination of all drywood termite infestations. |
| 2H | FINDING: Evidence of drywood termite infestation and damage was noted at second story rafter beam as marked on diagram. | Remove and replace fungus infected/fungus damaged and drywood termite damaged timbers, as necessary. (Patch minor damage caused by drywood termites and fungus infection, where possible and practical). Special order materials may take up to 5 working days for delivery. |
| 2I | FINDING: Evidence of drywood termites were noted under balcony frame as marked on diagram. | See fumigation recommendation for the extermination of all drywood termite infestations. |

| 2J | FINDING: Evidence of drywood termite infestation and damage was noted at under balcony frame as marked on diagram. | Owner is to contact an appropriate licensed contractor for further inspection and any needed corrections of the condition as noted in this finding. |
| 2K | FINDING: Evidence of drywood termites were noted balcony post as marked on diagram. | See fumigation recommendation for the extermination of all drywood termite infestations. |
| 2L | FINDING: Evidence of drywood termite infestation and damage was noted at where marked on diagram balcony post | Owner is to contact an appropriate licensed contractor for further inspection and any needed corrections of the condition as noted in this finding. |
| 2M | FINDING: Evidence of drywood termites were noted at balcony rail as marked on diagram. | See fumigation recommendation for the extermination of all drywood termite infestations. |
| 2N | FINDING: Evidence of drywood termite infestation and damage was noted at balcony rail as marked on diagram. | Owner is to contact an appropriate licensed contractor for further inspection and any needed corrections of the condition as noted in this finding. |
| 2O | FINDING: Evidence of drywood termites were noted where marked on diagram second story sheat line | See fumigation recommendation for the extermination of all drywood termite infestations. |
| 2P | FINDING: Evidence of drywood termite infestation and damage was noted at where marked on diagram second story sheatline | Remove and replace fungus infected/fungus damaged and drywood termite damaged timbers, as necessary. (Patch minor damage caused by drywood termites and fungus infection, where possible and practical). Special order materials may take up to 5 working days for delivery. |
| 3A | FINDING: Fungus infection and damage was noted at garage door jamb as marked on diagram. | Remove and replace fungus infected/fungus damaged and drywood termite damaged timbers, as necessary. (Patch minor damage caused by drywood termites and fungus infection, where possible and practical). Special order materials may take up to 5 working days for delivery. |
