WOOD DESTROYING PESTS AND ORGANISMS INSPECTION REPORT - Reinspection

Building Address: 1106 E. 45th Wy., Long Beach, CA 90807		Date of Inspection 09/20/2024	Number of Pages 7

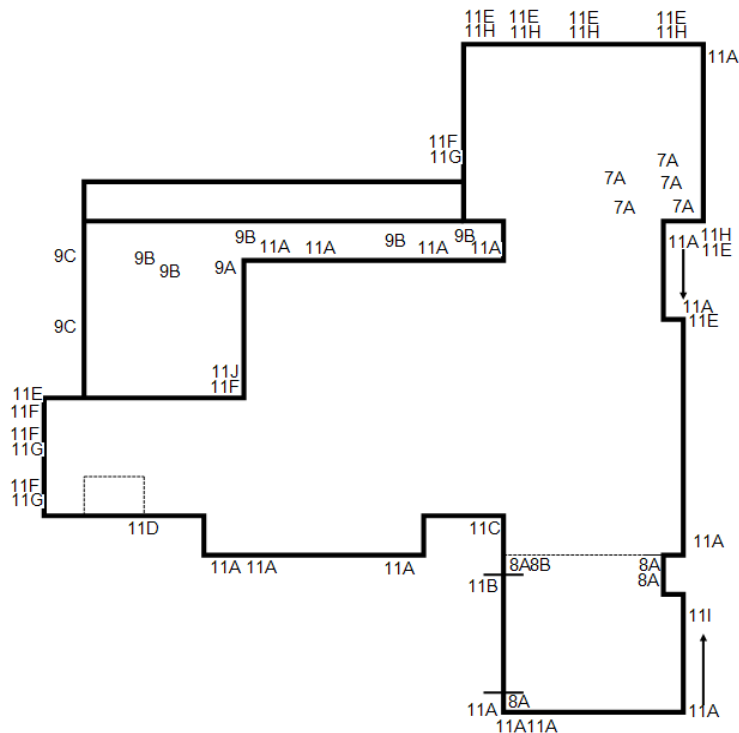
This Diagram is not to scale

- 7A PRICE: \$550.00 (Section II)
FINDINGS: Old termite droppings noted at time of inspection at attic as indicated on the diagram.
RECOMMENDATION: Re-treat to ensure no active infestations exist. Remove or cover accessible pellets.

- 8A PRICE: See 7A (Section II)
FINDINGS: Old termite droppings noted at time of inspection at garage framing as indicated on the diagram.
RECOMMENDATION: Re-treat to ensure no active infestations exist. Remove or cover accessible pellets.
- 8B PRICE: \$575.00 (Section I)
FINDINGS: Evidence of drywood termite damaged wood members noted at time of inspection at garage roof sheathing as indicated on the diagram
RECOMMENDATION: Reinforce 1"x3"x2' of termite damaged wood members as necessary.

- 9A PRICE: \$5,395.00 (Section I)
FINDINGS: Dry-rot wood members found at time of inspection at patio header as indicated on the diagram.
RECOMMENDATION: Replace 1"x4"x8' of dry-rot damaged wood members as necessary. Painting is included in this estimate.
- 9B PRICE: See 9A (Section I)
FINDINGS: Dry-rot wood members found at time of inspection at patio trellis as indicated on the diagram.
RECOMMENDATION: Replace 2"x3"x6' (4) and 2"x3"x8' (5) of dry-rot damaged wood members as necessary. Painting is included in this estimate.
- 9C PRICE: \$50.00 (Section I)
FINDINGS: Dry-rot wood members found at time of inspection at patio rafter beam as indicated on the diagram.
RECOMMENDATION: Remove dry-rot damaged wood members as necessary.

- 11A PRICE: See 9A (Section I)
FINDINGS: Dry-rot wood members found at time of inspection at tongue and groove siding as indicated on the diagram.
RECOMMENDATION: Replace and/or repair 1"x8"x8' (44), 1"x8"x4' (4) and 1"x8"x1' (2) of dry-rot damaged wood members as necessary. Painting is included in this estimate.

- 11B PRICE: See 9A (Section I)
FINDINGS: Dry-rot wood members found at time of inspection at garage door frame as indicated on the diagram.
RECOMMENDATION: Replace or repair dry-rot damaged wood members as necessary. Painting is included in this estimate.

- 11C PRICE: See 9A (Section I)
FINDINGS: Dry-rot wood members found at time of inspection at window trim as indicated on the diagram.
RECOMMENDATION: Replace 1"x8"x1' (5) of dry-rot damaged wood members as necessary. Painting is included in this estimate.

- 11D PRICE: See 9A (Section I)
FINDINGS: Dry-rot wood members found at time of inspection at header as indicated on the diagram.
RECOMMENDATION: Repair dry-rot damaged wood members as necessary. Painting is included in this estimate.

- 11E PRICE: See 9A (Section I)
FINDINGS: Dry-rot wood members found at time of inspection at fascia as indicated on the diagram.
RECOMMENDATION: Replace and/or repair 2"x6"x1' (4) and 2"x6"x3' dry-rot damaged wood members as necessary. Painting is included in this estimate.

- 11F PRICE: See 7A (Section I)
FINDINGS: Evidence of drywood termite infestation at rafter, fascia and door jamb as indicated on the diagram.
RECOMMENDATION: Chemically treat visible and accessible infestations. Remove or cover accessible pellets.

- 11G PRICE: See 9A (Section I)
FINDINGS: Evidence of drywood termite damaged wood members noted at time of inspection at rafters as indicated on the diagram
RECOMMENDATION: Replace or repair 4"x4"x1' and 2"x4"x8' (2) of termite damaged wood members as necessary. Painting is included in this estimate.

- 11H PRICE: See 9A (Section I)
FINDINGS: Dry-rot wood members found at time of inspection at rafter beam as indicated on the diagram.
RECOMMENDATION: Repair (3) dry-rot damaged wood members as necessary. Painting is included in this estimate.

- 11I PRICE: See 9A (Section I)
FINDINGS: Dry-rot wood members found at time of inspection at pedestrian as indicated on the diagram.
RECOMMENDATION: Replace and repair dry-rot damaged door and door casing as necessary. Painting is included in this estimate.

- 11J PRICE: See 9A (Section I)
FINDINGS: Evidence of drywood termite damaged wood members noted at time of inspection at door jamb as indicated on the diagram
RECOMMENDATION: Repair termite damaged wood members as necessary. Painting is included in this estimate.
