WOOD DESTROYING PESTS AND ORGANISMS INSPECTION REPORT

Building No. 3003	Street Crag Ave.	City Oroville	ZIP 95966	Date of Inspection 03/10/2022	Number of Pages 4
----------------------	---------------------	------------------	--------------	----------------------------------	----------------------

HOUSE DETECTIVE TERMITE CONTROL INC
11 COMMERCE CT. SUITE 10
 CHICO CA 95928
 (530) 894-7900 (530) 591-7079
 hdetective@att.net Fax (530) 894-7902

Report # : 14525
 Registration # : PR5960
 Escrow # :
 CORRECTED REPORT

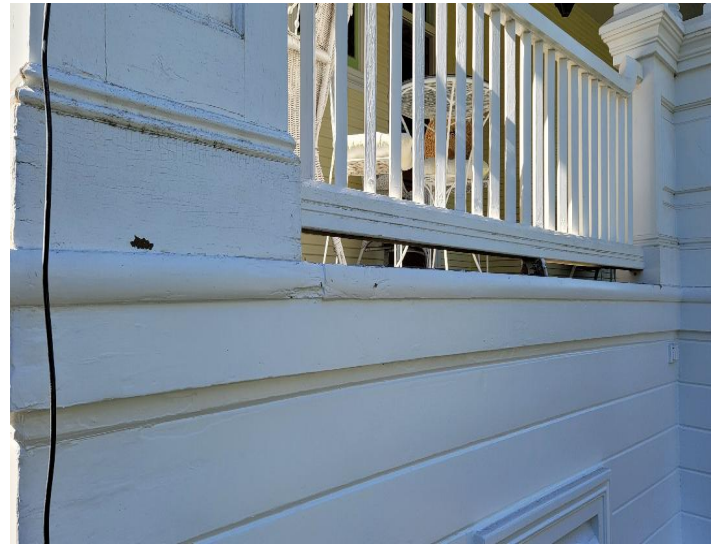
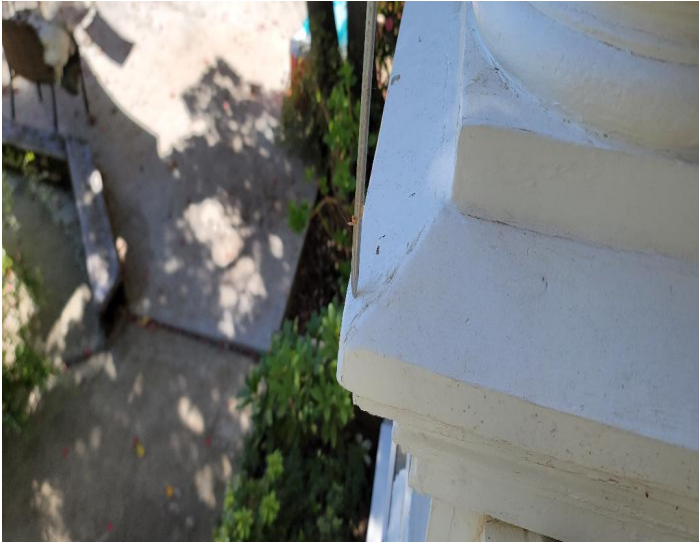
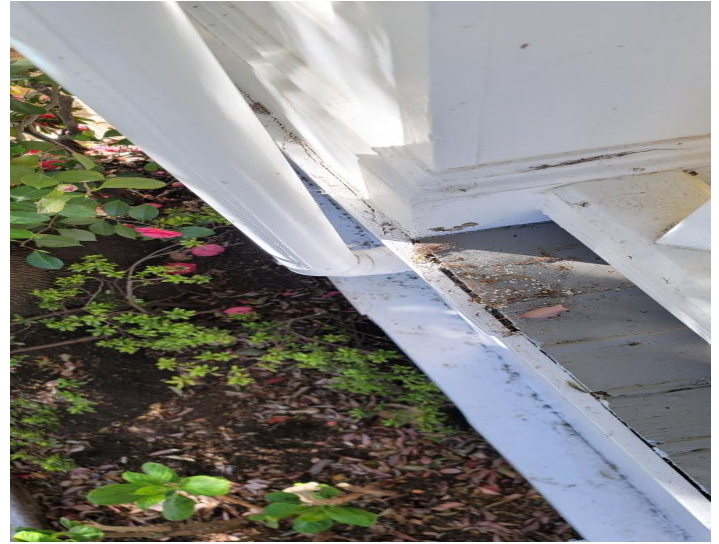
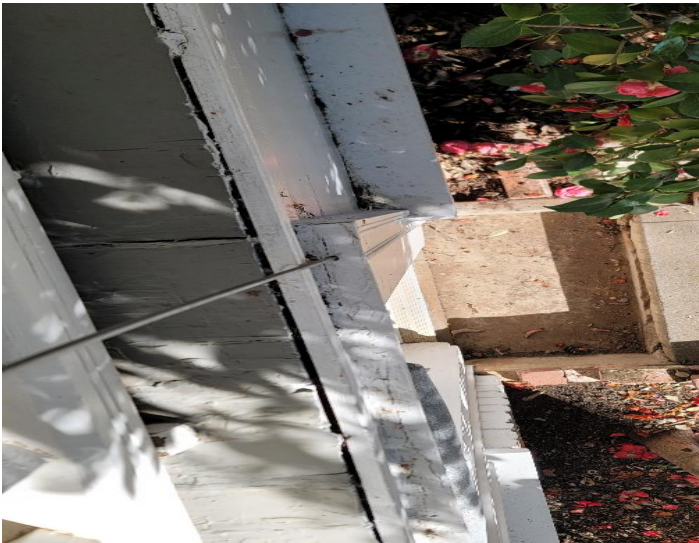
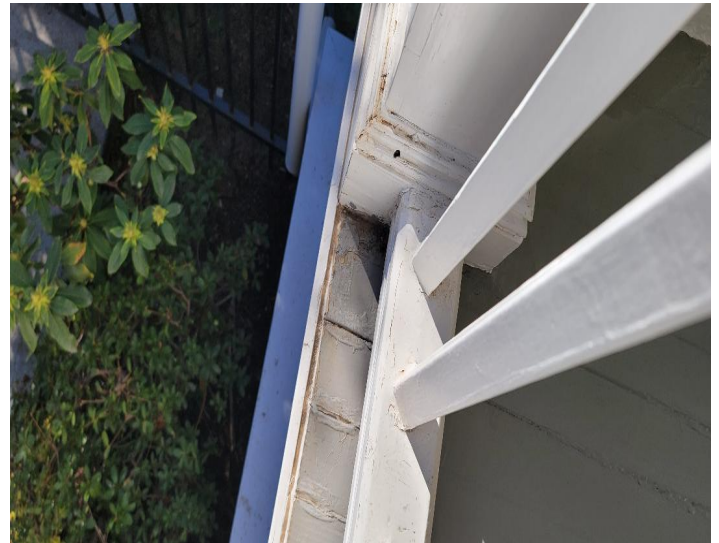
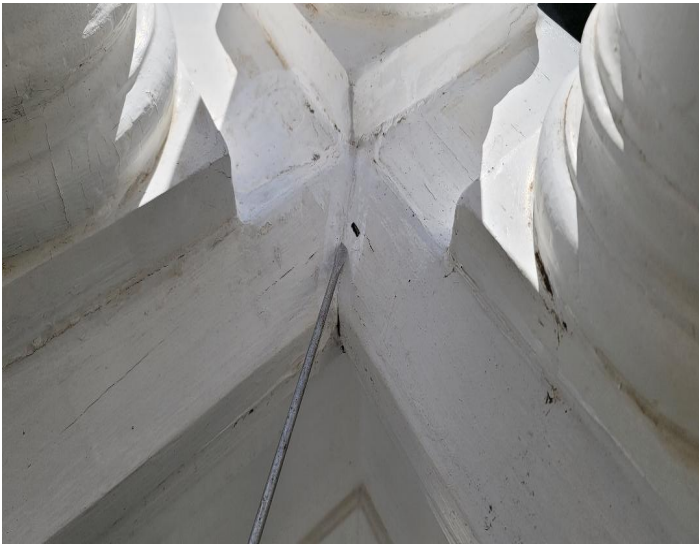
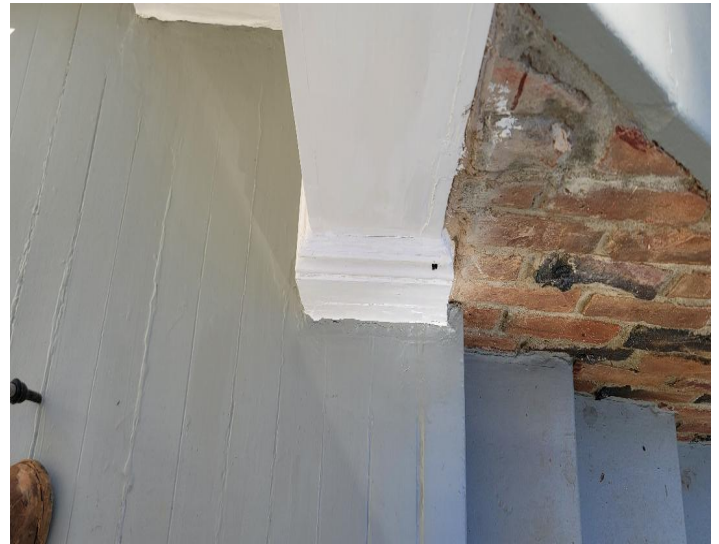
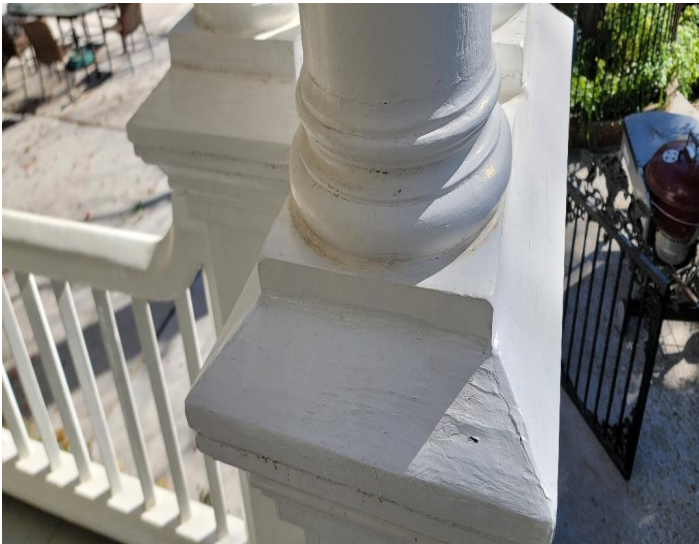
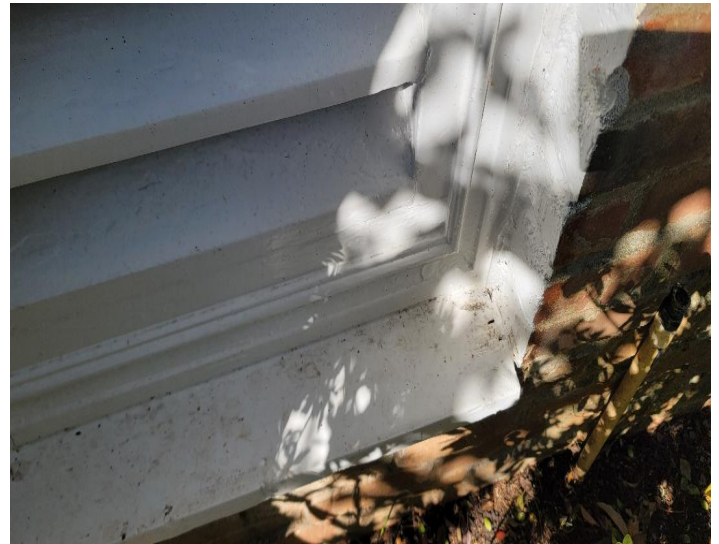
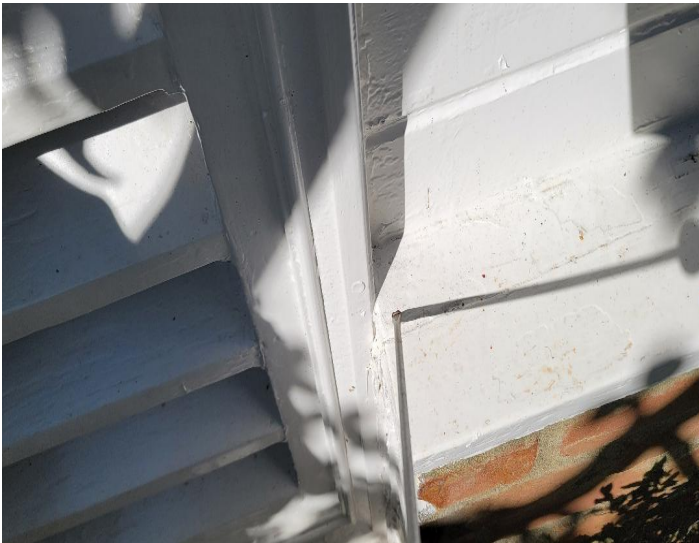
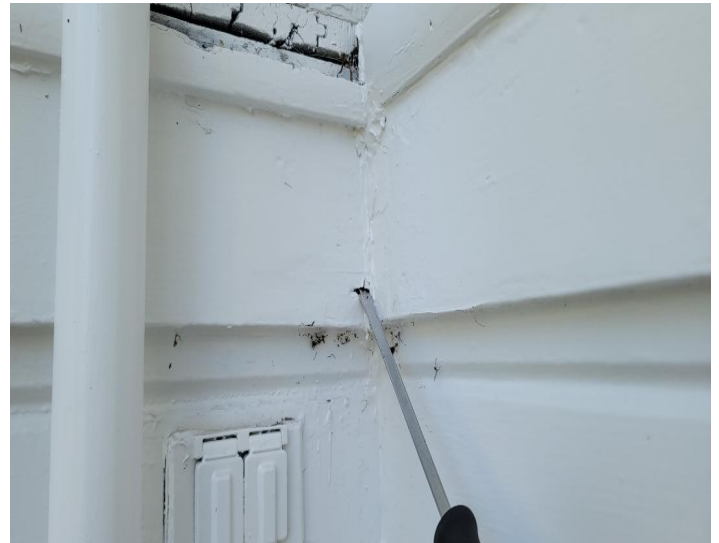
FINDING: Fungus damage was found to wood trim members around the structure,

3A - Damaged trim members.

RECOMMENDATION: We recommend the owner/agent engage the services of a licensed contractor to remove all damaged members and to replace with new appropriate material.

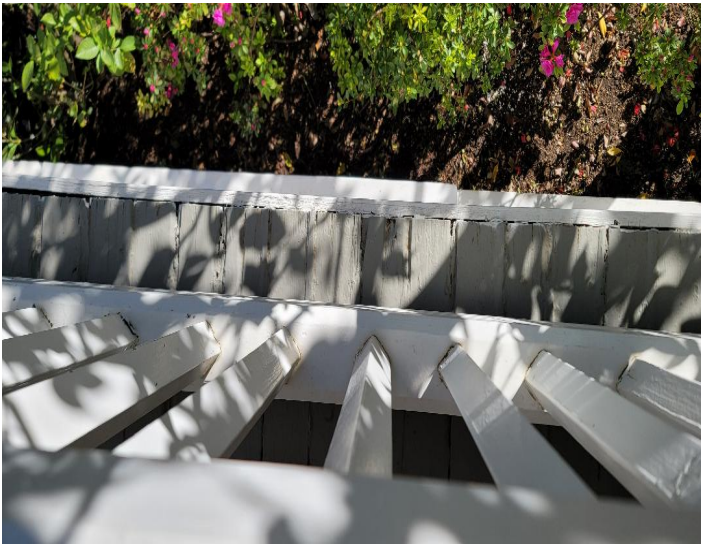
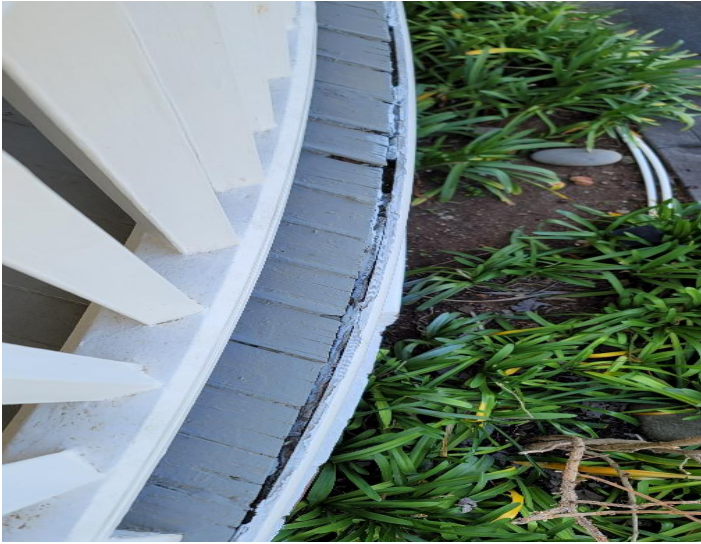
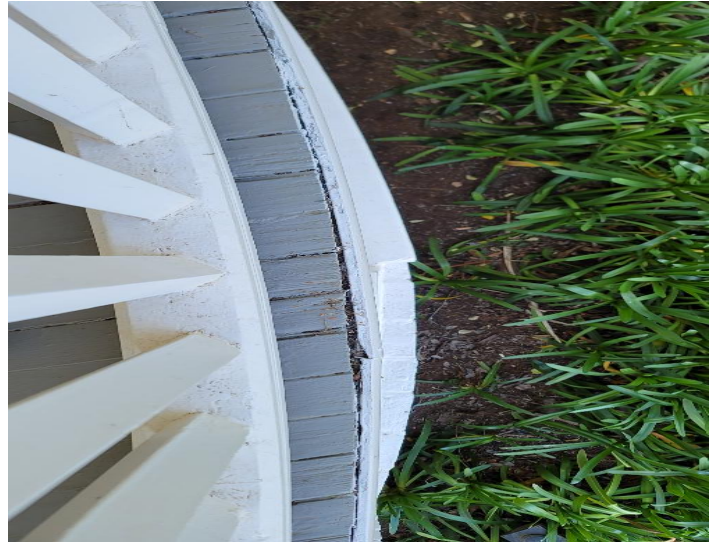
FINDING: Fungus damage was found to ends of decking and deck trim boards on the wood deck.

3B - Damaged deck trim.

RECOMMENDATION: We recommend the owner/agent engage the services of a licensed contractor to remove all damaged members and to replace with new appropriate material.

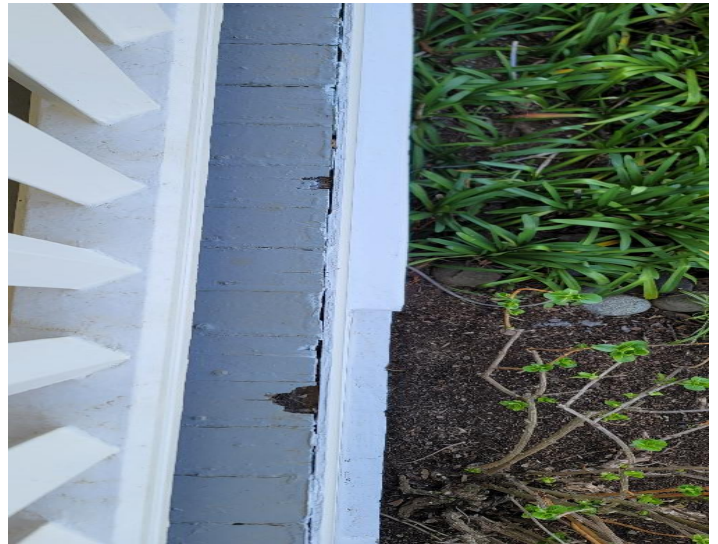
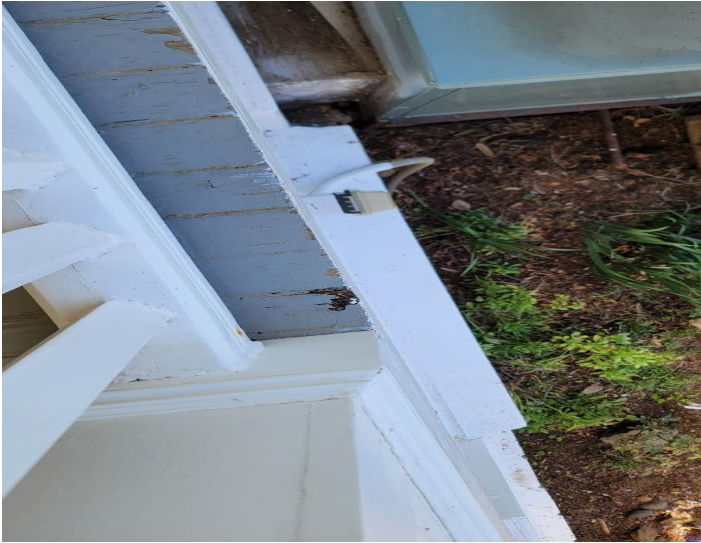
3B - Damaged decking.

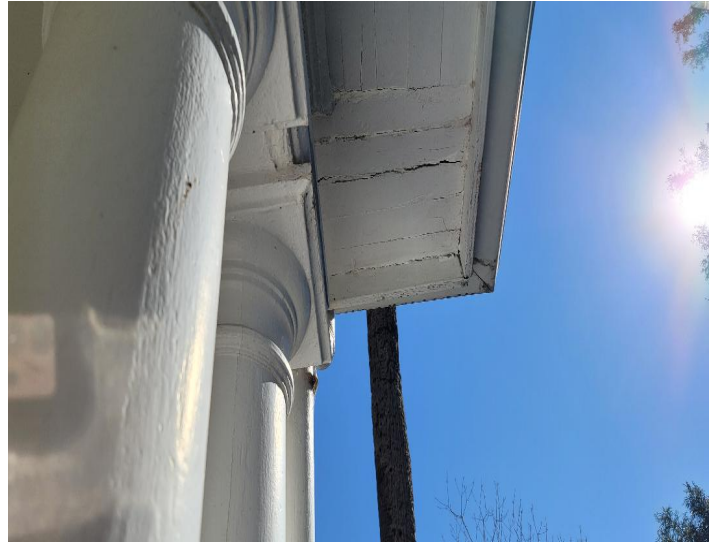
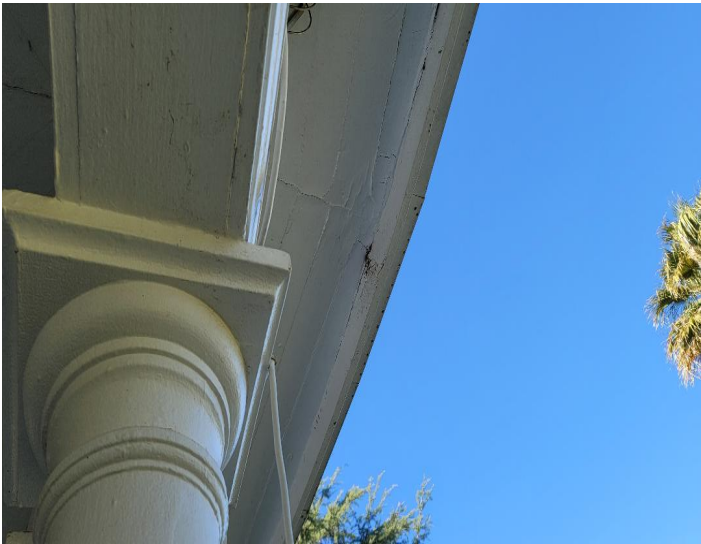
FINDING: Fungus damage was found to roof soffit members.

3C - Damaged roof soffit.

RECOMMENDATION: We recommend the owner/agent engage the services of a licensed contractor to remove all damaged members and to replace with new appropriate material.

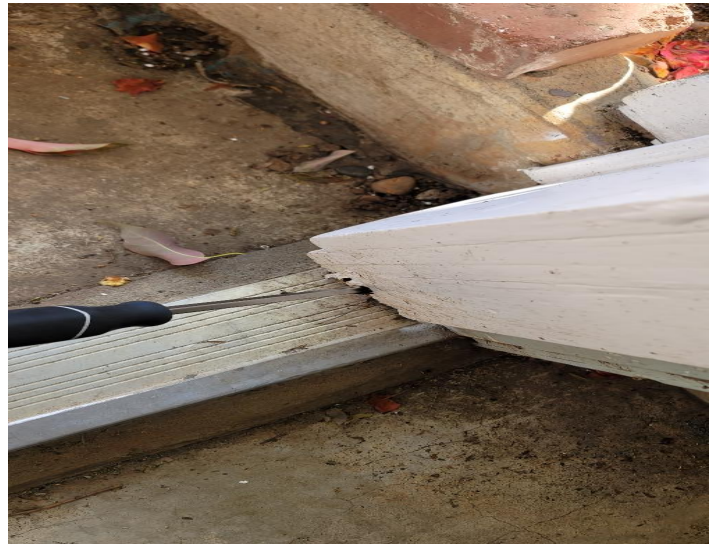
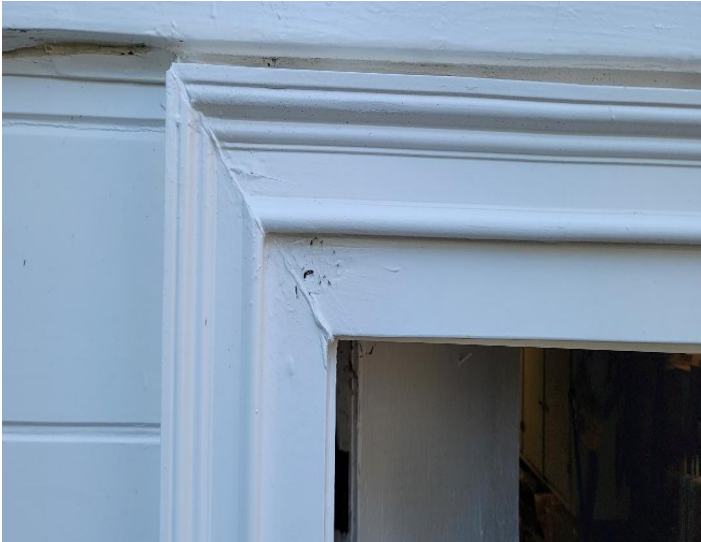
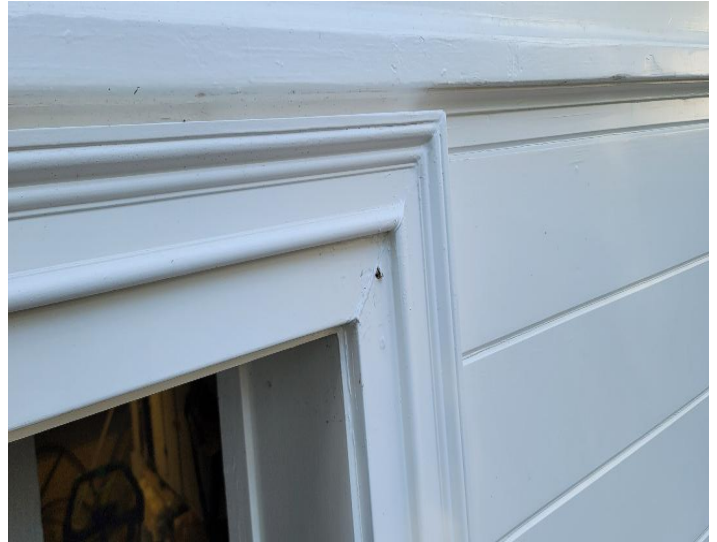
FINDING: Fungus damage was found to door jambs and door trim.

3D - Damaged door jambs.

RECOMMENDATION: We recommend the owner/agent engage the services of a licensed contractor to remove all damaged members and to replace with new appropriate material.

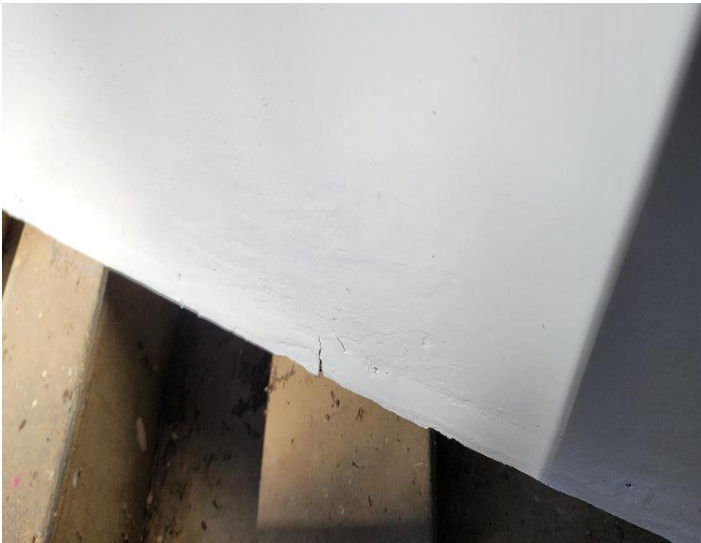
FINDING: Fungus damage was found to the basement door.

3E - Damaged basement door.

RECOMMENDATION: We recommend the owner/agent engage the services of a licensed contractor to remove all damaged members and to replace with new appropriate material.

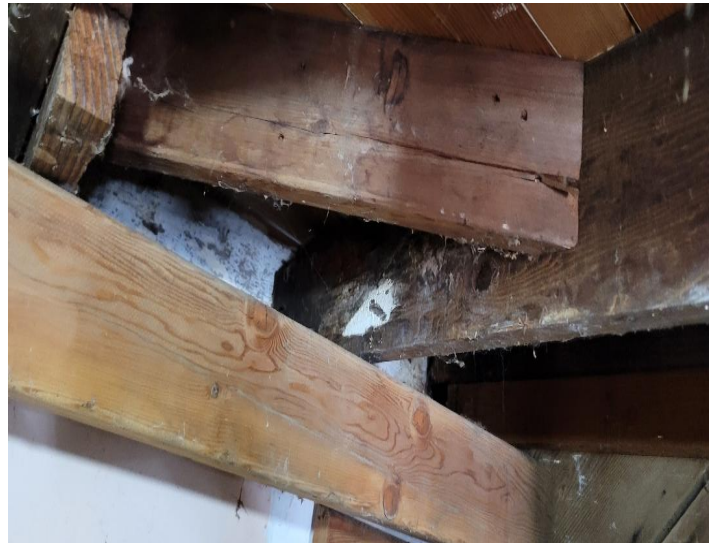
FINDING: Fungus damage was found to floor joist and framing plate.

3F - Damaged floor joist.

RECOMMENDATION: We recommend the owner/agent engage the services of a licensed contractor to remove all damaged

members and to replace with new appropriate material.

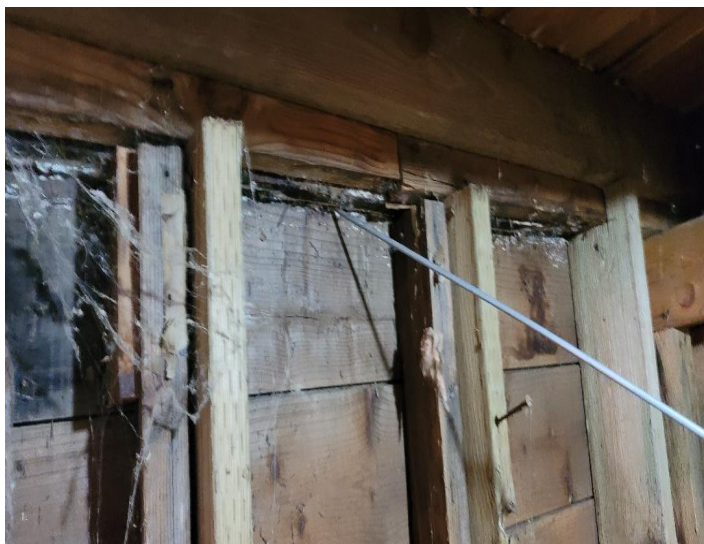
3F - Damaged framing plate.

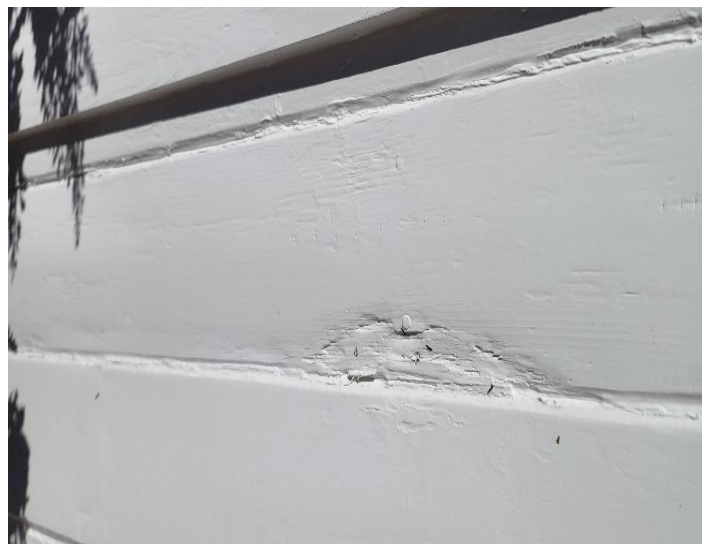
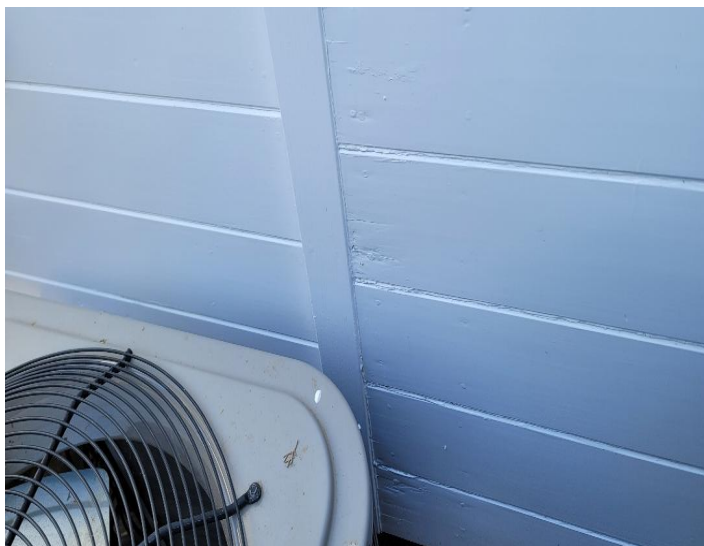
FINDING: Fungus damage was found to wood siding members.

3G - Damaged siding.

RECOMMENDATION: We recommend the owner/agent engage the services of a licensed contractor to remove all damaged members and to replace with new appropriate material.
