# Inspection Report

**Tammy Cody**  
**3662 Rock Garden**  
**San Luis Obispo, CA 93405**

Report Date: 8/9/2025

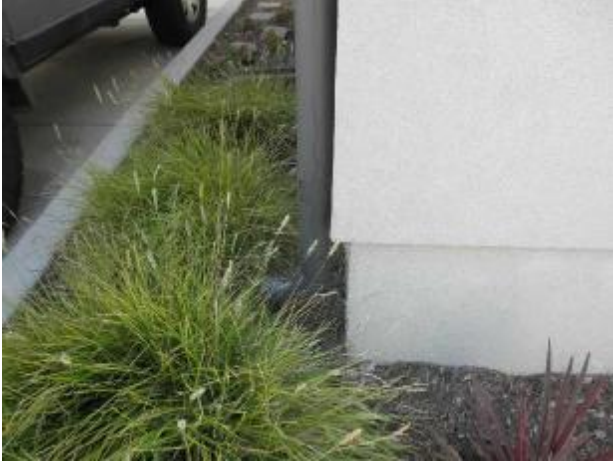
# R

| COMPONENT | CONDITION | ACTION RECOMMENDED | PERSPECTIVE |
|---|---|---|---|
| 6 Gutter system: | <b>Most Acceptable</b> | <b>Repair - See Comments below</b> | <b>Maintenance Item</b> |

**Maintenance Note:** Some of the down spouts have no splash block or extension to divert the runoff water from the roof away from the foundation. Recommend installing proper drainage of roof water away from the structure to reduce foundation moisture and potential foundation settlement.

Some of the down spouts need to be directed away from the foundation.

Maintenance Note: Some of the down spouts have no splash block or extension to divert the runoff water from the roof away from the foundation. Recommend installing proper drainage of roof water away from the structure to reduce foundation moisture and potential foundation settlement.

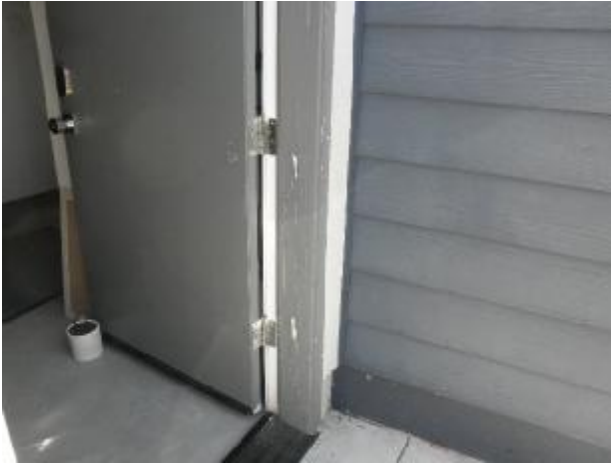
# EX

- 1.) The lock set does not properly latch at the front entry door.
- 2.) The jambs need to be refinished at the garage side door.

The jambs need to be refinished at the garage side door.

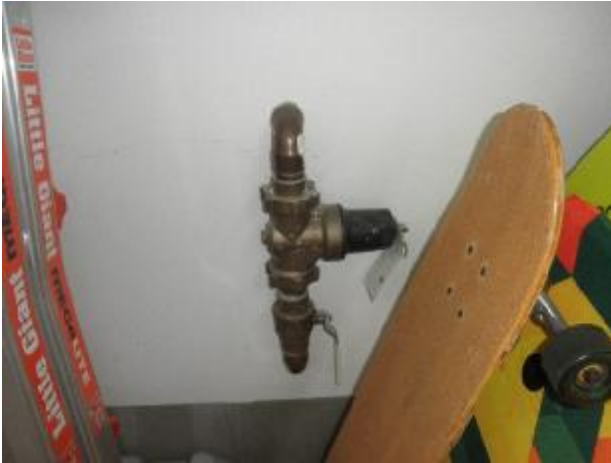
# P

The main water shut off is located at the interior SW wall of the garage.

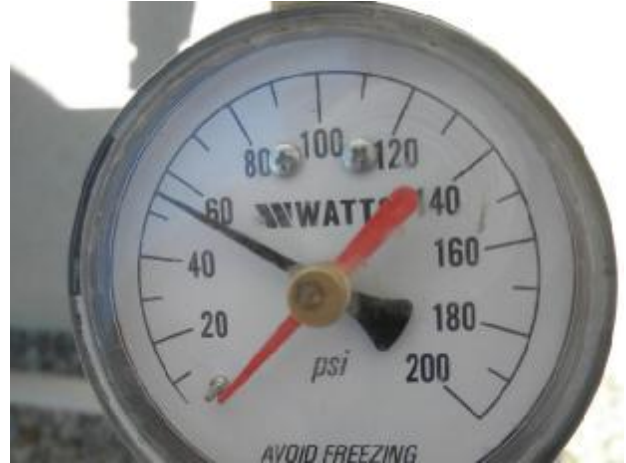
# P

Information Note: The water pressure was measured at 55 psi at the time of inspection. This is within a normal and acceptable range. Since the house is equipped with a pressure regulator it should be monitored and retested periodically to ensure that the pressure is below the maximum allowable 80 psi.

The water pressure was measured at 55 psi.

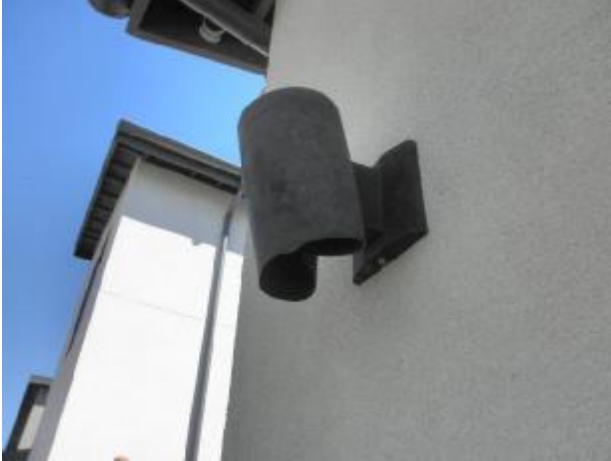
# EL

1.) There is some damage to one of the exterior lights at the front of the garage however, the light is still functional.

Damaged light fixture at the front of the garage.
