Inspection/Certification

Date of Inspection: **2/6/23** Property Owner: **Jay Ford**
Inspection Address: **210 Foxtail Lane, Templeton Ca 93465**
Realtor/Finance Company: **N/A**
Title Company: **N/A**

Existing Septic System Verification Form

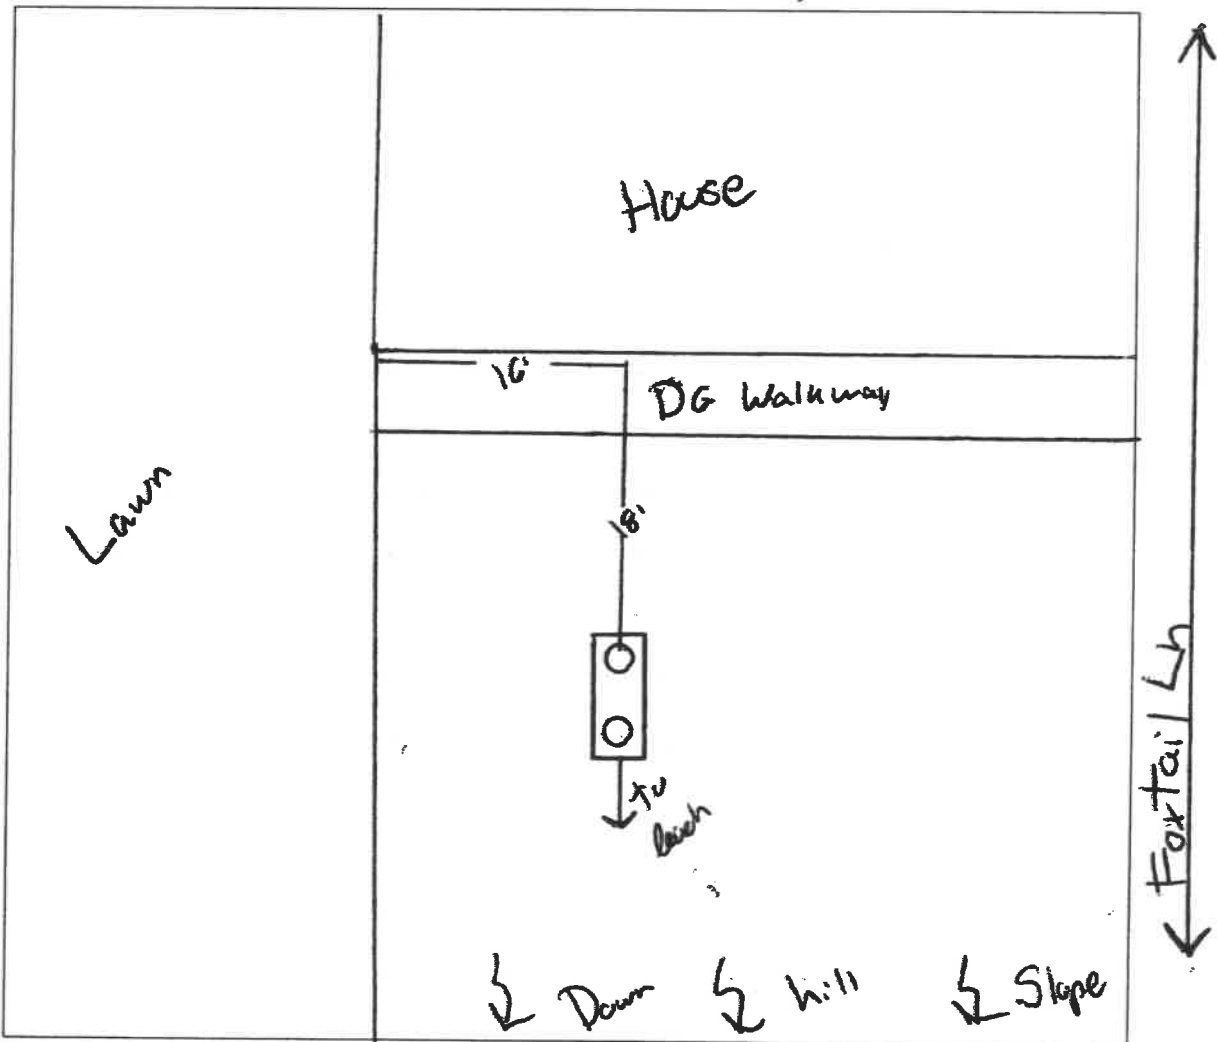
Comments: 1200 gal Concrete tank

6" Full Diameter Access Risers to Grade
Delux Flagstone
Distance to wellhead —

Depth From Top of Tank to Grade 26"

Clean Out Present yes
