## ***INSPECTION REPORT***

1338 Hermosa Drive, Merced

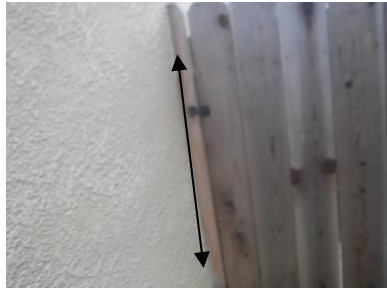
### **1.2 FENCING, GATES AND WALLS**

**Comments:** Appeared to be in sound condition. Fencing/gate support post requires repair in order to properly stabilize.

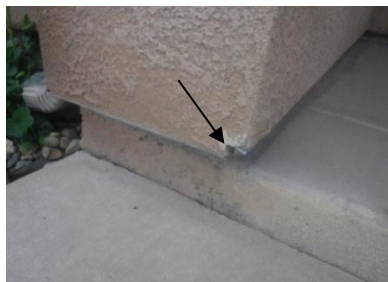
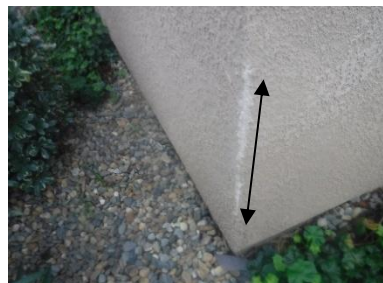
#### 1.4 HOUSE WALL FINISH TYPE AND CONDITION

**Comments:** Reviewed and noted stucco system present. Majority of typical settlement/stress cracks were present at corners of windows and doors. These cracks are not a structural issue but rather cosmetic in nature. If crack becomes wider than the thickness of a quarter, then these cracks should be filled with clear, paintable caulking. This will prevent possible moisture infiltration and/or insect infestation. Recommend using a good elastomeric paint when painting exterior of home. Minor damage and signs of previous repair noted at base of siding at front of home. Recommend ensuring that areas remain adequately sealed in order to prevent possible moisture infiltration.

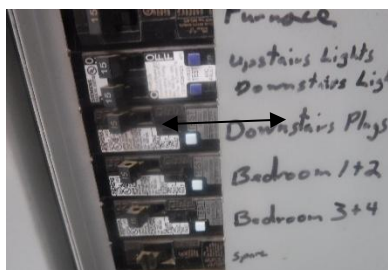
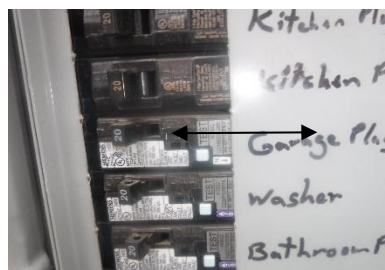
#### 1.11 EXTERIOR ELECTRICAL OUTLETS, LIGHTING, AND SWITCHES

**Comments:** Inspected, outlets functioned properly and tested for correct wiring. Outlets are GFCI/AFCI protected. Front porch outlet is wired to “downstairs plugs” AFCI breaker. Outlet at rear of home is wired to “garage plugs” AFCI breaker. All lights and corresponding switches functioned properly or tested positive for electrical current when operated.

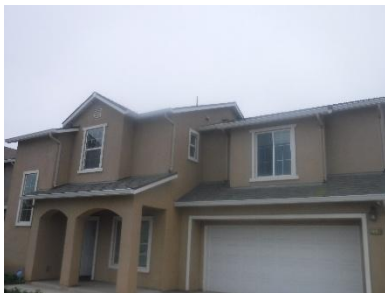
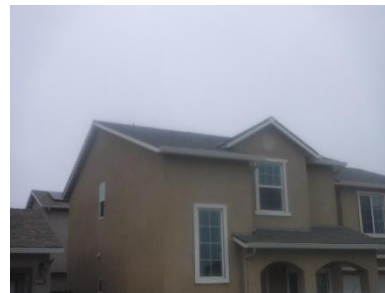
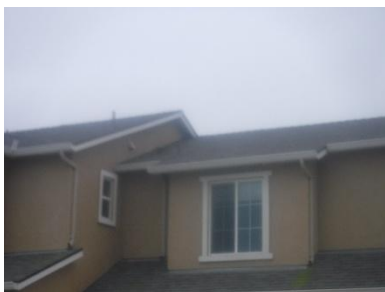
**3.5 CONDITION OF ROOF STRUCTURE**

**Comments:** Limited inspection performed as upper section of roof could not be walked due to lack of safe accessibility. Minor sways or sags noted due to duration loads imposed by wind, rain, and building material. This is not intended to be used as a roof certification and is not a guarantee regarding watertight integrity of roof. It is only our opinion based on our observations at time of inspection. If roof certification is required, contact licensed roofing contractor to perform further inspection.

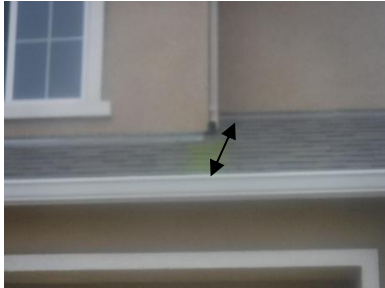
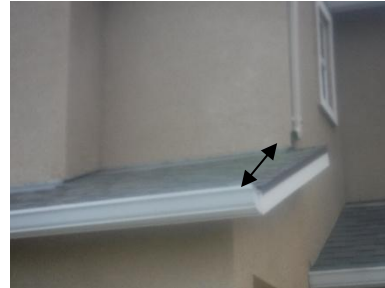
### 3.7 CONDITION OF ROOF COVERING (Damage/Moss/Decay/Rot)

**Comments:** Roof covering appeared to be in good condition at time of inspection. However, recommend cleaning roof covering near downspouts in order to eliminate/remove moss growth and prevent accelerated deterioration.

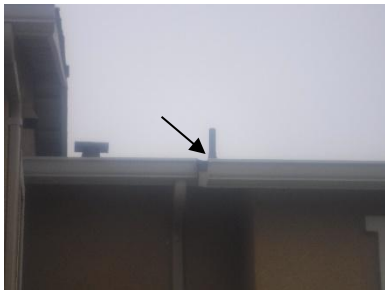
### 3.9 CONDITION OF ROOF MOUNTED STRUCTURES

**Comments:** Inspected and appeared to be in serviceable condition. However, areas where plumbing vents penetrate through roof jacks should be sealed with roof mastic, caulking, UV treated reflective plumbing tape, or rubber vent bonnets in order to prevent moisture from entering into attic area. Roof mounted structures appeared to have adequate protection at time of inspection. Recommend monitoring these areas in order to prevent possible future leakage into attic/home. Roof mounted structures include plumbing vents, exhaust vents, chimneys, T.V antennas, skylights, HVAC units etc.

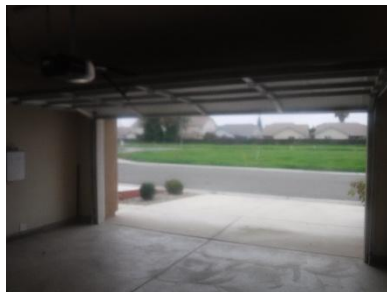
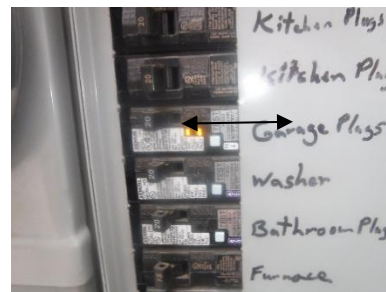
**6.2 OPERATION OF GARAGE DOOR OPENER AND/OR GARAGE DOOR**

**Comments:** Reviewed and functioned when tested. Lift Master opener present. Recommend adjusting down pressure in order to allow for door to reverse with less resistance. Garage door opener has been wired to “garage plugs” AFCI breaker, resulting in non-functionality when breaker is tripped.

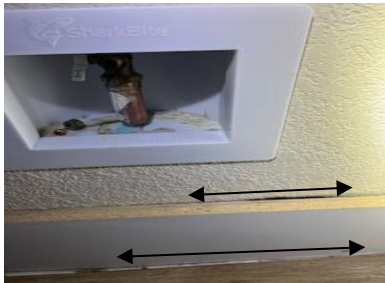
#### 7.3 WALL MATERIAL AND CONDITION

**Comments:** Sheetrock appeared to be in good condition with no significant cracks or damage noted. Minor moisture damage/staining noted near refrigerator water supply line at both wall and baseboards due to previous and active leakage at water supply line. Recommend necessary repairs to water supply line in order to prevent further leakage and damage when not in use.

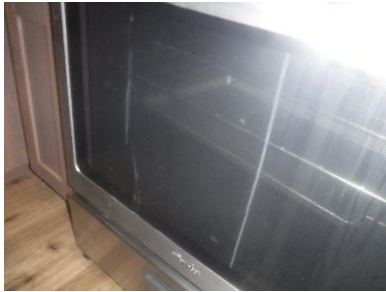
### 8.1 MANUFACTURER AND FUNCTIONALITY OF COOK TOP/OVEN

**Comments:** Whirlpool cook top and oven functioned properly when operated. Recommend ensuring that anti-tip device is installed in order to prevent possible safety hazard. Staining noted at oven cover glass.

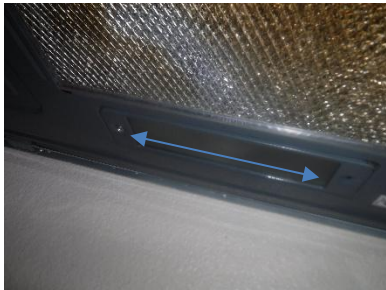
### 8.2 MANUFACTURER AND FUNCTIONALITY OF EXHAUST FAN/LIGHT

**Comments:** Whirlpool exhaust fan and light is part of built-in microwave. Exhaust fan functioned properly when tested. However, light was not working at time of inspection. Recommend replacing light bulb in order to allow for proper functionality.

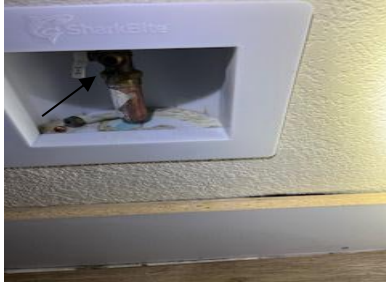
### 8.6 MANUFACTURER AND FUNCTIONALITY OF REFRIGERATOR

**Comments:** None present. However, minor moisture damage/staining noted near refrigerator water supply line at both wall and baseboards due to previous and active leakage at water supply line. Recommend necessary repairs to water supply line in order to prevent further leakage and damage when not in use.

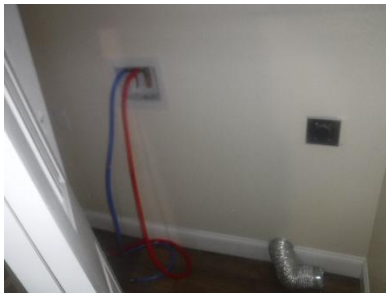
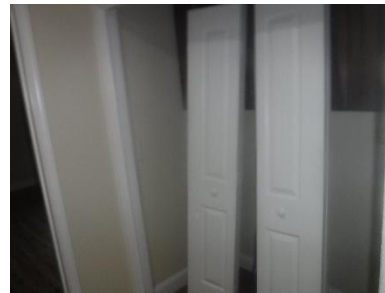
#### **9.1 LOCATION AND CONDITION OF LAUNDRY FACILITIES**

**Comments:** Laundry area is located at interior of home in upstairs hallway closet. Laundry connections appeared to be in serviceable condition. Closet doors were detached at time of inspection.

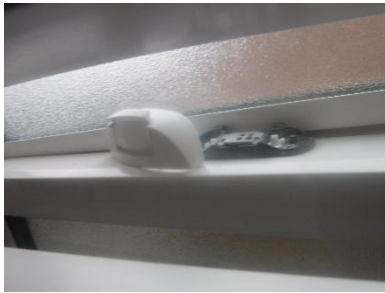
### 13.5 FUNCTIONALITY OF WINDOW(S)

**Comments:** Damaged/detached components noted at latch/lock at upstairs vertical window. Recommend necessary repairs in order to allow for proper functionality.

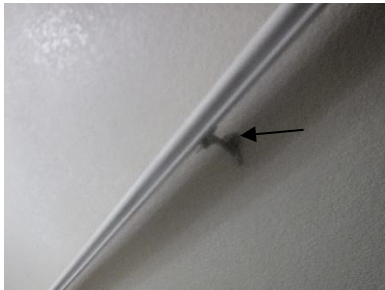
### 13.7 CONDITION OF STAIR RAILINGS, BALUSTER AND GUARDRAILS

**Comments:** Slightly loose railing noted at 2<sup>nd</sup> landing leading to upstairs hallway. Recommend securing hardware.

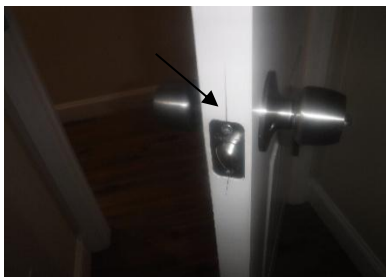
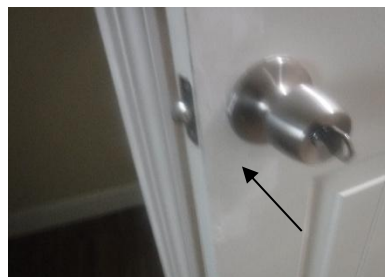
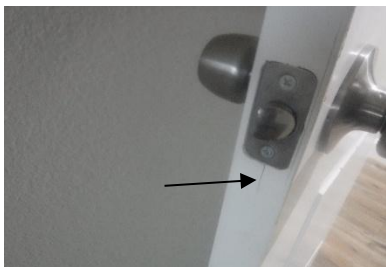
#### 14.5 FUNCTIONALITY OF ENTRY DOORS/CLOSET DOORS

**Comments:** Reviewed and entry doors closed and latched properly. However, minor damage/cracking noted near hardware at hallway bedroom entry doors. Signs of previous repair also noted near 1<sup>st</sup> hallway bedroom entry door hardware. Closet doors functioned properly.

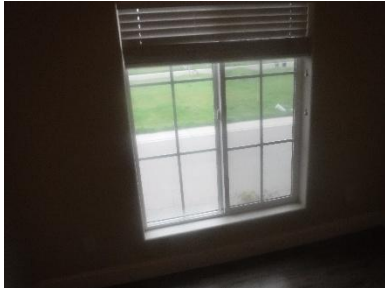
#### 14.6 FUNCTIONALITY OF WINDOW(S)

**Comments:** Windows functioned properly when tested. Due to low windowsill in master bedroom, recommend ensuring that window is properly tempered in order to prevent possible safety hazard.

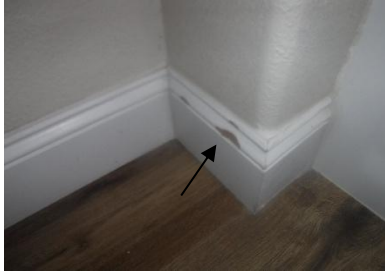
#### 15.5 CONDITION OF BASEBOARDS AND CAULKING

**Comments:** Reviewed and baseboards appeared to be in good condition. Minor damage noted near tub/shower in master bathroom. Also, caulking at tubs/showers, toilets, and sinks appeared to be in decent condition.

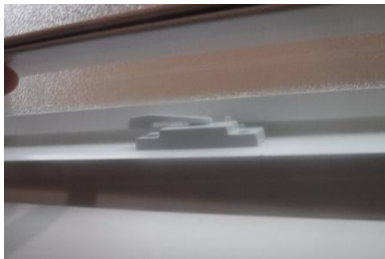
#### **15.7 FUNCTIONALITY OF WINDOW(s)**

**Comments:** Vertical window in downstairs ½ bathroom would not properly lock when operated. Recommend necessary repairs in order to allow for proper functionality. All remaining windows functioned properly when operated.

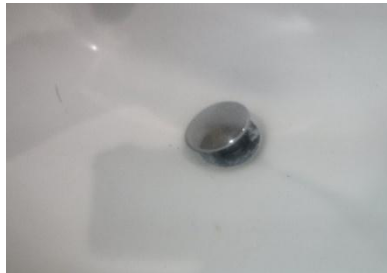
**16.6 CONDITION AND FUNCTIONALITY OF PLUMBING COMPONENTS**

**Comments:** Inspected and all plumbing fixtures drained properly with no leaks noted. Detached/unsecure drain stop noted at left sink in upstairs hallway bathroom.

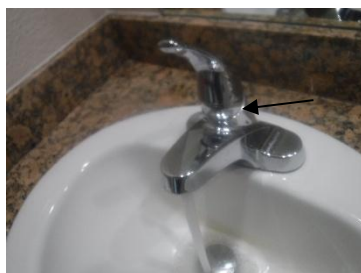
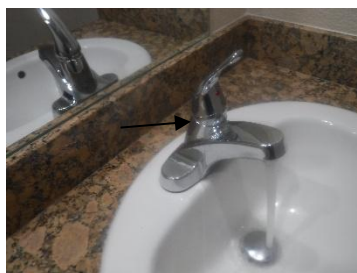
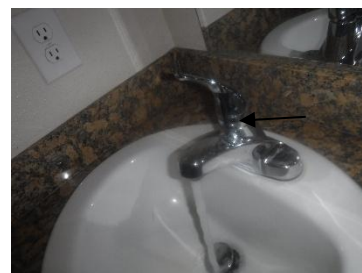
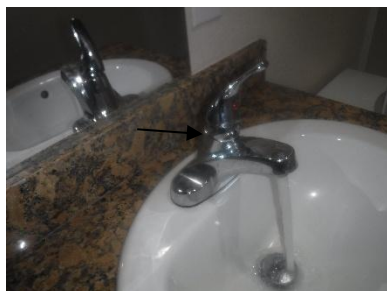
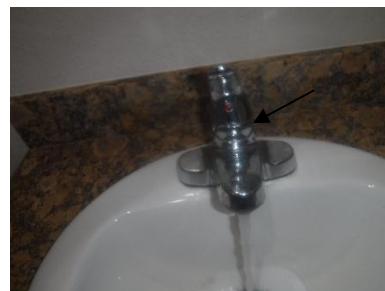
**16.8 CONDITION AND FUNCTIONALITY OF SINK/SHOWER/TUB FAUCETS**

**Comments:** All faucets functioned when operated and appeared to be in good condition. However, leakage noted at all bathroom sink faucet handles when operated. Recommend necessary repairs or replacing fixtures in order to prevent further leakage during use.

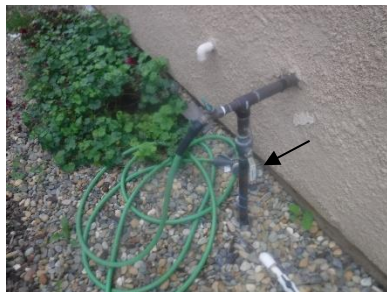
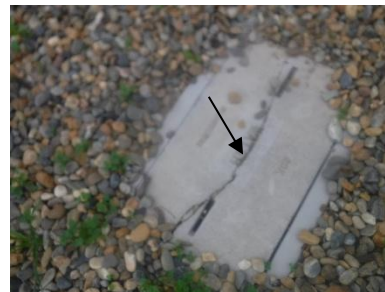
#### 16.12 ANY LEAKS NOTED ON WATER SUPPLY OR WASTE LINES

**Comments:** Inspected and it appeared no leaks were present on supply lines or waste lines. Arrow indicates location of main water shut off to home. Damaged noted at City of Merced water access cover.

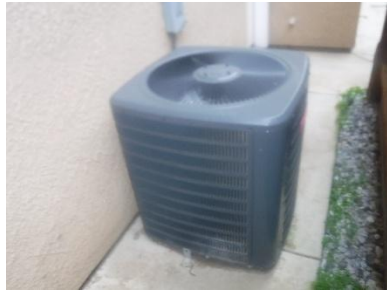
**18.3 LOCATION, CONDITION, AND FUNCTIONALITY OF AIR CONDITIONING UNIT(s)**

**Comments:** Fan and condensing unit located in back yard near patio. Unit appeared to be in serviceable condition. However, it is recommended that coil fins be cleaned on a bi-annual schedule. This will aid in unit operating more efficiently. When tested, an ideal temperature differential of 15 to 20 degrees between return air and supply registers is desired. Unit was not tested due to outside temperature being less than 65 degrees at time of inspection. Operating unit at such temperatures could result in permanent damage to compressor motor.
