TRIDENT INSPECTION GROUP

PROPERTY INSPECTION V 5.0

8812 Sapphire Ave Westminster, CA 92683

> Tricia Vandermarlierre 11/07/2025

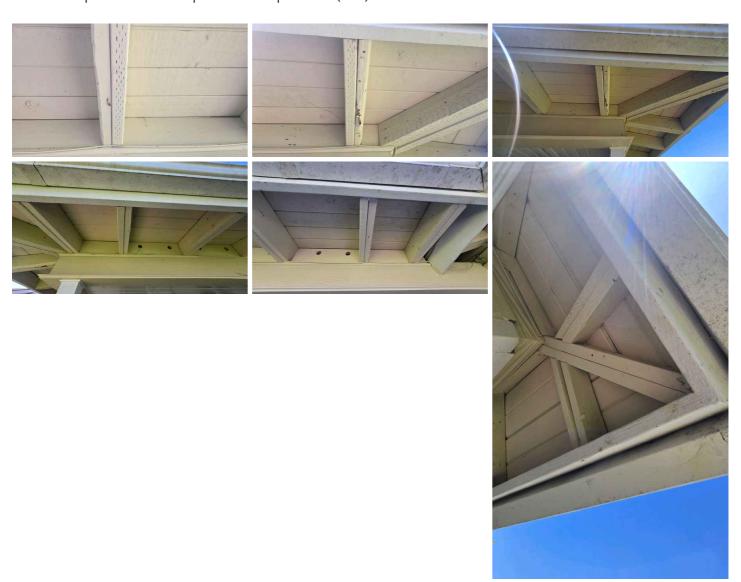
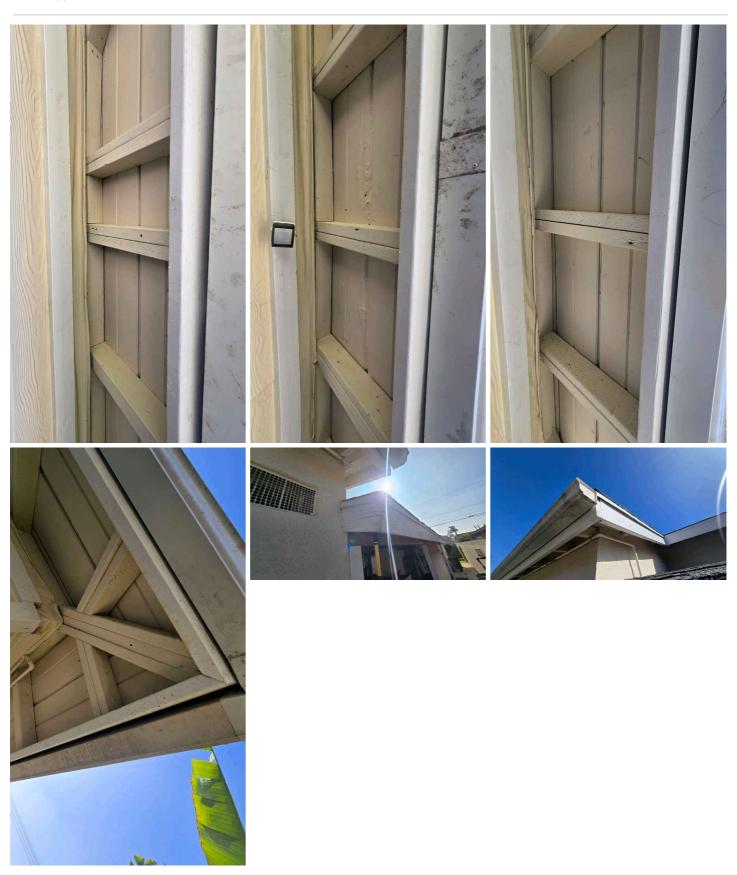
WDO ACTIVITY - DAMAGE PRESENT

Presumed wood destroying organism activity was present at the referenced area(s). An evaluation of the activity is recommended to be conducted by a licensed pest control company. An invasive evaluation of the area(s) of damage is recommended to be conducted by a qualified contractor with repairs made as deemed necessary to any damage found.

Contact a qualified trident pest control pr#8662 (949)294-1188

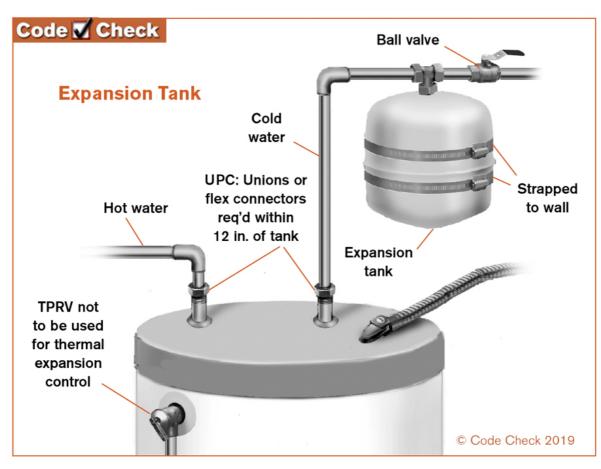
NO EXPANSION TANK

No expansion tank was present. Expansion tanks allow for the thermal expansion of water in the pipes. These are becoming required in certain areas for new installs.

Recommendation
Contact a
qualified
plumbing
contractor.

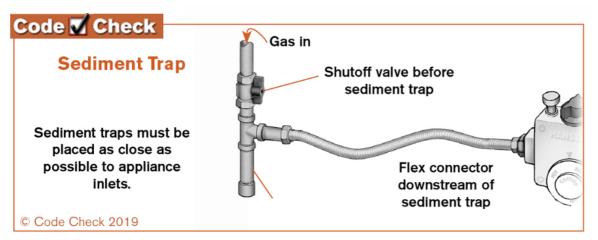
10.4.2 Water Heater, Controls, Flues & Vents

No sediment trap installed. May not have been required at time of construction, however it is required today. Recommend adding.

Recommendation Contact a qualified professional.

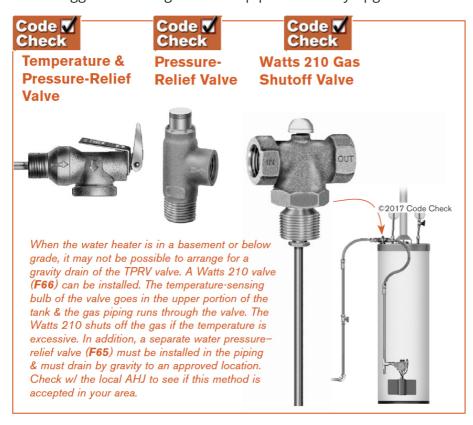
NEED DISCHARGE PIPE

No extension pipe found on the temperature and pressure relief valve. Suggest installing extension pipe as a safety upgrade.

Recommendation

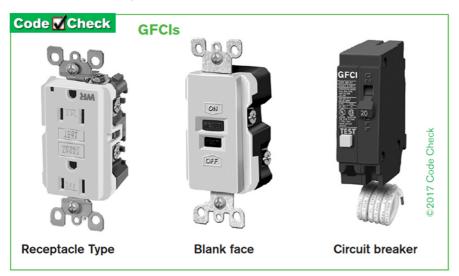
A GFCI receptacle can provide protection for other receptacles downstream on the circuit. GFCI protection can be provided by GFCI breakers, blank face devices, or GFCI receptacles

Contact a qualified electrical contractor.

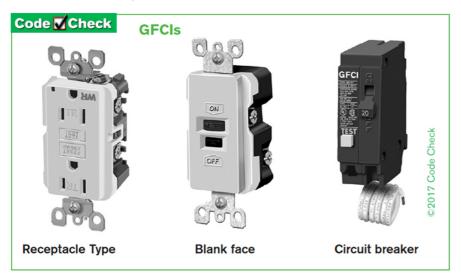
A GFCI receptacle can provide protection for other receptacles downstream on the circuit. GFCI protection can be provided by GFCI breakers, blank face devices, or GFCI receptacles

Contact a qualified professional.

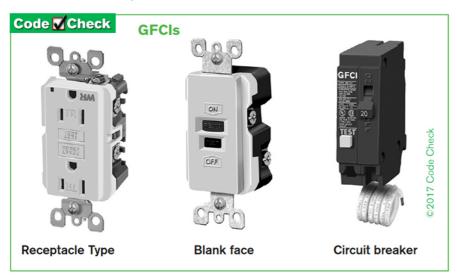
A GFCI receptacle can provide protection for other receptacles downstream on the circuit. GFCI protection can be provided by GFCI breakers, blank face devices, or GFCI receptacles

Contact a qualified electrical contractor.
