## WOOD DESTROYING PESTS AND ORGANISMS INSPECTION REPORT

Building No. 8812	Street Sapphire Ave	City Westminster	ZIP 92683		Inspection 8/2025	Number of Pages 8
ssoc	IATED NATORS	2430	iated Extermina ON Glassell St. Unit Drange CA 92865 (949) 294-1188 tedclientcare@gmail	L	Regis Escro	ort # : 10929 stration # : PR7117 ow # : DRRECTED REPORT
Ordered by:		Property Owner a Tricia Vanderma	nd Party of Interest: rlierre		eport sent to: ichelle Metzler	
COMPLETE REPOR	T 🔀 LIMITED	REPORT 🗌	SUPPLEMEN	TAL REPOR	T REINS	SPECTION REPORT
GENERAL DESCRIPT The subject property		amily residence (S	FR) constructed on a	concrete	Inspection Tag Garage	Posted:
The subject property is a one-story single-family residence (SFR) constructed on a concrete slab foundation. The roof is covered with composition shingles, and the exterior walls are finished with a combination of wood composite and stucco cladding. An attached garage is present.  At the time of the inspection, the property was occupied and fully furnished, which may have restricted visibility and limited access to certain areas, including wall perimeters, interior closets, and garage margins due to furniture, stored items, and personal belongin

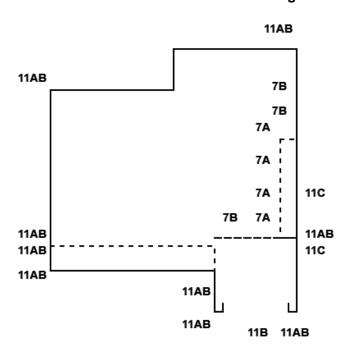
## **Diagram Not To Scale**

Evidence of **drywood termite activity** was observed at **SEE DIAGRAM**, as indicated on the attached diagram. Indicators include **termite frass** (pelletized droppings), **exit holes**, and/or **visible wood damage**. Drywood termites can cause **progressive deterioration of structural wood members** if not properly treated.

Minor water stains were observed on framing members and/or roof sheathing within the attic area at SEE DIAGRAM. The stains appeared to be dry at the time of inspection and showed no visible signs of active leaks, fungal growth, or ongoing moisture intrusion.

Evidence of **termite damage** was observed at **exterior wood members** at **one or more of the follwoing fascia, rafter tails, siding, trim, door frames**, **etc** as indicated on the **attached diagram**. The damage has compromised the integrity of the affected wood members and may worsen over time if left unaddressed.

Evidence of **patching and repair work** was observed at the **shiplap siding** at **SEE DIAGRAM**. The presence of patched areas may indicate **past damage** related to **wood-destroying organisms (WDOs)** or other structural issues.

To ensure full eradication of the infestation, we recommend **whole-structure fumigation** using **Vikane® gas fumigant** or an equivalent **state-registered product**. The fumigation process will include:

To restore structural integrity and prevent further deterioration, we recommend that the **damaged exterior wood members be repaired or replaced.** Best practices for termite-damaged wood repair include:
