# Property Inspection Report

Date of Inspection: 5/8/2026

**27809 Alpen Dr**

**Lake Arrowhead, CA. 92352**

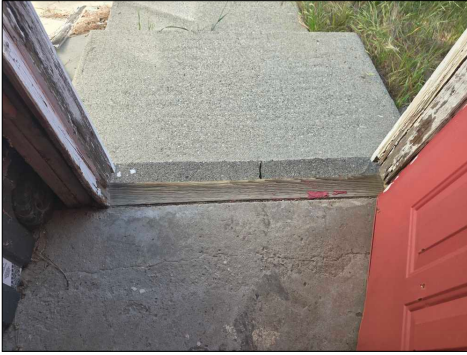
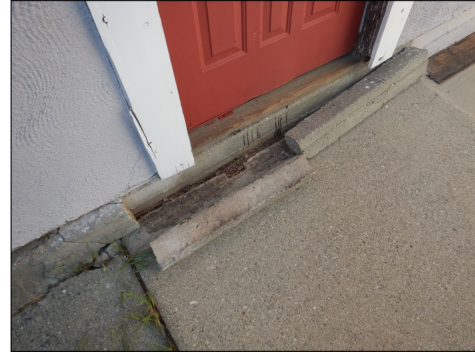
The step in front of the garage access door was damaged; further evaluation and correction are recommended.

The door at the garage rubs its frame and should be adjusted. We recommend a "tune up" by a carpenter skilled in trim work as a prudent preventive maintenance measure.

The garage pedestrian door was not equipped with a threshold, or weather stripping; recommend installing these items as an upgrade.

Suggest complete review/correction including cost estimate (bids) by a qualified licensed foundation contractor before the end of the contingency period.

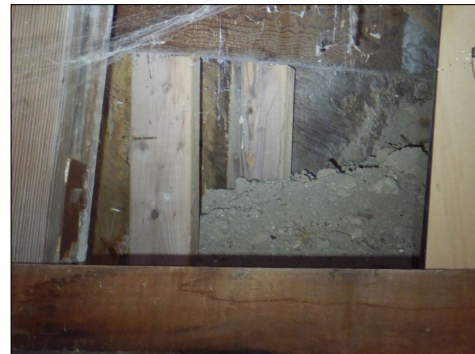
Earth to wood contact was found at the mud sill in the crawl space under the garage and below that master bathroom. This condition is conducive to deterioration. Action should be taken to ensure that a 6-inch clearance is maintained between wood and soil.

Suggest complete review/correction including cost estimate (bids) by a qualified licensed foundation contractor before the end of the contingency period.

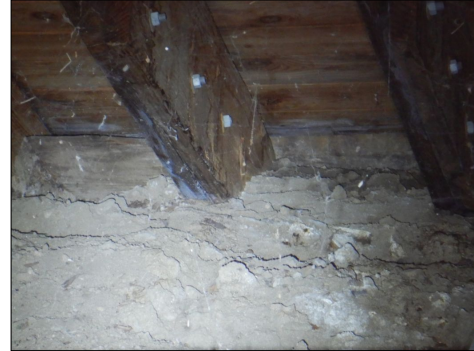
The joists in garage crawlspace were in contact with the crawlspace soil. This condition is conducive to deterioration. Action should be taken to ensure that a 6-inch clearance is maintained between wood and soil.

Suggest complete review/correction including cost estimate (bids) by a qualified licensed foundation contractor before the end of the contingency period.

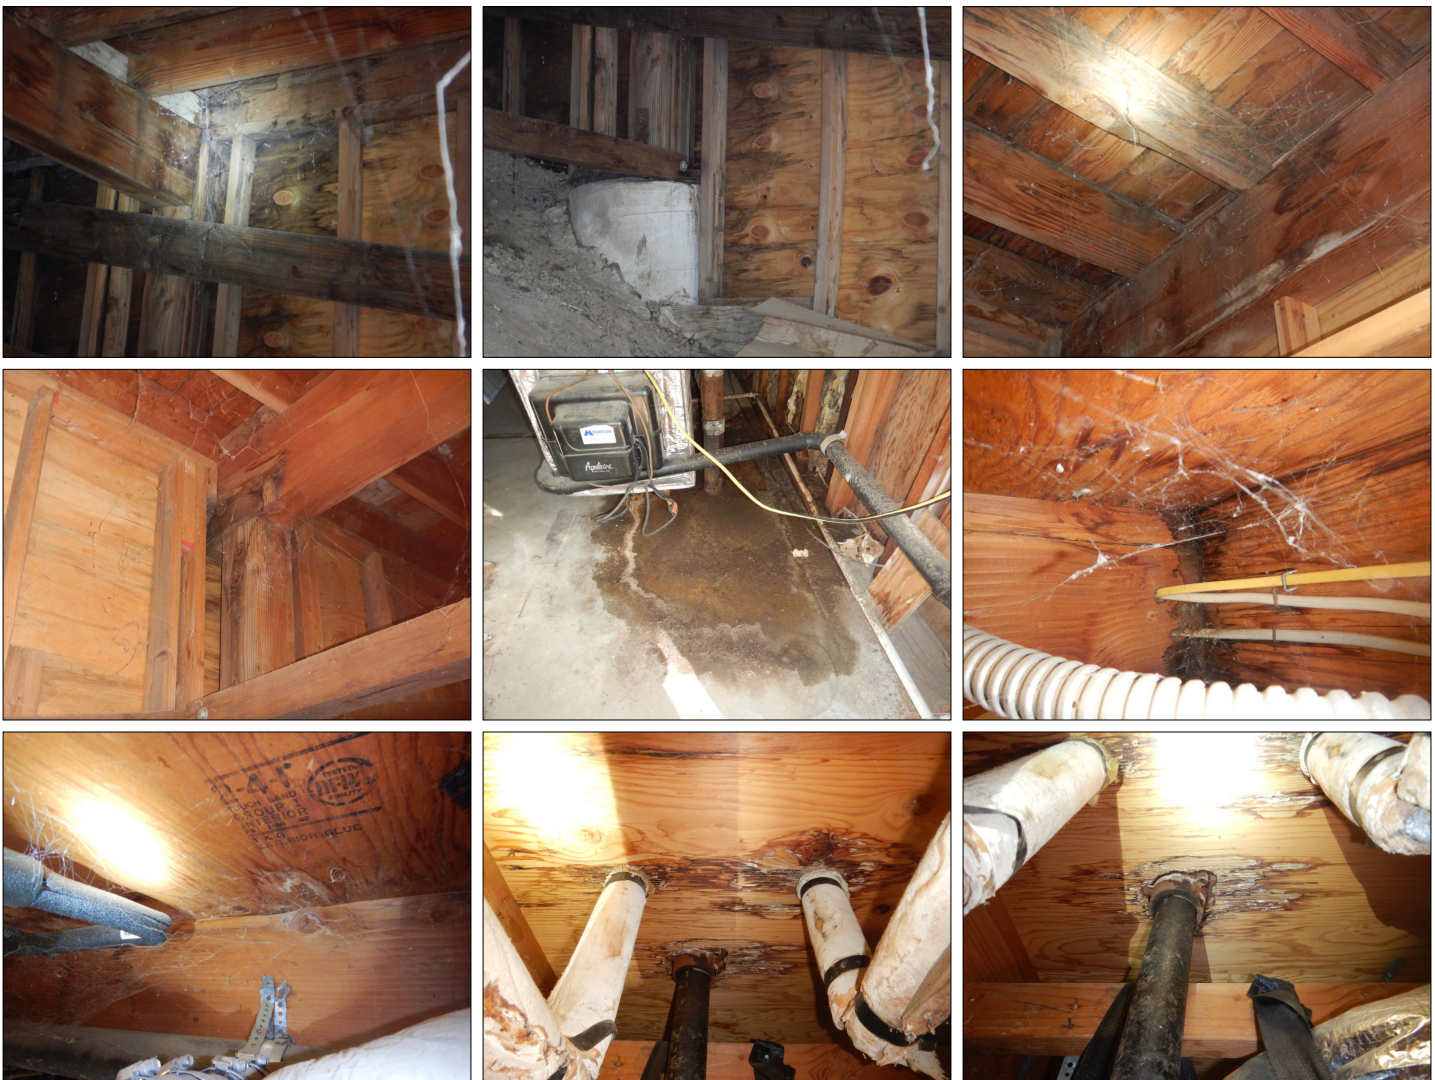
Water stains were found at the cripple walls below the carport and sub floor in the house. Most of the stains were dry but this does not mean they are not active; further evaluation and correction are recommended.

Wet soil was noted in the garage crawl space; further evaluation and correction are recommended.

Water was found in the crawl space for the house due to an active leak; further evaluation and correction are recommended. Hidden damage may exist.

Suggest complete review/correction including cost estimate (bids) by a qualified licensed leak detection contractor before the end of the contingency period.

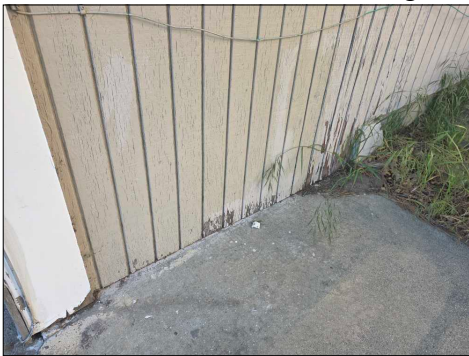
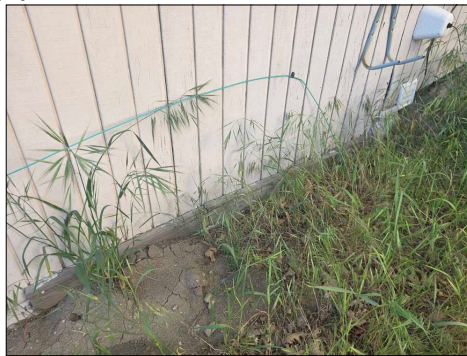
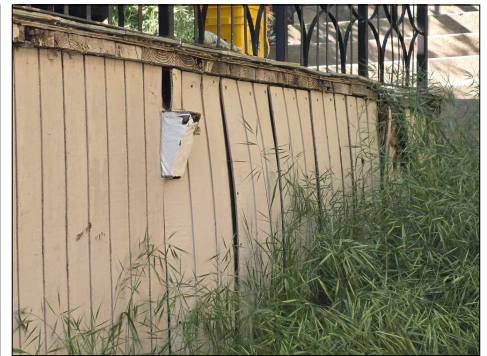
The siding was in proximity to the earth in a number of locations. These areas will require vigilant maintenance to guard against damage and deterioration. We recommend these areas be monitored regularly and painted or otherwise sealed.

The siding at the front entryway was bowed and damaged; further evaluation and correction are recommended. Hidden damage may exist.

Suggest complete review/correction including cost estimate (bids) by a qualified licensed contractor before the end of the contingency period.

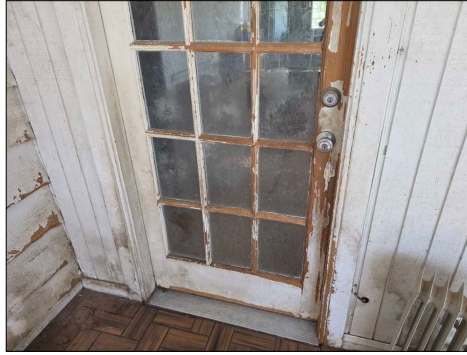
The right-side pedestrian door was pet damage; replacement is recommended.

Suggest complete review/correction including cost estimate (bids) by a qualified licensed door contractor before the end of the contingency period.

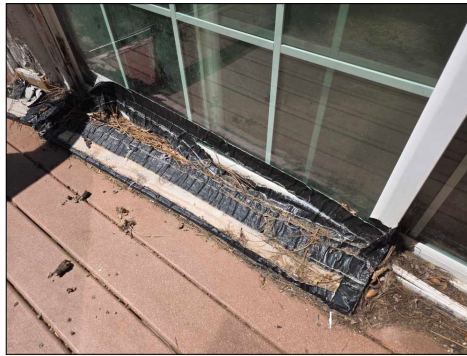
The sliding door does not operate properly, indicating the track was misaligned, dirty, or the wheels are damaged. We recommend repair or replacement.

The sliding glass door appears to have a makeshift water proofing on the exterior side; further evaluation and correction are recommended.

Suggest complete review/correction including cost estimate (bids) by a qualified licensed door and window contractor before the end of the contingency period.

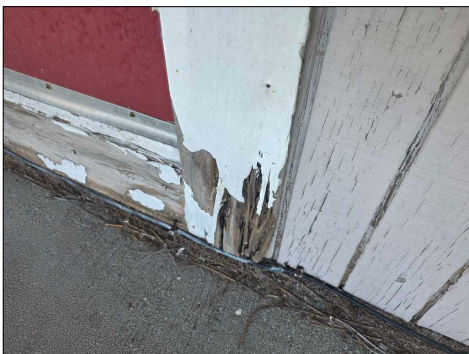
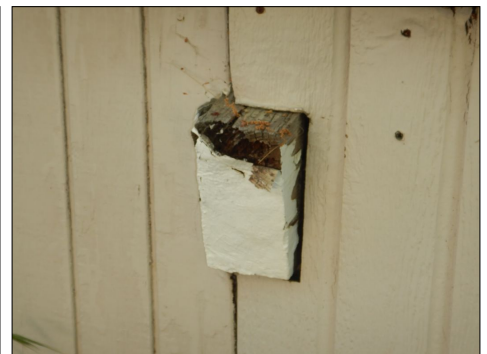
Signs of wood-destroying pest/organism damage noted at the trim; recommend further evaluation and correction by a licensed pest control operator before removing any contingencies.

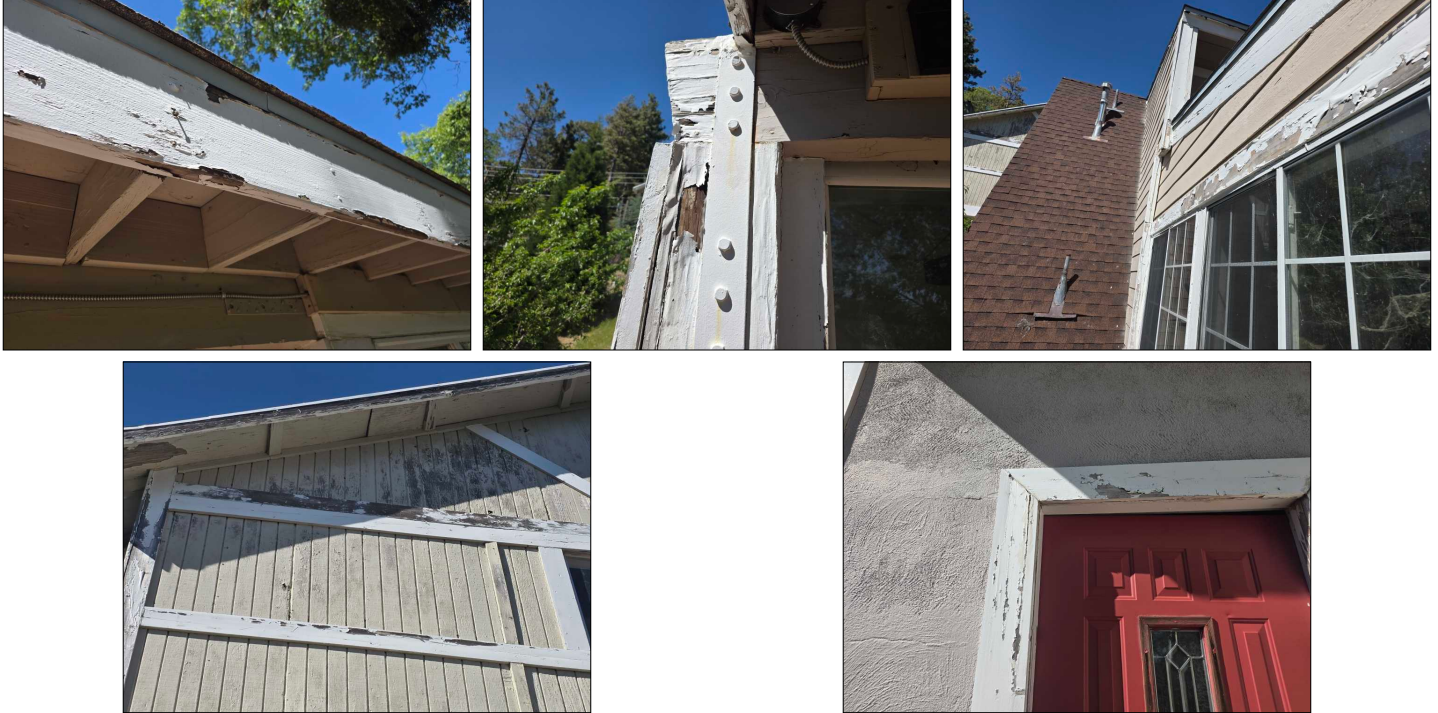
Portions of the exterior finish in several locations around the dwelling were failing, exposing the underlying surfaces to damage. We recommend thorough scraping, sanding, caulking, and priming prior to application of a high quality exterior finish in accordance with the manufacturer's directions.

Suggest complete review/correction including cost estimate (bids) by a qualified licensed paint contractor before the end of the contingency period.

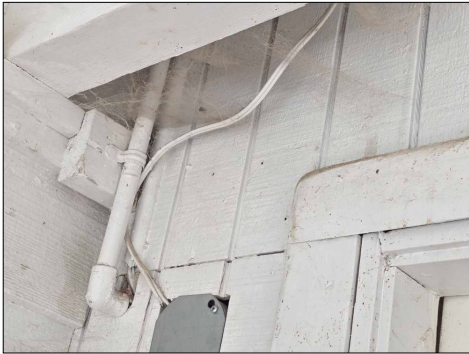
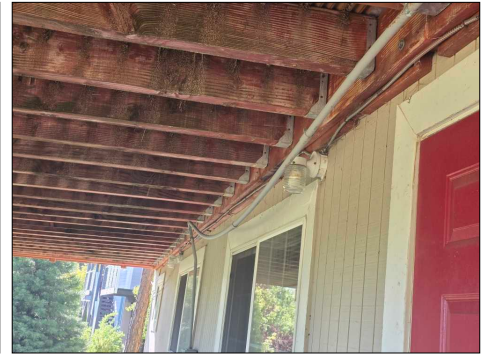
Unsupported conduit was found at the rear of the house; further evaluation and correction are recommended.

There are non-exterior rated materials used in a number of locations around the house. Non-exterior materials are not weather tight and can become damaged over time due to exposure, we recommend all non-exterior rated materials be replaced with approved materials.

Lamp cord or extension cord wiring has been installed as permanent wiring. This type of wiring is easy to overload, easily damaged, and is not rated for exterior use.

Suggest complete review/correction including cost estimate (bids) by a qualified licensed electrical contractor before the end of the contingency period.

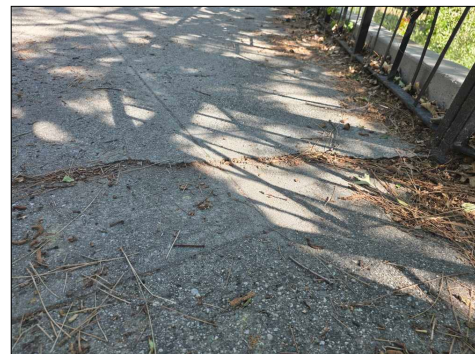
The driveway surface was raised and creating trip hazards, corrections are recommended.

Suggest complete review/correction including cost estimate (bids) by a qualified licensed general contractor before the end of the contingency period.

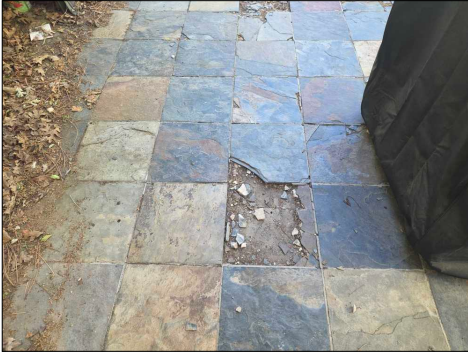
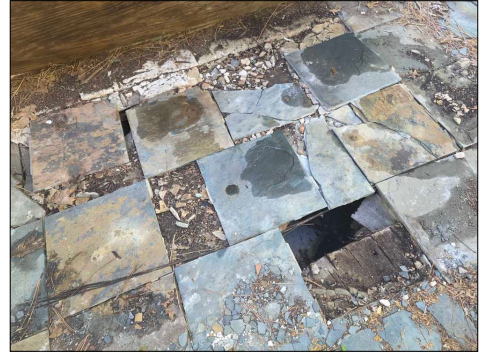
The main entry walkway had damaged tiles and failed substrates, this is a safety hazard, further evaluation and correction are recommended.

Suggest complete review/correction including cost estimate (bids) by a qualified licensed general contractor before the end of the contingency period.

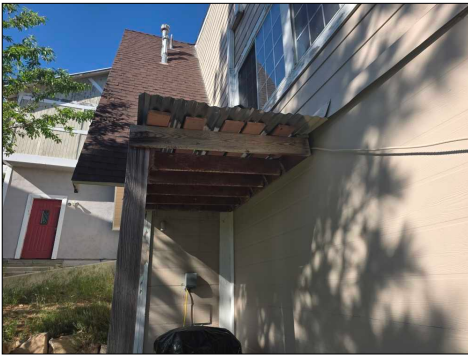
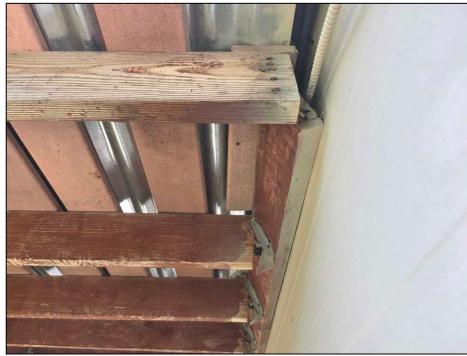
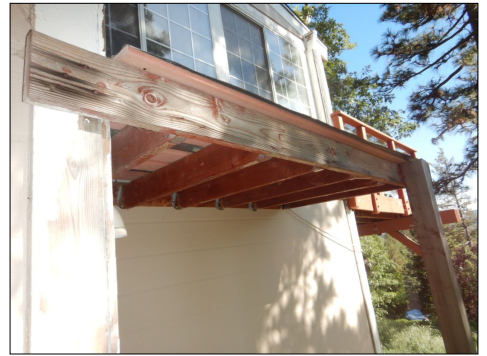
The small patio cover on the right side of the house was pulled away from the structure, this is a safety hazard; further evaluation and correction are recommended.

Suggest complete review/correction including cost estimate (bids) by a qualified licensed general contractor before the end of the contingency period.

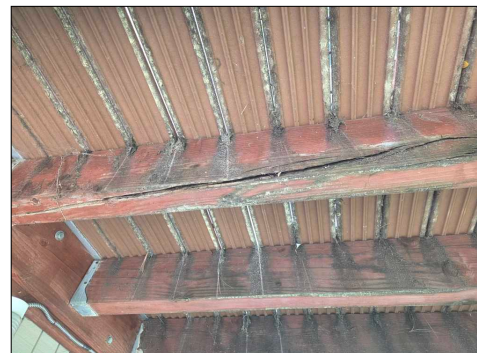
The deck board attached to the structure has been installed without flashing, creating a condition conducive to deterioration. We recommend this board be flashed or caulked to help prevent deterioration at this location.

One of the deck joists had significant checking that may compromise the integrity; further evaluation and correction are recommended.

Suggest complete review/correction including cost estimate (bids) by a qualified licensed general contractor before the end of the contingency period.

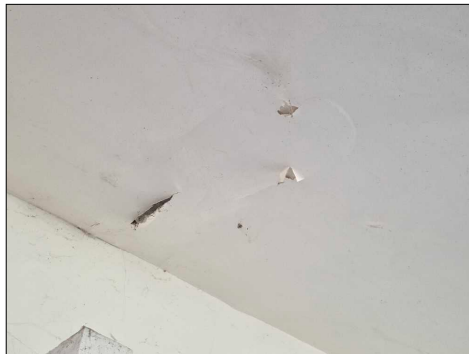
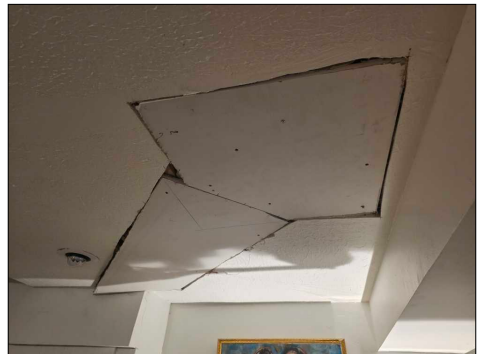
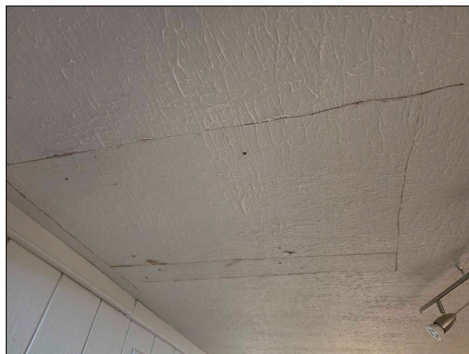
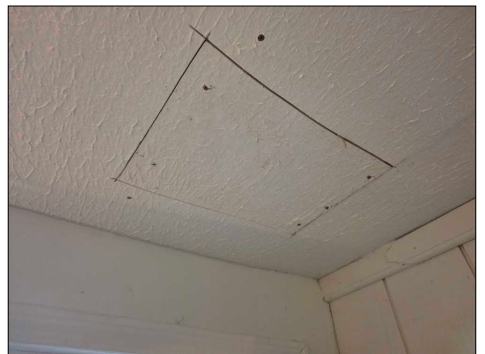
The lower level ceiling had unfinished repairs; further evaluation and correction are recommended.

Suggest complete review/correction including cost estimate (bids) by a qualified licensed drywall contractor before the end of the contingency period.

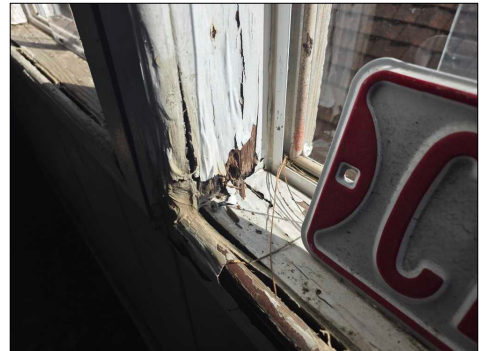
Signs of wood-destroying pest/organism damage noted at the window frames; recommend further evaluation and correction by a licensed pest control operator before removing any contingencies.
