# Titus Inspections

# **Inspection Report**

510 Harkness Ln Redondo Beach CA 90278

Property AddressDate of InspectionReport ID510 Harkness Ln7/3/2023230714-02

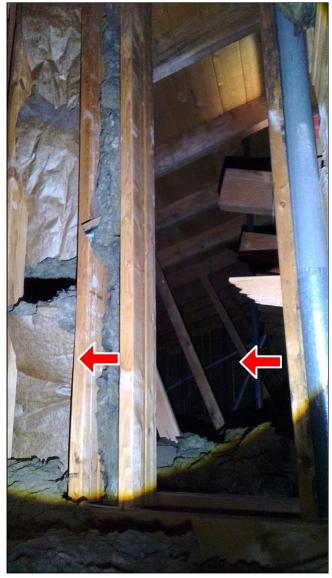
**2.4** Firewall separation inside attic between units was not present. Recommend a qualified person install proper firewall separation as needed.

2.4 Item 1(Picture) Missing firewall separation, attic

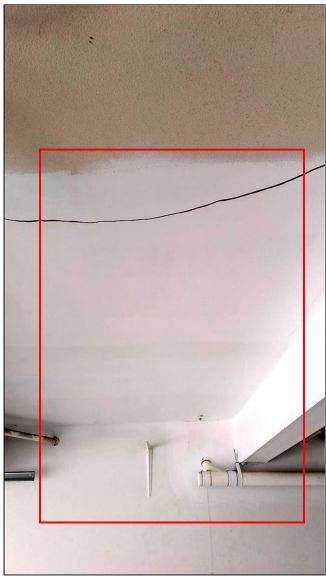
**3.1** Multiple repairs found on garage ceiling. No elevated moisture levels were found at time of inspection. Recommend a qualified person prep and paint ceiling as needed.

3.1 Item 1(Picture) Garage ceiling repairs

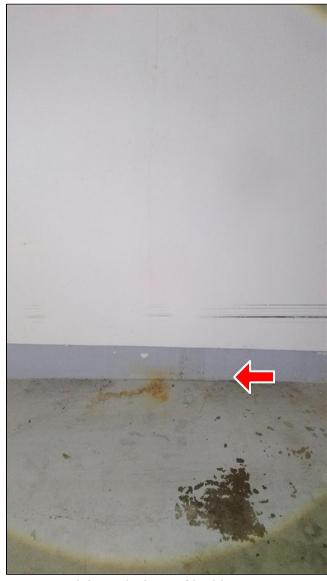
**3.2** Signs of active leaking found inside the garage. Leaking from south wall, from second floor bathroom drain lines (see section 6.5.5). Water was found on garage surface and water stains on garage wall. Elevated moisture levels were found on south wall in multiple areas below drain line exiting from wall. Recommend a qualified person further inspect for repair or remediation recommendations.

3.2 Item 1(Picture) Signs of leaking, garage south wall

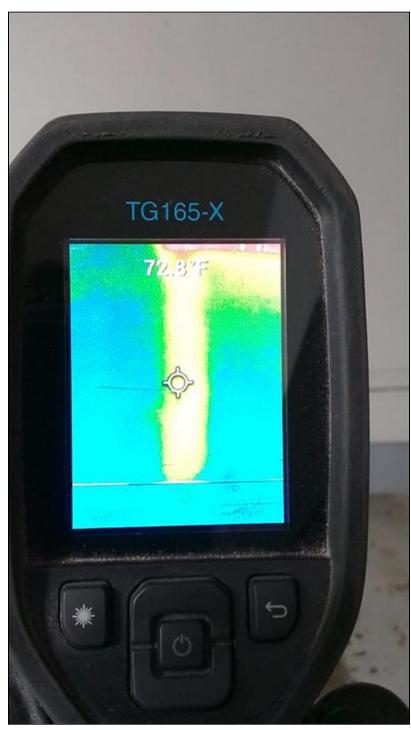
3.2 Item 2(Picture) Thermal imaging

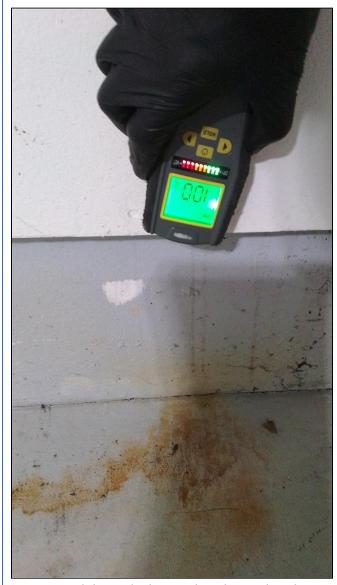
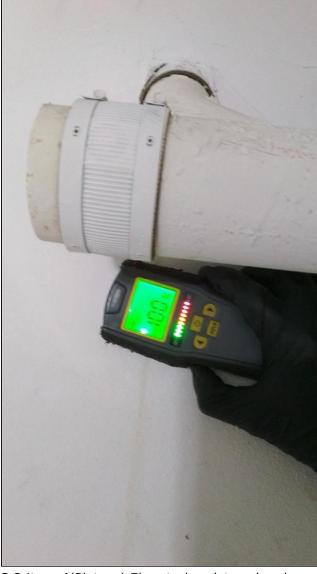
3.2 Item 3(Picture) Elevated moisture levels

3.2 Item 4(Picture) Elevated moisture levels

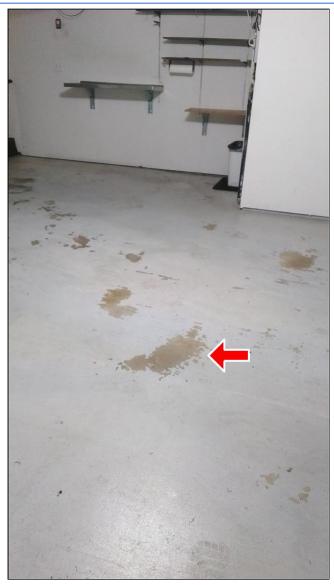
**3.3** Deteriorated surface paint on garage surface. Recommend a qualified person further inspect for repair, prep, and paint recommendations.

3.3 Item 1(Picture) Garage surface

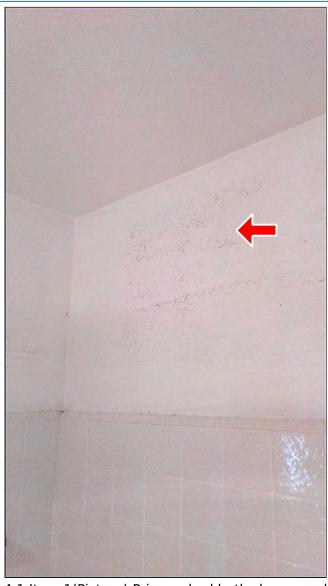
**4.1** (1) Deteriorated paint on primary bedroom bathroom shower walls. Recommend a qualified person further inspect for repair, prep, and paint recommendations.

4.1 Item 1(Picture) Primary bed bath shower wall

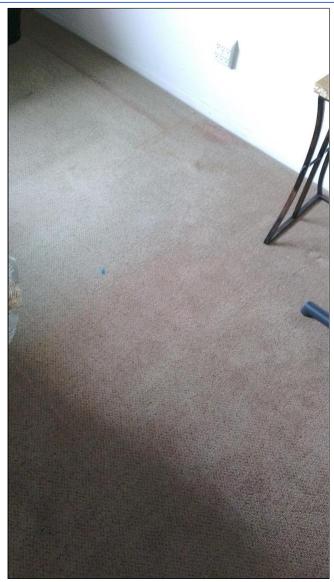
**4.2** (1) Carpet is dated and has discoloration and wear and tear in multiple areas throughout home. Recommend a qualified person further inspect for repair or replacement recommendations.

4.2 Item 1(Picture) Carpet

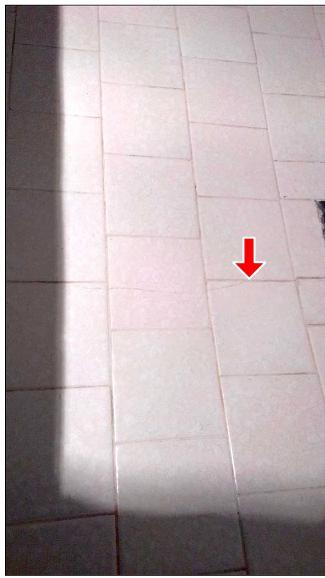
**4.3** (1) Primary bedroom bathroom shower has deteriorated grout and cracked tile. No signs of leaking found at time of inspection. Recommend a qualified person further inspect for repair or replacement recommendations.

4.3 Item 1(Picture) Minor crack, primary bed bath shower

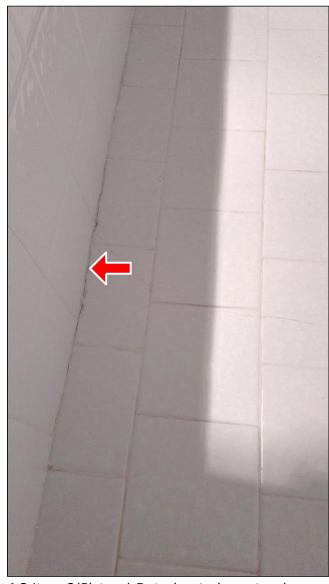
4.3 Item 2(Picture) Deteriorated grout, primary bed bath shower

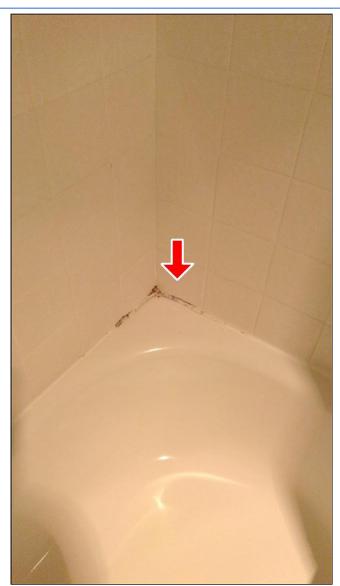
**4.3** (2) Second floor hall bathroom shower wall has cracked and deteriorated seal between bathtub and shower wall. Recommend a qualified person remove deteriorated seal and properly seal transition as needed.

4.3 Item 3(Picture) Cracked and deteriorated seal, 2nd floor hall bathroom

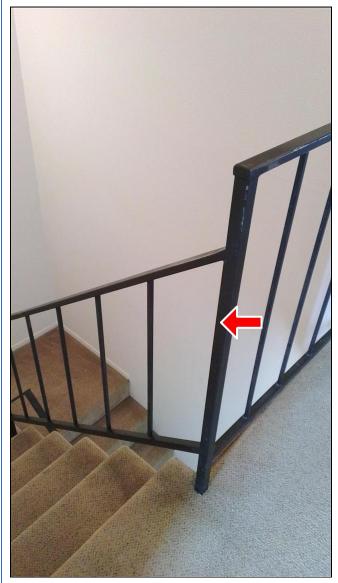
**4.4** Balusters on stairwell railing and guard railing are spaced more than four inches apart. This is a safety issue. Spacing between balusters should be no more than four inches. Recommend a qualified person further inspect and repair as needed

4.4 Item 2(Picture) Guard railing

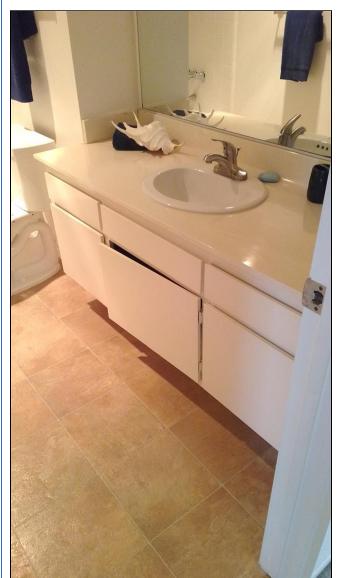
**4.5** Kitchen and bathroom cabinets and countertops are dated and have wear and tear. Doors are difficult to close. Recommend a qualified person further inspect for repair or replacement

4.5 Item 1(Picture) 2nd floor hall bathroom, base cabinets

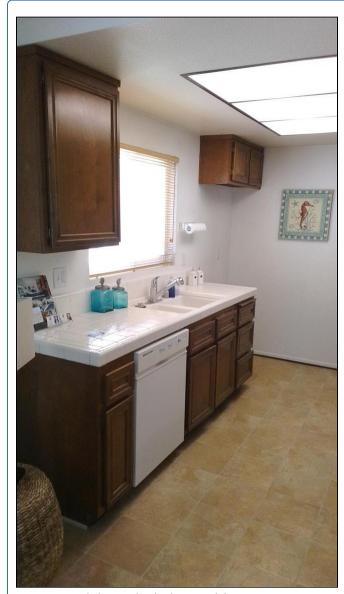
4.5 Item 3(Picture) Kitchen cabinets

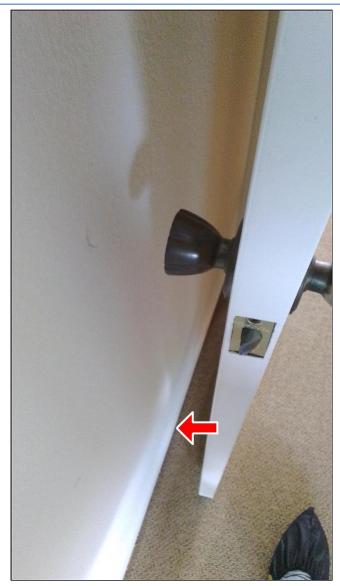
**4.6** Interior doors throughout home do not have door stops installed. Doors open and make contact with walls. Recommend installing door stops to prevent contact with walls and damage to walls. Install as needed.

4.6 Item 1(Picture) Missing door stop

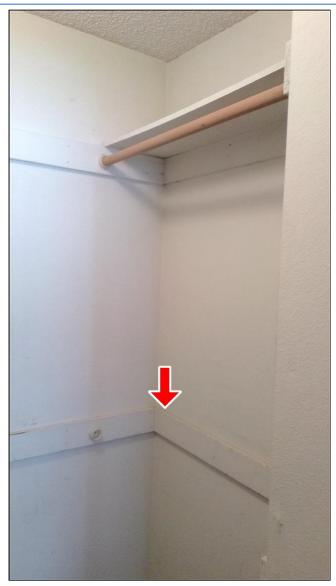
**4.8** Second floor northeast bedroom closet is missing hanger rod. Recommend a qualified person further inspect and install as needed.

4.8 Item 1(Picture) Missing hanger rod, 2nd floor NE bed closet

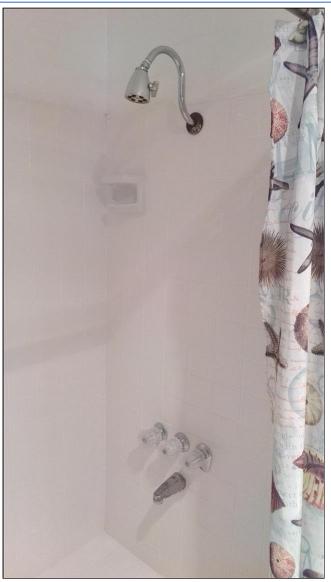
**6.3** (1) Water supply fixtures throughout home are dated and have scale and corrosion build up. Recommend a qualified person further inspect and thoroughly clean or replace as needed.

6.3 Item 1(Picture) Primary bed bath shower fixtures

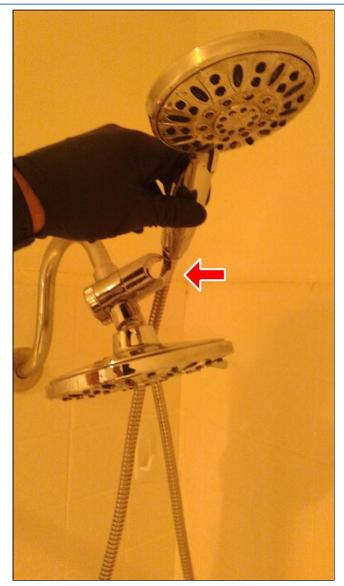
**6.3** (2) Second floor hall bathroom shower handheld sprayer did not mount properly to shower head fixture bracket. Recommend a qualified person further inspect for repair recommendations.

6.3 Item 2(Picture) 2nd floor hall bath shower head

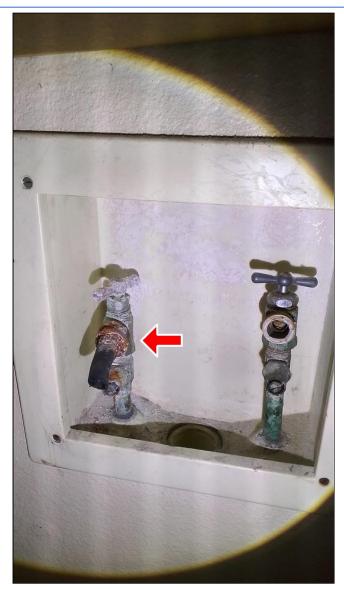
**6.3** (3) Water supply hose was cut off on washing machine water line valve in laundry closet. Unable to remove hose fitting. Rust and deterioration to fitting is present. Recommend a qualified person further inspect for repair or replacement recommendations.

6.3 Item 3(Picture) Washer water supply, laundry closet

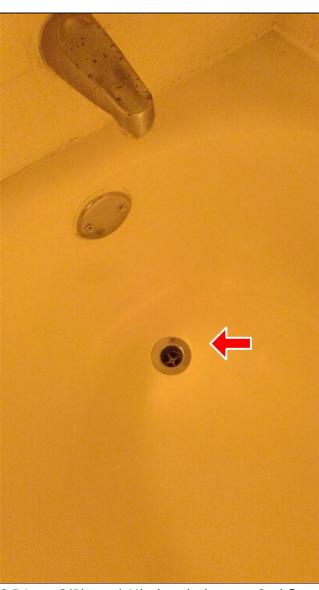
**6.5** (1) Primary bedroom bath and second floor hall bath tub are missing a drain stop. Recommend a qualified person install drain stops to prevent foreign objects from entering into drain line and causing restriction. Replace as needed.

6.5 Item 2(Picture) Missing drain stop, 2nd floor hall bath tub

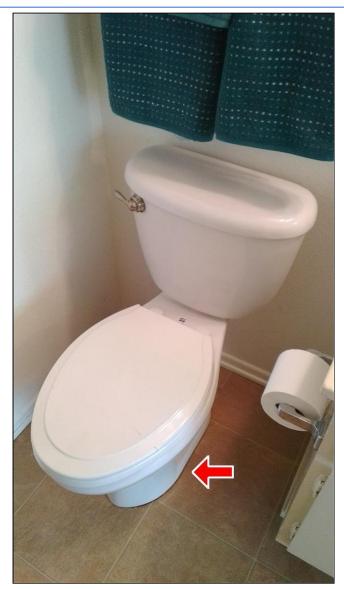
**6.5** (2) The toilet is loose at floor in the powder room off kitchen. Repairs may involve re-setting the toilet on a new wax seal. Recommend a qualified licensed plumber repair or correct as needed.

6.5 Item 3(Picture) Loose toilet, powder room off kitchen

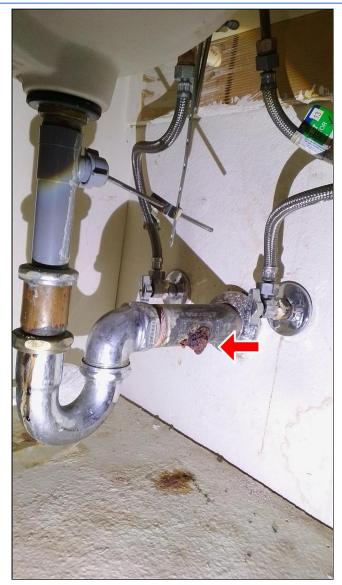
**6.5** (3) Seepage found from drain line below powder room sink. Recommend a qualified person further inspect for repair or replacement recommendations.

6.5 Item 4(Picture) Seepage, drain line, powder room sink

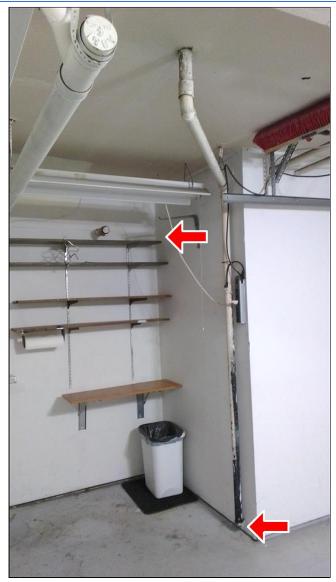
**6.5** (6) Washer drip pan drain line discharges directly into garage to ground. It appears drain line has been re-directed to ground and not to north wall. North wall has a capped off drain line. Recommend a qualified plumber further inspect drain line system for repair recommendations.

6.5 Item 7(Picture) Washer drip pan drain line, garage

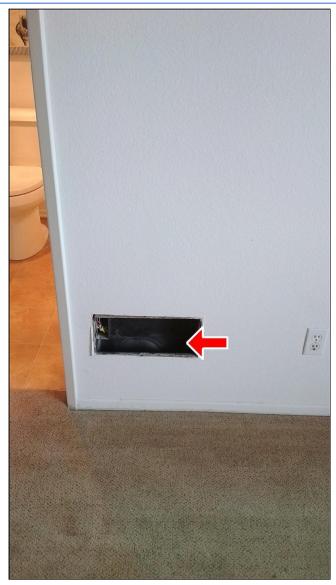
**9.0** (6) Electric wall heater inside primary bedroom was missing. Recommend a qualified person further inspect and install proper wall heater as needed.

9.0 Item 6(Picture) Wall heater missing, primary bedroom

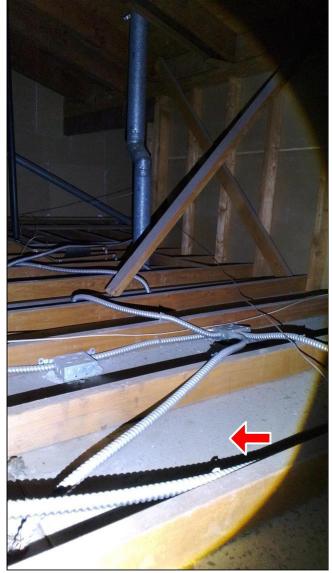
**10.0** Attic was not insulated at time of inspection. Heat loss can occur more on this home than one that is properly insulated. Recommend a qualified person properly install attic insulation as desired.

10.0 Item 1(Picture) Missing attic insulation

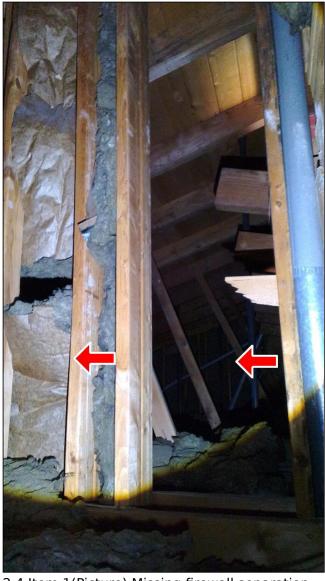
2.4 Item 1(Picture) Missing firewall separation, attic

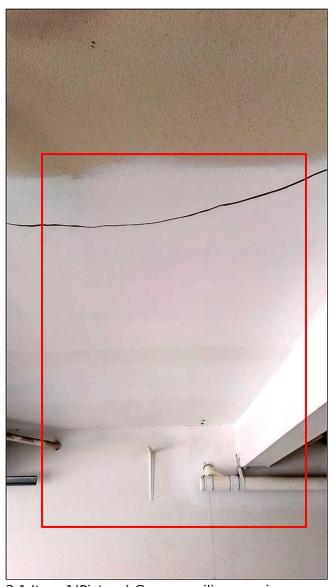
3.1 Item 1(Picture) Garage ceiling repairs

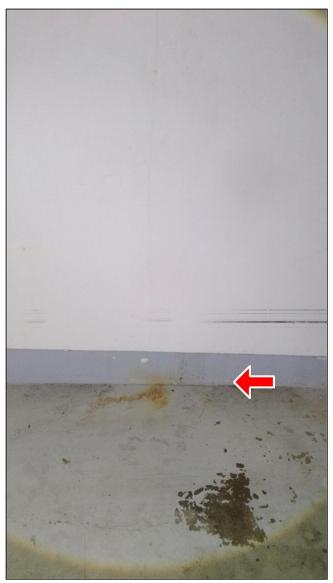
3.2 Item 1(Picture) Signs of leaking, garage south wall

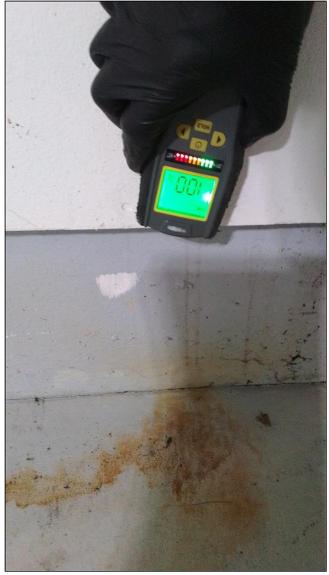
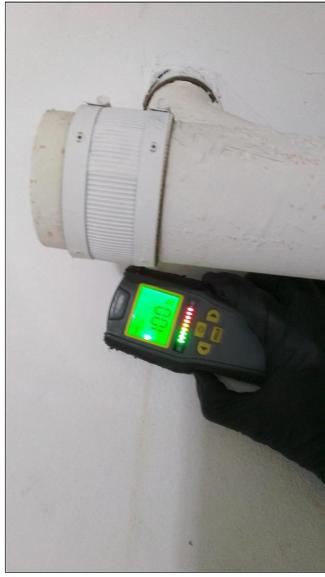
3.2 Item 3(Picture) Elevated moisture levels

3.2 Item 4(Picture) Elevated moisture levels

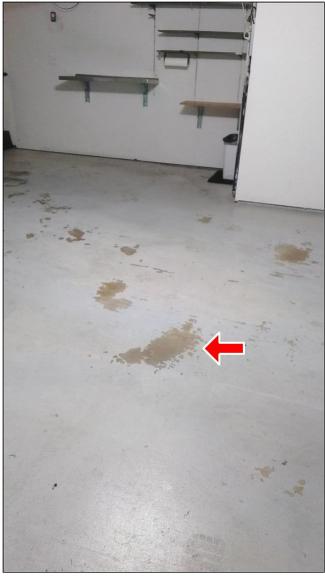
3.3 Item 1(Picture) Garage surface

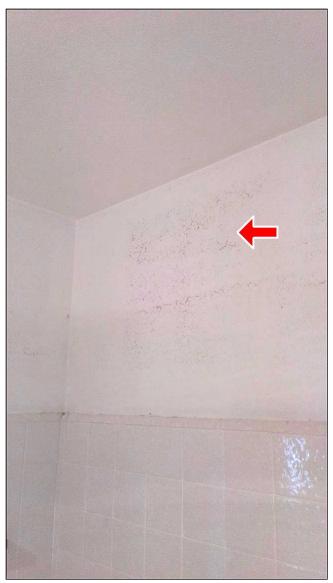
4.1 Item 1(Picture) Primary bed bath shower wall

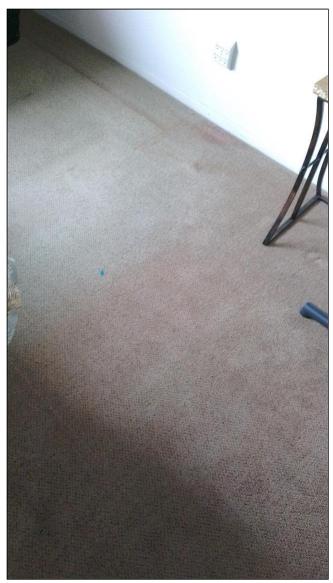
4.2 Item 1(Picture) Carpet

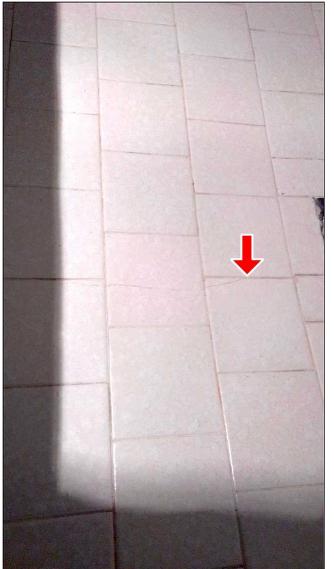
4.3 Item 1(Picture) Minor crack, primary bed bath shower

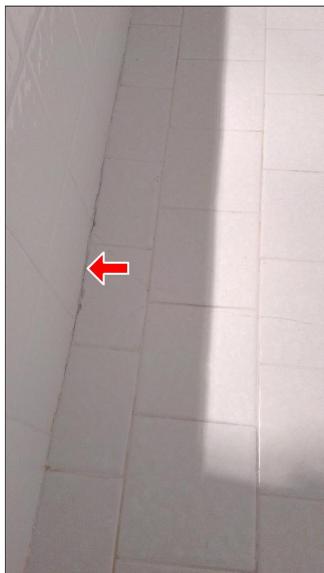
4.3 Item 2(Picture) Deteriorated grout, primary bed bath shower

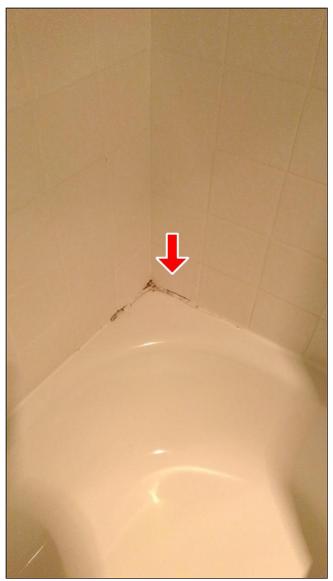
4.3 Item 3(Picture) Cracked and deteriorated seal, 2nd floor hall bathroom

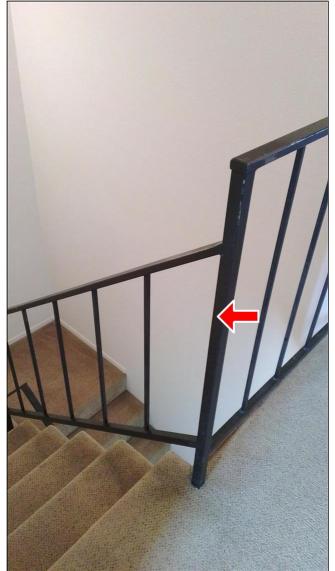
4.4 Item 2(Picture) Guard railing

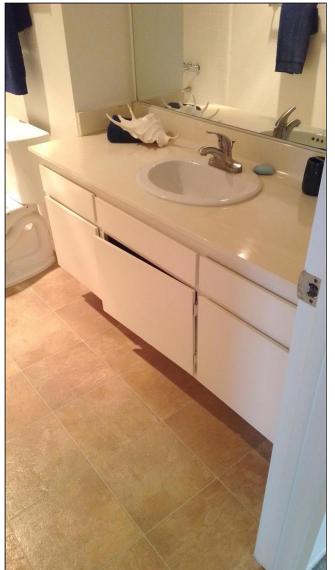
4.5 Item 1(Picture) 2nd floor hall bathroom, base cabinets

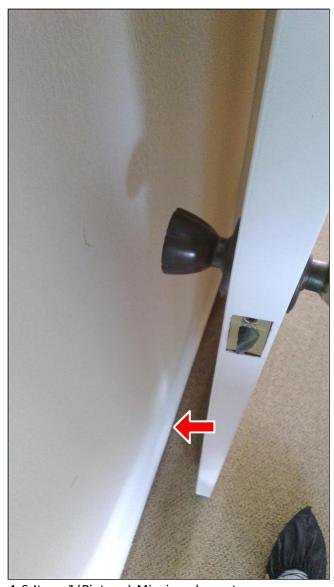
4.6 Item 1(Picture) Missing door stop

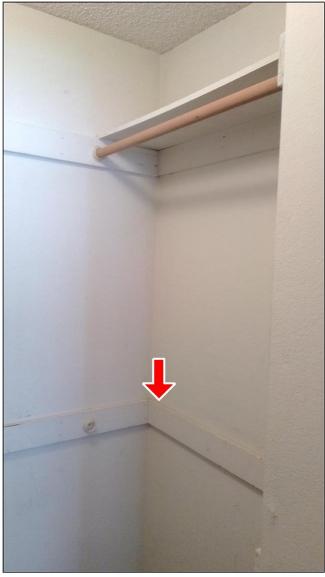
4.8 Item 1(Picture) Missing hanger rod, 2nd floor NE bed closet

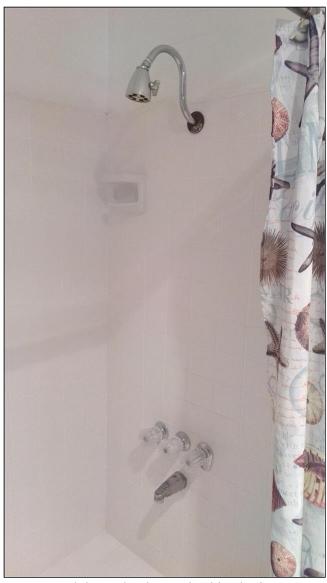
(1) Water supply fixtures throughout home are dated and have scale and corrosion build up. Recommend a qualified person further inspect and thoroughly clean or replace as needed.

6.3 Item 1(Picture) Primary bed bath shower fixtures

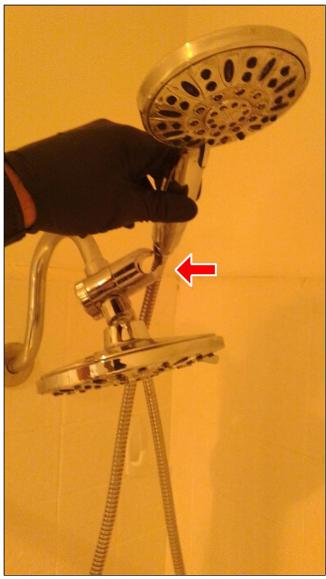
6.3 Item 2(Picture) 2nd floor hall bath shower head

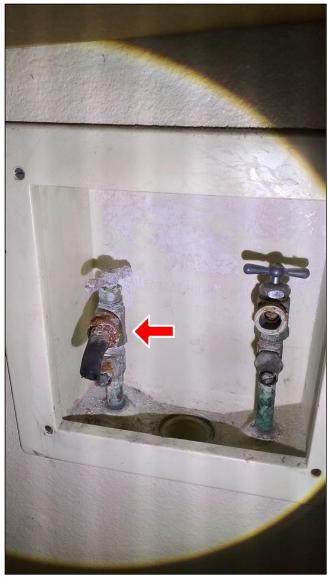
6.3 Item 3(Picture) Washer water supply, laundry closet

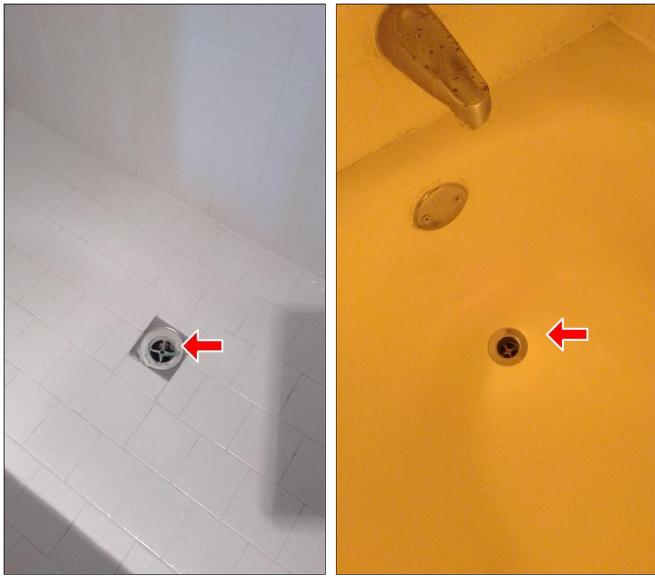
6.5 Item 1(Picture) Missing drain stop, primary bed bath

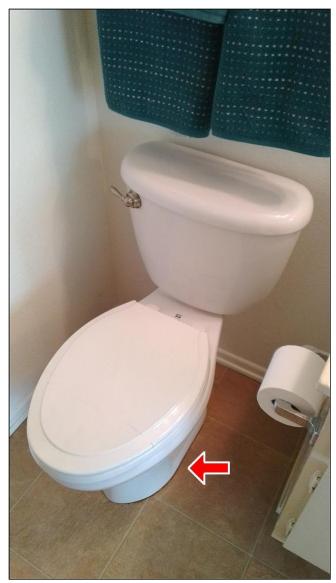
6.5 Item 3(Picture) Loose toilet, powder room off kitchen

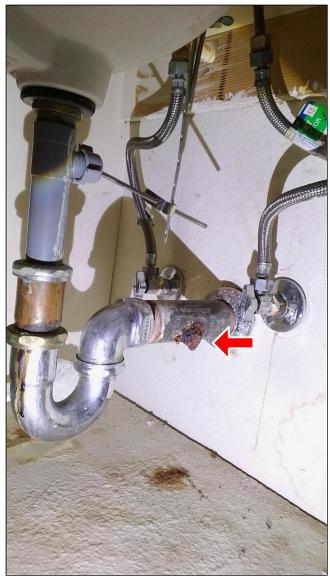
6.5 Item 4(Picture) Seepage, drain line, powder room sink

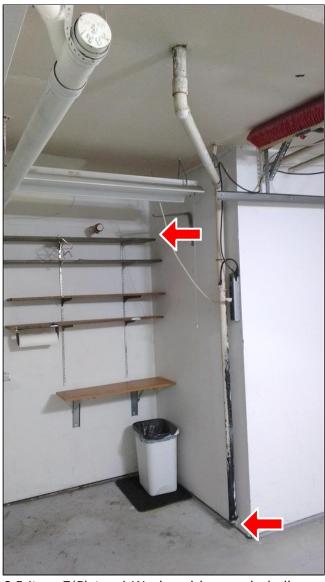
(6) Washer drip pan drain line discharges directly into garage to ground. It appears drain line has been re-directed to ground and not to north wall. North wall has a capped off drain line. Recommend a qualified plumber further inspect drain line system for repair recommendations.

6.5 Item 7(Picture) Washer drip pan drain line, garage

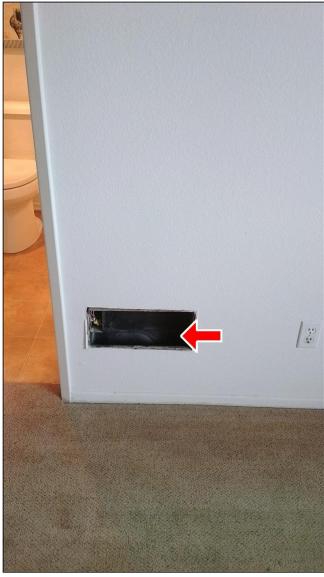
9.0 Item 6(Picture) Wall heater missing, primary bedroom

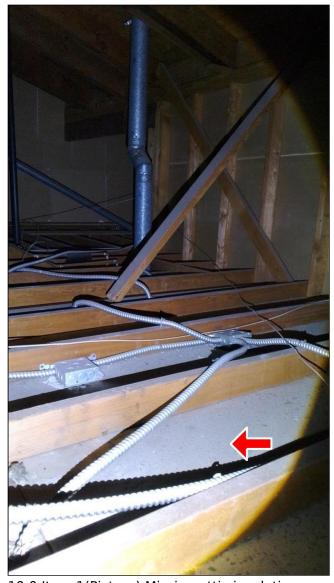
10.0 Item 1(Picture) Missing attic insulation
