Address: 28709 Rothrock Dr. Rancho Palos Verdes

Date of Inspection: 04-02-26

Main Sewer Line Inspection Report

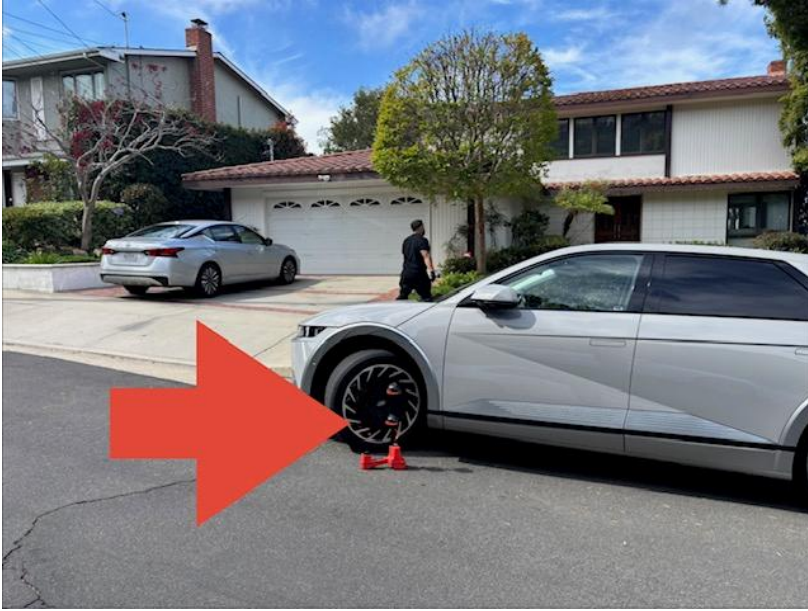
Connection to city sewer under tool.
