Imperial Home Inspection Services

General Information

BUILDING ADDRESS: 3021 Bay Ave
CITY: Chico
STATE: Ca
ZIP CODE: 95973
INSPECTION DESCRIPTION: Whole Home Inspection
SQUARE FOOTAGE: 3453

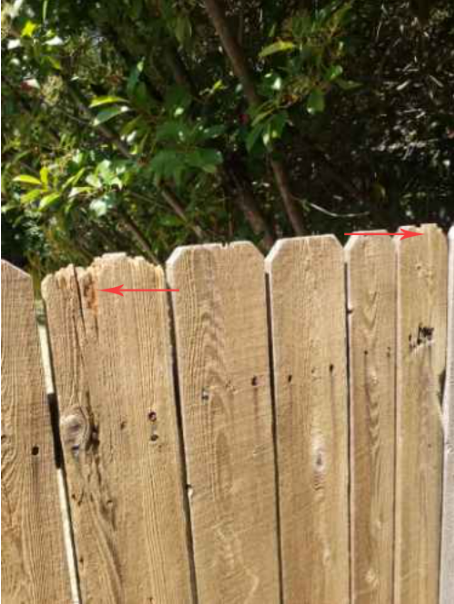
Water damage and deterioration of wood was observed to the gate on the right side of the home.

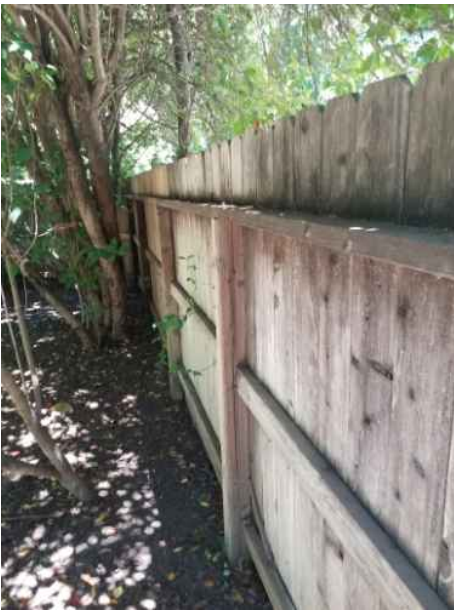
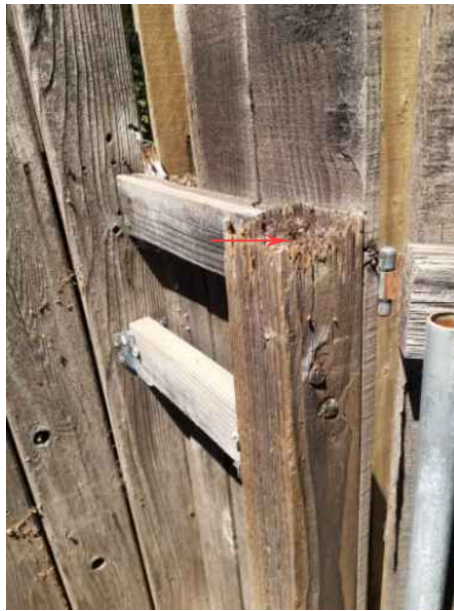
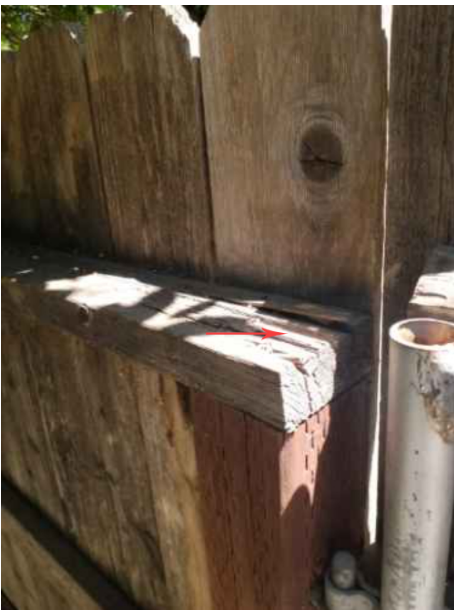
Water damage and deterioration of wood was observed to posts and runners, portions of this fence are nearing the end of their useful life spans. Recommend further evaluation by licensed fencing contractor.

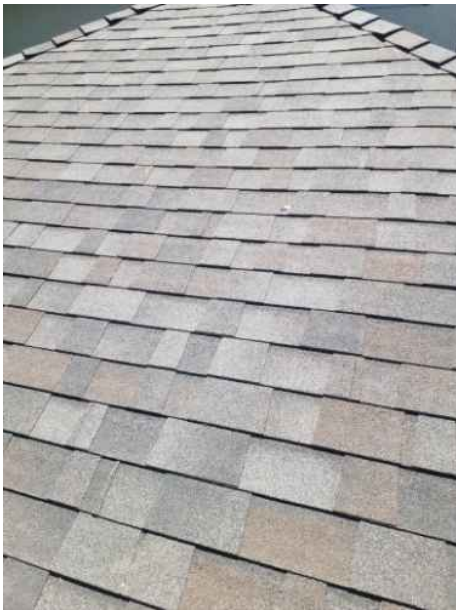
This roof appears to be fairly new.

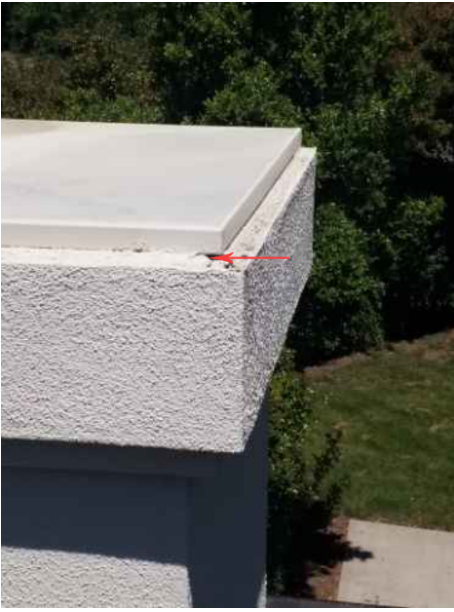
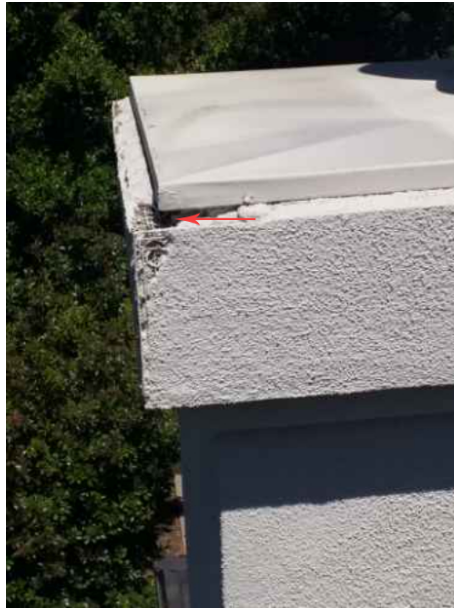
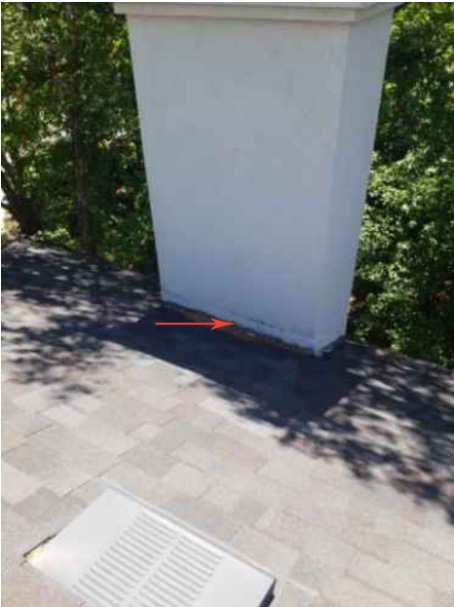
Deteriorating stucco was observed at the chimney crown adjacent to the garage, recommend further evaluation by licensed stucco contractor to prevent water intrusion.

- 3. Gaps in the stucco were observed at the chimney crown near the garage as well as water stains in the attic and ceiling of garage near the chimney.**

Recommend further evaluation by licensed contractor for installation of cricket (water diverter) on high side of both chimneys to prevent water from sitting up against chimneys.

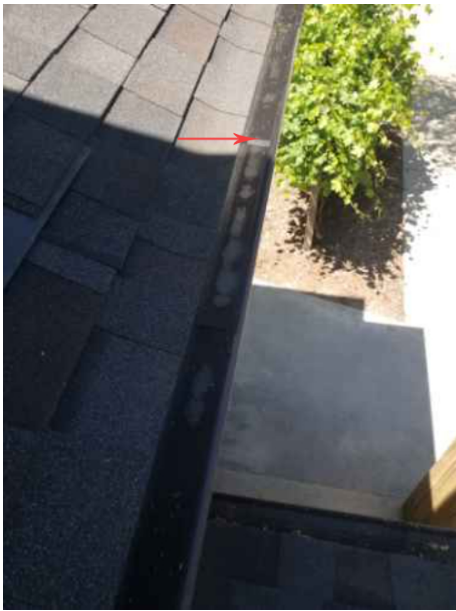
Gutter guards have been installed

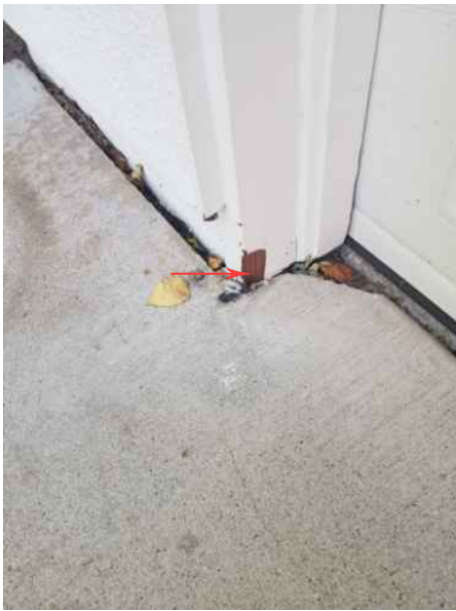
Minor damage was observed at the large overhead garage door.
Recommend painting to prevent water damage.

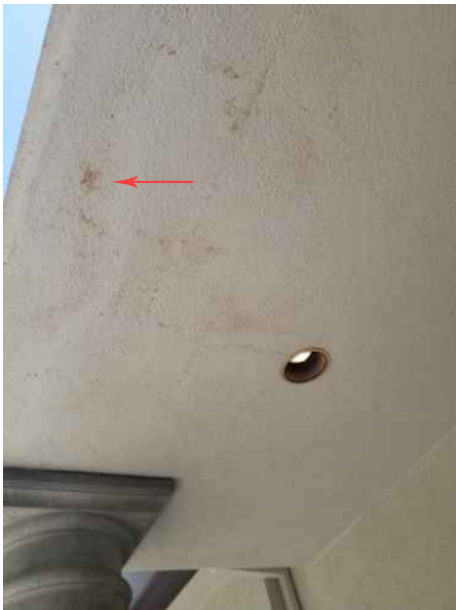
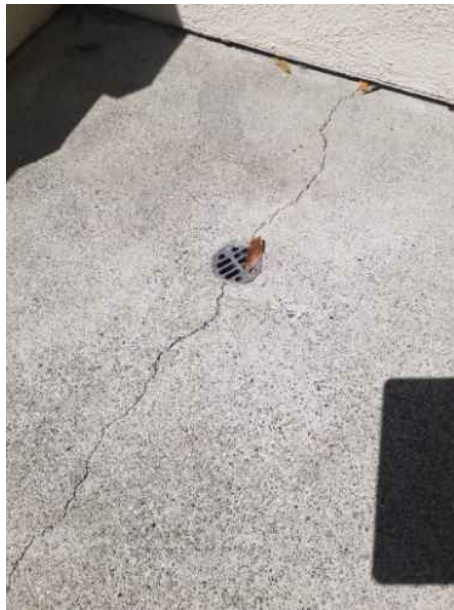
Signs of past possible water intrusion were observed at the balcony for the master bedroom, recommend further evaluation by licensed contractor. Cracks in the concrete were observed, recommend sealing cracks to prevent water intrusion.

- 1. The type B gas vent for the water heater does not have the minimum clearance required to combustibles, this is a potential fire hazard.**
- 2. Signs of past water intrusion were observed at the balcony off of the master bedroom.**

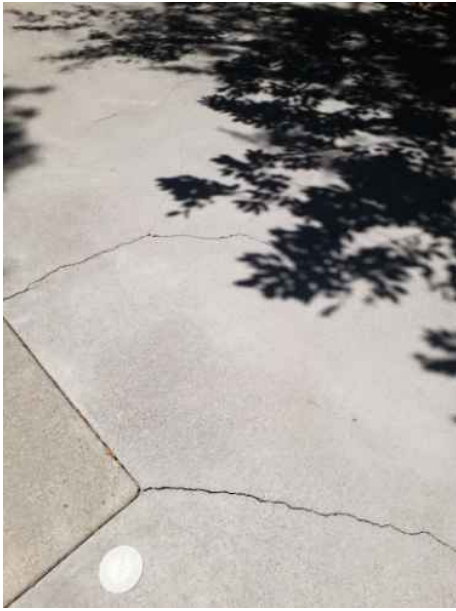
Cracking of concrete was observed, recommend sealing cracks to prevent water intrusion and further damage.

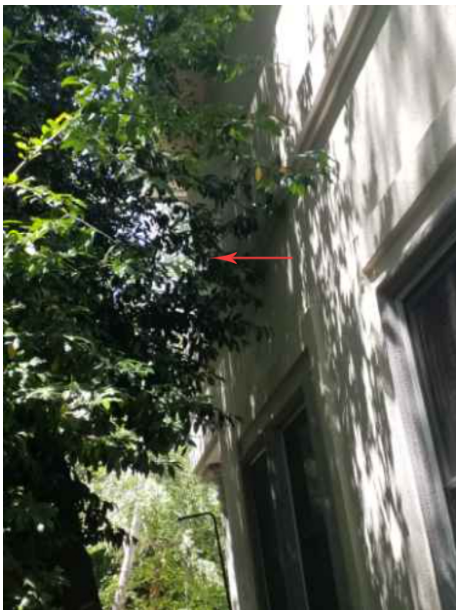
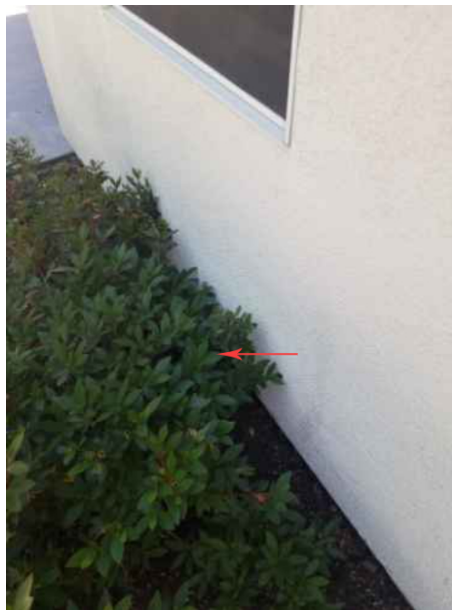
Recommend keeping vegetation cut back from home to prevent damage.

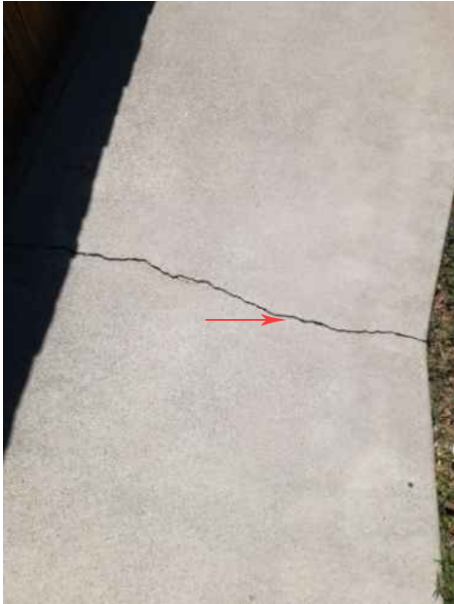
Cracking of concrete was observed, recommend sealing cracks to prevent water intrusion and further damage.

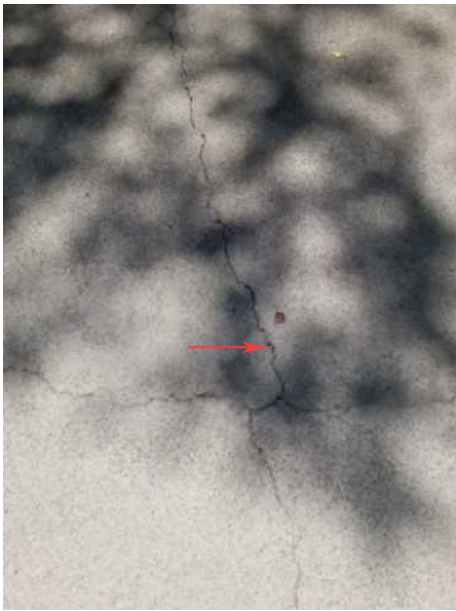
Cracking of concrete was observed, recommend sealing to prevent water intrusion and further damage.

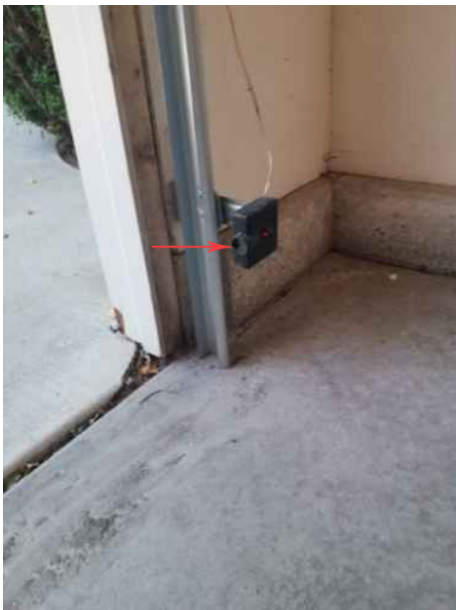
The safety sensors are set higher than the recommended 4-6 inch maximum height.

The auto reverse safety feature for the small garage door did not function.

Recommend adjustment of both by licensed garage door contractor for child safety.

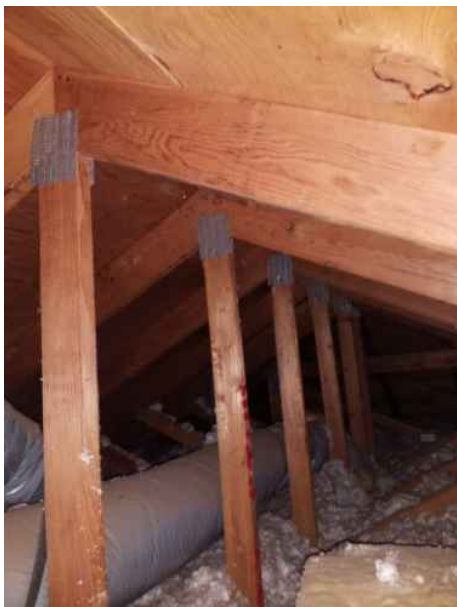
Engineered truss framework

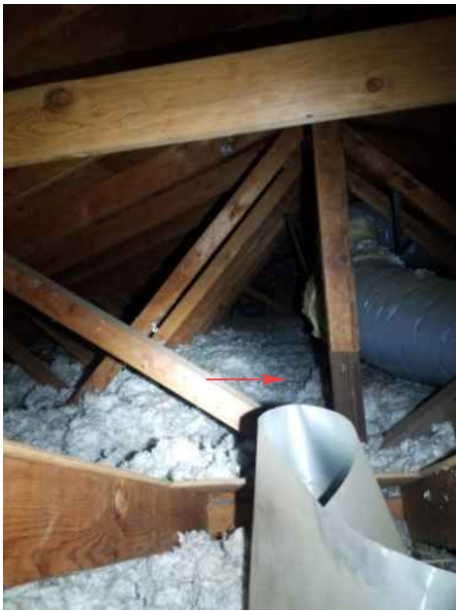
Portions of the blown fiberglass insulation have been compacted and no longer meet R-30 recommendations for this area. Recommend additional insulation to bring R value up to 30.

- 4. The upstairs cooling system functioned poorly.**
- 5. Portions of the attic insulation do not meet R-30 recommendations for this area.**
- 6. Exhaust fan venting for the laundry room and downstairs bathroom terminate in the attic.**

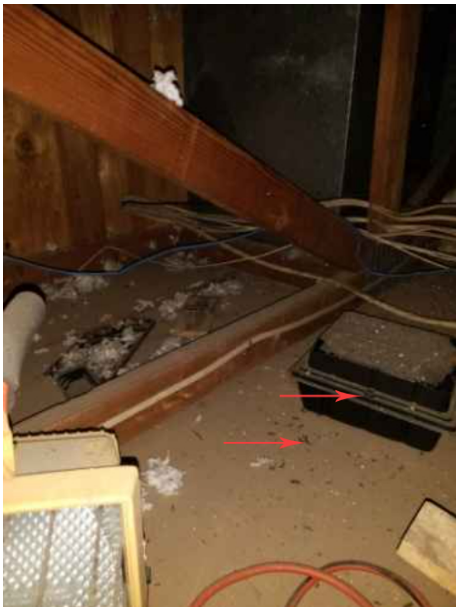
Rodent droppings and bait stations were observed

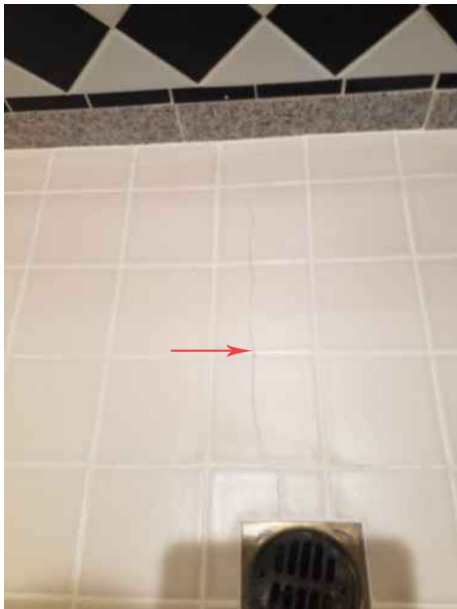
Cracked tile were observed in the shower, recommend sealing to prevent water intrusion to the sub floor.

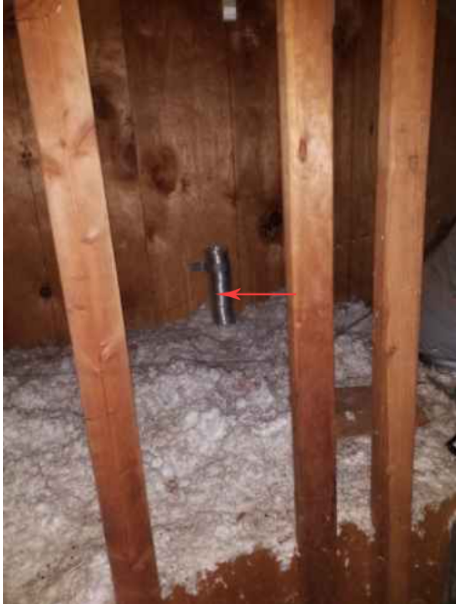
The exhaust fan venting terminates in the attic. Recommend running venting to an attic vent to prevent moist air from being vented into the attic.

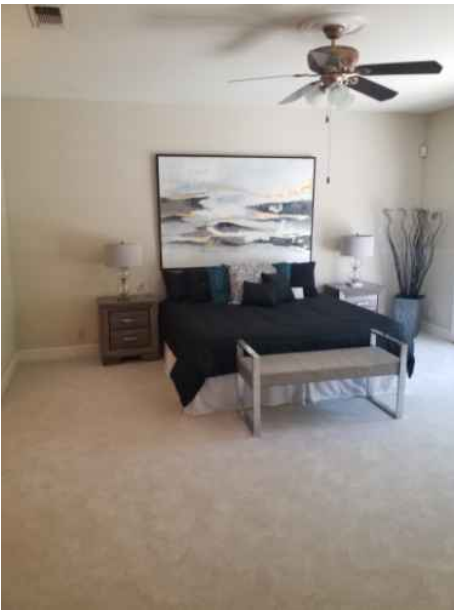
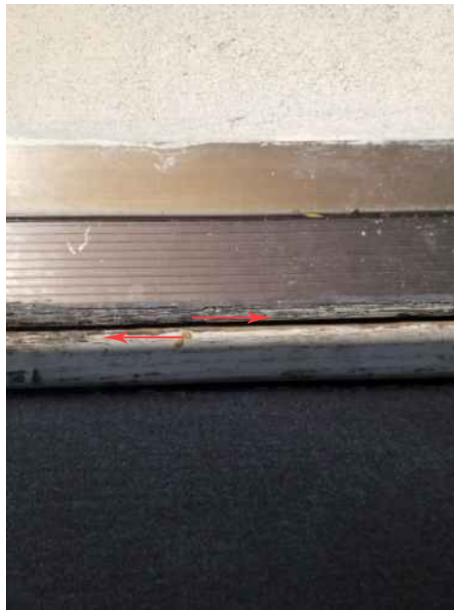
Damaged weatherstripping and signs of past water intrusion were observed at the bottom of the exterior doors.

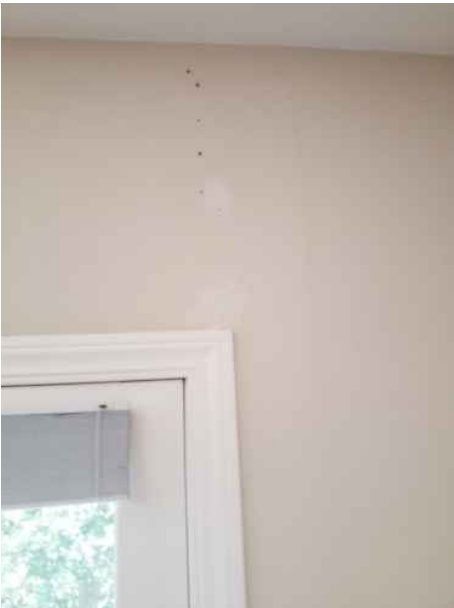
Patched holes were observed above the exterior doors.

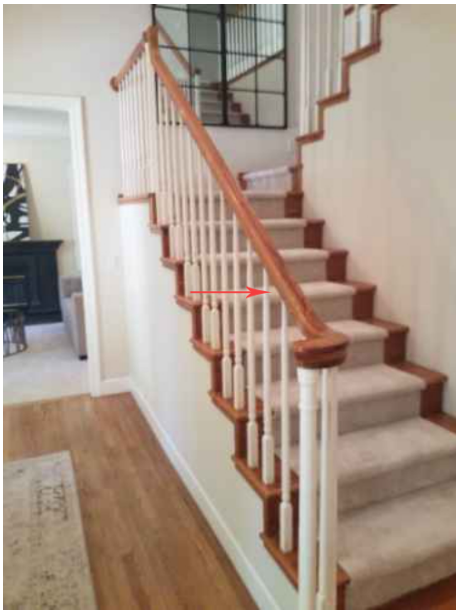
The hand rail is a little loose

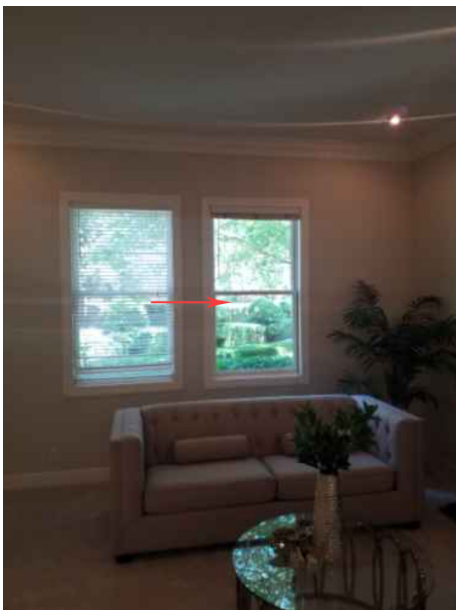
Condensation stains were observed in between the panes of glass in the window pictured. This indicates failed glazing, recommend further evaluation by licensed window contractor.

- 9. The water heater is beyond its expected life span.**
- 10. The air gap device for the dishwasher has been bypassed.**
- 11. The glazing is failing in one window in the 1st living area.**

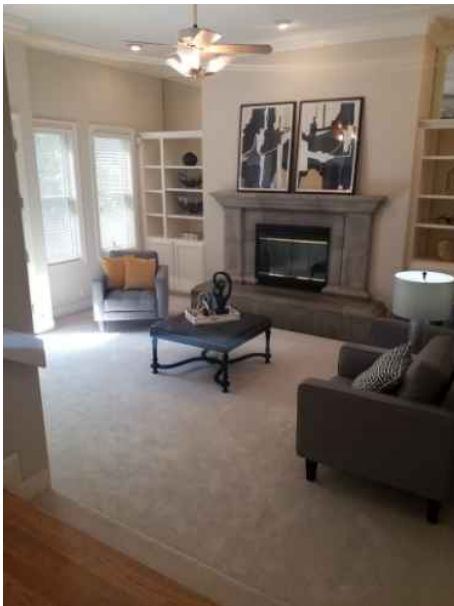
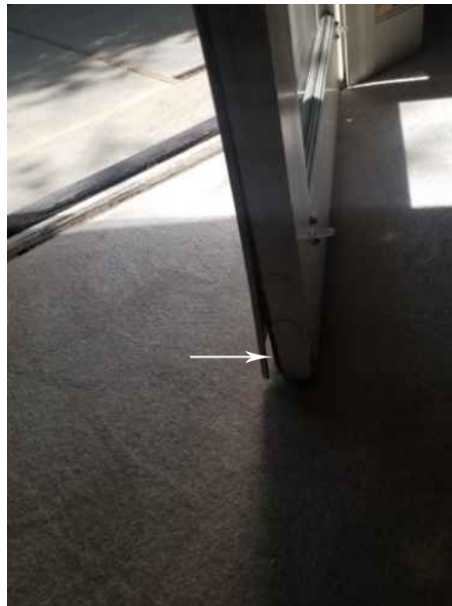
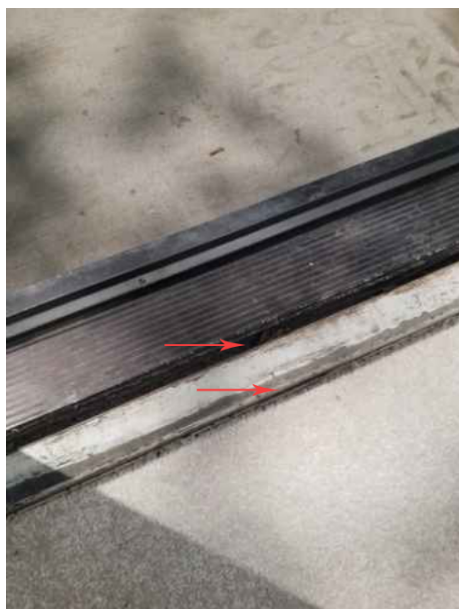
Damage was observed to the bottom of the French doors as well as deteriorating weatherstripping and signs of past water intrusion

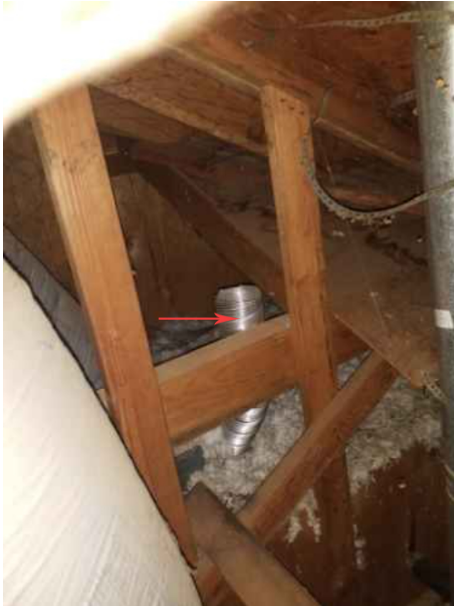
The venting for the exhaust fan terminates in the attic, recommend extending venting to an attic vent to prevent moist air from being vented into the attic.

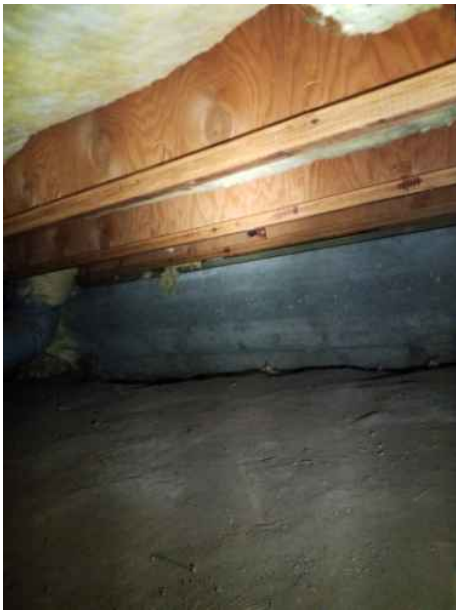
Poured concrete perimeter foundation with footing and engineered wood I beams.

Due to placement of plumbing drain piping the portion of the foundation area near the garage was not accessible for inspection.

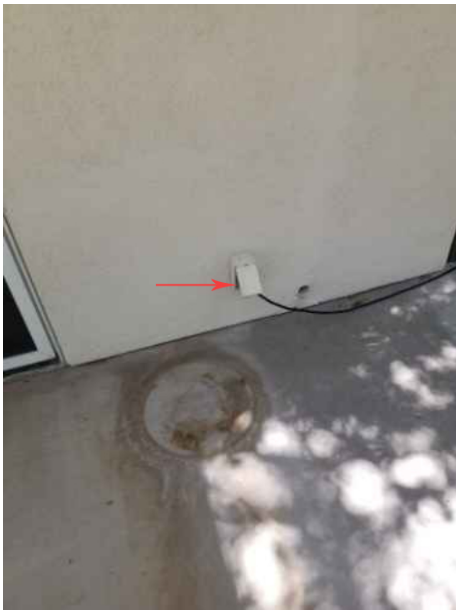
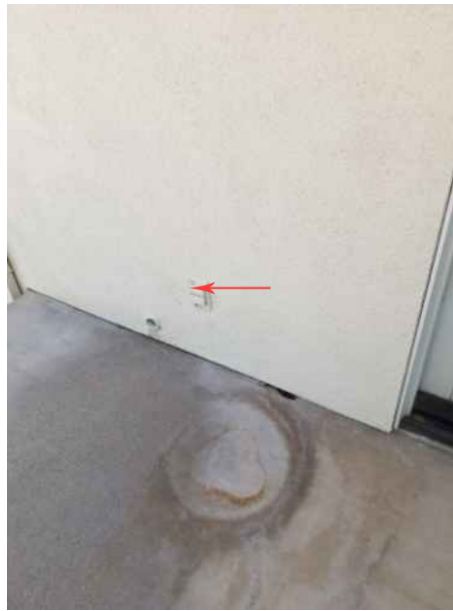
The exterior electrical outlets outside the dining room French doors show no power, one if these is a gfci outlet that is faulty. It is possible the other exterior outlet and the dining room outlets are downstream of this gfci outlet. Recommend further evaluation by licensed electrical contractor.

- 7. None of the electrical outlets in the dining room showed power.**
- 8. The Day and Night heating and cooling systems are beyond their expected life spans.**

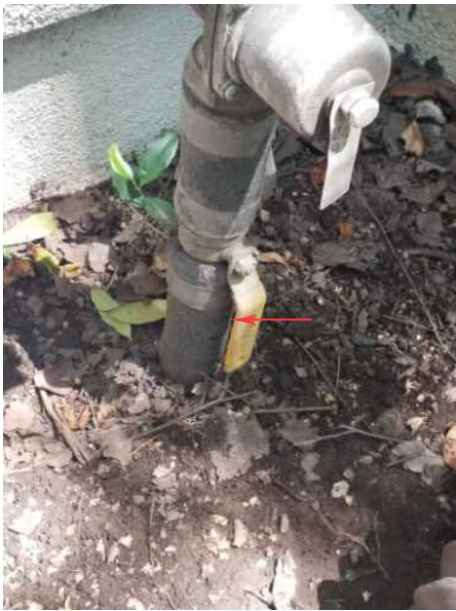
The main shutoff valve is located on the left side of the home.

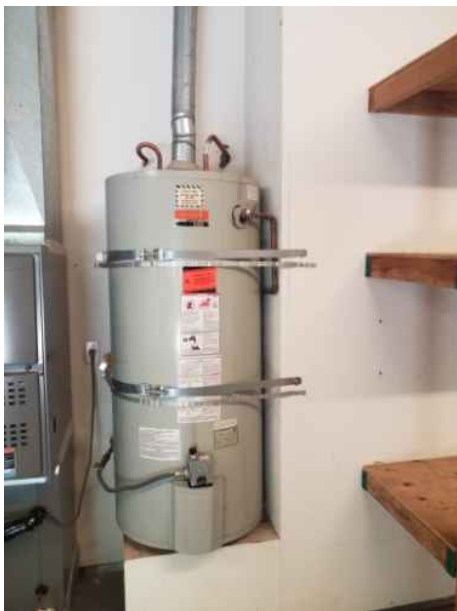
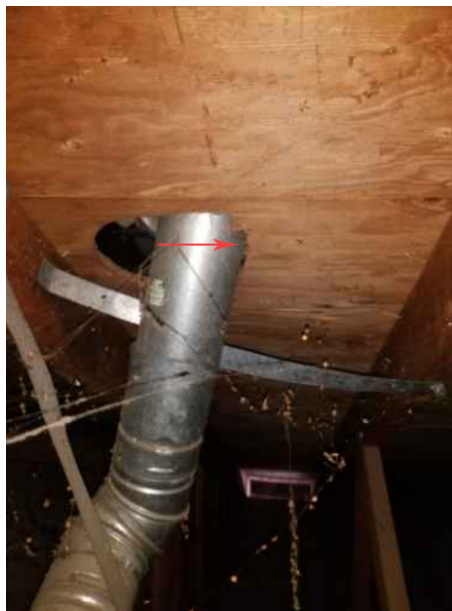
The 75 gallon gas fired water heater was manufactured in 1990. The expected life span of a water heater is 10-15 years, this unit is beyond its expected life span but still functioning.

The type B gas vent does not have the minimum 1 inch clearance to combustible materials required where it penetrates the roof, this is a potential fire hazard. Recommend further evaluation by licensed contractor.

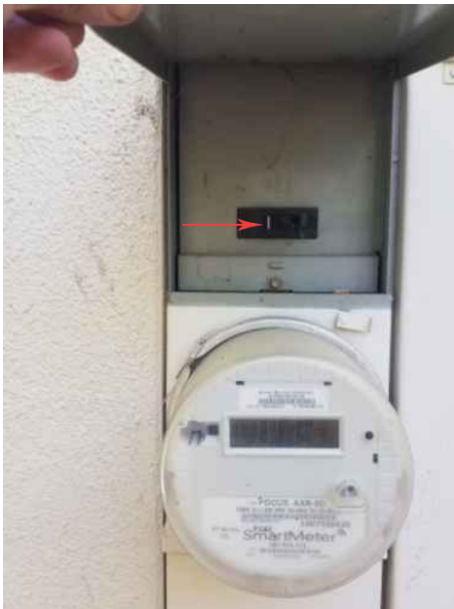
The main disconnect is located in the circuit panel on the exterior of the home.

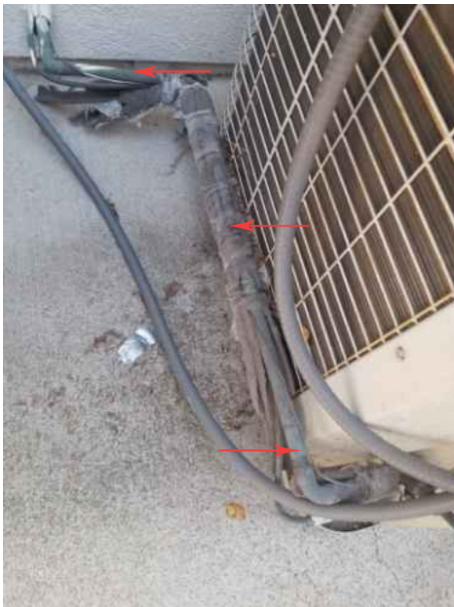
The insulation wrap for the line set at the compressor and condenser unit manufactured by Day and Night is no longer intact, recommend installation of new insulation wrap to prevent damage.

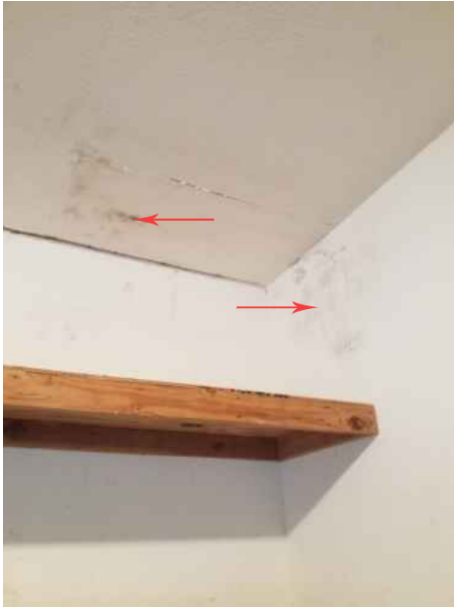
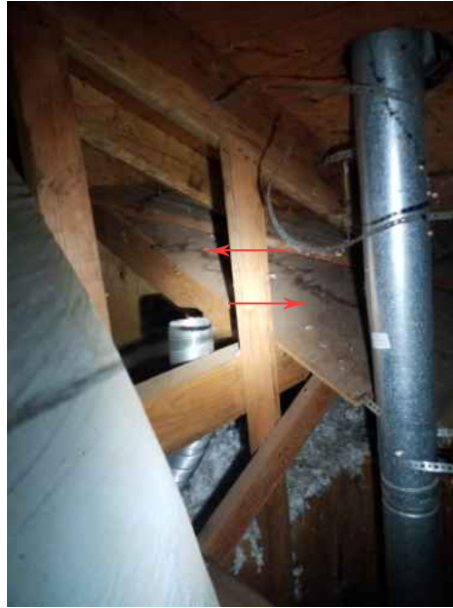
Signs of past water intrusion were observed in the garage ceiling and attic space. This is near the chimney that has gaps at the crown and could have come from the chimney chase. Recommend further evaluation by licensed contractor.

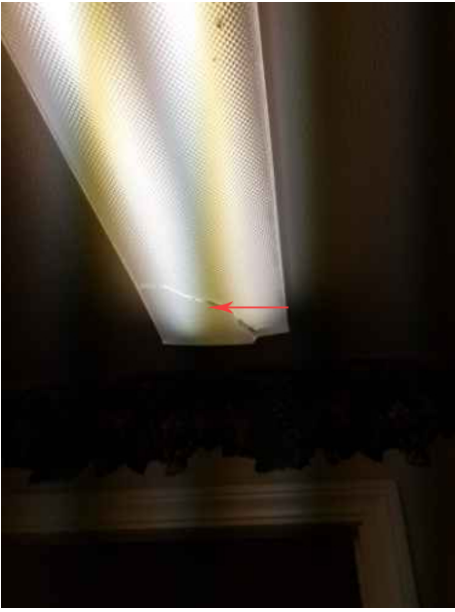
Damage was observed to this light cover.
