WOOD DESTROYING PESTS AND ORGANISMS INSPECTION REPORT

Building No. 2321	Street GONZAGA LN	City RIVERSIDE	Zip 92507	Date of Inspection 01/26/22	Number of Pages 1 of 5
-----------------------------	-----------------------------	--------------------------	---------------------	---------------------------------------	----------------------------------

Report # 11077

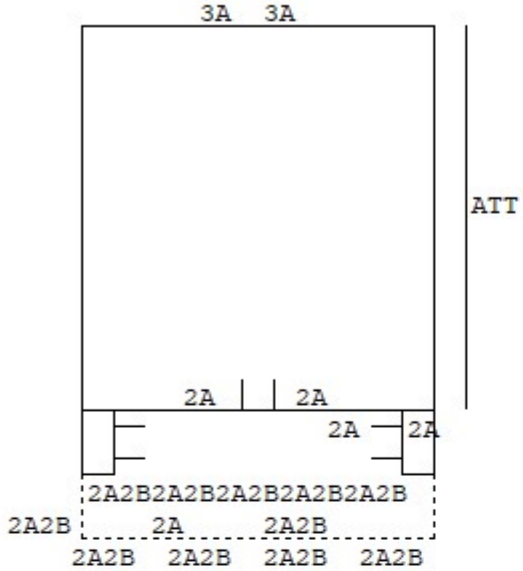
NOTED ON THE DIAGRAM AS 2A THERE IS EVIDENCE OF DRYWOOD TERMITES.

NOTED ON THE DIAGRAM AS 2B THERE IS EVIDENCE OF DRYWOOD TERMITE DAMAGE.

NOTED ON THE DIAGRAM AS 3A THERE IS EVIDENCE OF DRYROT.

FUMIGATE ENTIRE STRUCTURE WITH VIKANE FUMIGANTE FOR THE CONTROL OF DRYWOOD TERMITES. RECOMMENDATION TO REMOVE OR COVER ALL ACCESSIBLE PELLETS AND FRASS OF WOOD-DESTROYING PEST. CONTRACTOR WILL TAKE REASONABLE CARE, BUT NO RESPONSIBILITY FOR ANY DAMAGE TO: PLANTS, SHRUBS, TREES, OR ROOFS.

REMOVE, REPLACE, AND/OR REPAIR TERMITE DAMAGE AT 2X3X10 54PCS, DOOR JAM, 6X10 4PCS BEAM, 4X6 POST, BASE. IF DAMAGE IS FOUND TO EXTEND INTO AREAS NORMALLY CONSIDERED INACCESSIBLE, AN ADDITIONAL CHARGE MAYBE MADE.

REMOVE, REPLACE, AND/OR REPAIR ROT AT 2X8X16 2PCS FASCIA. IF DAMAGE IS FOUND TO EXTEND INTO AREAS NORMALLY CONSIDERED INACCESSIBLE, AN ADDITIONAL CHARGE MAY BE MADE.
