### *Inspection Report*

Address: 2556 Nutmeg Ave Morro Bay, CA 93442

09/04/2025

Inspector: Taylor Vreeken, CCI

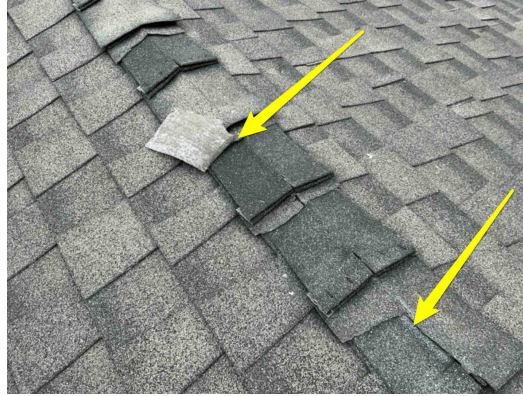
**E&C s-65:** Some damaged and missing roof shingles noted at areas of the roof. Corrections are needed. Contact a qualified roofer to evaluate the roof and make the appropriate recommendations and repairs as needed.

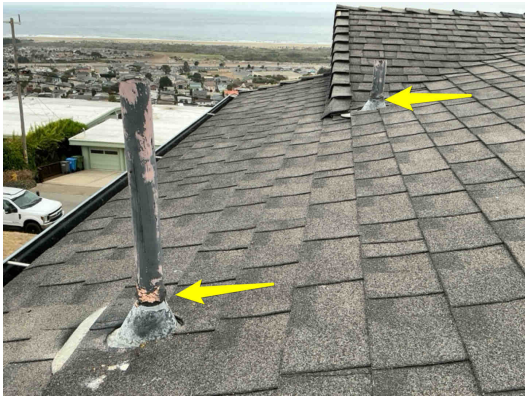
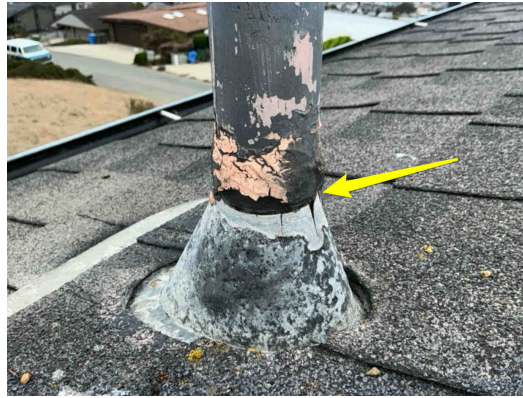
**MR s-67:** Deteriorated sealant at some roof flashings, around the roof penetrations. Maintenance recommended to help prevent water intrusion into areas of the attic. Have roofer evaluate the roof flashings and correct as needed.

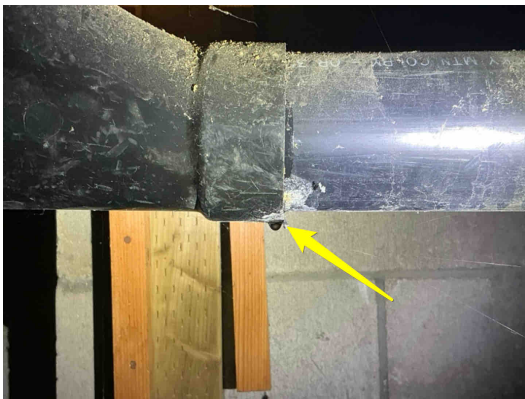
**FI s-87:** Active water leak(s) found in the waste pipe in the crawlspace: LAUNDRY AREA. Have plumber check all waste piping throughout the crawlspace for any additional leakage.

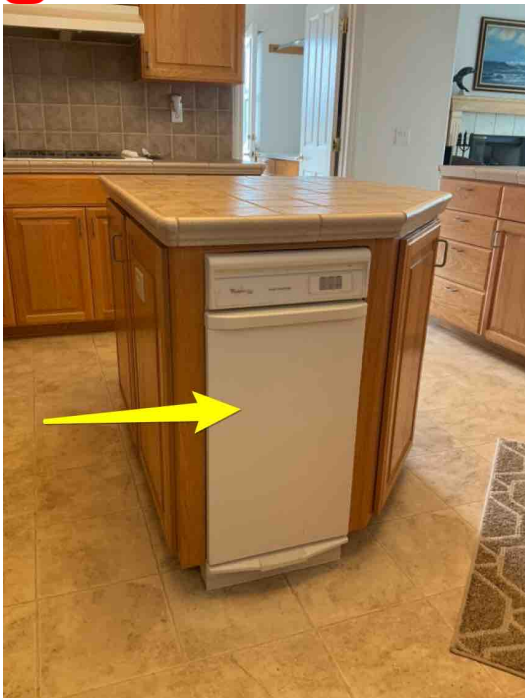
**E&C s-131:** Trash Compactor found non-operational / damaged / not operating properly.

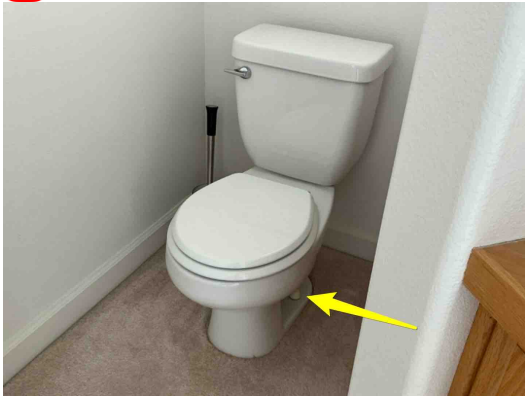
**E&C** s-145: Toilet loose at floor: PRIMARY BEDROOM BATHROOM

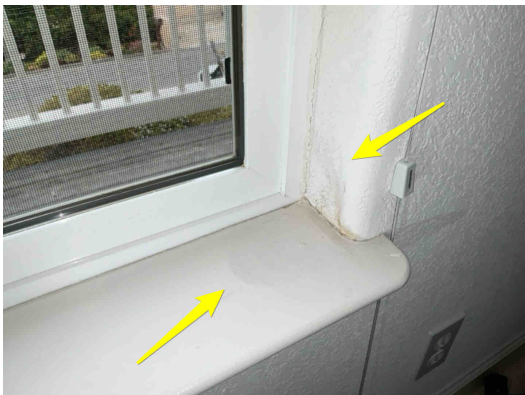
**FI** s-167: Moisture stains and/or damage on the inside at some window sills. Refer to the termite report for additional comments and recommendations.

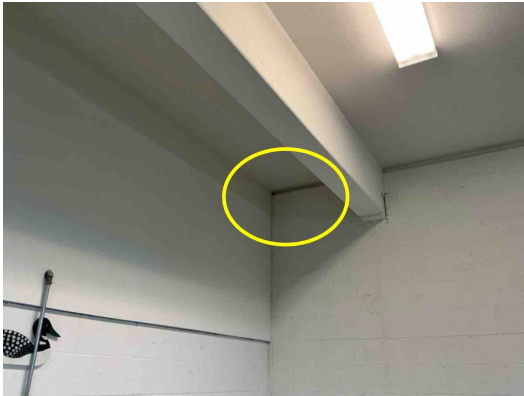
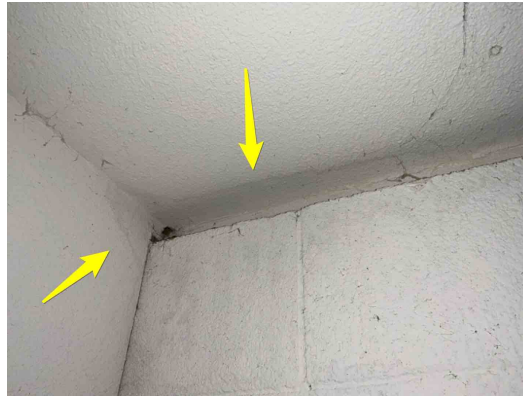
**FI s-180:** Evidence of past moisture stains & damage at ceiling area in the GARAGE (southeast corner). Recommend further review of the water stains to determine the cause, the current condition and if repairs are needed.

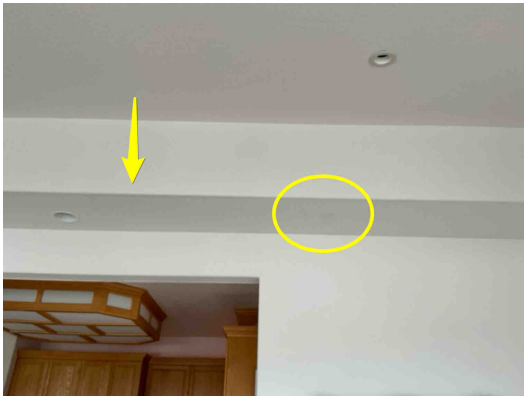
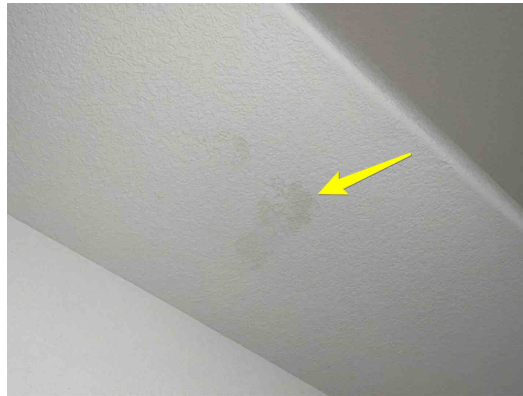
**FI s-181:** Evidence of past moisture stains & damage at ceiling area in the LIVING ROOM. Recommend further review of the water stains to determine the cause, the current condition and if repairs are needed.

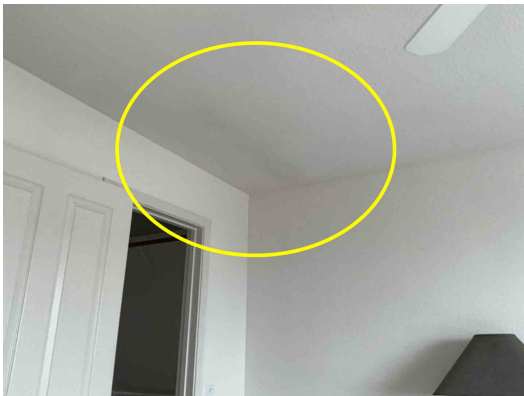
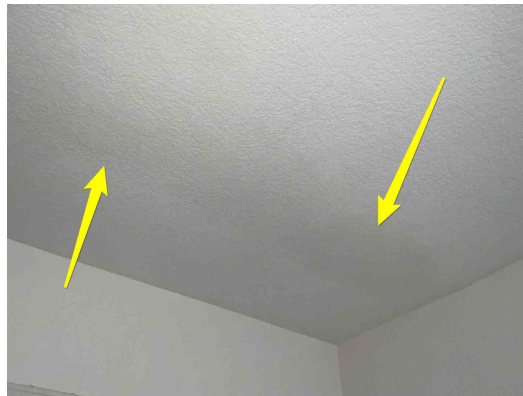
**FI s-182:** Evidence of past moisture stains & damage at ceiling area in BEDROOM-2. Recommend further review of the water stains to determine the cause, the current condition and if repairs are needed.

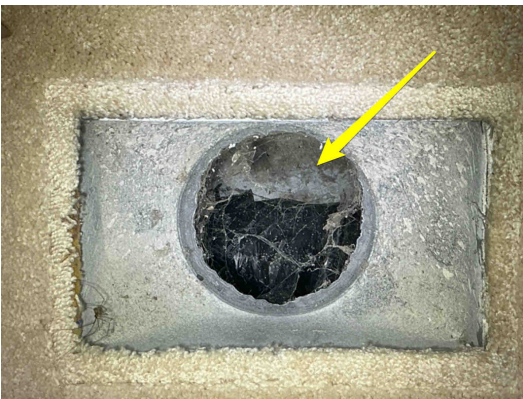
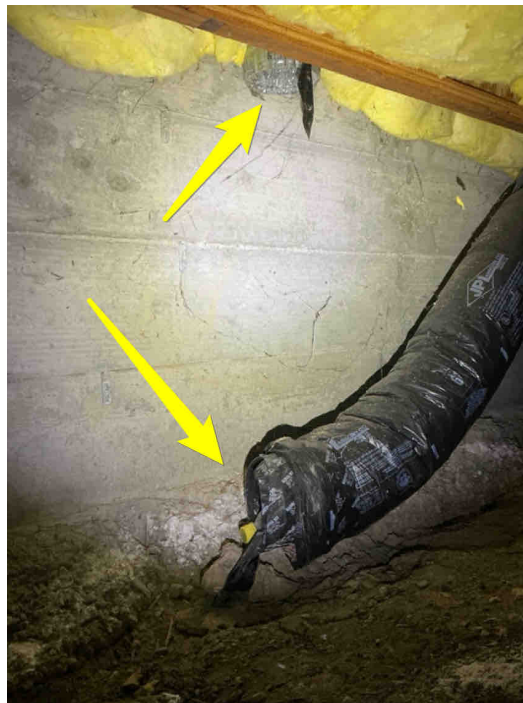
**E&C s-195:** Disconnected and damaged heating ducting found in the crawlspace below BEDROOM-2. Correct pions recommend.

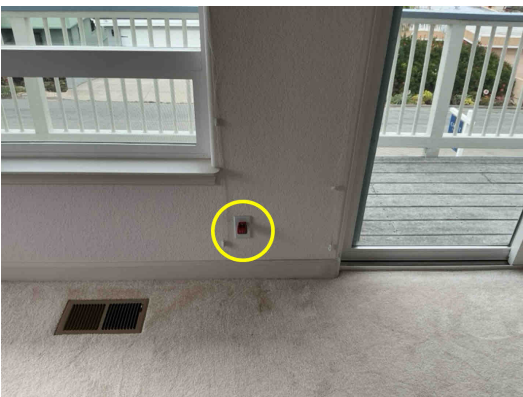
**SC s-208:** Miswired electrical outlet (Reverse polarity) found LIVING ROOM EAST WALL. Have electrician check all outlets and correct as needed.

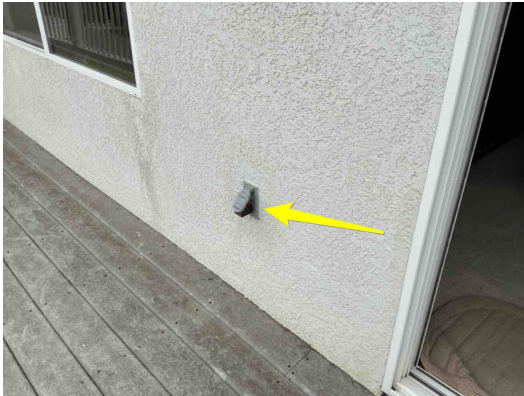
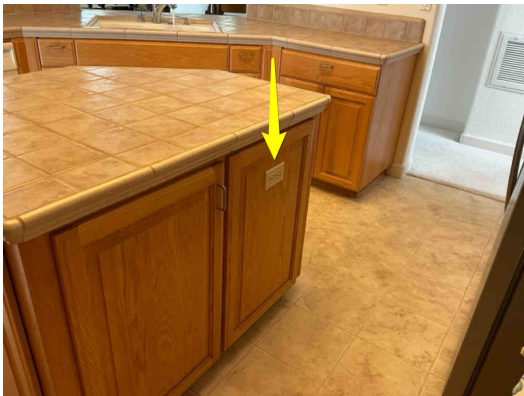
**SC s-210:** Missing GFCI protected outlets in some required locations. Recommend repairs and upgrades by a qualified and licensed electrical professional familiar with the minimum GFCI protection requirements: EXTERIOR (REQ.1971)  
FIVE OUTLETS IN THE KITCHEN (REQ.1987)

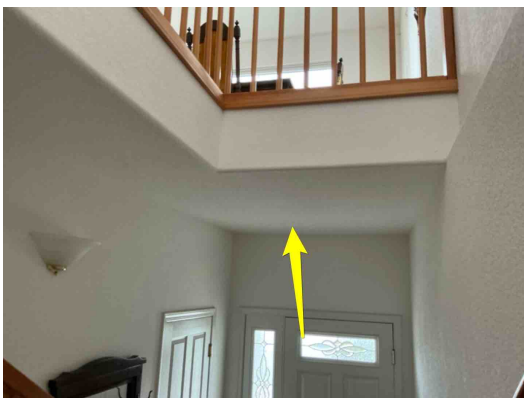
**SC s-213:** Smoke detector AND Carbon Monoxide detector are missing at required location: ENTRY LEVEL

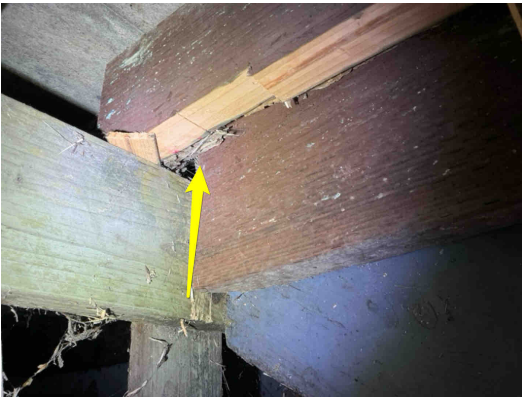
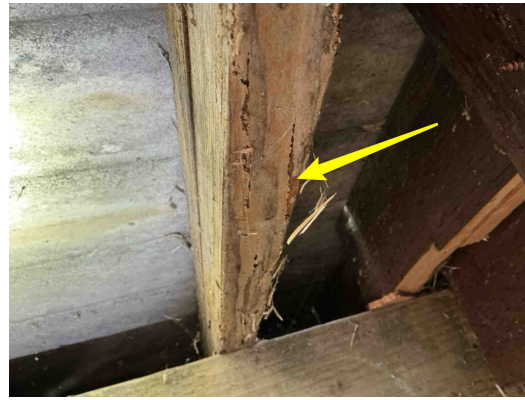
**E&C 33:** Some moisture and/or bug-type damage and deterioration found at areas of the wood decking and/or wood deck railings: UPSTAIRS DECK OFF THE LIVING ROOM and SOUTH DECK. *Refer to the termite report for additional comments and recommendations.*

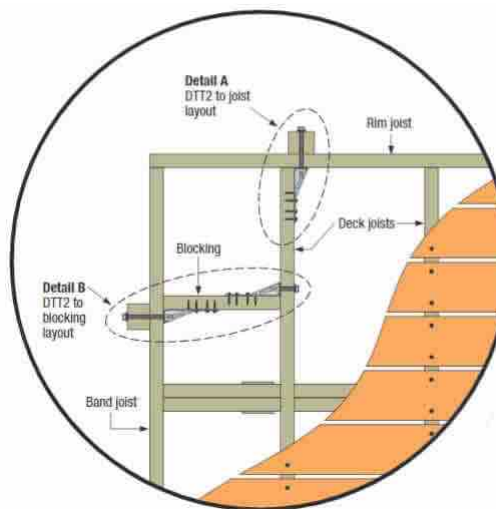
**34:** The deck railing attachments do not meet minimum installation standards. Contact a qualified contractor for upgrade and/or repair recommendations: UPSTAIRS DECK OFF THE LIVING ROOM

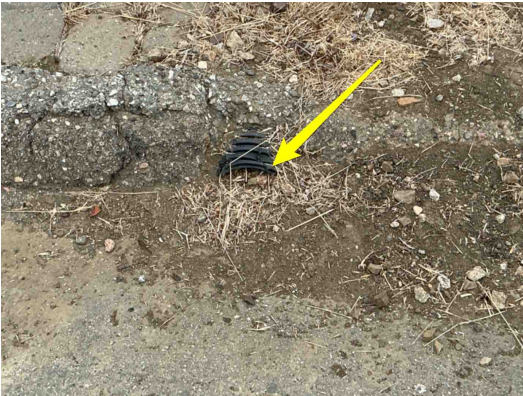
**MR 38:** Surface and/or yard drain boxes found full of debris. Recommend having drains tested to determine proper flow and termination.

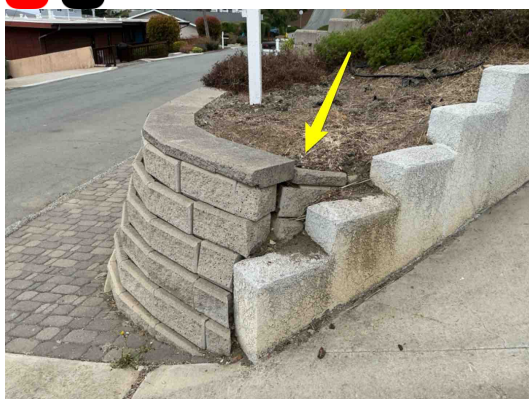
**42:** A few areas of the stacked brick retaining walls found settling and/or bulging.

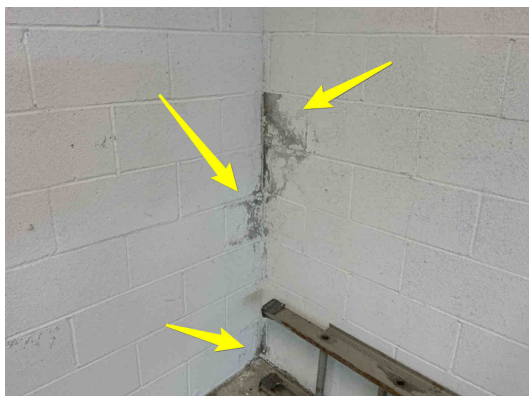
**FI DS 52:** Some visible efflorescence found on areas of the below grade garage foundation walls in the garage. This is indicative of moisture intrusion with a failure of the below grade foundation wall waterproofing.

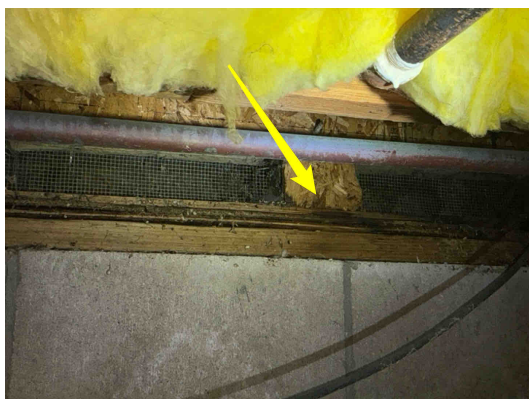
**FI 56:** Moisture and/or bug type deterioration and/or damage found in areas of the crawlspace at wood framing and/or sub-floor. Refer to the current Termite / pest inspection report for additional comments.

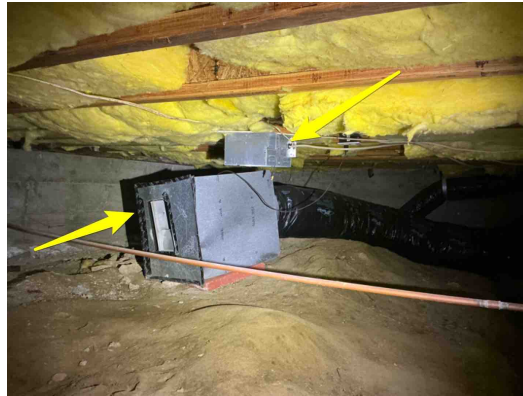
**E&C FI 59:** The crawlspace ventilation system appears to be partially installed and/or abandoned. Full condition is unknown. Ventilation systems are not currently functional. Contact a qualified contractor for evaluation and upgrades/repairs or completion.

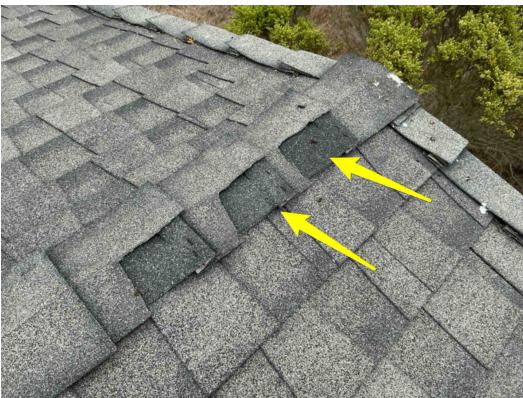
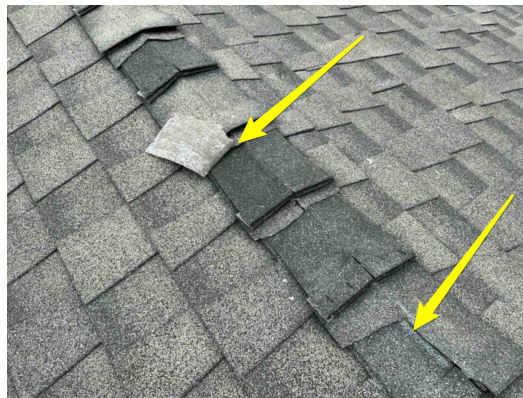
**E&C 65:** Some damaged and missing roof shingles noted at areas of the roof. Corrections are needed. Contact a qualified roofer to evaluate the roof and make the appropriate recommendations and repairs as needed.

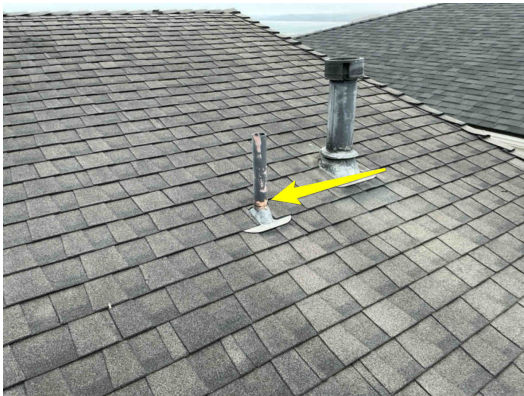
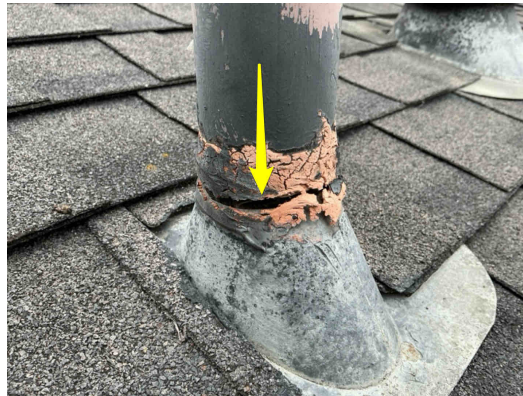
**MR 67:** Deteriorated sealant at some roof flashings, around the roof penetrations. Maintenance recommended to help prevent water intrusion into areas of the attic. Have roofer evaluate the roof flashings and correct as needed.

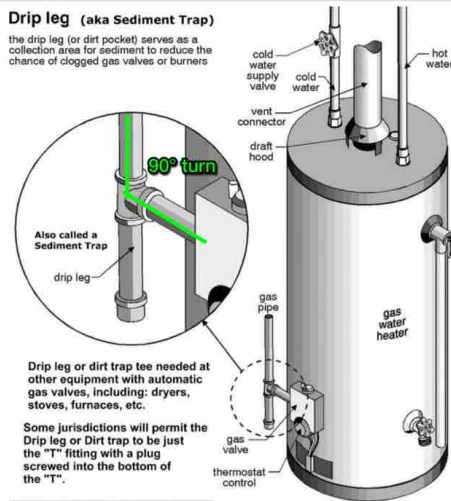
**SU** 102: Recommend the installation of the missing sediment trap / drip leg at the WATER HEATER gas piping at flex connection by a certified or licensed plumbing professional familiar with minimum requirements. [CPC 1212.8]

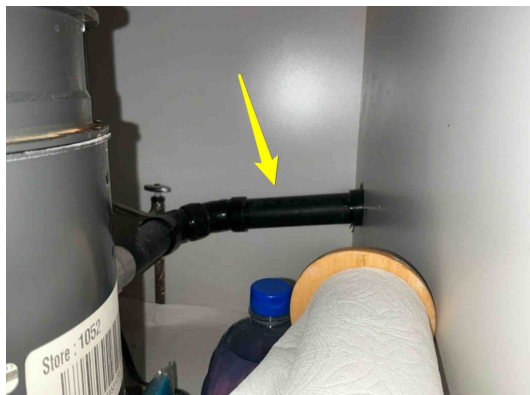
**E&C 114:** Sections of the drain piping under the kitchen sink improperly flow uphill. Maintenance or repair recommended.

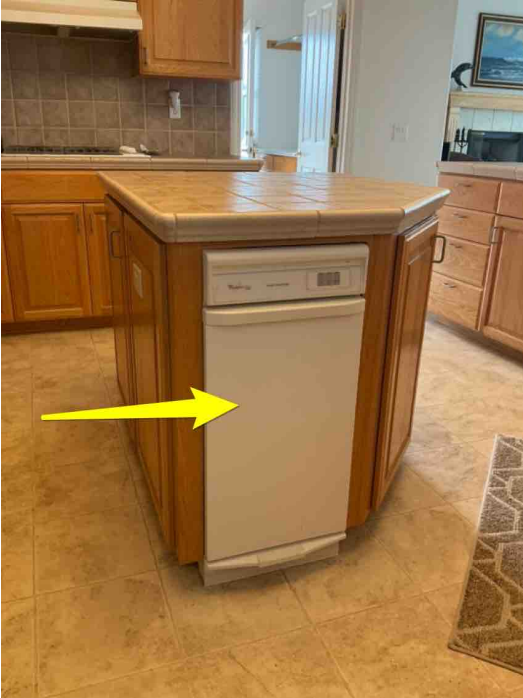
**E&C 131:** Trash Compactor found non-operational / damaged / not operating properly.

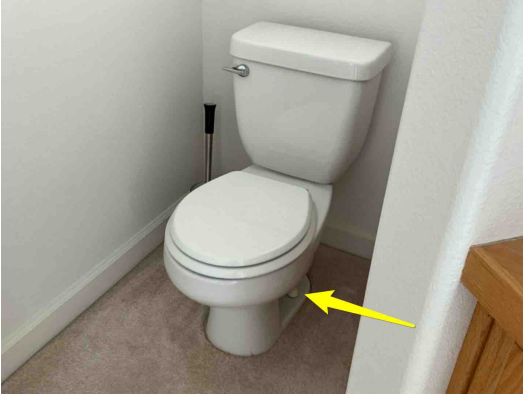
**E&C 145:** Toilet loose at floor: PRIMARY BEDROOM BATHROOM

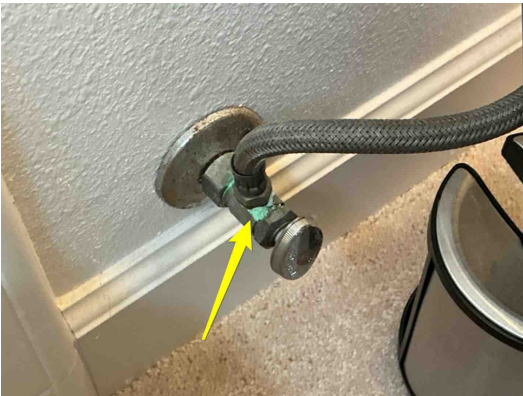
**FI 146:** Evidence of past Leakage with corrosion on the cold water supply valve at the toilet: GUEST BEDROOM BATHROOM

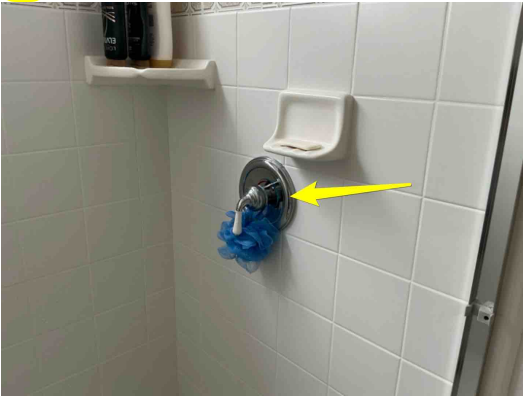
**SU 154:** Hot & cold reversed at the shower faucet: HALLWAY BATHROOM

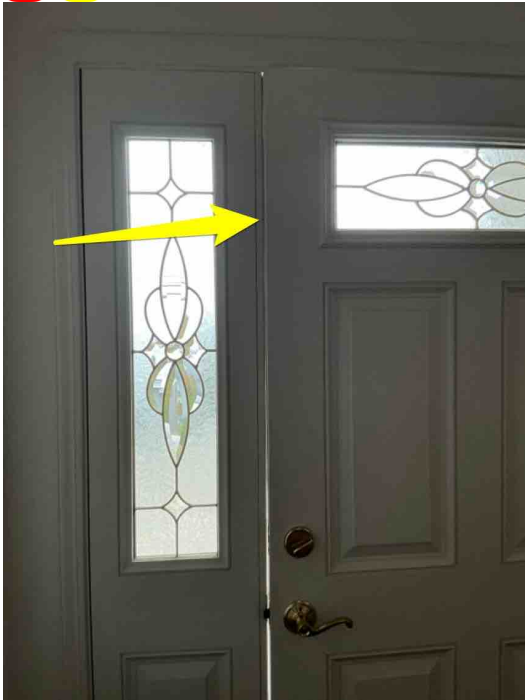
**E&C** **SU** **158:** Front entry door rubs & sticks a little. Maintenance or servicing recommended.

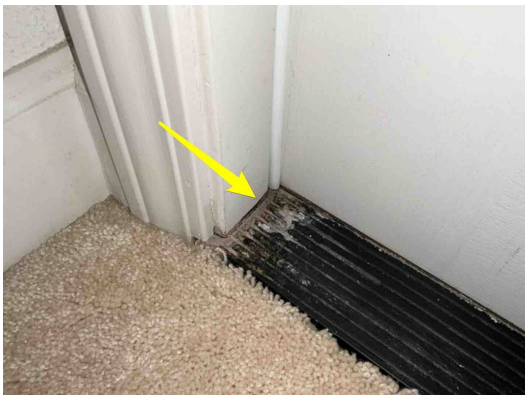
**FI** **159:** Evidence of past minor water intrusion from around the BACKYARD exterior door with stains on the interior.

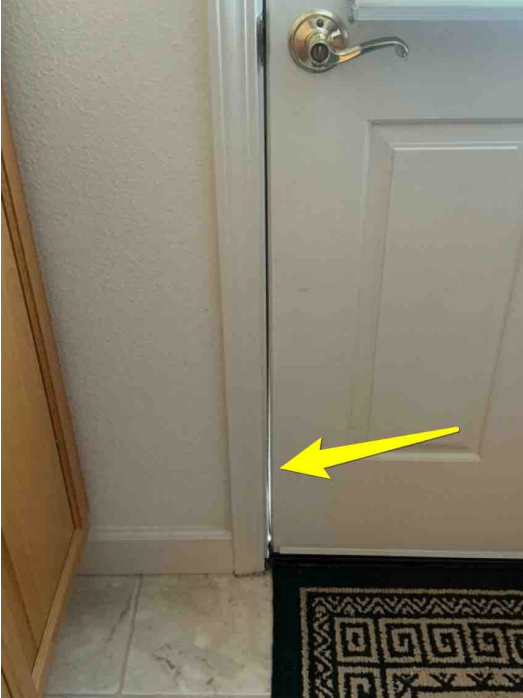
**MR 160:** Visible daylight noted around some of the exterior doors. Adjustment and/or repair of the weather stripping is recommended to help prevent water and critter intrusion.

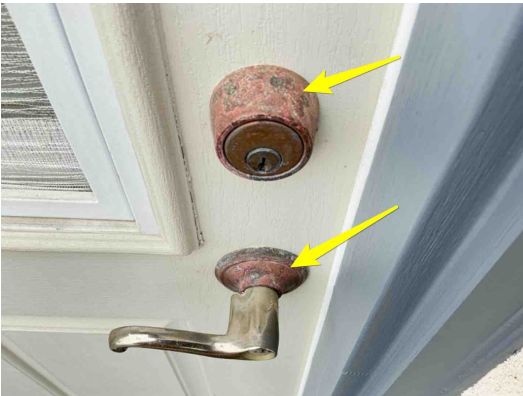
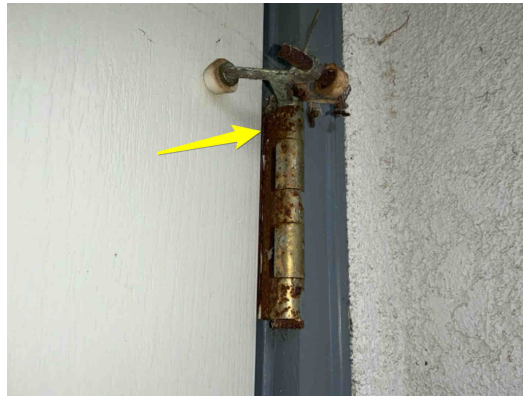
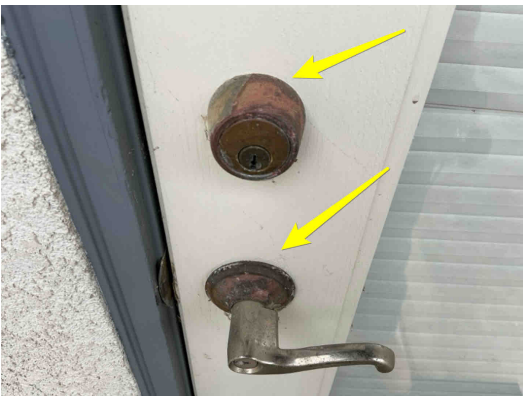
**MR 161:** Deteriorated / corroded door latching hardware and/ or hinges noted at exterior doors. Maintenance recommended.

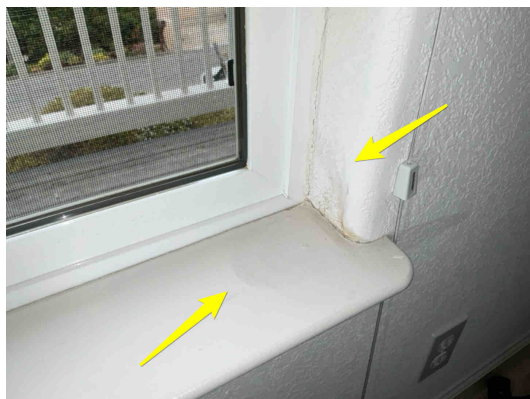
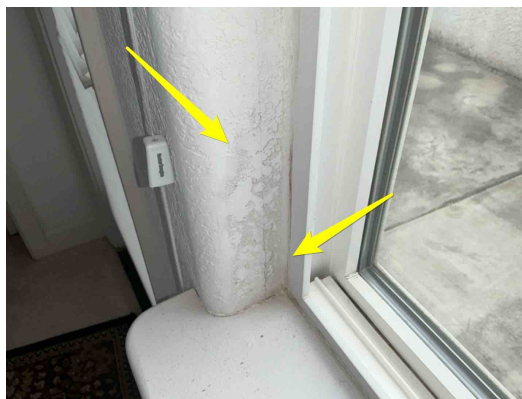
**FI 167:** Moisture stains and/or damage on the inside at some window sills. Refer to the termite report for additional comments and recommendations.

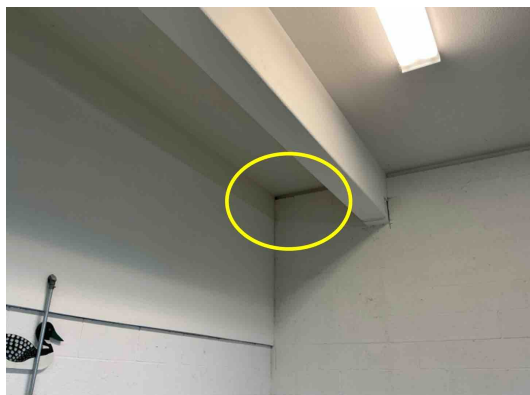
**FI 180:** Evidence of past moisture stains & damage at ceiling area in the GARAGE (southeast corner). Recommend further review of the water stains to determine the cause, the current condition and if repairs are needed.

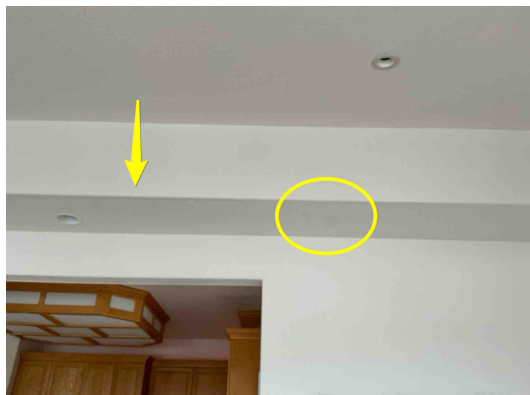
**FI 181:** Evidence of past moisture stains & damage at ceiling area in the LIVING ROOM. Recommend further review of the water stains to determine the cause, the current condition and if repairs are needed.

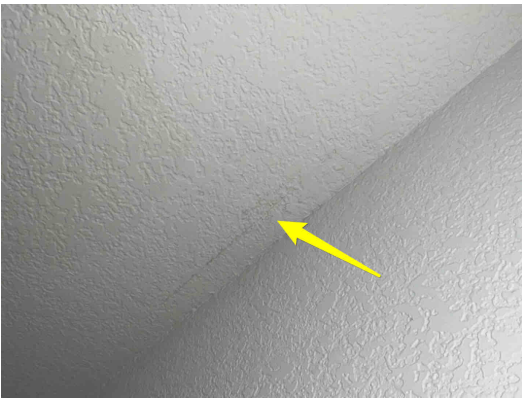
**FI 182:** Evidence of past moisture stains & damage at ceiling area in BEDROOM-2. Recommend further review of the water stains to determine the cause, the current condition and if repairs are needed.

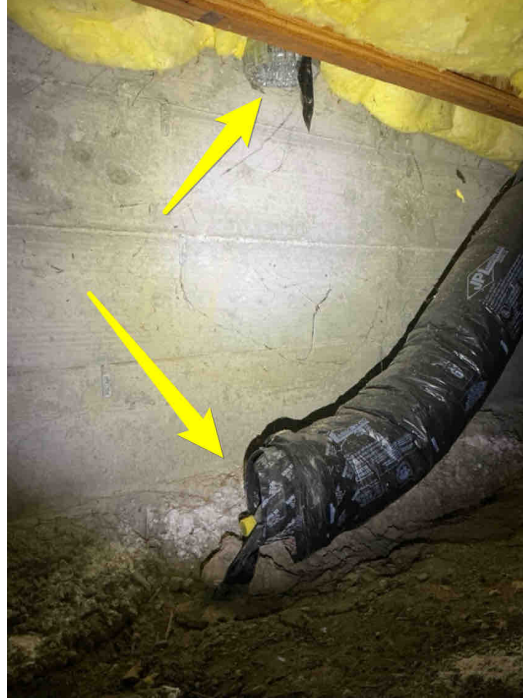
**E&C 195:** Disconnected and damaged heating ducting found in the crawlspace below BEDROOM-2. Correct pions recommend.

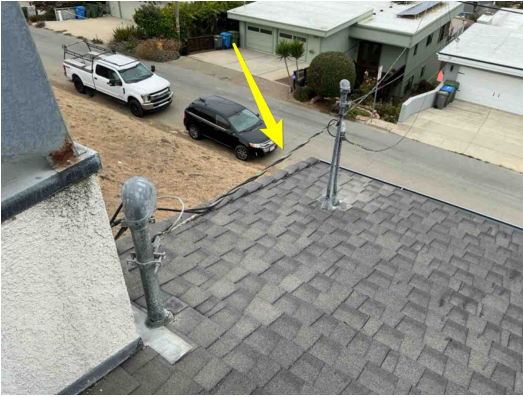
**SC 202:** The overhead electrical service wires found to be improperly installed and are considered unsafe as the wires are hanging too close to the ROOF. A minimum of (18 inches.) needed above a roof for safety per standards. Recommend further review and repair by a qualified and licensed professional familiar with the minimum installation requirements.

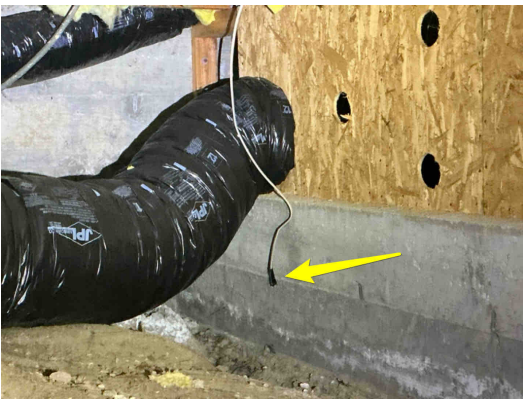
**SC 205:** Improper electrical wiring. Exposed electrical wires and/or splices not protected in a box with a cover:  
CRAWLSPACE BELOW BEDROOM-2
