WOOD DESTROYING PESTS AND ORGANISMS INSPECTION REPORT

141 W. 12th St

Building No. 141	Street West 12th Street	City Chico	Zip 95928	Date of Inspection 1-25-22	Number of Pages 4
----------------------------	-----------------------------------	----------------------	---------------------	--------------------------------------	-----------------------------

REGISTRATION # PR 3101	REPORT # 122-141 WE	ESCROW # n/a
Ordered by: Nancy Campos	Property Owner and/or Party of Interest: Campos Rentals, Chico, CA n/a	Report sent to: Mike & Nancy Campos

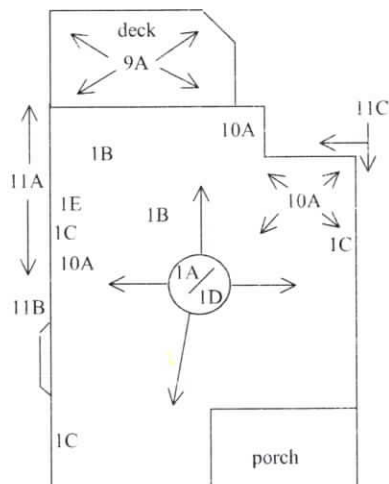
DIAGRAM NOT TO SCALE

work done
re inspection
on May 4th
