**Inspection
Service Inc.**

Exclusive Property Inspection Report Prepared For

Property Address: 12 Arrowhead Ln. Rolling Hills Estates CA.

Inspection Date: 1/6/2024

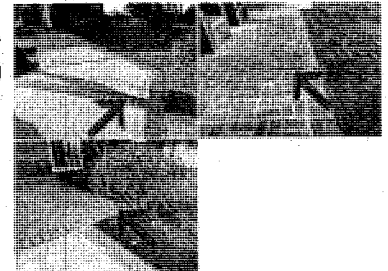
- Uneven surface joints are visible at multiple locations along the front and rear walkways. The condition poses a trip hazard. We recommend correction using appropriate methods by a qualified concrete and masonry contractor.

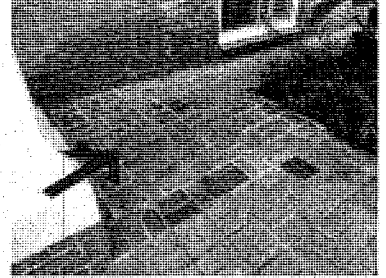
- Moss is visible on the surface of the front walkway. The condition poses a slip hazard. Removal of the moss is recommended.

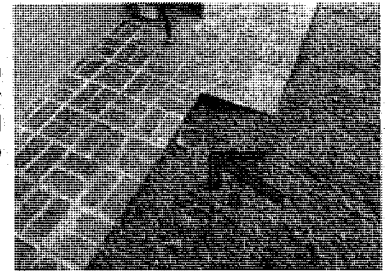
- A sub surface drainage system is installed at the right side yard adjacent the building. Determining the condition of the underground drains and location of the drain terminations is beyond the scope of this inspection, therefore not inspected. Water testing is beyond the scope of this inspection. Further evaluation by a qualified specialist should be considered. We also recommend consulting with the seller to confirm the location of drain terminations.

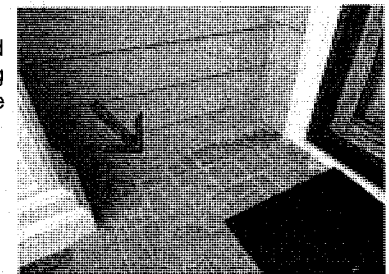
- The surface is installed over the exterior wall siding. Moisture entrapment and subsequent damage can occur as a result. We recommend correction using appropriate methods by a qualified masonry contractor. Determining if any damage exists within the walls as a result is beyond the scope of this inspection.

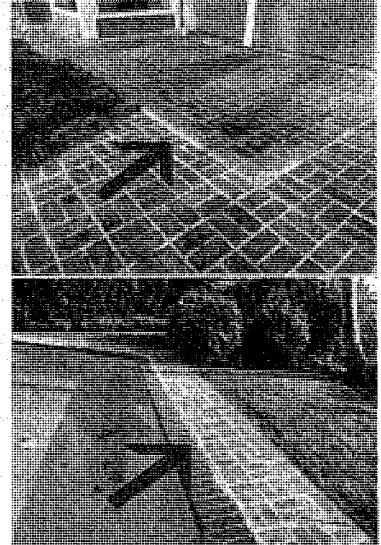
- Uneven surface joints are visible at multiple locations. The condition poses a trip hazard. We recommend correction using appropriate methods by a qualified masonry contractor. We also recommend further evaluation by a qualified geo-technical engineer to determine if the damage is caused by any adverse geological conditions.

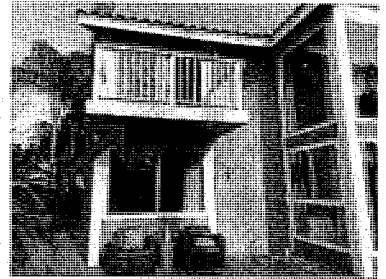
- The underside of the balcony deck is enclosed. A means to ventilate and / or drain the enclosed space is absent. This type of installation is inherently problematic as lack of ventilation can cause adverse moisture related conditions within the concealed space. Current construction standards require the enclosed areas to be ventilated both to prevent condensation and to allow any leakage to drain out. Determining the condition of the concealed areas is beyond the scope of this inspection due to inaccessibility. We recommend correction using appropriate methods. We also recommend further evaluation / cost estimate for corrections by a state licensed contractor who is qualified to perform work on these systems / components.

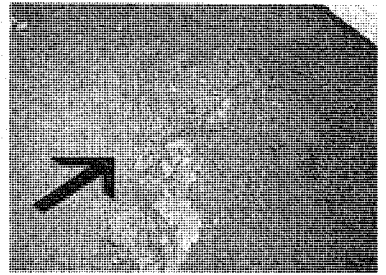
- Crack damage is visible to the surface. The condition is conducive to moisture intrusion and subsequent damage. We recommend correction using appropriate methods by a qualified waterproofing / elastomeric coating specialist.

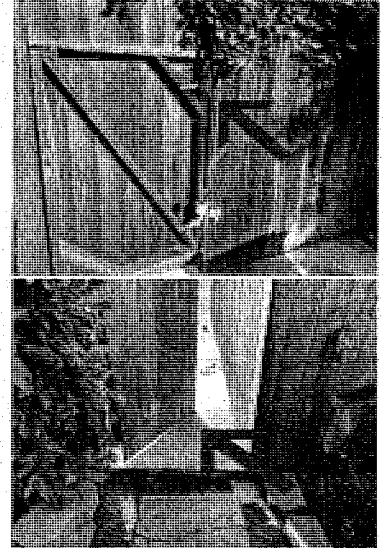
- The hinges are loose on the left side gate which is causing the bottom of the gate to rub on the patio surface. We recommend correction using appropriate methods.

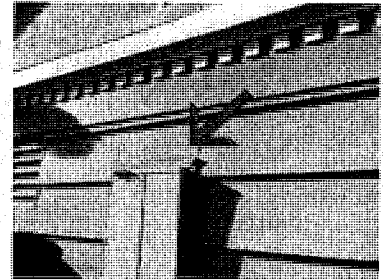
- Flashings are absent at the horizontal joints where repairs have been made to the siding at the left side exterior wall. The condition is conducive to moisture intrusion and subsequent damage. We recommend correction using appropriate methods by a qualified siding specialist.

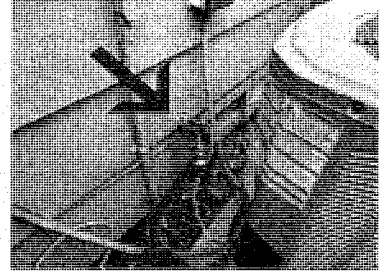
- Flashings are absent where each of the cooling system refrigerant line sets transition into the exterior wall. The condition is conducive to moisture intrusion and subsequent damage. We recommend correction using appropriate methods by a qualified siding specialist.

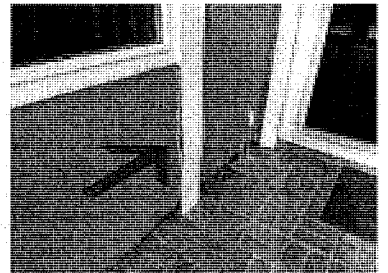
- Warped wall trim at the rear exterior wall. The trim is likely not an appropriate material for exterior location. Replacement with an appropriate installation is recommended.

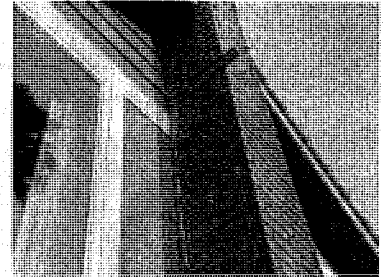
- Separation is visible between the chimney and exterior wall at the living room fireplace. The condition may indicate movement of the chimney has occurred. Further evaluation by a qualified chimney specialist is recommended. We also recommend further evaluation by a qualified geo-technical engineer to determine if the damage is caused by any adverse geological conditions.

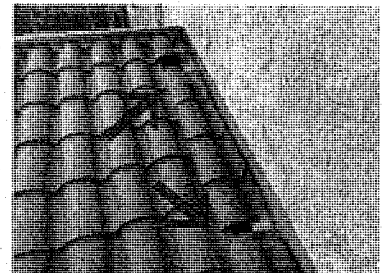
- Loose tiles that have slid are visible at multiple locations. The condition is conducive to moisture intrusion and subsequent damage. We recommend correction using appropriate methods by a qualified roofing contractor.

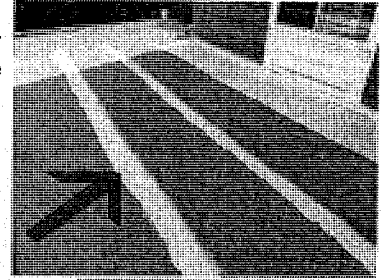
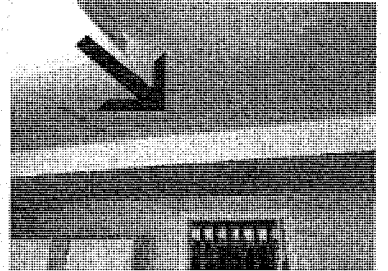
- Patching is visible to the garage roof material which is likely an attempt to repair leakage as moisture related damage is visible to the ceiling cladding below. We recommend further evaluation / correction using appropriate methods by a qualified roofing contractor.

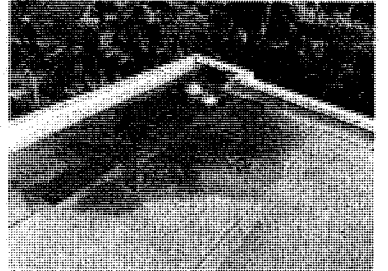
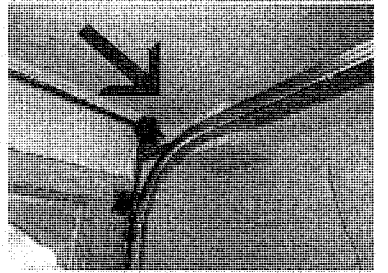
- Standing water is visible on the garage roof adjacent the roof drain. Moisture related damage is visible to the ceiling cladding below which likely indicates a leakage condition exists. We recommend further evaluation / correction using appropriate methods by a qualified roofing contractor.

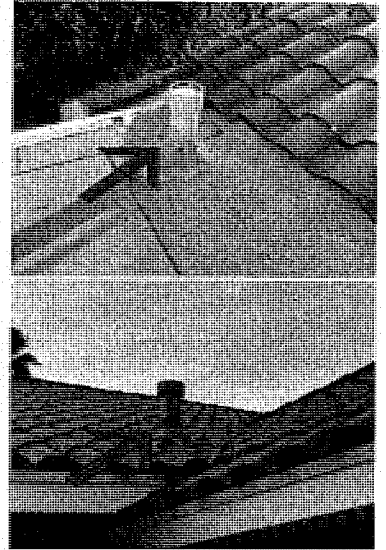
- Storm collars are absent where the furnace and water heater vent pipes transition through their flashings. The condition is conducive to moisture intrusion and subsequent damage. We recommend correction using appropriate methods by a qualified roofing contractor.

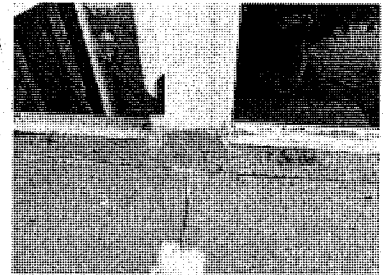
- Flashing is absent at the garage roof to exterior post interface. The condition is conducive to moisture intrusion and subsequent damage. We recommend correction using appropriate methods by a qualified roofing contractor.

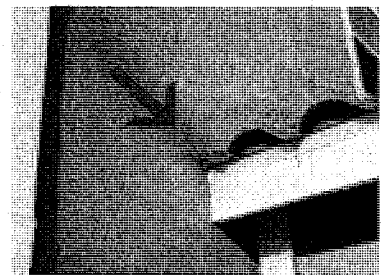
- Kickout flashings are absent at the roof eave to sidewall interfaces. The condition is conducive to moisture intrusion and subsequent damage. We recommend correction using appropriate methods by a qualified roofing contractor.

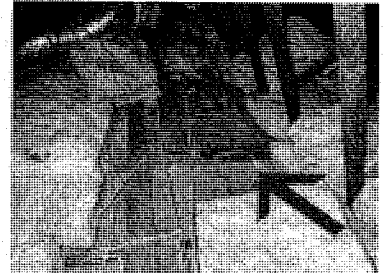
- Insulation has been moved away at multiple locations. The condition is conducive to thermal loss from the interior living space. We recommend moving the insulation back into place.

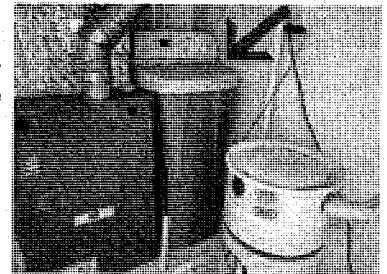
- A water softener system is installed which is beyond the scope of this inspection, therefore not inspected. Water quality and condition is not determined. Further evaluation by a qualified state licensed plumbing contractor who is familiar with these types of systems is recommended.

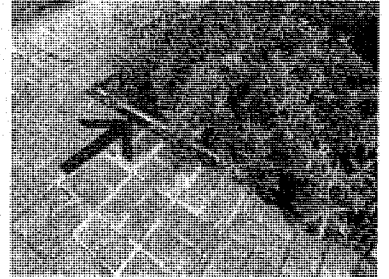
- The main line is exposed therefore such to damage as viewed at the front planter. We recommend correction using appropriate methods by a qualified plumbing contractor.

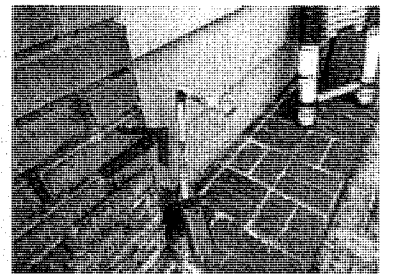
- Pipe support is absent from a hose faucet at the front exterior wall, therefore the pipe is subject to damage and subsequent leakage. We recommend correction using appropriate methods.

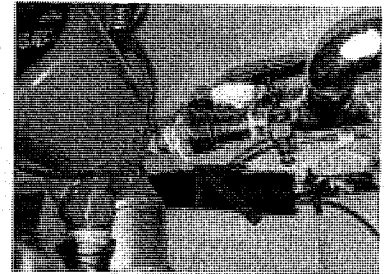
- Corrosion related damage caused by leakage is visible on the water shut off valve. Replacement of the valve by a qualified plumbing contractor is recommended.

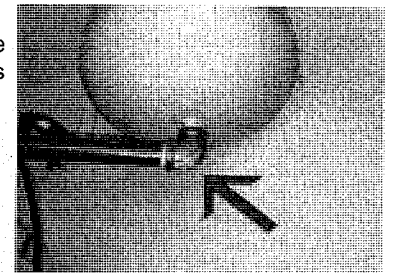
- Corrosion related damage caused by leakage is visible to a pipe fitting at the expansion tank. Replacement of the fitting by a qualified plumbing contractor is recommended.

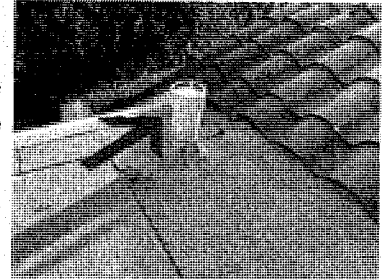
- The vent pipe was not replaced when this water heater was installed. The existing transite pipe may not heat fast enough to establish a draft. A vent pipe that does not draft properly poses a carbon monoxide poisoning hazard from potential spillage of hazardous exhaust gases into the building. Condensation can also form inside the transite pipe which could cause damage to the vent system. Replacement with an appropriate installation by a qualified plumbing contractor is recommended. Refer to the water heater manufacturers installation manual for vent piping installation instructions.

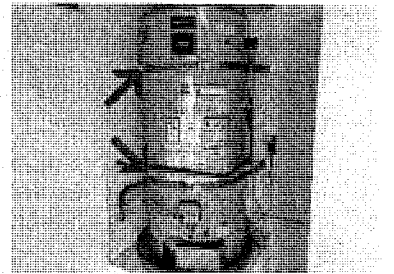
- There are only two seismic straps installed. Three seismic straps are required for 75 gallon tanks. Approved seismic restraints should be installed in the upper 1/3 and lower 1/3 of the tank with a 4" clearance to the gas control with an additional mid height strap to prevent lateral movement of the tank. We recommend correction using appropriate methods by a qualified plumbing contractor.

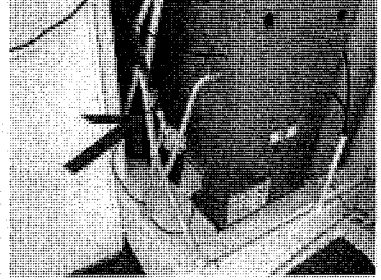
- There are no sediment traps at the gas lines supplying each heater. The purpose of a sediment trap is to catch potential debris that could clog and block an automatic gas valve in the open position, preventing the appliance from shutting off. A gas valve blocked in the open position poses a risk of fire hazard. We recommend correction using appropriate methods by a qualified Warm-Air Heating, Ventilating and Air-Conditioning contractor. Refer to the heater manufacturers installation manual for gas piping installation instructions.

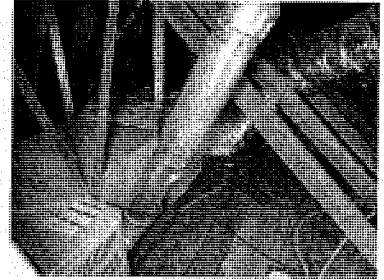
- Type B vent piping is cut to make a joint which is improper as viewed at the upstairs heater. Spillage of hazardous exhaust gases can occur as a result, therefore a carbon monoxide poisoning hazard exists. Type B vent piping should utilize factory made snap lock joints. We recommend correction using appropriate methods by a qualified Warm-Air Heating, Ventilating and Air-Conditioning contractor.

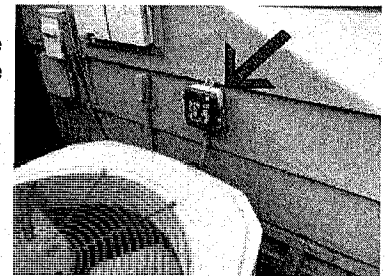
- Edison Co. metering devices are installed at each condenser unit which is beyond the scope of this inspection, therefore not inspected. We recommend contacting the Edison Co. for information regarding the devices.

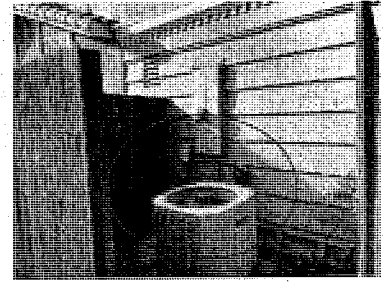
- A condenser unit encroaches within the 30"x36" dedicated equipment space which blocks proper access to the main electrical panel. We recommend correction using appropriate methods by a qualified Warm-Air Heating, Ventilating and Air-Conditioning contractor.

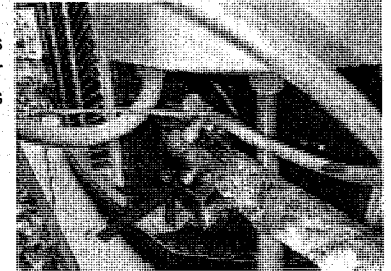
- Locking-type tamper-resistant caps are absent from the refrigerant circuit access ports. We recommend correction using appropriate methods by a qualified Warm-Air Heating, Ventilating and Air-Conditioning contractor to prevent unauthorized access resulting in injury.

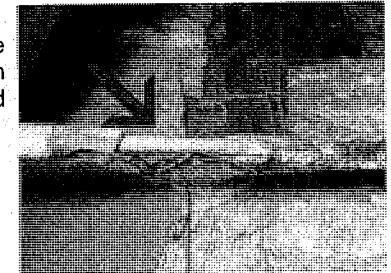
- Damaged pipe insulation is visible on a portion of the line set in the attic. The condition could reduce the efficiency of the system. Moisture caused by condensation can also drip onto the ceiling from the exposed pipe. Replacement of any damaged insulation is recommended.

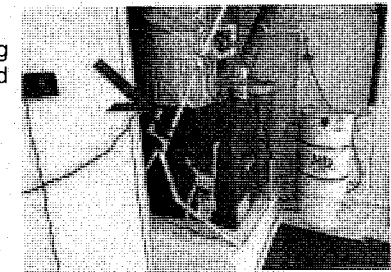
- An unused open pipe is visible on the condensate drain at the downstairs cooling system. We recommend correction using appropriate methods by a qualified Warm-Air Heating, Ventilating and Air-Conditioning contractor.

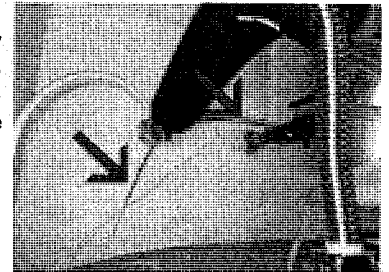
- The gauge of the bonding jumper wire is too small at the water heater, therefore may not function as intended. The bonding jumper wire should be of the same gauge as the service grounding electrode conductor. The function of the bonding jumper is to prevent electrical shock hazards in the event the water and gas pipes become energized. We recommend correction using appropriate methods by a qualified electrical contractor.

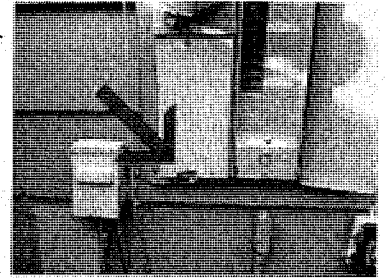
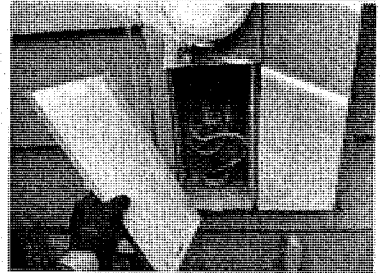
- A utility company locking device is absent from the underground service weather cover. The purpose of a locking device is to prevent unauthorized access to the high voltage service wiring. The condition poses an electrical shock hazard. We recommend contacting the electric utility company that serves power to the building for further evaluation and correction.

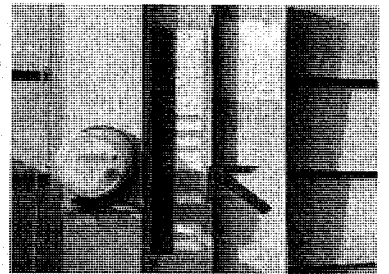
- The circuit breakers lack complete location labeling. We recommend that each breaker be properly labeled to allow persons to identify them for safe operation when and if necessary. We recommend further evaluation / correction using appropriate methods by a qualified electrical contractor.

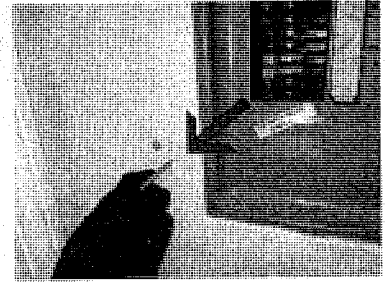
- Sharp pointed screws are used to secure the dead front cover which is an improper installation. The screws can potentially pierce the wiring within the panel. We recommend correction using appropriate methods by a qualified electrical contractor.

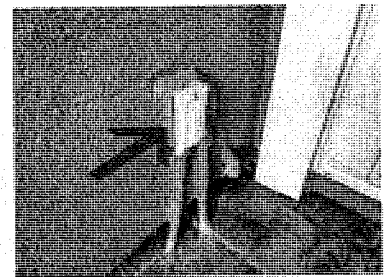
- Receptacle and weather cover are loose from the outlet box at the rear exterior wall. The condition poses an electrical shock hazard. We recommend correction using appropriate methods.

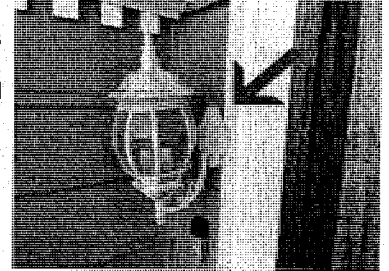
- Plinth blocks are improperly installed, therefore gaps exist between the exterior walls and light fixtures at the main entry porch. Moisture can seep into the outlets as a result, therefore an electrical shock and risk of fire hazard exists. We recommend correction using appropriate methods by a qualified electrical contractor.

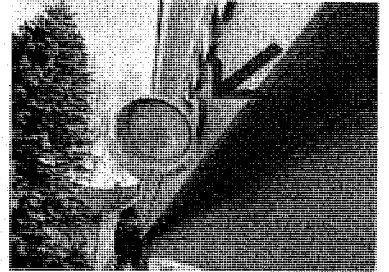
- Outlet box is not an appropriate type for installation outdoors as viewed at the garage front exterior wall. Moisture can seep into the box as a result, therefore an electrical shock and risk of fire hazard exists. Replacement with an appropriate installation by a qualified electrical contractor is recommended.

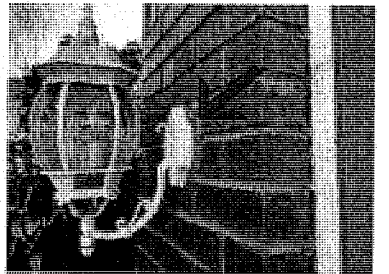
- Weather gaskets are absent from multiple exterior wall fixtures. Moisture can seep into the outlets as a result, therefore an electrical shock and risk of fire hazard exists. We recommend correction using appropriate methods by a qualified electrical contractor.

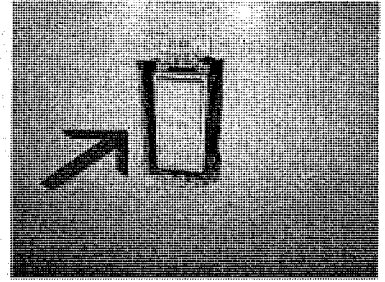
- Protection cover is absent from a switch at the kitchen. The condition exposes the energized switch components, therefore an electrical shock hazard exists. Replacement of any absent protection covers is recommended.

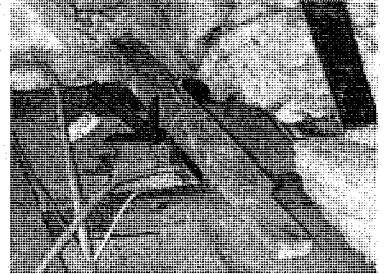
- The outlet box for the main entryway hanging fixture is supported by wires wrapped around wood boards. The condition is an improper installation that can make the fixture support unstable. We recommend correction using appropriate methods by a qualified electrical contractor.

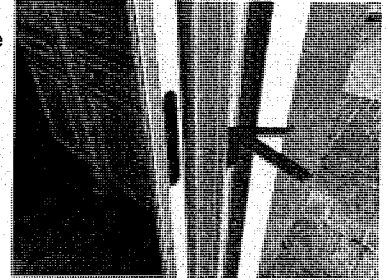
- The latch on the kitchen screen door is not functional as there is no receiver. We recommend correction using appropriate methods.
