Address: 1931 Ruhland Ave, Redondo Beach

Date of Inspection: 2-15-23

Name of Inspector: Nemecio "Nemo" Padilla

Main Sewer Line Inspection Report

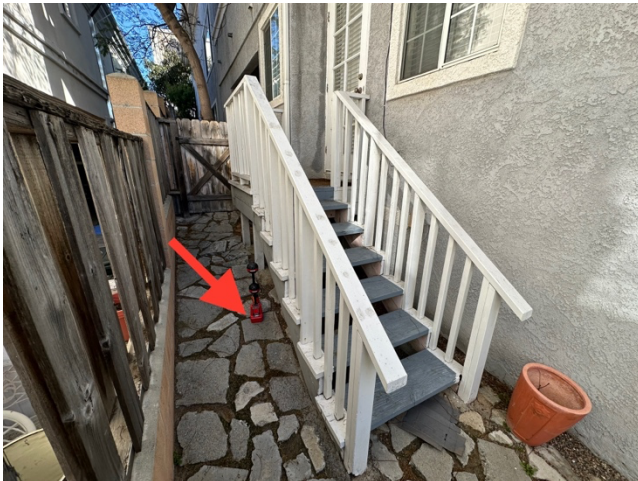
Transition from a cast iron pipe to fiberglass liner.

The rust in the cast iron pipe should be removed at this time, by a specialized machine with a high-speed rotating cable and attachments are able to scrape away build up in cast iron pipe inner walls. Descaling the cast iron pipe may extend the life of the pipe as it will remove some of the rust build up.

We can descale the cast iron pipe for \$200.

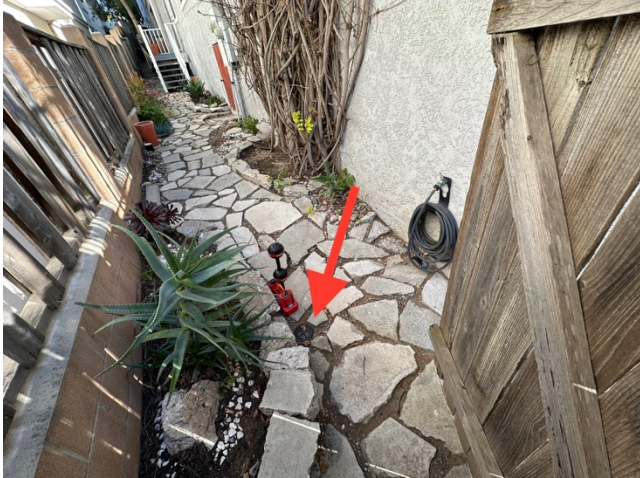
Areas Needing Attention: The transition from plastic to fiberglass lined pipe has roots intruding in through the connection between these two pipe materials. This is a section of pipe which when properly installed will not allow root intrusion. There is also a section within the fiberglass liner that roots are penetrating the fiberglass liner near steps leading the front garage (see pictures for location). This fault in the installation of this pipe might be covered under the warranty for the installation. If so the cost of bringing this up to standard might be covered by the warranty. Otherwise, a contractor should be hired to repair the root intrusion in the fiberglass liner.

Location of root intrusion from fiberglass liner to plastic cleanout. 3' deep.

Estimated Costs for Repairs: To repair the roots coming through the fiberglass liner to plastic cleanout it might cost \$1,600 - \$1,800.

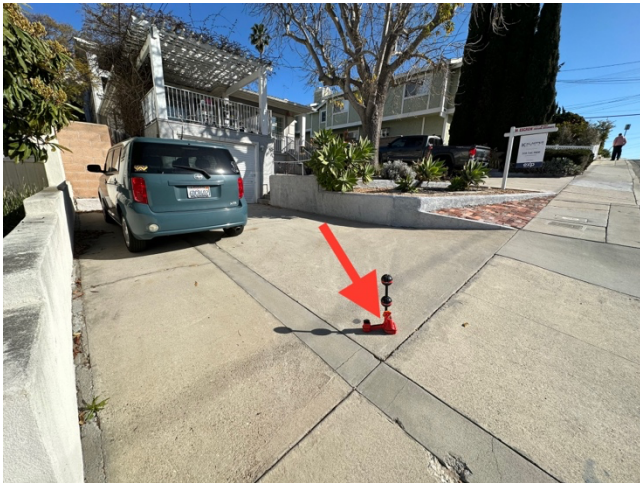
Location where the 1931 and 1931 ½ sewer line tie in together.

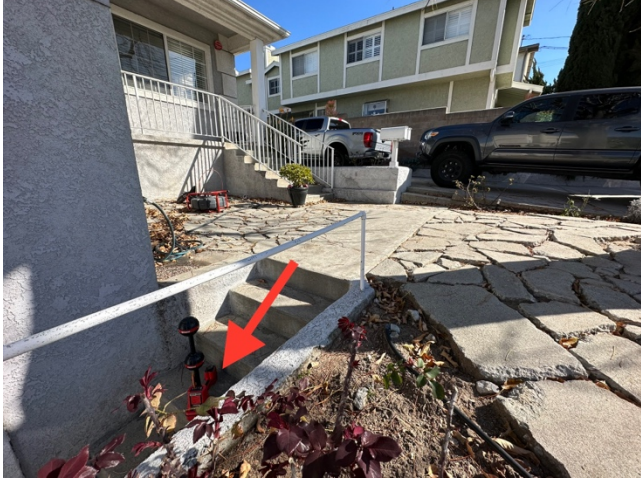
Location of heavy root intrusion in fiberglass liner. 3.5' deep under tool.

To repair/replace the fiberglass liner with root intrusion as it exits the front house it might cost between \$10,000 to \$12,000.

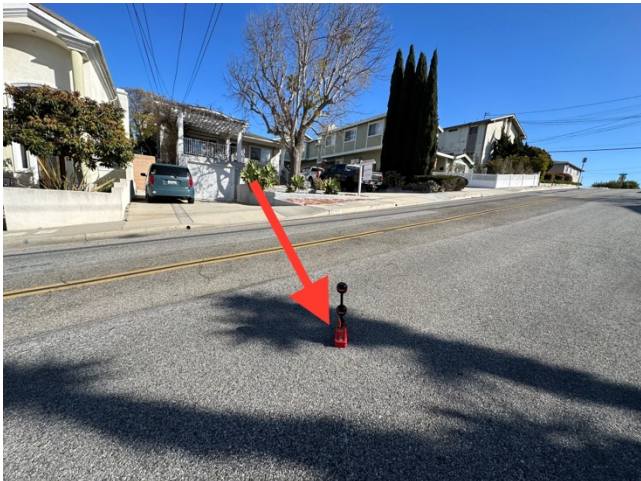
Connection to city sewer under tool.
