# National Property Inspections

Seashine Financial LLC, 22303 Vista Verde Drive, Lake Forest, CA, 92630

Inspection Date:  
01/10/2022

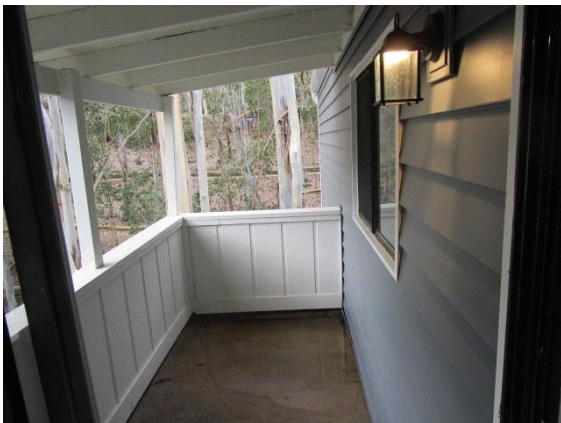
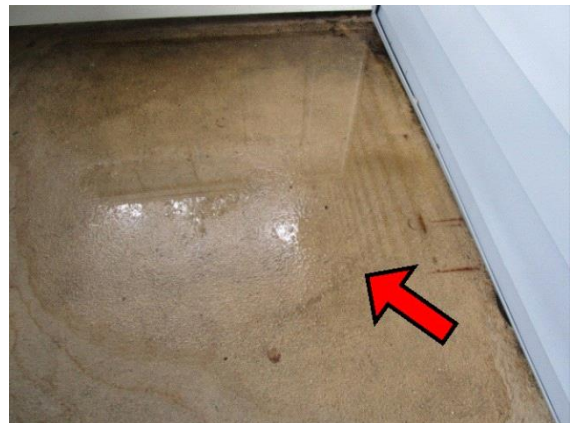
Patio (Second Floor):

- Pooling on patio's concrete floor. Suspect leaking from the interior of house, but no leaks found during this inspection. Has not rain in over a week. Recommend further evaluation/repair by qualified contractor(s).

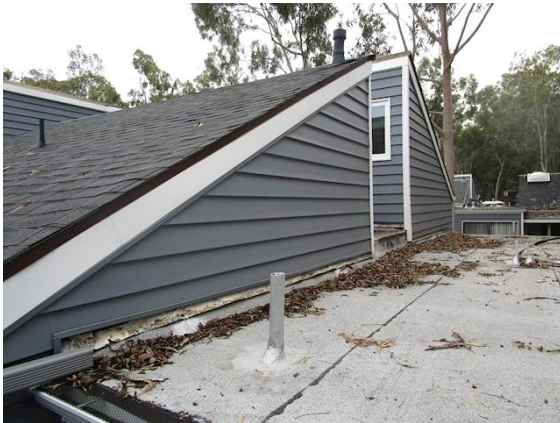
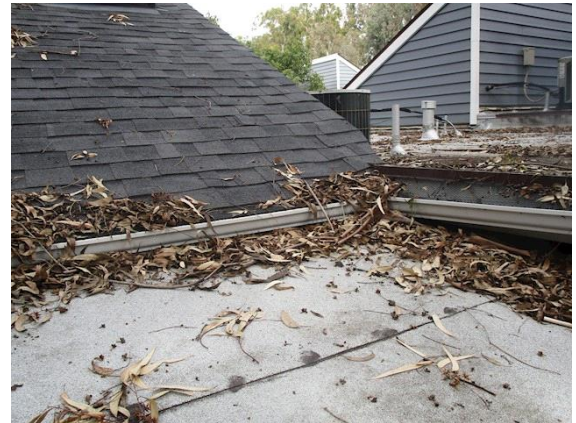
Flashing/Valleys:

- Metal flashing around perimeter of eave was loose and needs repair. Recommend further evaluation/repair by qualified contractor(s).
- Some older/rusty flashings noted which were not replaced at the time of re-roof. Paint and/or seal as necessary. Monitor for leakage and replace/repair as required. Recommend further evaluation/repair by qualified contractor(s).
- Flashing not visible at dormer where shingles meet siding. Recommend further evaluation/repair by qualified contractor(s).
- Kick Out Flashing missing near gutters. Recommend further evaluation/repair by qualified contractor(s).

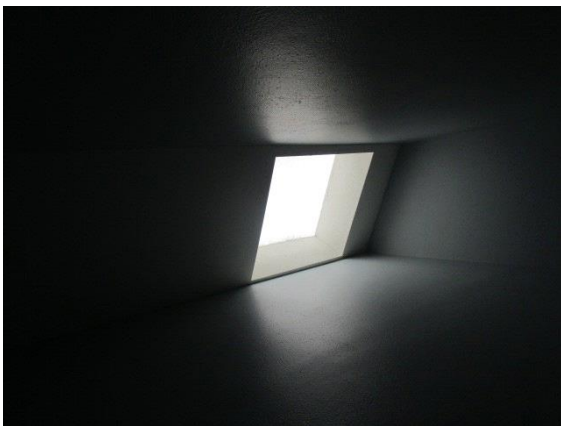
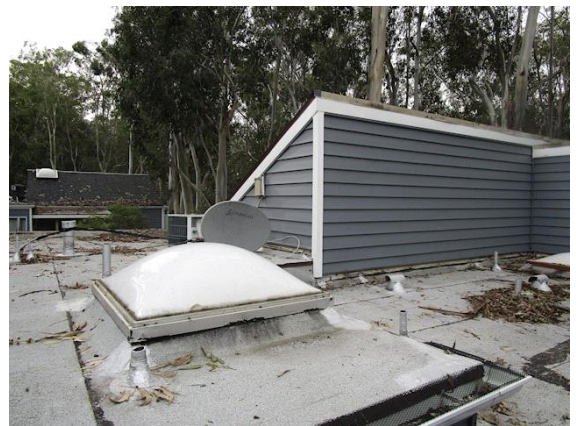
Skylights:

Flashing and caulking around skylights did not appear adequate and water leakage may occur. Skylights had turned hazy. This is normal wear for non glass manufactured skylights.

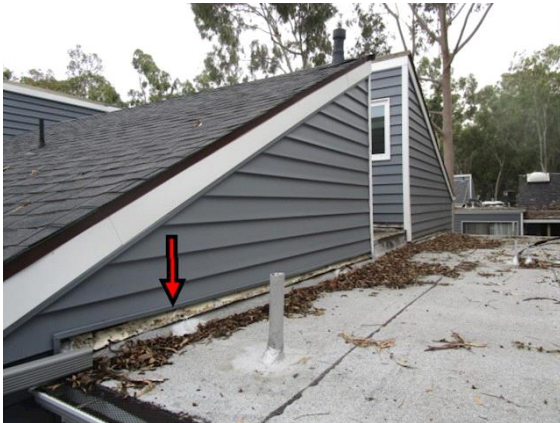
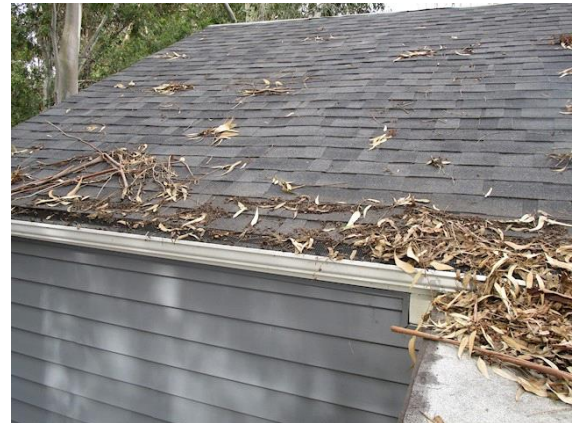
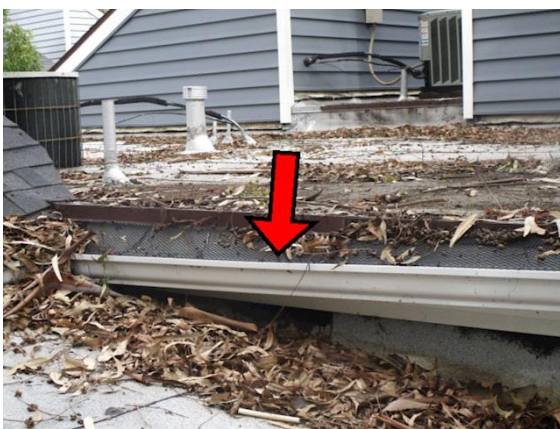
Gutters/Down Spouts:

- Downspouts were discharging close to the foundation wall. Recommend the downspouts have extensions added to a minimum of six (6) feet away from the foundation wall. This could help reduce water pressure against the foundation which could lead to leakage and water related problems at the interior.
- No kick out flashing at the bottom edge of the roof to redirect water into the gutter system and prevent it from getting behind the siding/wall.
- Gutter at east side appeared to be sloping the wrong direction.
- Gutter guards were bent and have debris inside.

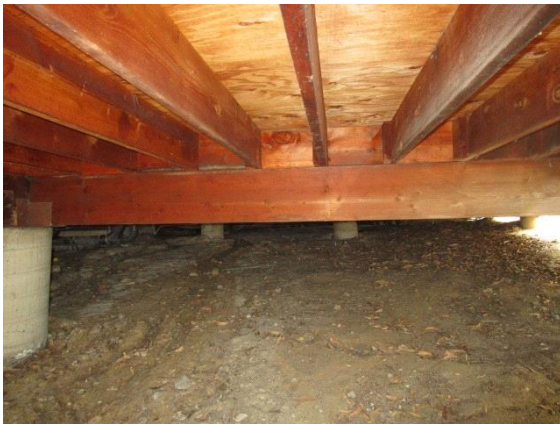
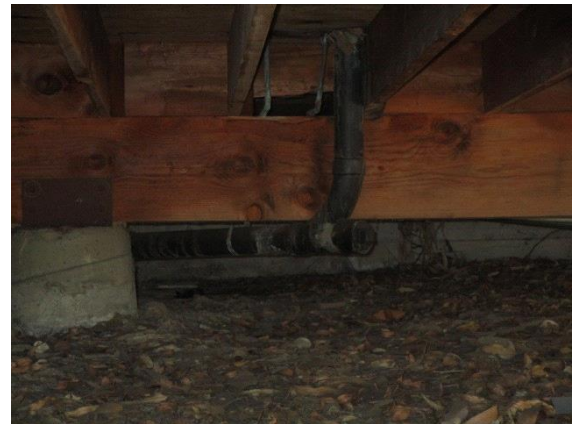
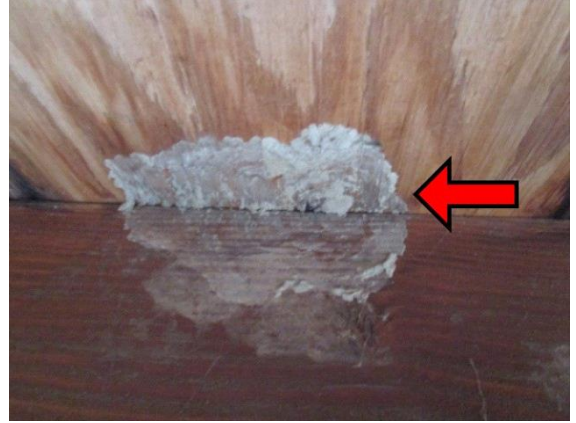
Under Floor Framing & Support:

- There was a white wood mold present on the wood floor joists located in the crawl space. This type of mold eats the pulp of the wood and over time weakens the structural integrity of the wood members. The mold appeared to be just surface mold and could be removed and treated successfully.

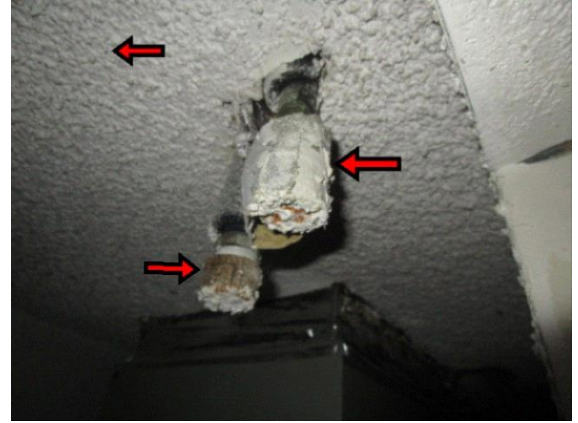
- Exhaust fan was dirty and needs to be cleaned. Recommend further evaluation/repair by qualified contractor(s).
- Ceiling(s) are of the age (vintage) that may contain asbestos. If concerned, should have the ceiling tested by certified lab.
- Two abandoned air ducts noted in the water heater closet, Could not determine if they have been properly abandoned. Recommend further evaluation/repair by qualified contractor(s).
- Two metal pipes noted in the water heater closet with insulation wrapped around piping that have asbestos. Could not determine if they have been properly abandoned. Recommend further evaluation/repair by qualified contractor(s).

Laundry Facilities: Metal piping and stipple ceiling

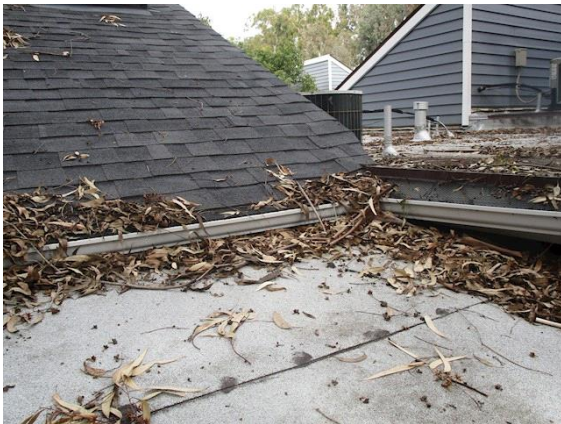
Cooling:

- A/C unit could not be operated due to no entryway found for roof access where the unit is. Recommend further evaluation/repair by qualified HVAC contractor(s).

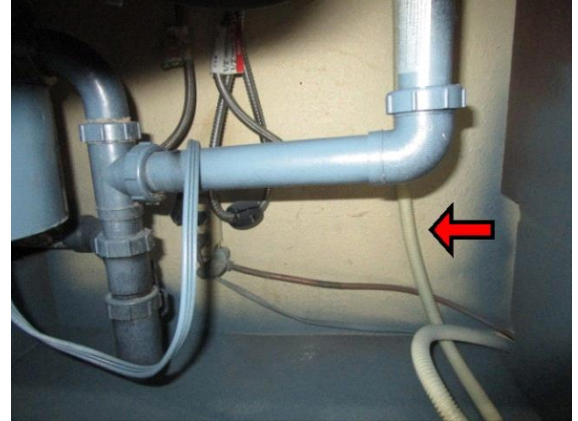
Kitchen: Discharge tube should be mounted

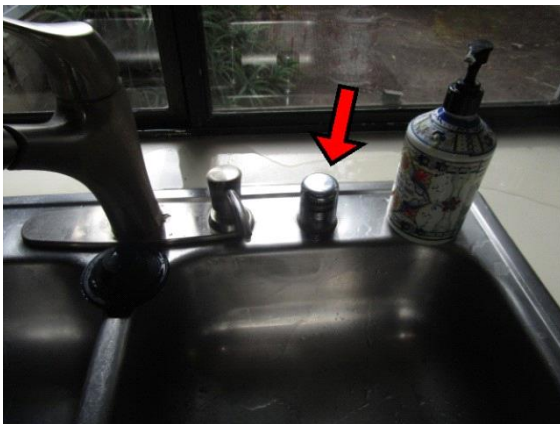
Kitchen: Water leaking from the dishwasher.

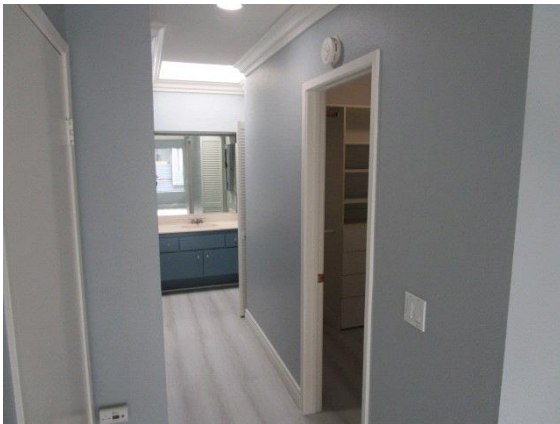
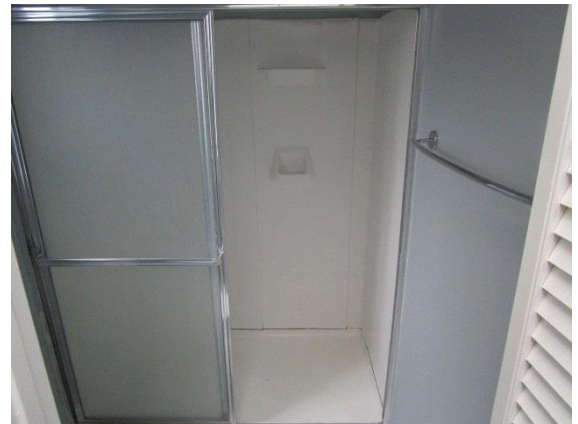
Bathroom 3:

- Holes/damaged screen(s) noted in window. Recommend further evaluation/repair by qualified contractor(s).

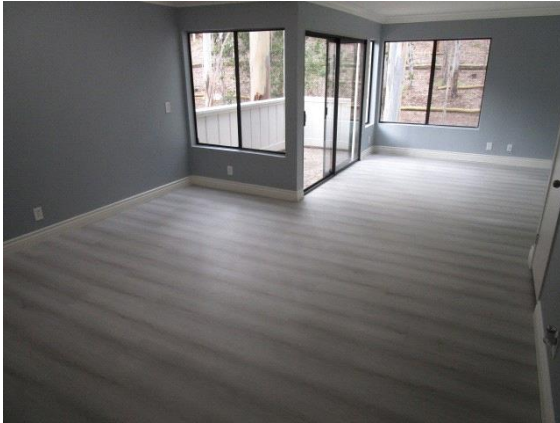
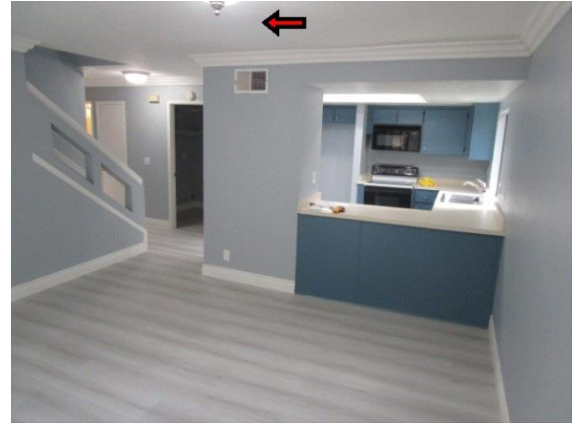
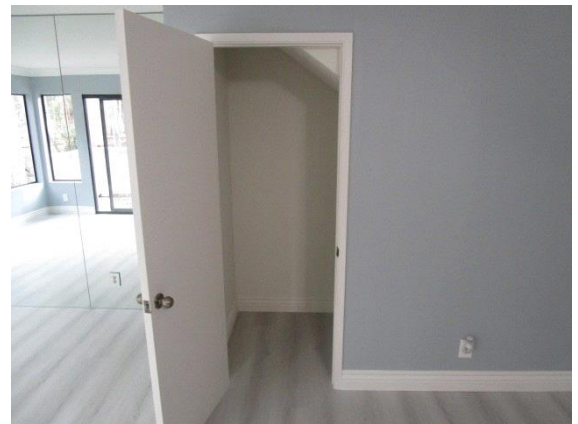
Dining Room:

- Stains observed on ceiling. Possible previous and/or present leak. Noted area tested dry at time of inspection. Recommend monitoring conditions for future possible water intrusion.
- The air distribution was very low. Recommend further evaluation/repair by qualified contractor(s).

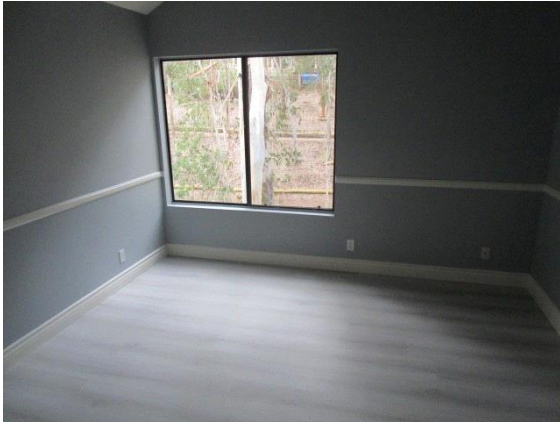
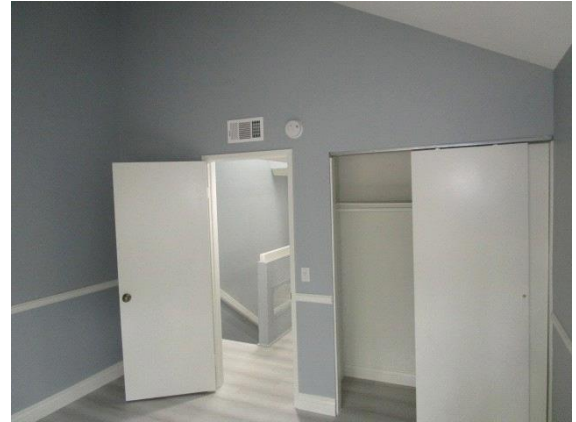
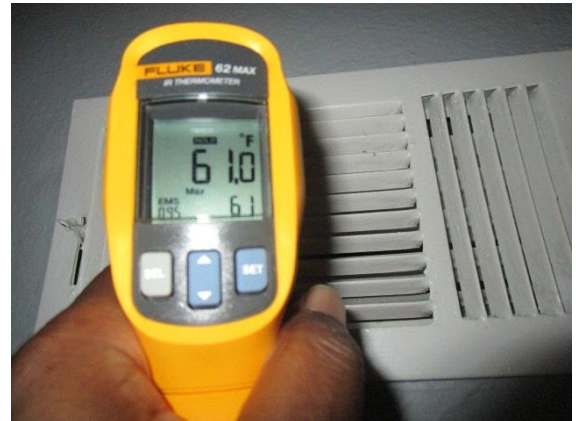
Bedroom 1 :

- Cover plate were loose on outlet. Recommend further evaluation/repair by qualified electrician(s).
- The air distribution was very low. Recommend further evaluation/repair by qualified contractor(s).
