Per home inspection completed on March 31, 2022, for 2214 Curtis Ave., Redondo Beach, CA, the following are the "potentially significant findings" listed on page 3 of "Curtis-Ave-Home Insp3-31-22.pdf". All of the following have been addressed by the home owners and the details are documented on following pages.

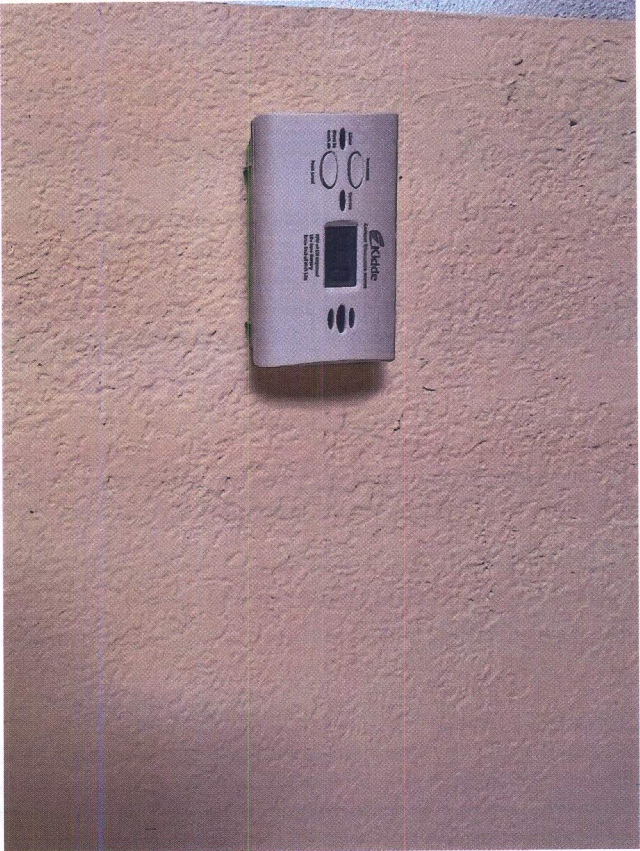
Page 12 Item: 13

- Missing at hall - needs to be installed
- No carbon monoxide detector present - we recommend installation per requirements prior to the close of escrow

- Carbon monoxide detector has been installed outside of the kitchen

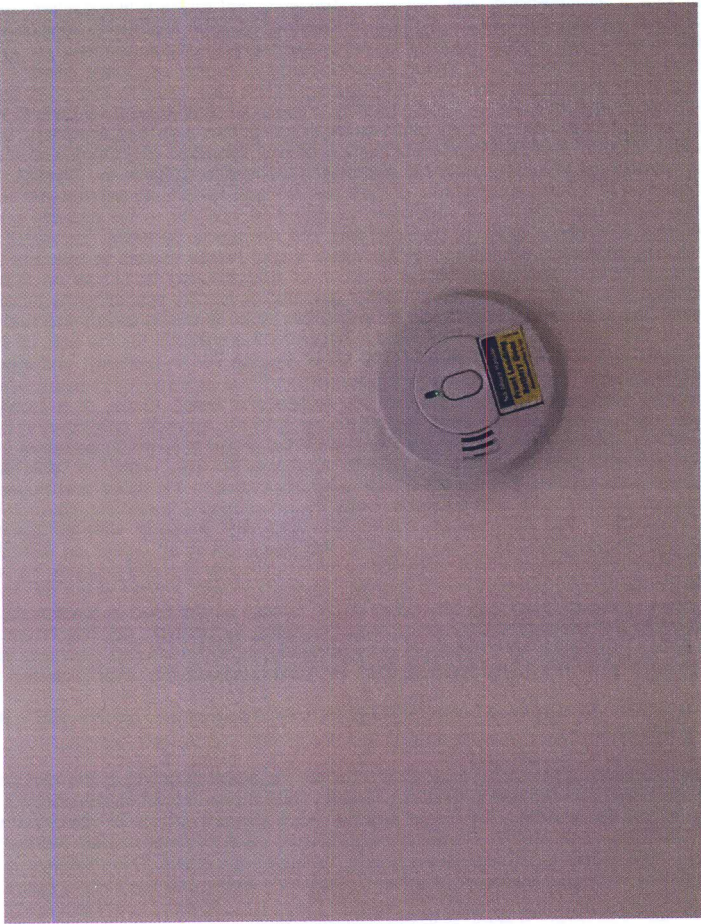
Page 16 Item: 9

• Did not operate - needs to be serviced or replaced

- Brand new smoke detectors have been installed throughout the home.

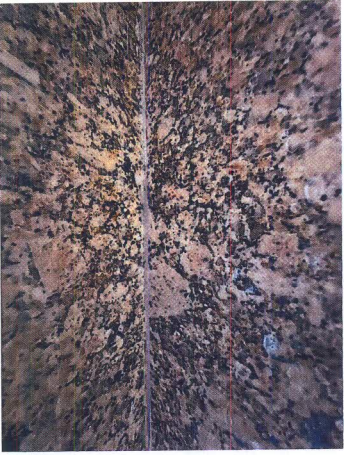
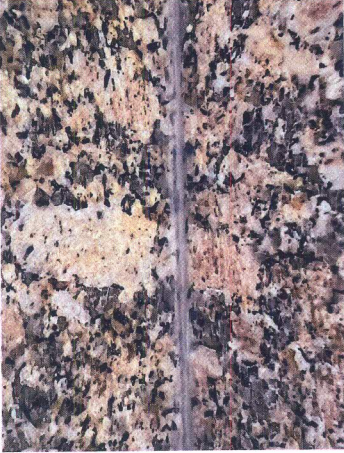
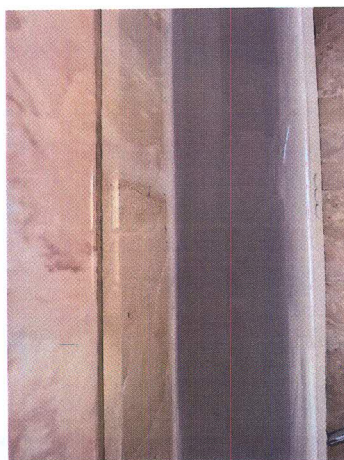
Page 19 Item: 7	Counters	<ul style="list-style-type: none">• Gap at backsplash to countertop joint - needs to be serviced
Page 20 Item: 9	Sinks	<ul style="list-style-type: none">• Hot water above 120 degrees, recommend adjusting the temperature at the water heater
Page 21 Item: 11	Bath Tubs	<ul style="list-style-type: none">• Tub fixture leaks when operated - needs to be serviced
Page 24 Item: 16	Plumbing	<ul style="list-style-type: none">• Visible leaking under spa tub. recommend licensed plumbing contractor for further evaluation and repair• Recommend licensed plumber to further evaluate

- The gap between backsplash and counter has been re-sealed.
- Water heater temperature level has been reset to medium from high
- Spa tub fixtures have been tightened to prevent leaks
- Identified the leak is due to improper seal between the tub and the tile surface. Applied sealant material to this gap all around the tub.

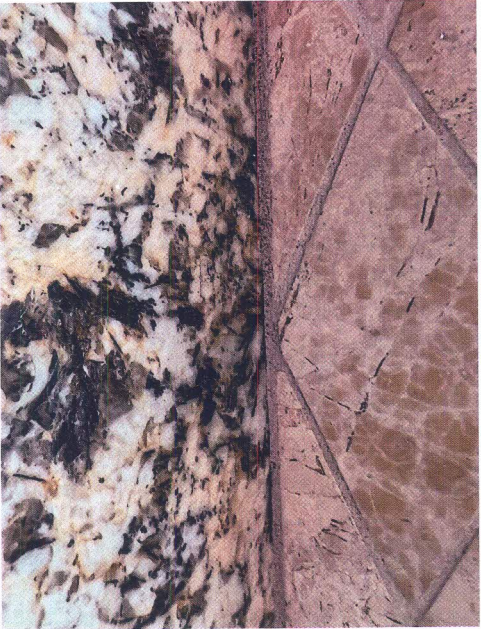
Page 28 Item: 5

- Gap at backsplash to countertop joint - needs to be serviced

- Loose/worn fixture - needs minor maintenance

- Backsplash to counter gap has been re-sealed
- Loose fixture at the sink has been tightened

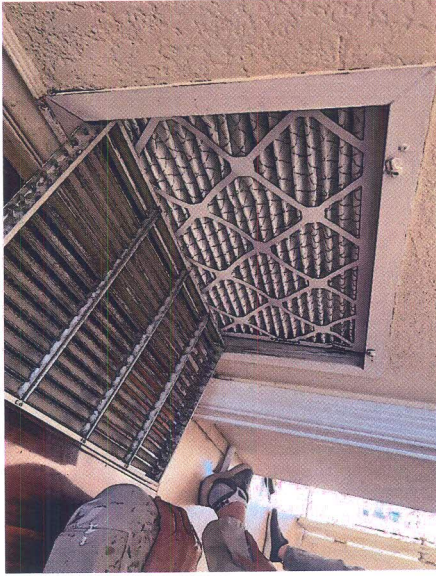
- Missing filter - needs to be serviced

- Installed new filter to the air conditioning vent

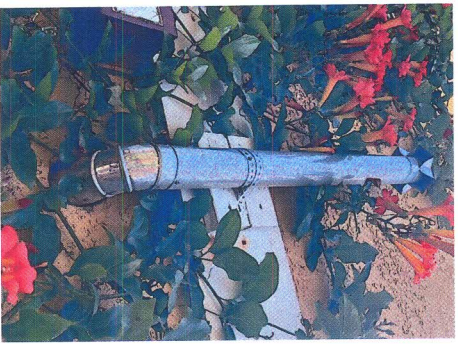
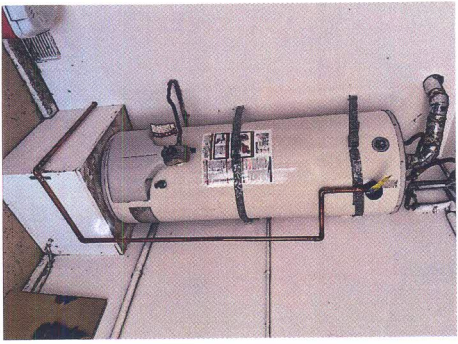
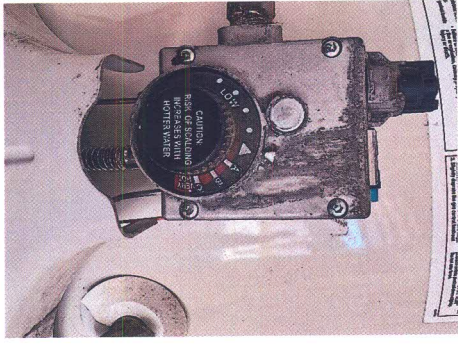
WATER HEATERS		
Page 42 Item: 2	Venting	<ul style="list-style-type: none"> • Vent too close to combustibles - needs to be serviced
Page 43 Item: 5	Overflow Line/s	<ul style="list-style-type: none"> • None - needs to be serviced/installed
Page 43 Item: 6	Water Heater Temperature	<ul style="list-style-type: none"> • Temperature was above 120 F at one or more fixtures within the structure, this a potential scald hazard - needs to be serviced/adjusted - consult a plumber

- Area near water heater has been cleared.
- Visually verified that vent tube has clear passage to the exterior of the house
- New overflow line has been installed
- Water heater temperature level has been reset to medium from high

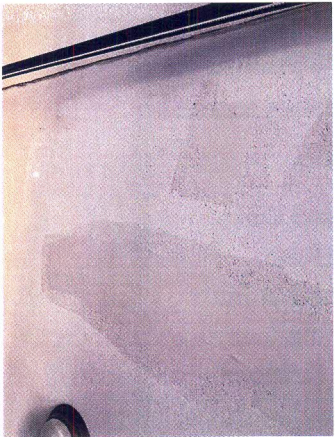
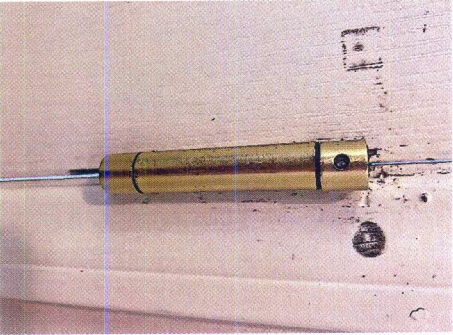
Page 51 Item: 1	Rafters & Ceilings	<ul style="list-style-type: none">• Heavy blistering - needs to be evaluated/serviced
Page 52 Item: 7	Fire Doors	<ul style="list-style-type: none">• Door did not properly self-close and latch - needs to be serviced

- Garage ceiling has been repaired
- Replaced lock and installed self-close mechanism to garage to house fire door
