August 22, 2018

**Re: Limited Asbestos Inspection in an Area Affected by Water Intrusion  
Second Bedroom  
1532 9th Street, Unit 7  
Santa Monica, California 90401**

**Report Number** 1832224

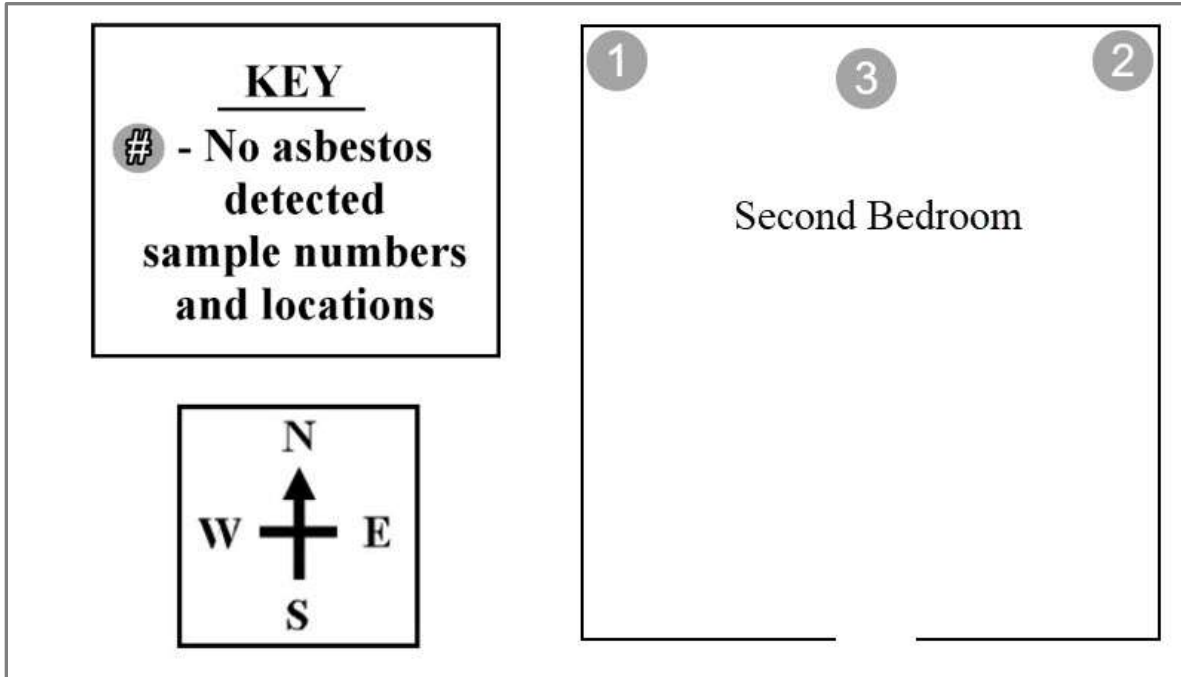
Lab ID and Sample ID	Sample Location	Material Description	Color	Laboratory Results
1832224-001 1	Second Bedroom Ceiling, Northwest	LAYER 1 Joint Compound LAYER 2 Drywall	LAYER 1 Beige LAYER 2 White/Brown	None Detected
1832224-002 2	Second Bedroom Ceiling, Northeast	LAYER 1 Joint Compound LAYER 2 Drywall	LAYER 1 White/Cream LAYER 2 White/Brown	None Detected
1832224-003 3	Second Bedroom Ceiling, North center	LAYER 1 Joint Compound LAYER 2 Drywall	LAYER 1 White LAYER 2 White/Brown	None Detected

The following is a diagram of the asbestos sample numbers and their locations
